# Habitus Fashion Ltd. (Extension 2)

Gajariapara, Bhawal Mirzapur, Gazipur Sadar, Gazipur 1703, Dhaka,

24 December 2025

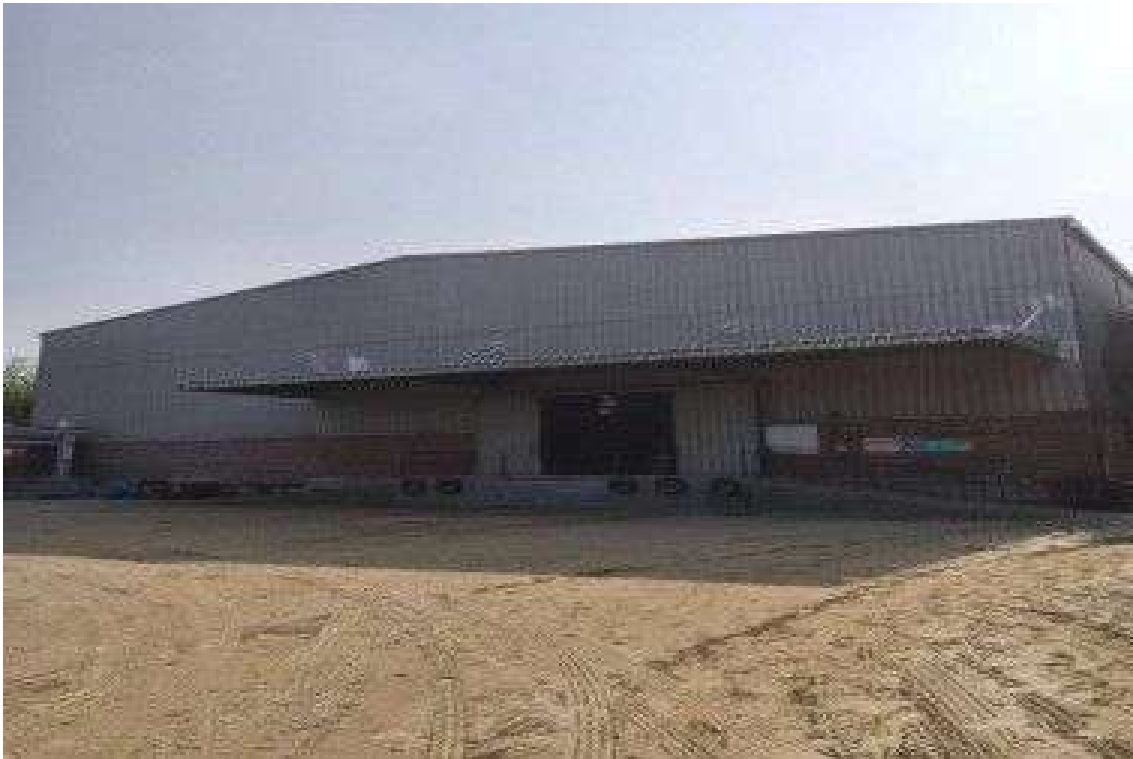
**Serial** : Observation 1  
**Structure Name** : Building-1: Warehouse Shed  
**Observation:**  
Absence of a design report of the shed.

During the inspection, no design documents were available for the Warehouse shed. Building engineer is required to prepare the design report as per Sec 1.9.1 of BNBC 2006.

| Item No | Observation | Action Plan | Timeline |
|---|---|---|---|
| 1 | Absence of a design report of the shed. (Building-1: Warehouse Shed) | Building engineer is required to prepared design report in compliance of sec 1.9.1 of BNBC 2006 | 6 weeks |
| 2 | | Carry out required remedial works where necessary. | 6 months |

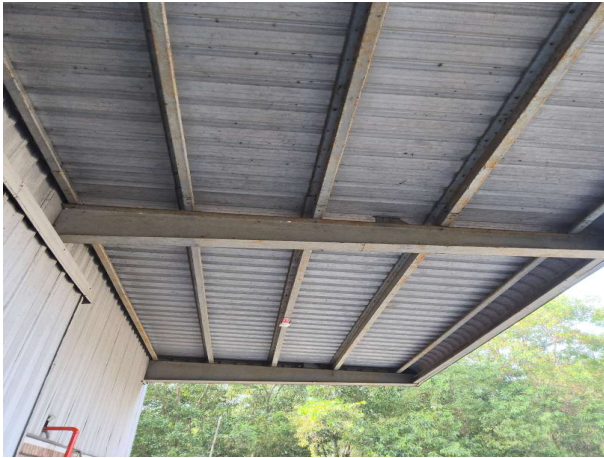
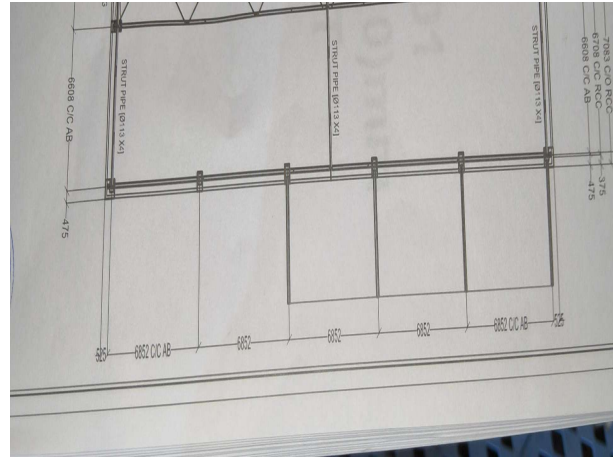
**Serial** : Observation 2  
**Structure Name** : Building-1: Warehouse Shed  
**Observation:**  
 Absence of lateral stability system (bracing resisting system).

No bracing found on the roof canopy system. Building engineer is required to check the requirements of the canopy as part of the design report preparation.

| Item No | Observation | Action Plan | Timeline |
|---|---|---|---|
| 3 | Absence of lateral stability system (bracing resisting system). (Building-1: Warehouse Shed) | Building engineer is required to check the requirements of the canopy as part of the design report preparation. | 6 weeks |

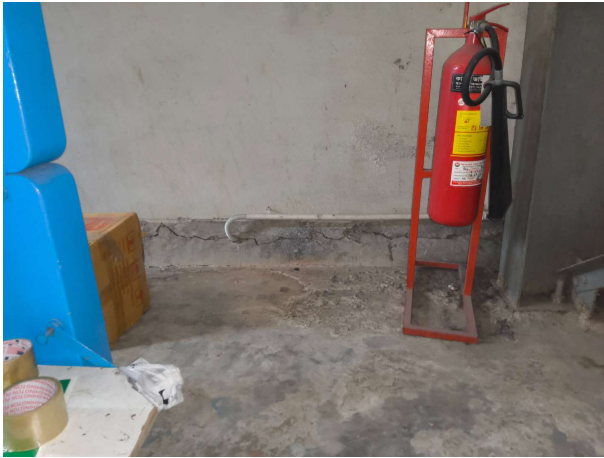
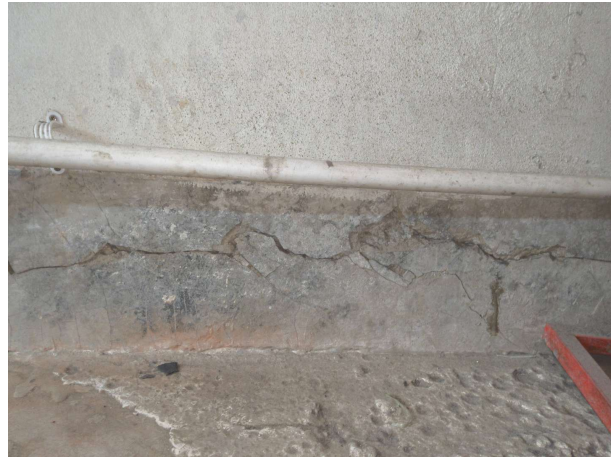
**Serial** : Observation 3  
**Structure Name** : Building-1: Warehouse Shed  
**Observation:**  
Crack in the brick wall joint along the grade beam.

Crack observed in the brick wall along the joint of the grade beam and periphery brick walls. Building engineer is required to investigate the reason of the crack, prepare an investigation report. Repair the cracks as per the investigation report.

| Item No | Observation | Action Plan | Timeline |
|---|---|---|---|
| 4 | Crack in the brick wall joint along the grade beam. (Building-1: Warehouse Shed) | Building engineer is required to investiage the reason of the crack, prepare an investigation report. Repair the cracks as per the investigation report. | 6 weeks |

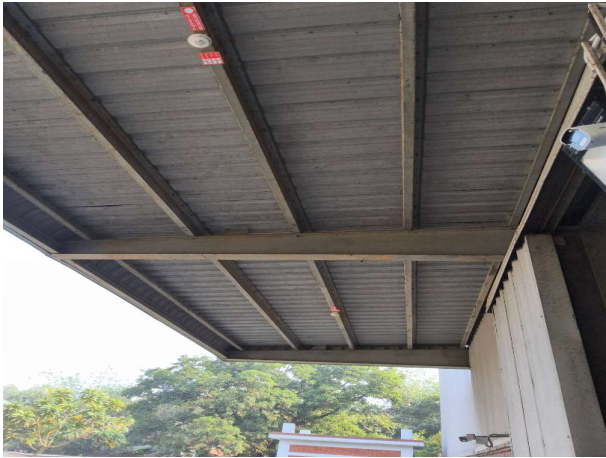
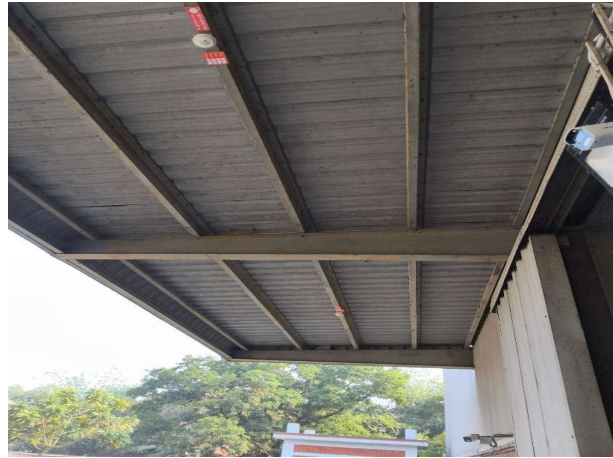
**Serial** : Observation 4  
**Structure Name** : Building-1: Warehouse Shed  
**Observation:**  
Sign of corrosion observed in the exposed steel member.

Corrosion was observed on the steel member. Building engineer is required to remove rust and provide anti-rust proofing.

| Item No | Observation | Action Plan | Timeline |
|---|---|---|---|
| 5 | Sign of corrosion observed in the exposed steel member. (Building-1: Warehouse Shed) | Remove the rusting and apply anti corrosive coating the affected member | 6 weeks |

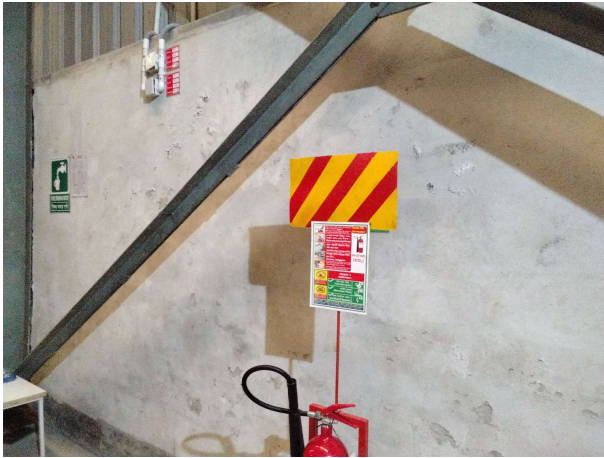
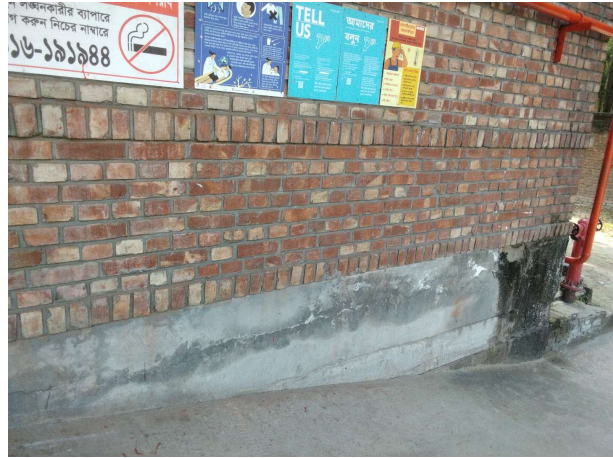
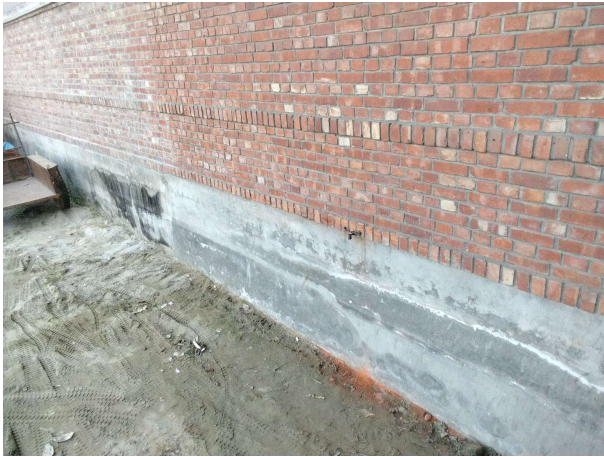
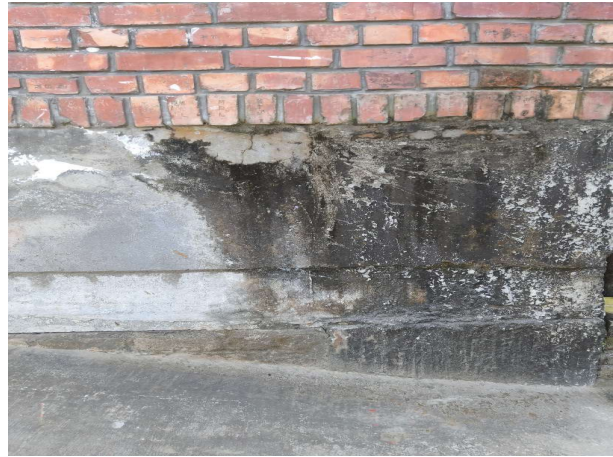
**Serial** : Observation 5  
**Structure Name** : Building-1: Warehouse Shed  
**Observation:**  
 Dampness in the brick wall and grade beams.

Dampness was observed on the RC grade beam and periphery brick walls.

| Item No | Observation | Action Plan | Timeline |
|---|---|---|---|
| 6 | Dampness in the brick wall and grade beams. (Building-1: Warehouse Shed) | Building engineer is required to remove the investigate the reason for the dampness and repair with a suitable method. | 6 weeks |

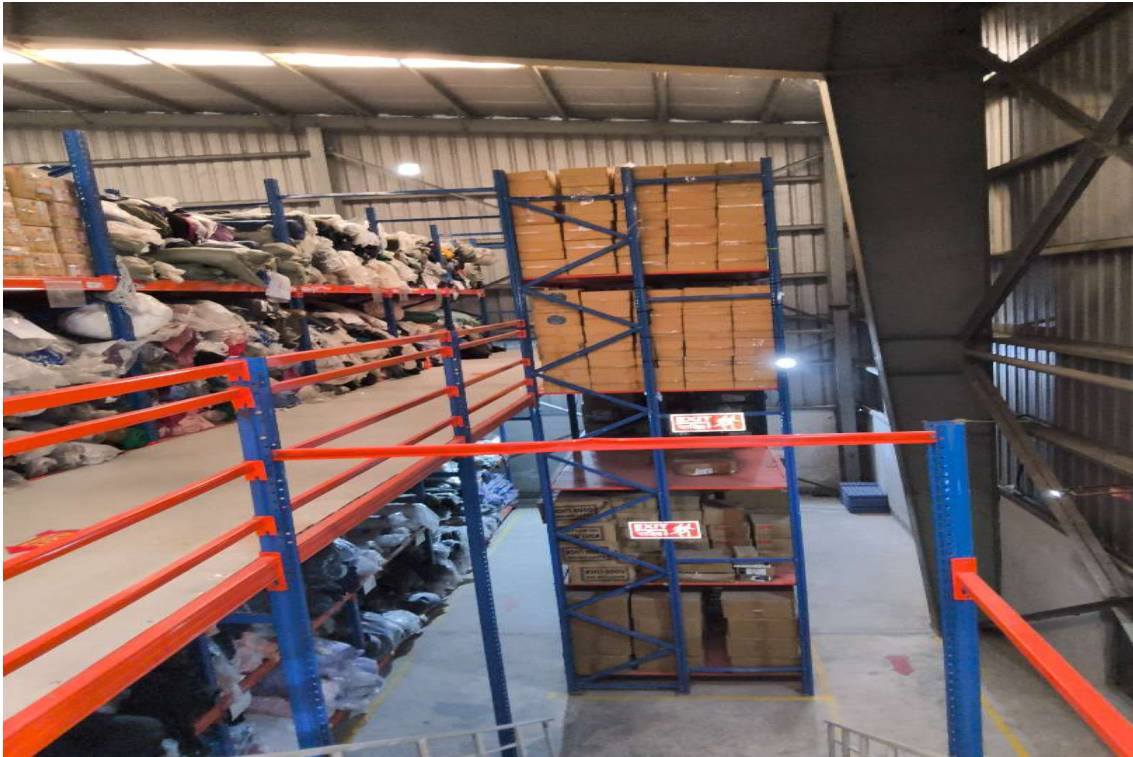
**Serial** : Observation 6  
**Structure Name** : Building-1: Warehouse Shed  
**Observation:**  
Damage to the structural member steel rack system.

Damaged was observed on the structural member of the storage racks. Building engineer is required to repair the damaged members.

| Item No | Observation | Action Plan | Timeline |
|---|---|---|---|
| 7 | Damage to the structural member steel rack system. (Building-1: Warehouse Shed) | Building engineer is required to repair the distorted members. | 6 weeks |

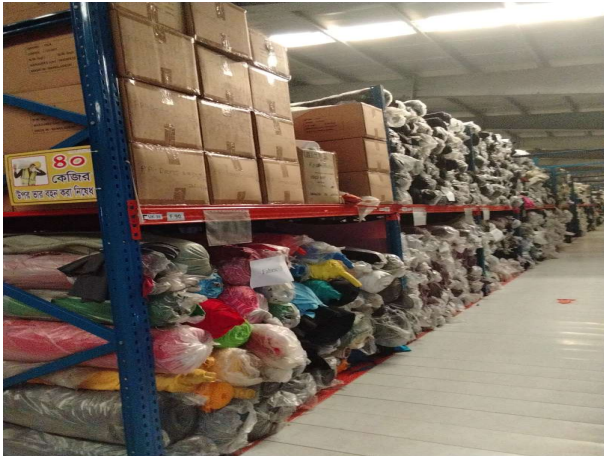
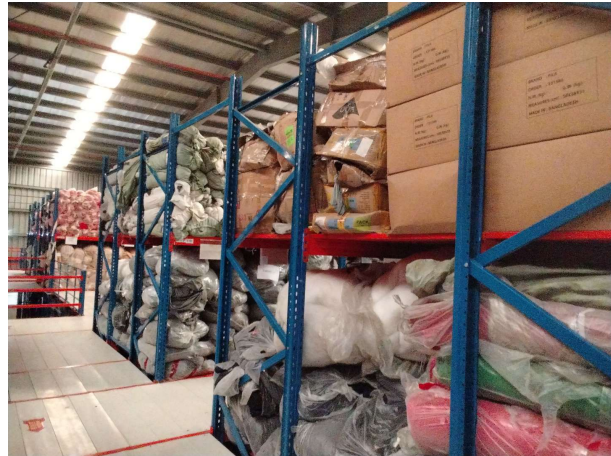
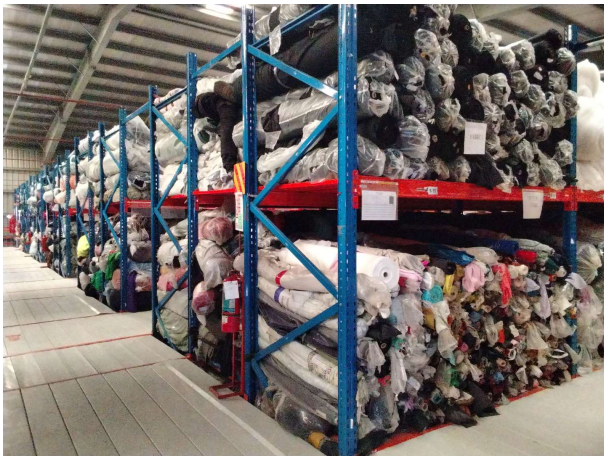
**Serial** : Observation 7  
**Structure Name** : Building-1: Warehouse Shed  
**Observation:**  
 No floor Load Management system found on site.

Heavy storage observed on storage racks. However, there was no floor load plan available.

| Item No | Observation | Action Plan | Timeline |
|---|---|---|---|
| 8 | No floor Load Managment system found on site. (Building-1: Warehouse Shed) | Building engineer is required to prepare load plan according to the structural member capacity, provide height marking and actively manage the loading plan. | 6 weeks |

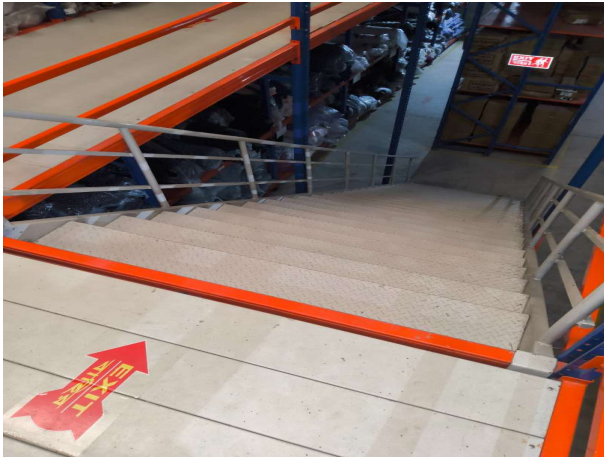
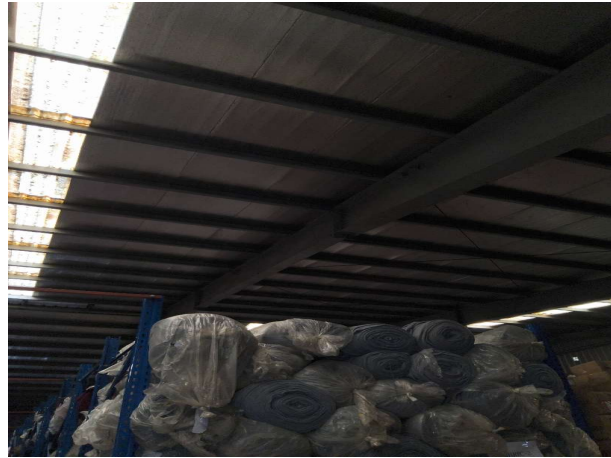
**Serial** : Observation 8  
**Structure Name** : Building-1: Warehouse Shed

Mismatch between as-built drawings and on-site conditions.

During the inspection lack of information found in the as-built drawing, details of the stairs, and the architectural layout not found. Building engineer is required to prepare detailed as-built drawings.

| Item No | Observation | Action Plan | Timeline |
|---|---|---|---|
| 9 | Mismatch between as-built drawings and on-site conditions. (Building-1: Warehouse Shed) | Building engineer is required to prepare detailed as-built drawings. | 6 weeks |

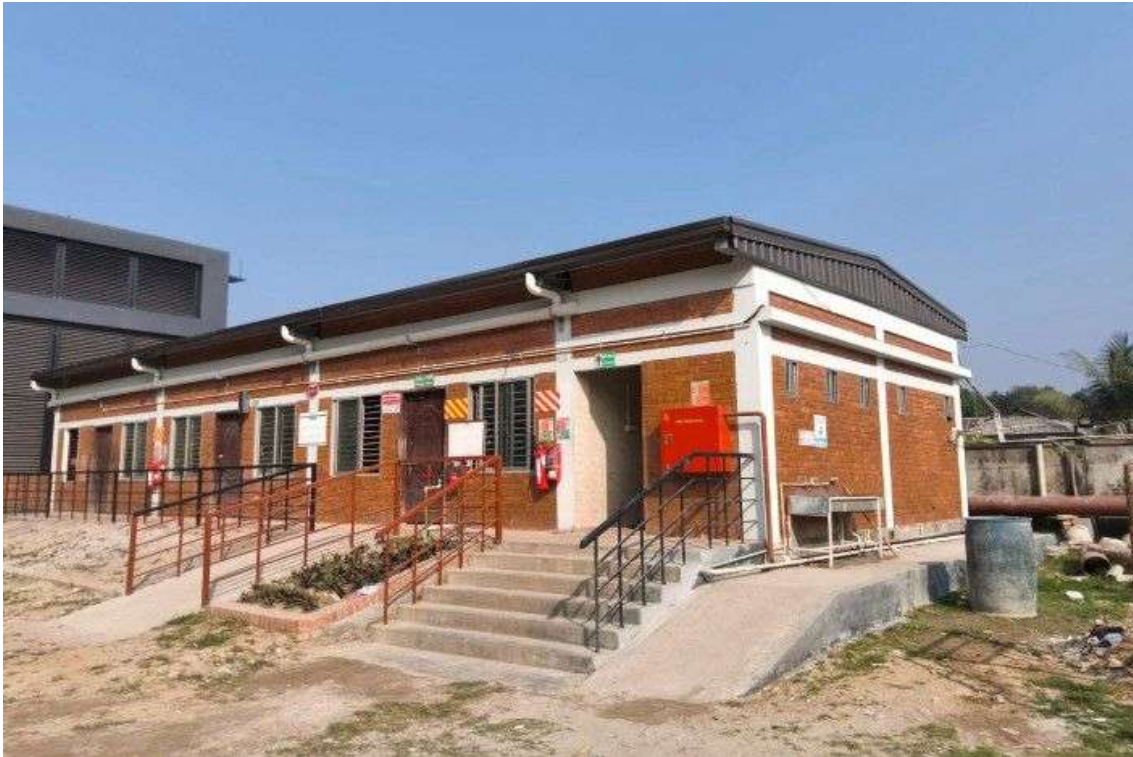
**Serial** : Observation 9  
**Structure Name** : Building-3: Diesel and Wastage Storage Shed  
**Observation:**  
Absence of a design report of the shed.

During the inspection, no design documents were available for the shed. Building engineer is required to prepare the design report as per Sec 1.9.1 of BNBC 2006.

| Item No | Observation | Action Plan | Timeline |
|---|---|---|---|
| 10 | Absence of a design report of the shed. (Building-3: Diesel and Wastage Storage Shed) | Building engineer is required to prepare design report following BNBC 1.9.1. | 6 weeks |
| 11 | | Carry out required remedial works where necessary. | 6 months |
