# Sustainable Wet Processing Plant Ltd

17 December 2025

## Structural Inspection Report

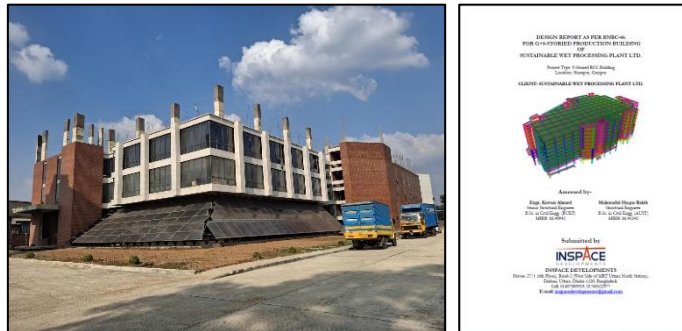
**Observation 01:** Prepared design report needs to be reviewed against lateral loading. (Production Building)

**Description:** Factory prepared design report for these structures. The building engineer is required to submit the prepared design report to RSC for detailed review against lateral forces.

Item No	Observation	Action Plan	Timeline
1.	Prepared design report needs to be reviewed against lateral loading.	The building engineer is required to submit the prepared design report to RSC for detailed review against lateral forces.	within 6 weeks

2.	(Production Building)	Carry out remedial work if required.	within 6 months
3.	Change of floor occupancy & mismatch in as-built drawing (Production Building)	The building engineer is required to finalize the floor occupancies, update as-built drawings and load plan submit them to RSC.	within 6 weeks

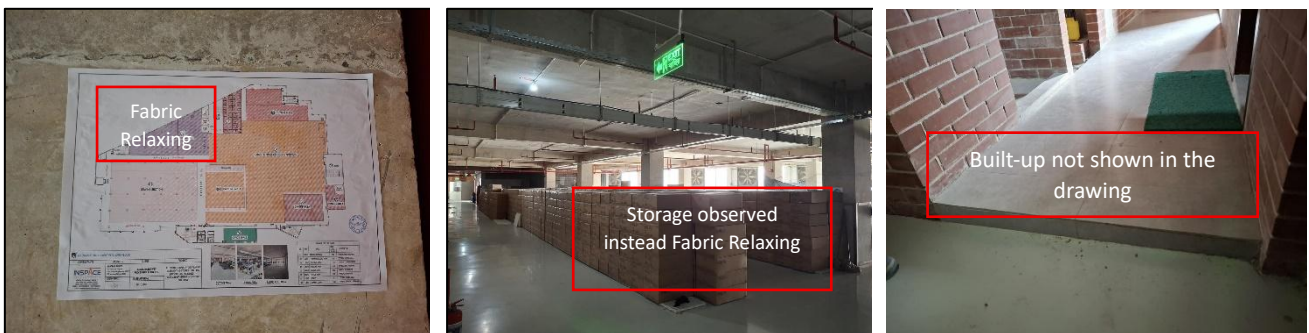
**Observation 02:** Change of floor occupancy & mismatch in as-built drawing (Production Building)

**Description:** During inspection, change of floor occupancy was observed. And floor built ups on 1<sup>st</sup> & 2<sup>nd</sup> floors were not mentioned in the drawings. The building engineer is required to finalize the floor occupancies, update as-built drawings and load plan submit them to RSC.

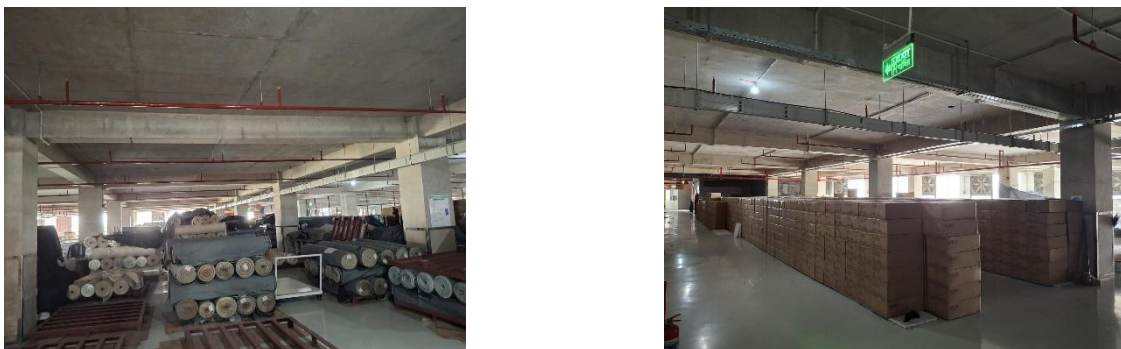
**Observation-03:** Lack of floor load management (Production Building)

**Description:** Storage height marking was not found onsite. Also, some storage was found in non-dedicated storage areas. The building engineer is required to maintain floor occupancy as per prepared load plan, provide storage height marking and manage floor loading within limits.

4.	Lack of floor load management (Production Building)	The building engineer is required to maintain floor occupancy as per prepared load plan, provide storage height marking and manage floor loading within limits.	within 6 weeks

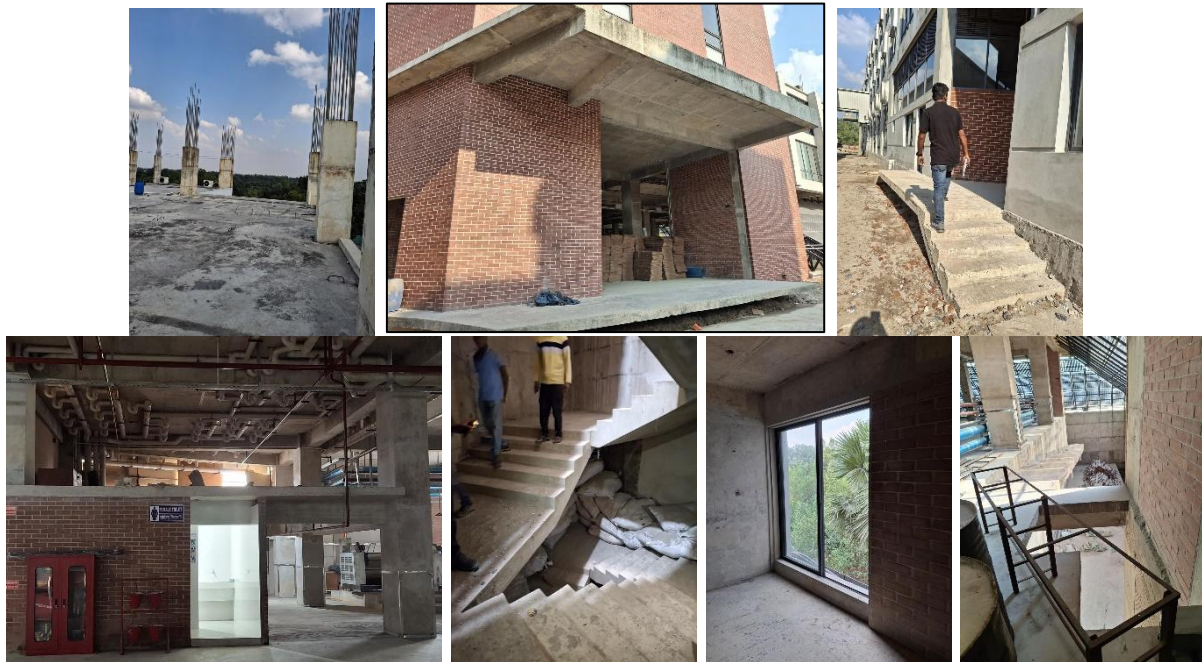
**Observation 04: Falling hazards at several locations (Production Building)**

**Description:** Falling hazard observed at several locations including roof openings, stairs & landings, mezzanine floor open edge, loading-unloading platforms, internal & external drain openings. The building engineer is required to provide necessary parapets, railing, barriers, covers as required.

5.	Falling hazards at several locations (Production Building)	The building engineer is required to provide necessary parapets, railing, barriers, covers as required.	within 6 weeks

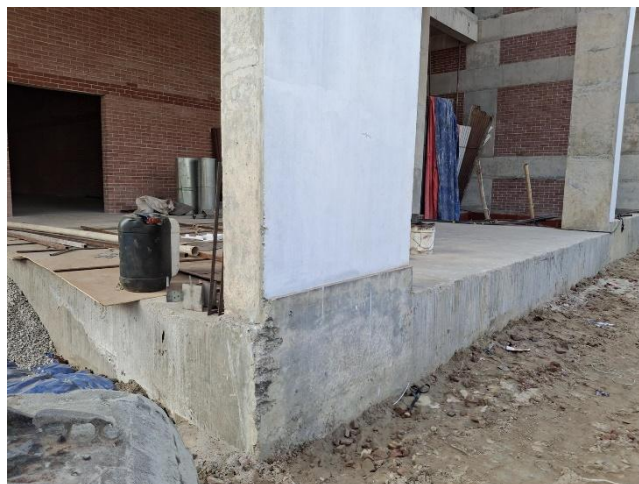
**Observation 05: Potential vehicle impact on columns (Production Building)**

**Description:** Signage of vehicle impact was observed on ground floor column at loading-unloading zone. The building engineer is required to provide separate barriers around the column to avoid vehicle impact on column.

6.	Potential vehicle impact on columns (Production Building)	The building engineer is required to provide separate barriers around the column to avoid vehicle impact on column.	within 6 weeks

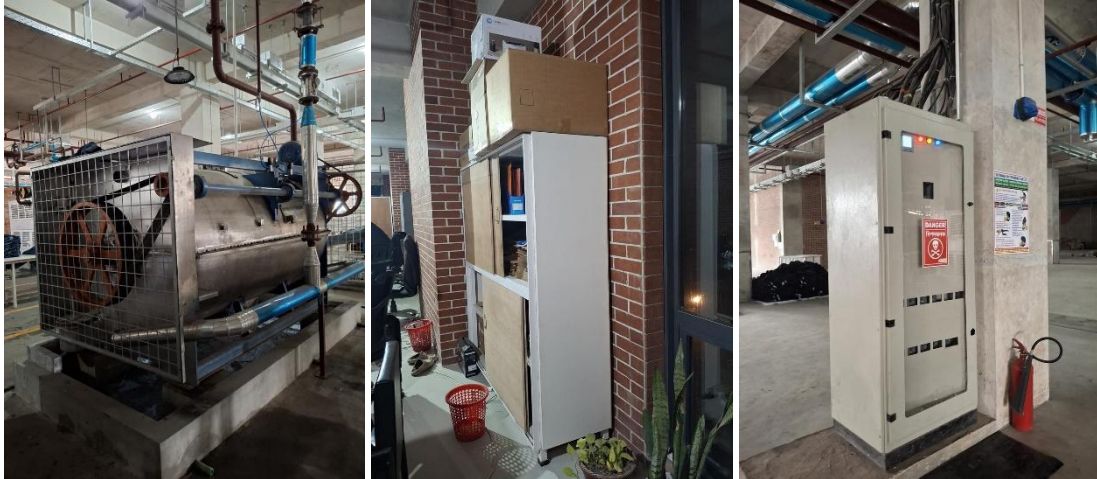
**Observation 06:** Lack of anchorage for washing machinery, storage racks and electrical panel boards (Production Building)

**Description:** Lack of anchorage for non-structural elements including washing machinery, storage racks and electrical panel boards was observed within the building. The building engineer is required to provide adequate anchorage to protect them from tilting during seismic event.

7.	Lack of anchorage for washing machinery, storage racks and electrical panel boards (Production Building)	The building engineer is required to provide adequate anchorage to protect them from tilting during seismic events.	within 6 weeks

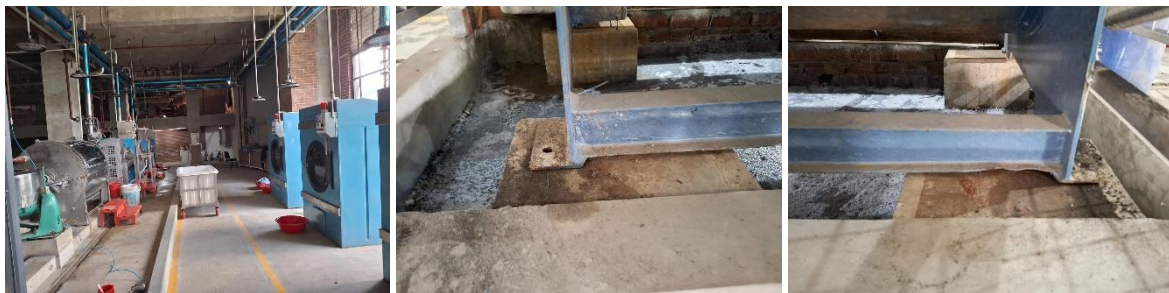
**Observation 07:** Source of Vibration and Absence of Vibration Damper (Production Building)

**Description:** A washing machine has been identified as a source of vibration; however, no vibration damping pad was observed beneath the equipment. To mitigate the transmission of dynamic loads and potential adverse effects on the structural elements, the building engineer is required to provide an adequate vibration damper beneath the machinery.

8.	Source of Vibration and Absence of Vibration Damper (Production Building)	To mitigate the transmission of dynamic loads and potential adverse effects on the structural elements, the building engineer is required to provide an adequate vibration damper beneath the machinery.	within 6 weeks

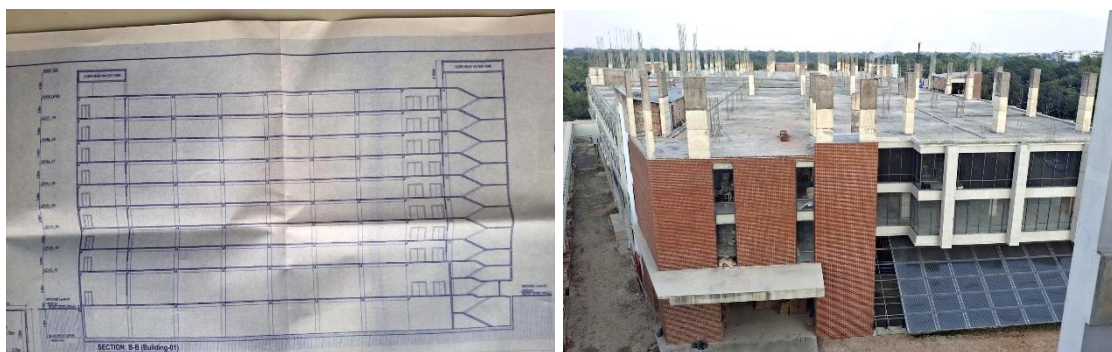
**Observation 08:** Possible vertical extension (Production building)

**Description:** The building is currently constructed up-to 3 storied (B+G+2) with a basement & mezzanine floor. Factory has a building permit for proposed 9 (B+G+8) storied building. The column of the roof was found extended which indicates possible future vertical extension of the building. However, prior to any kind the extension prepares Detail Engineering Assessment (DEA) and submit RSC for detail review.

9.	Possible vertical extension (Production building)	Prior to any kind the extension prepares Detail Engineering Assessment (DEA) and submit RSC for detailed review.	within 6 months

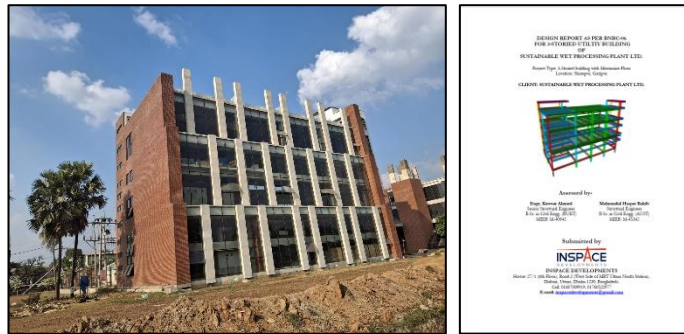
**Observation 09:** Prepared design report needs to be reviewed against lateral loading. (Utility Building)

**Description:** Factory prepared design report for these structures. The building engineer is required to submit the prepared design report to RSC for detailed review against lateral forces.

10.	Prepared design report needs to be reviewed against lateral loading.	The building engineer is required to submit the prepared design report to RSC for detailed review against lateral forces.	within 6 weeks

11.	(Utility Building)	Carry out remedial work if required.	within 6 months
12.	Lack of floor load management (Utility Building)	The building engineer is required to maintain floor occupancy as per prepared load plan, provide storage height marking and manage floor loading within limits.	within 6 weeks

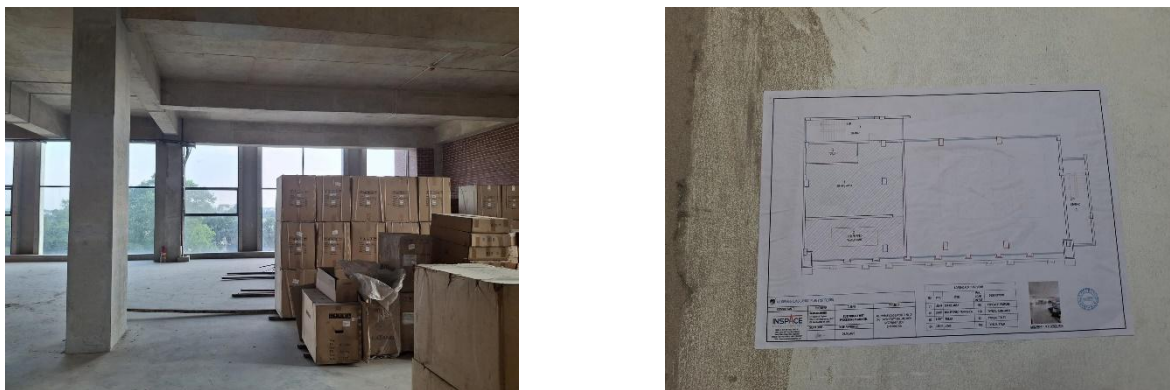
**Observation-10:** Lack of floor load management (Utility Building)

**Description:** Undocumented storage was observed on top two floors. Also, storage height marking was not found onsite. The building engineer is required to maintain floor occupancy as per prepared load plan, provide storage height marking and manage floor loading within limits.

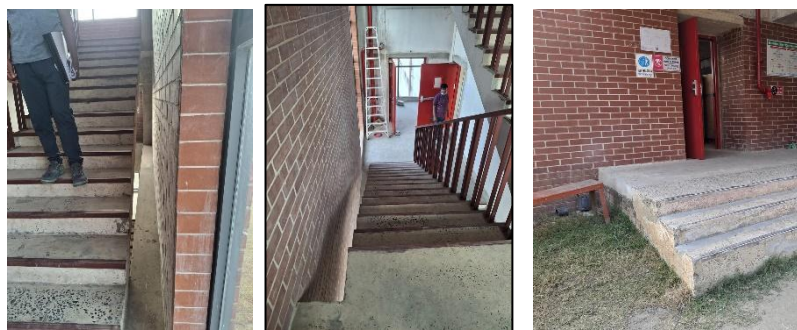
**Observation 11:** Falling hazards at several locations (Utility Building)

**Description:** Falling hazard observed at several locations including opening in stair waist slab, ground floor stair edge. The building engineer is required to provide necessary railing, barriers as required.

13.	Falling hazards at several locations (Utility Building)	The building engineer is required to provide necessary railing, barriers as required.	within 6 weeks

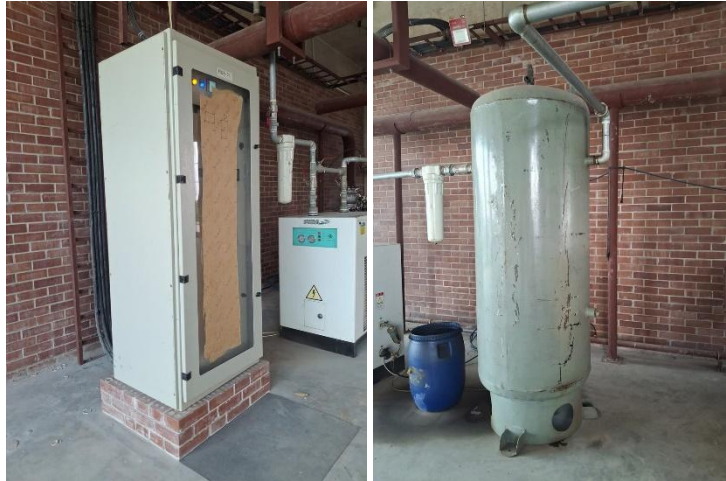
**Observation 12: Lack of anchorage for electrical panel boards (Utility Building)**

**Description:** Lack of anchorage for non-structural elements including electrical panel boards was observed within the building. The building engineer is required to provide adequate anchorage to protect them from tilting during seismic event.

14.	Lack of base anchorage for electrical panel boards (Utility Building)	The building engineer is required to provide adequate anchorage to protect them from tilting during seismic events.	within 6 weeks

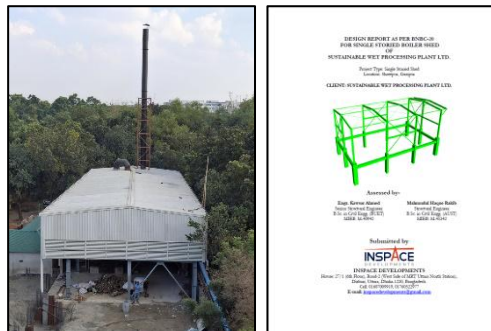
**Observation 13: Prepared design report needs to be reviewed against lateral loading. (Boiler Shed)**

**Description:** Factory prepared design report for these structures. The building engineer is required to submit the prepared design report to RSC for detailed review against lateral forces.

15.	Prepared design report needs to be reviewed against lateral loading.	The building engineer is required to submit the prepared design report to RSC for detailed review against lateral forces.	within 6 weeks

16.	(Boiler Shed)	Carry out remedial work if required.	within 6 months
17.	Mismatch in as-built drawing (Boiler Shed)	The building engineer is required to update as-built drawings, check the design and submit them to RSC.	within 6 weeks

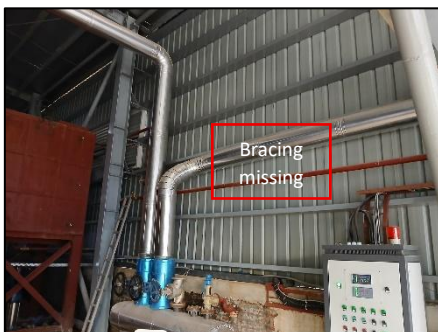
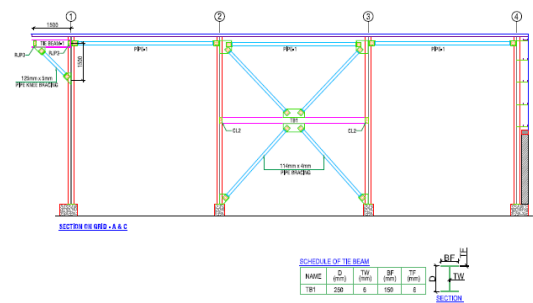
Boiler Shed

**Observation 14: Mismatch in as-built drawing (Boiler Shed)**

**Description:** Bracing along long direction of the shed was missing onsite. The building engineer is required to update as-built drawings, check the design and submit them to RSC.

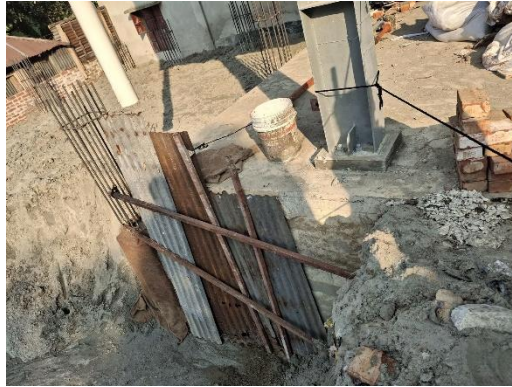
**Observation 15: Falling hazards on ground floor (Boiler Shed)**

**Description:** Falling hazard observed at ground floor slab edge. The building engineer is required to provide necessary railing, barriers as required.

18.	Falling hazards on ground floor (Boiler Shed)	The building engineer is required to provide necessary railing, barriers as required.	within 6 weeks
19.	Perforated poor gusset plate (Boiler Shed)	The building engineer is required to repair or replace the perforated gusset plate	within 6 weeks

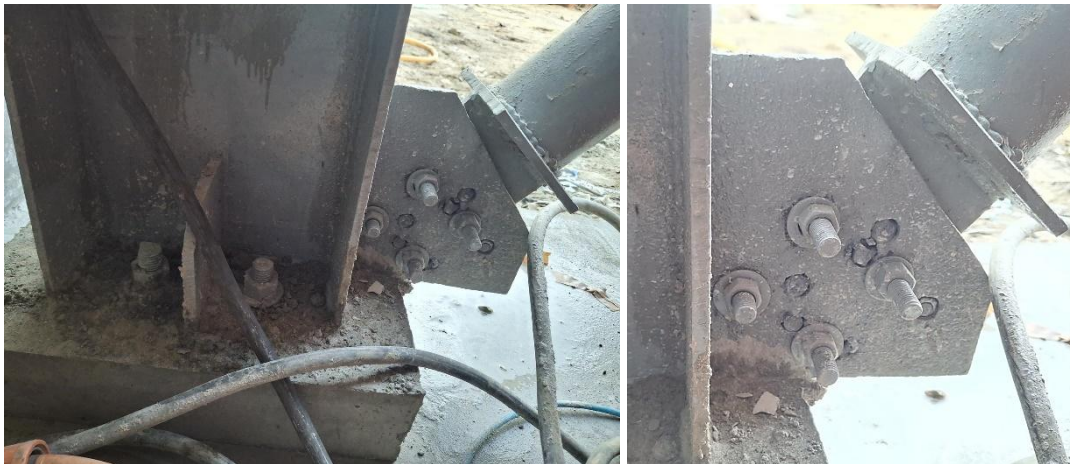
**Observation 16: Perforated poor gusset plate (Boiler Shed)**

**Description:** Perforated poor gusset plate was observed. The building engineer is required to repair or replace the perforated gusset plate.

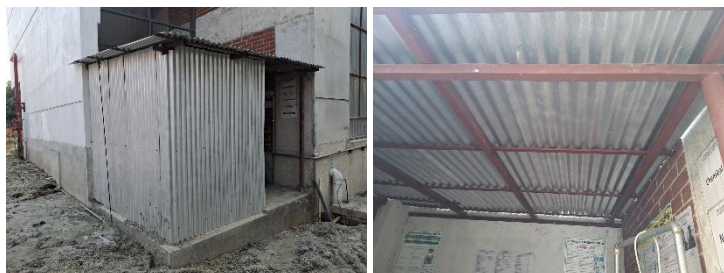
**Observation 17: Lack of documents for ancillaries (Diesel Shed)**

**Description:** The building engineer is required to prepare as-built drawings for the shed.

20.	Lack of documents for ancillaries (Diesel Shed)	The building engineer is required to prepare as-built drawings for the shed.	within 6 weeks
21.	Inadequate and deflected steel member (Workshop Shed)	The building engineer is required to prepare as-built drawings, check the adequacy of the steel shed, prepare engineering assessment report with necessary remedial action and submit to RSC for review.	within 6 weeks

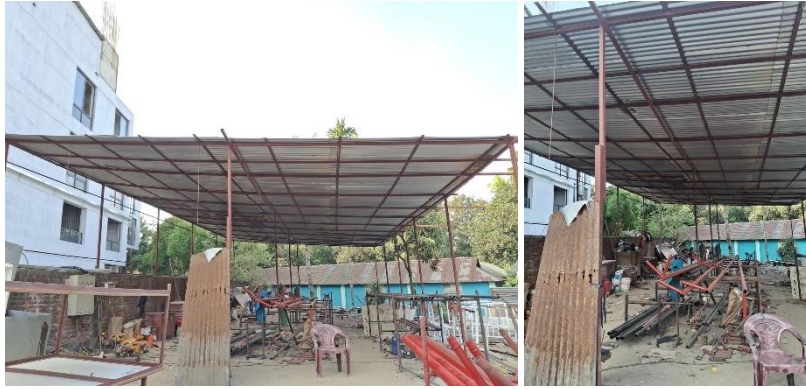
**Observation 18:** Inadequate and deflected steel member (Workshop Shed)

**Description:** The steel members and joints were found inadequate. Also, there was no obvious lateral stability system. The building engineer is required to prepare as-built drawings, check the adequacy of the steel shed, prepare engineering assessment report with necessary remedial action and submit to RSC for review. Carry out remedial work, otherwise demolish the structure.

22.		Carry out suggested remedial works.	within 6 months
