# Eurotex Knitwear Ltd

Nayamati, Kutubpur, Fatullah, Narayanganj, Bangladesh  
(23.64885N,90.5021E)

02 April 2014

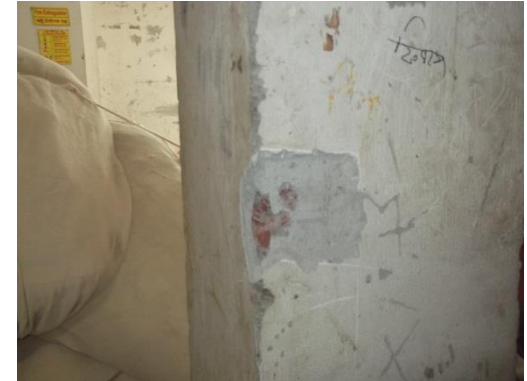
Tested Ground Floor Column – Brick Aggregate

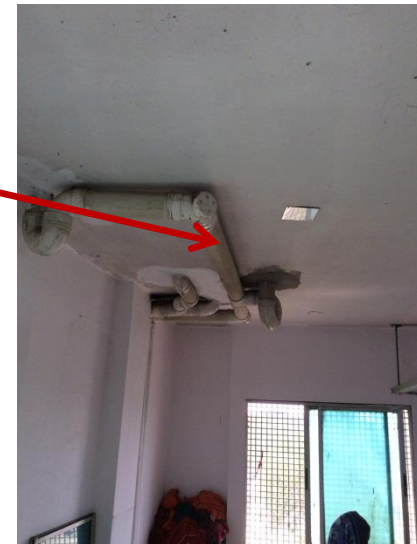
**Capacity of floor slab, at the north east corner, may be reduced due to penetrations adjacent to a column on the underside of 3<sup>rd</sup> floor. Building Engineer to review.**

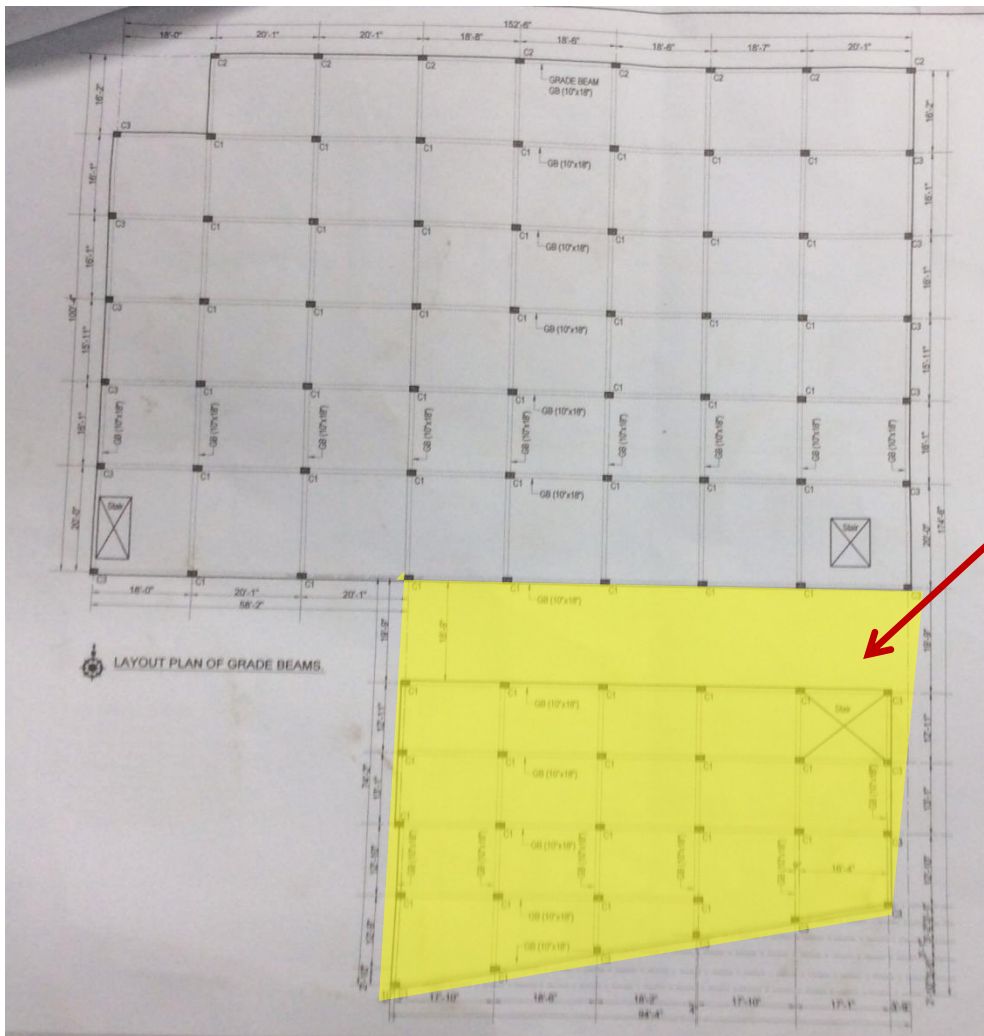
Column sizes measured in this highlighted area are smaller than the size noted on the construction drawings

Building Engineer to survey as-built structure and update drawings including verification of column sizes.

| Item No. | Observation | Recommended Action Plan | Recommended Timeline |
|---|---|---|---|
| 5 | Inconsistencies between structural drawings and the as-constructed arrangement of the factory | Building Engineer to survey as constructed building. Updated drawings to be prepared showing the correct as constructed layout. | 6-months |
| 6 | Inconsistencies between structural drawings and the as-constructed arrangement of the factory | Prepare/update calculations showing the structural adequacy of the building structure taking into account the factory design imposed loading and the as built structure. | 6-months |

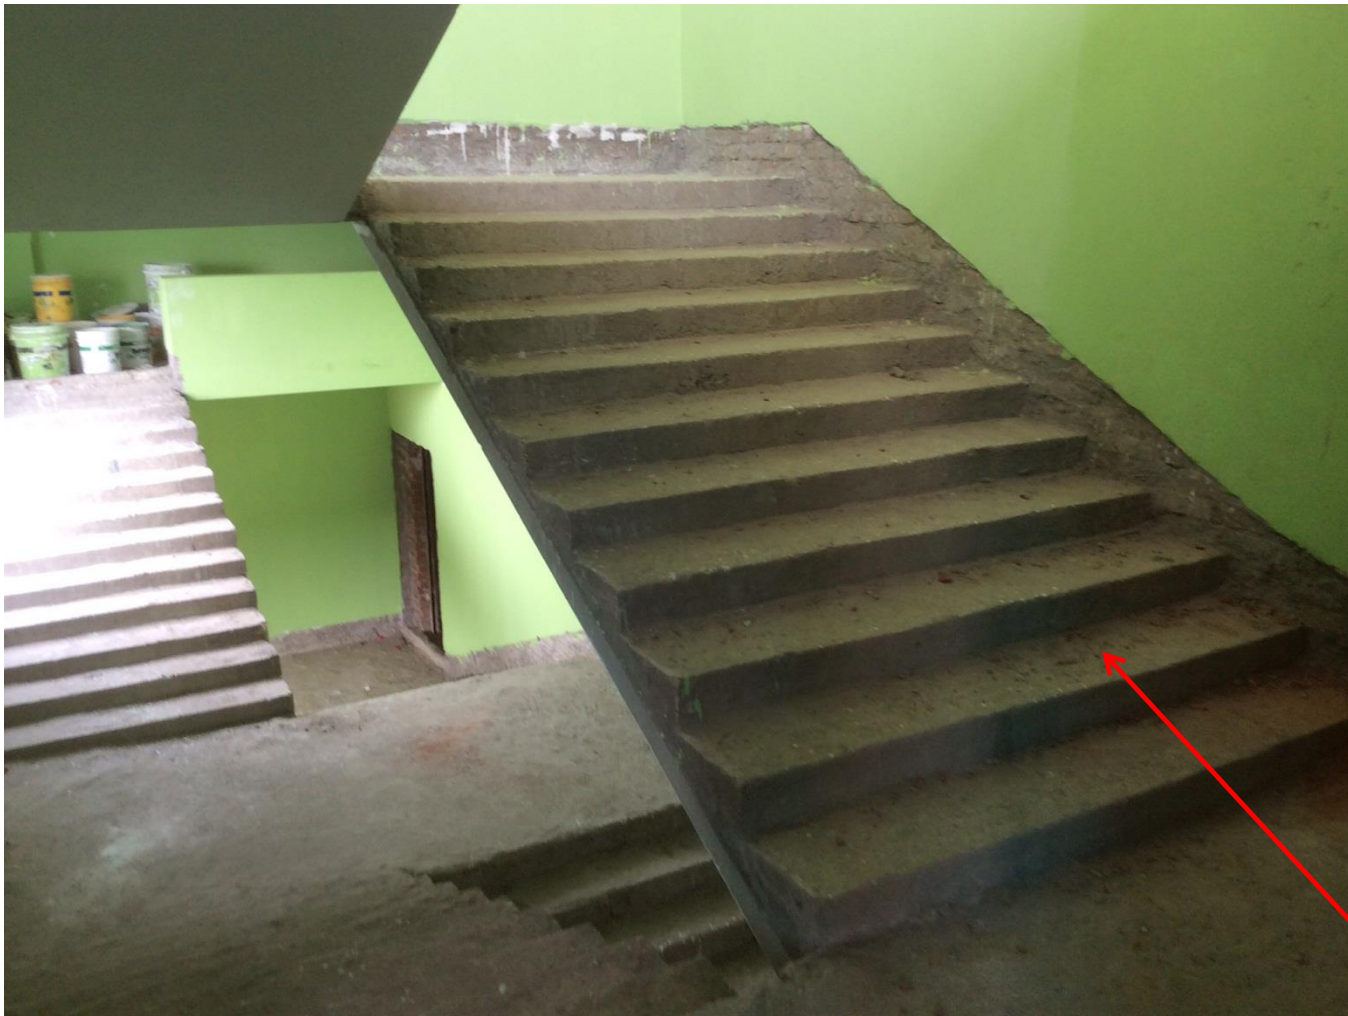
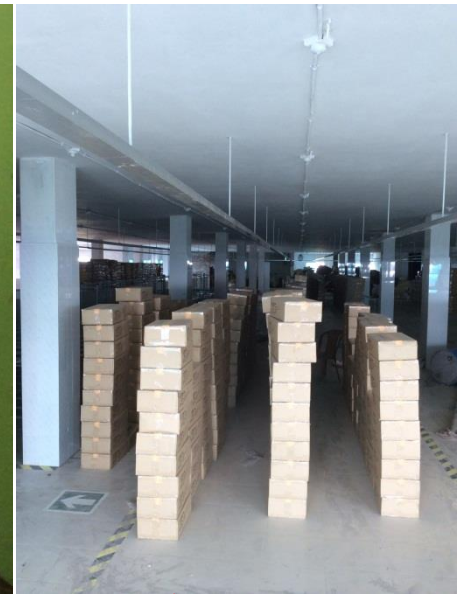
**No Handrail on Stairs to  
Construction/Finished Goods  
Storage Area**

**An area on the 5<sup>th</sup> floor, where construction  
fit-out is on-going, is being used for storage of  
finished goods.**

**No handrail is provided to the access stairs.**

| Item No. | Observation | Recommended Action Plan | Recommended Timeline |
|---|---|---|---|
| 8 | Non Structural Observation - Finished goods are stored at 5th floor level and no handrails are provided on the stairs to this level | A handrail should be provided to the access stairs to the 4th and 5th floors to ensure that factory workers accessing stored finished goods on these floors are adequately protected | Immediate - Now |
