# Croydon Kowloon Designs Ltd. (Unit-2)

Plot no -136-139, Dhaka EPZ (Old Zone), Ashulia, Savar

2 December 2025

## Structural Inspection Report

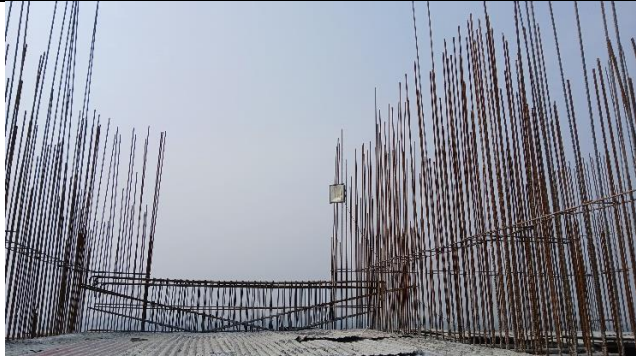
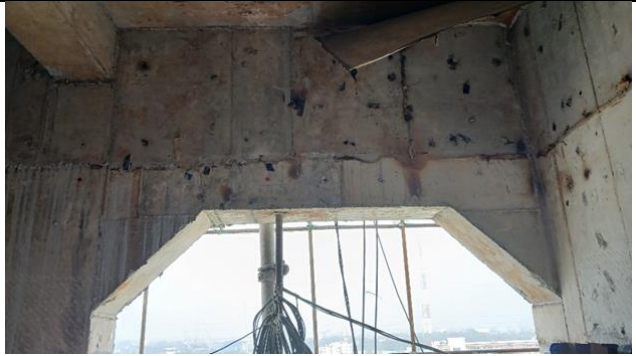
### Observation-01: Inconsistencies in the design report. (Production Building)

**Description:** During the inspection, the design report was found on-site, and the following observations were noted:

- No check was provided for the Special Shear Wall (Boundary Element, Confinement) as per BNBC 2020 section 8.3.6.2 & 8.3.6.6.
- No check was provided for Coupling Beam as per BNBC 2020 section 8.3.6.7 & 8.3.6.8.

The building engineer is required to address all the inconsistencies in the revised design report and submit the revised design report to RSC for detail review against lateral forces.

| Item No | Observation | Action Plan | Timeline |
|---|---|---|---|
| 1. | Inconsistencies in the design report. (Production Building) | The building engineer is required to address all the inconsistencies in the revised design report and submit to RSC for detailed review against lateral forces. | within 6 weeks |

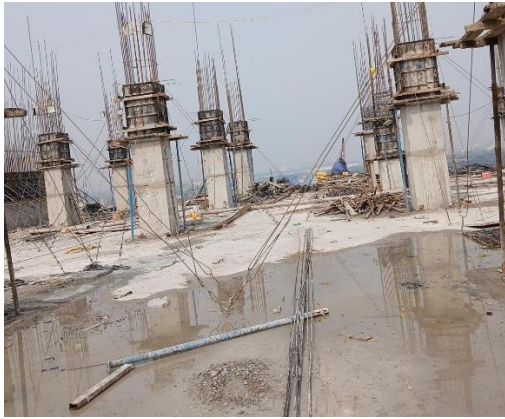
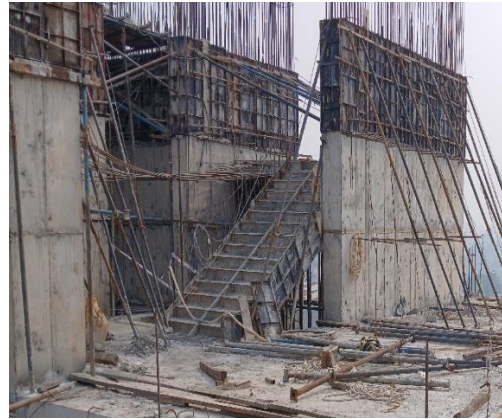
**Observation-02:** Construction safety practice for the factory premises. (Production Building and Utility Building)

**Description:** Lack of construction safety practices observed in the Production & Utility Building. The building engineer is required to follow all the standard construction safety practices according to BNBC 2020, Part 7, Chapter 3.

| Item No | Observation | Action Plan | Timeline |
|---|---|---|---|
| 4. | Lack of standard construction safety practice in Production Building | The building engineer is required to ensure the health & safety of the workers and follow the standard construction safety practices according to BNBC 2020, Part 7, Chapter 3. | Immediate |

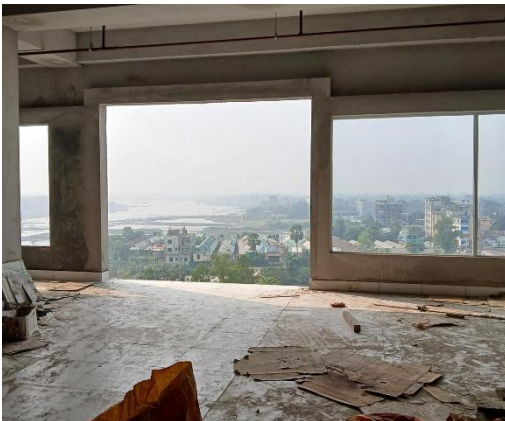
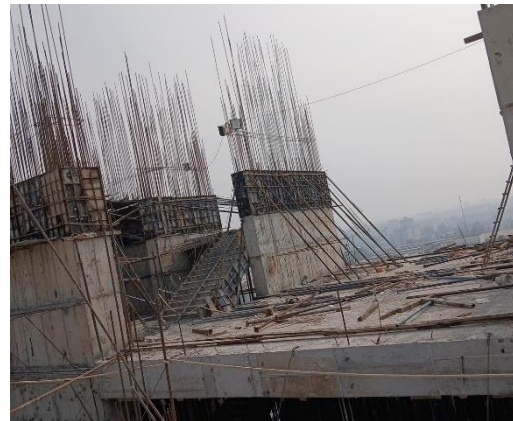
**Observation-03:** Falling hazard on the existing roof. (Production Building and Utility Building)

**Description:** During inspection, falling hazard was found on the existing roof and floors. The building engineer is required to provide an adequate (height & spacing) barrier to avoid the falling hazard.

| Item No | Observation | Action Plan | Timeline |
|---|---|---|---|
| 5. | Falling hazard on the existing unoccupied floors. (Production Building) | The building engineer is required to provide barrier (with adequate height & spacing) to avoid the falling hazard. | within 6 weeks |
| 12. | Falling hazard on the existing unoccupied floors. (Utility Building) | The building engineer is required to provide barrier (with adequate height & spacing) to avoid the falling hazard. | within 6 weeks |

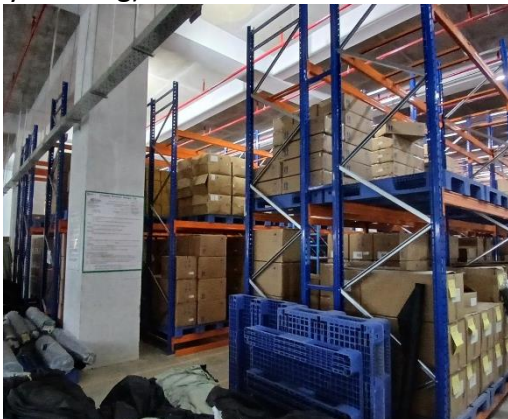
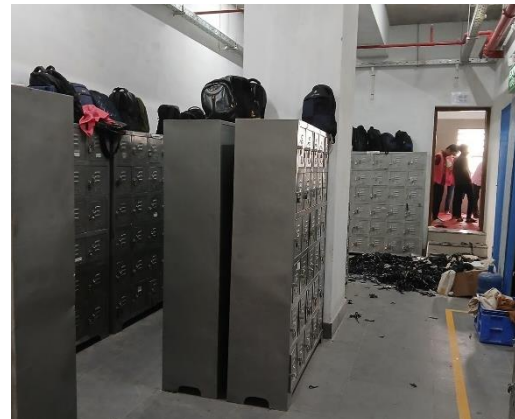
**Observation-04:** Non-structural elements found unbraced/unanchored. (Production Building and Utility Building)

**Description:** Non-structural elements (storage racks & locker racks) were observed on Production Building and Utility Building were found unbraced/unanchored. The building engineer is required to brace/anchor all non-structural elements within the building.

| Item No | Observation | Action Plan | Timeline |
|---|---|---|---|
| 6. | Non-structural elements found unbraced / unanchored. (Production Building) | The building engineer is required to brace/anchor all non-structural elements within the building. | within 6 weeks |
| 13. | Non-structural elements found unbraced / unanchored. (Utility Building) | The building engineer is required to brace/anchor all non-structural elements within the building. | within 6 weeks |

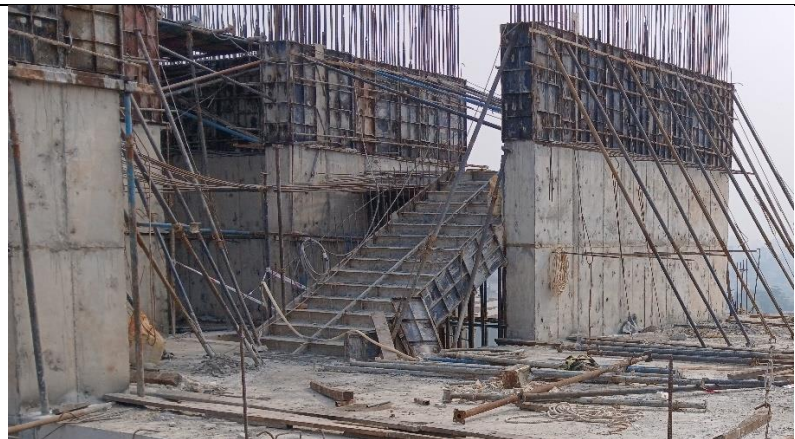
## Observation-05: Inconsistencies in the design report. (Utility Building)

**Description:** During the inspection, the design report was found on-site, and the following observations were noted:

- No check was provided for the Special Shear Wall (Boundary Element, Confinement) as per BNBC 2020 section 8.3.6.2 & 8.3.6.6.
- No check was provided for Coupling Beam as per BNBC 2020 section 8.3.6.7 & 8.3.6.8.

The building engineer is required to address all the inconsistencies in the revised EA report and submit the revised EA to RSC.

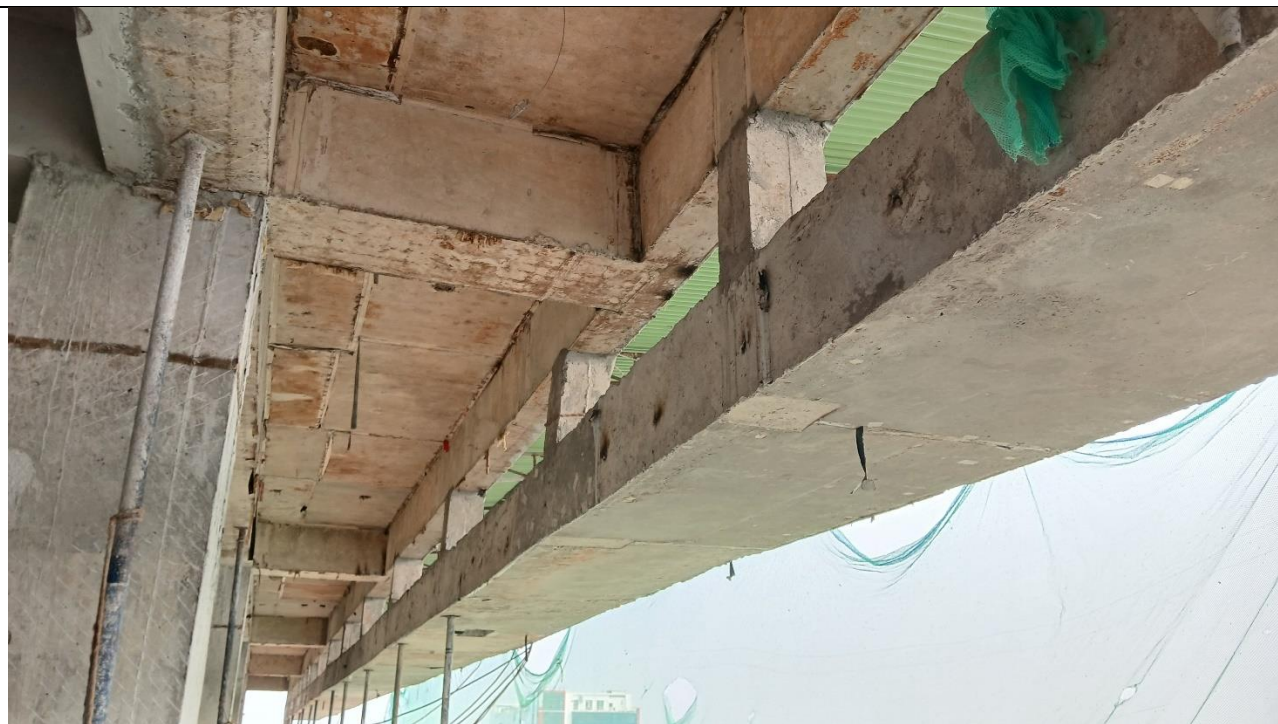
**Observation-06:** Missing information in the as-built drawing. (Utility Building)

No water tank is shown

**Description:** Stiffener columns integrated with a false slab were observed on-site; however, no corresponding information was provided in the as-built drawings. The building engineer is required to survey the whole structure and produce an accurate as-built drawing.

| Item No | Observation | Action Plan | Timeline |
|---|---|---|---|
| 10. | Missing information in the as-built drawing. (Utility Building) | The building engineer is required to survey the whole structure and produce an accurate as-built drawing. | within 6 weeks |
