# Tropical Knitex Ltd (Extension 2)

30 November 2025

Structure Name : Building-22

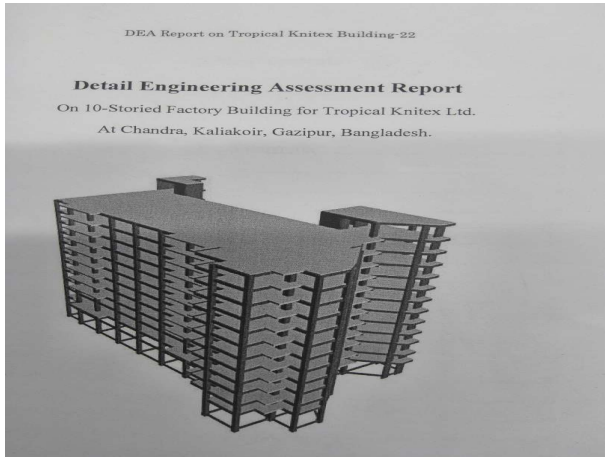
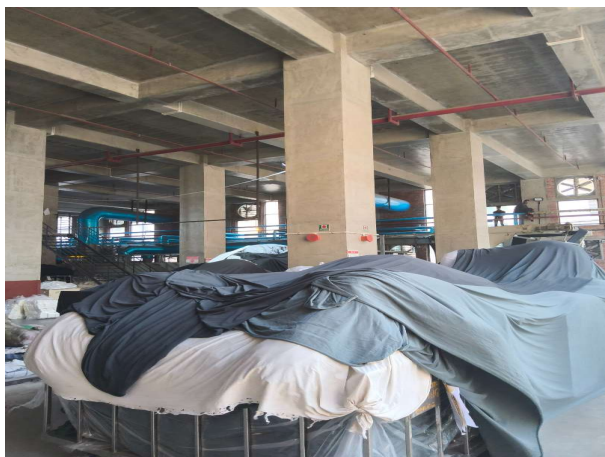
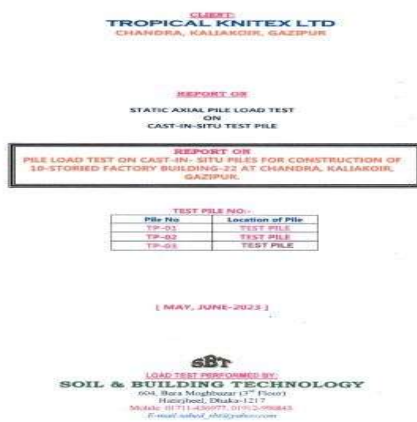
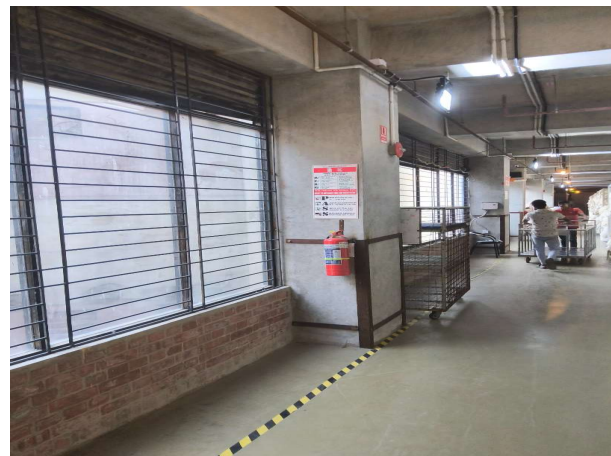
Serial : Observation 1

Inconsistency in design report

Framing system identification and calculation not provided. Material strength calculation from the cylinder test report not included. Adequacy check of the slender columns is not included. Short column effect for 250 mm thick brick wall

Item No	Observation	Action Plan	Timeline
1	Inconsistency in design report (Building-22)	Building engineer is required to prepare the design report as per BNBC 1.9.1 and incorporate all the inconsistencies.	6 weeks
2		Carry out the required remedial works where necessary.	6 months
3	Lack of load management program (Building-22)	Develop a program to ensure that all live loads for which a floor or roof has been designed for will not be exceeded. Display the floor live load plan on each floor level, provide load restriction height marking in storage areas, maintain floor live loading within allowable limit.	6 weeks
4	Stability of unrestrained masonry walls/cladding (Building-22)	Building engineer is required to check the stability of the masonry walls and cladding and suggest proper remedial actions accordingly.	6 weeks
5		Carry out the required remedial works where necessary	6 months
6	Falling hazard on the ground floor loading-unloading zone and stairs (Building-22)	Provide barrier/railing/parapet to the opening/roof/staircase/lift core/void to prevent possible falling hazard.	6 weeks

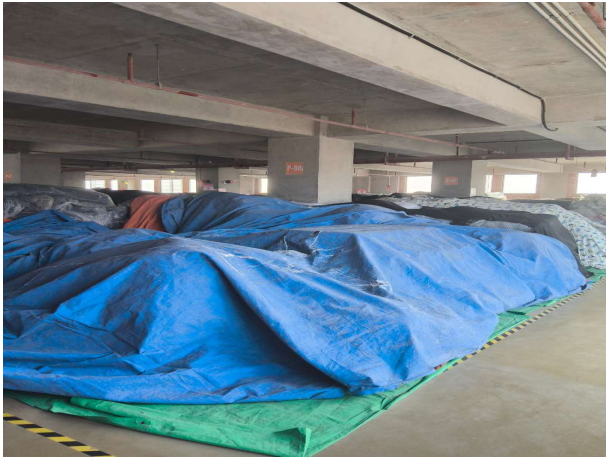
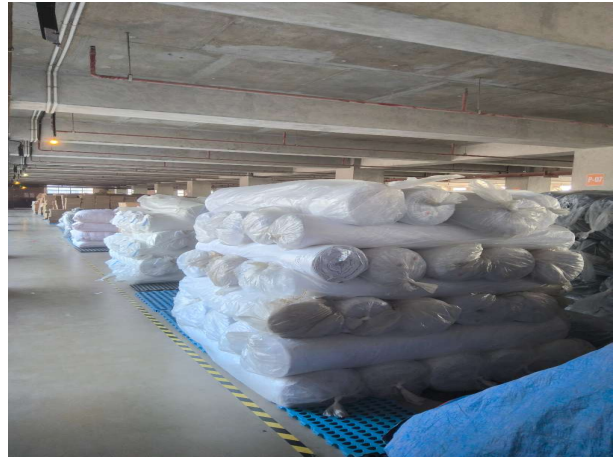
**Serial** : Observation 2

Lack of load management program

The load management program (load plan and signage not posted) was not observed on the floors. Building engineer is required to implement floor load management program.

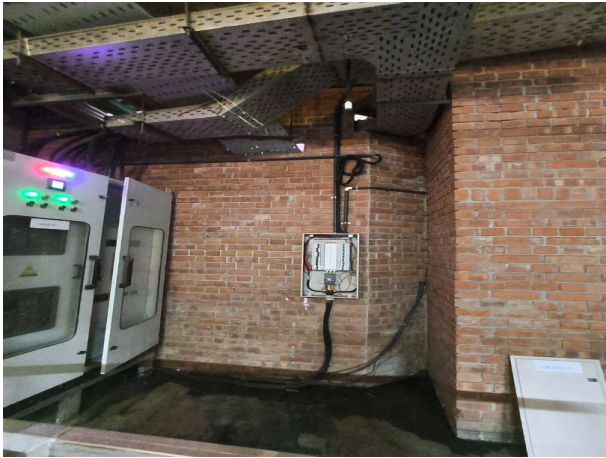
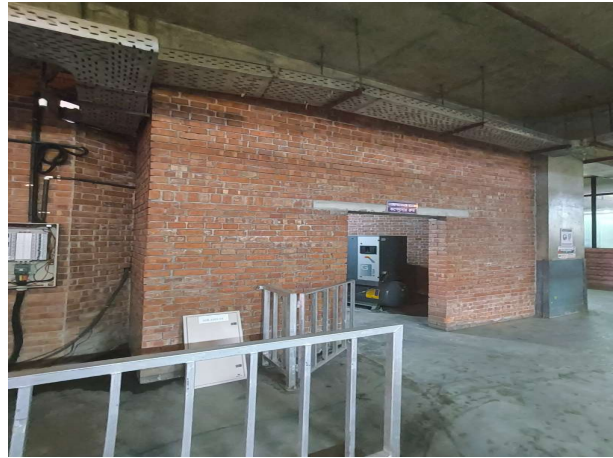
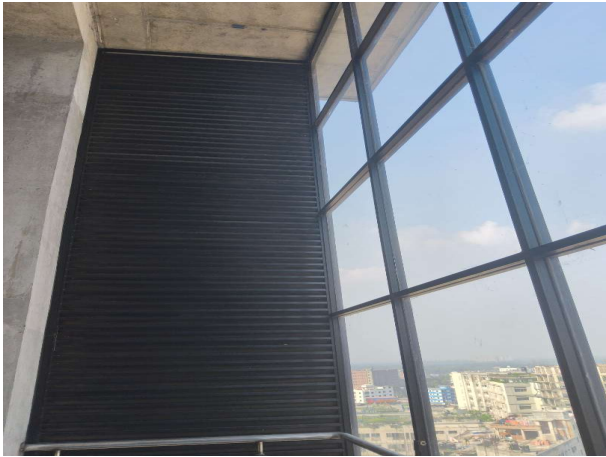
**Serial** : Observation 3  
**Structure Name** : Building-22  
**Observation:**  
Stability of unrestrained masonry walls/cladding

There was unrestraint brick wall in the building. Building engineer is required to check the stability of the unrestrained brick walls and steel-framed glass cladding.

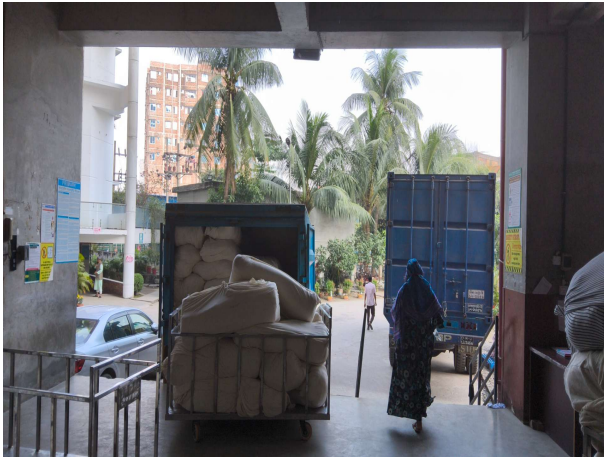
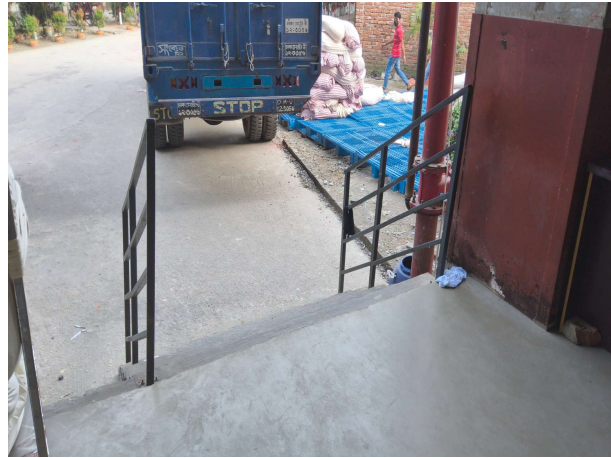
**Serial** : Observation 4

Falling hazard on the ground floor loading-unloading zone and stairs

Falling hazard was observed on the ground floor stair and loading-unloading zone

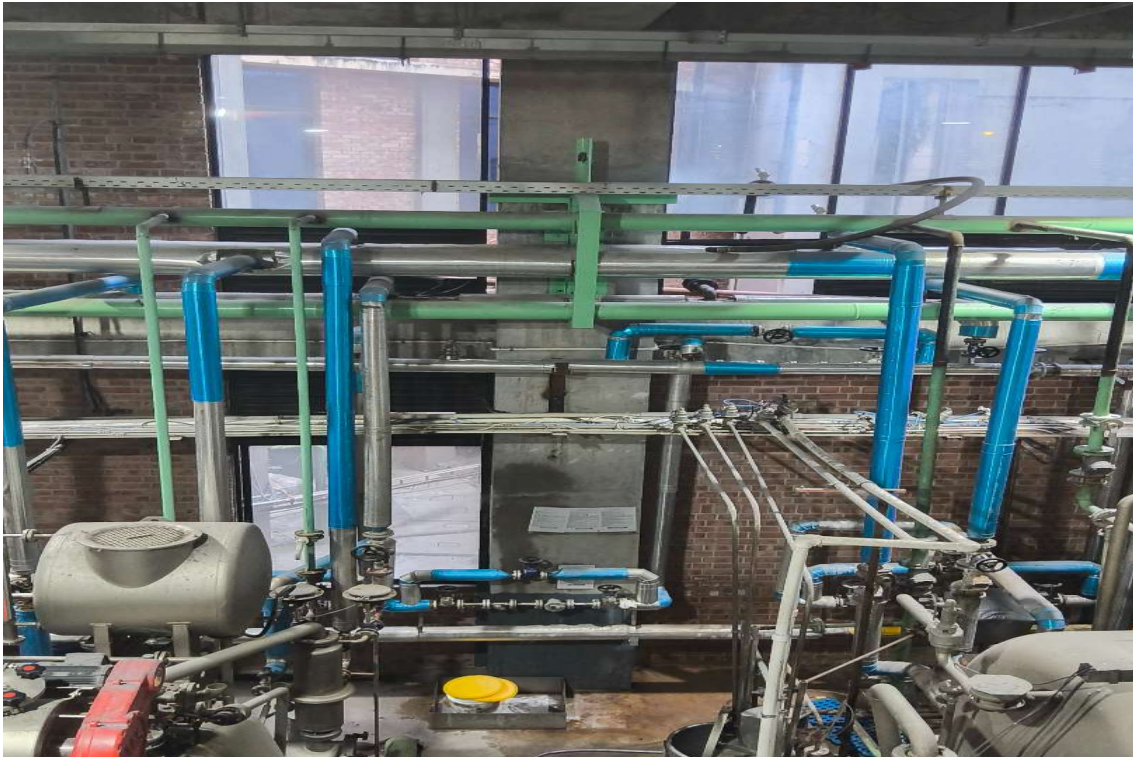
**Serial** : Observation 5

Potential dampness in column/beam due to steam water

Leakage of the steam pipe discharges water on the column, causing water ingress. Building engineer is required to remove the leaked steam pipes or protect the columns from water ingress.

7		Restrict All access	6 weeks
8	Potential dampness in column/beam due to steam water (Building-22)	Remove the streamline away from the structural members (column) or protect the column from water ingress.	6 weeks
9	Potential Trolley and vehicle impact on column/wall (Building-22)	Provide barrier around the structural members to protect from possible vehicle/trolley impact.	6 weeks
10	Lack of anchorage for non-structural elements (Building-22)	Provide adequate anchorage/bracing to the non-structural elements.	6 weeks
11		Provide adequate anchorage/bracing to the non-structural elements.	6 weeks
12	Building Permits not available (Salt Shed)	The factory is required to obtain building permits from the local authority.	6 months
13	Building Permits not available (Cement Shed)	The factory is required to obtain building permits from the local authority.	6 months

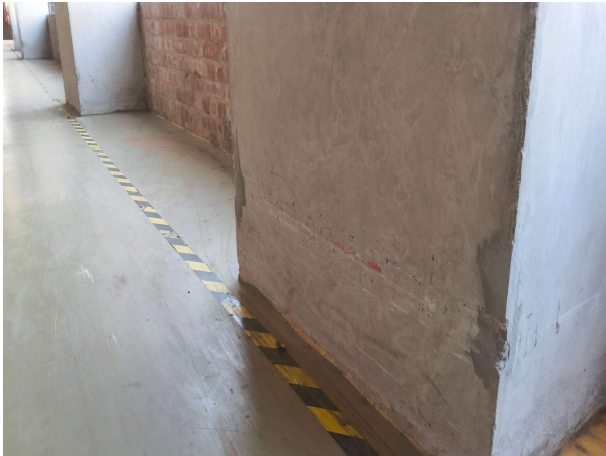
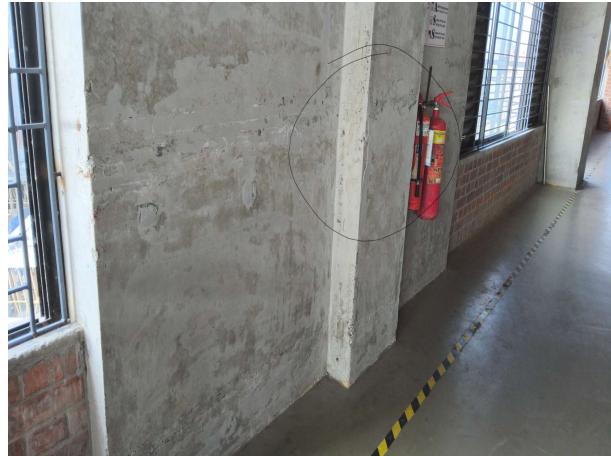
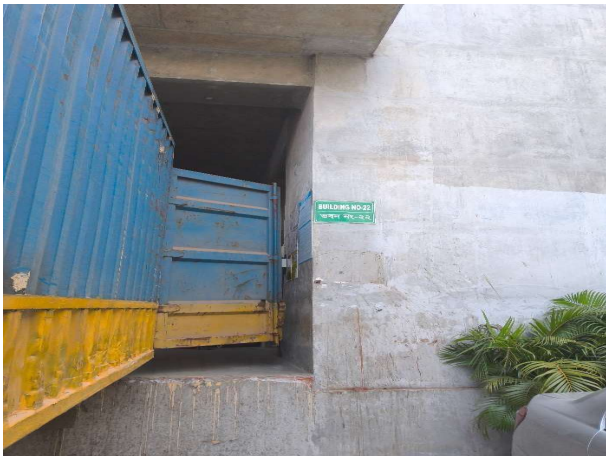
**Serial** : Observation 6

Potential Trolley and vehicle impact on column/wall

Trolley impact observed, the building engineer is required to provide safety barriers and impact protection on the columns and walls.

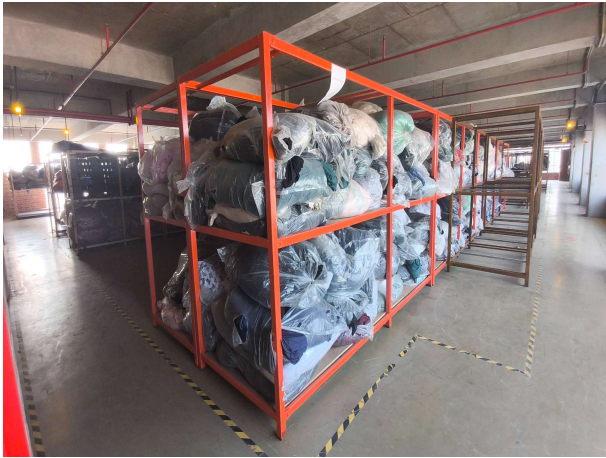
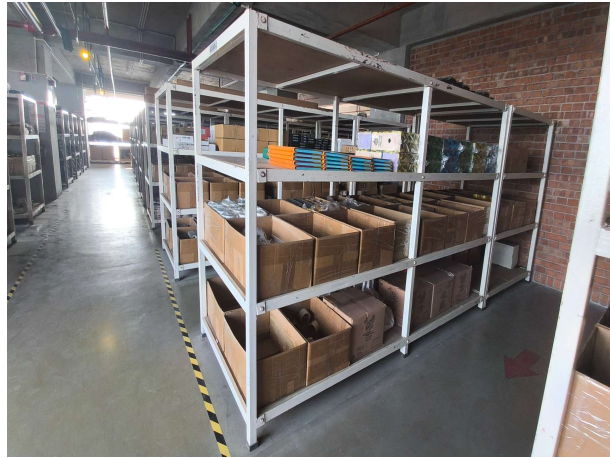
**Serial** : Observation 7

Lack of anchorage for non-structural elements

Anchorage was not observed for the non-structural elements including storage racks

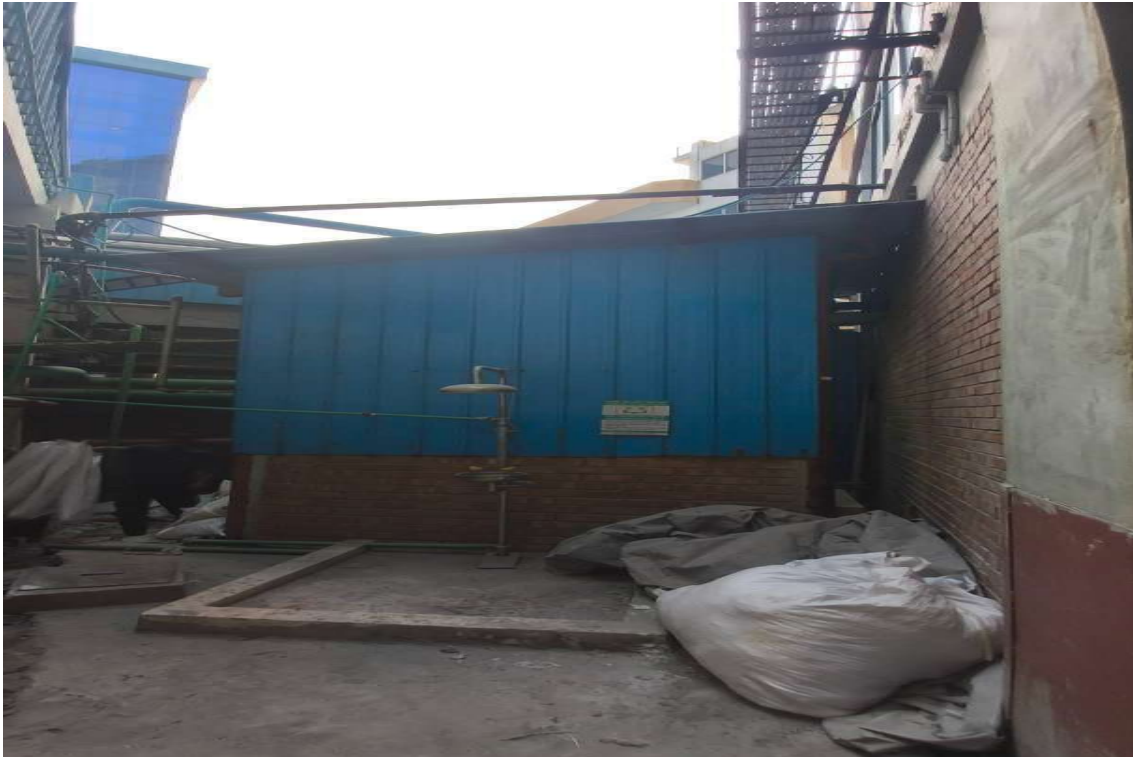
**Serial** : Observation 8  
**Structure Name** : Salt Shed  
**Observation:**  
Building Permits not available

Building permit was not found for the structure. The building engineer is required to collect building permit from concern local authority

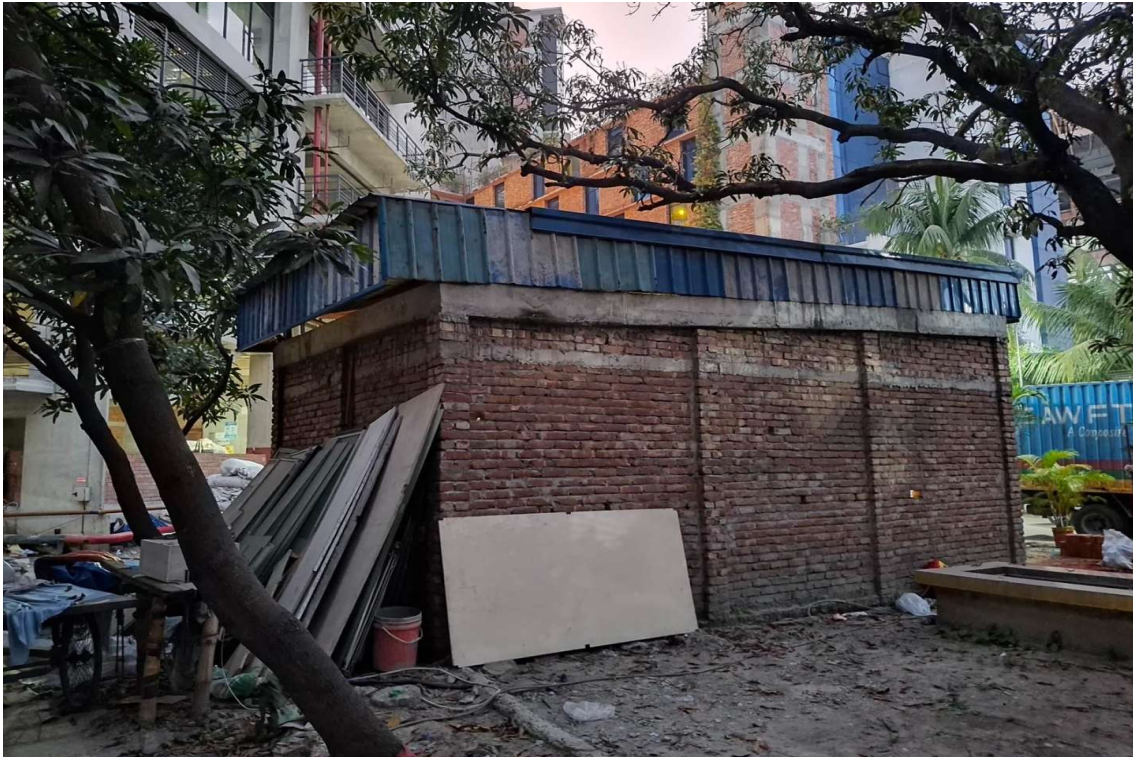
**Serial** : Observation 9  
**Structure Name** : Cement Shed  
**Observation:**  
Building Permits not available

Building permit was not found for the structure. The building engineer is required to collect building permit from concern local authority
