# Safia Apparels Ltd

Plot-b-46/47 & 64/65, BSCIC Industrial Estate, Panchobati, Fatullah, Narayanganj  
(23.62576, 90.47897)

12<sup>th</sup> April 2014

# Observations

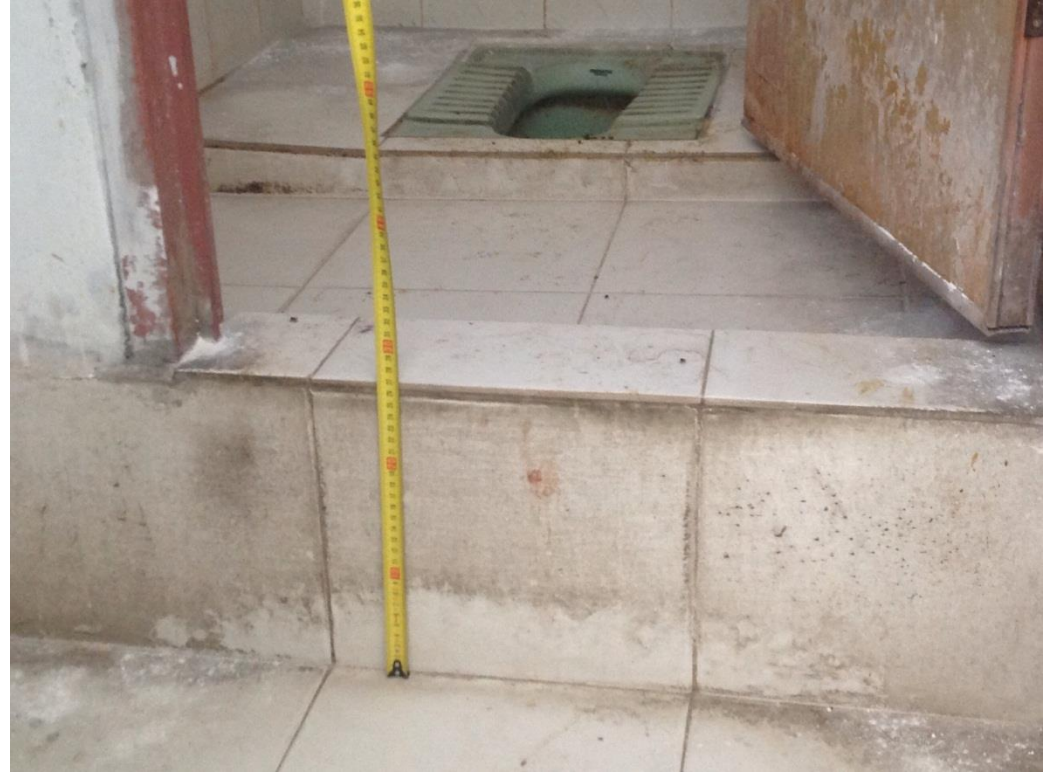
Heavy loading was noted in the toilets along the North elevation of Buildings 1 & 2, in the form of plinths and walls. Building Engineer to check that the slabs and beams have been adequately designed to accommodate this loading.

300mm Plinth to Toilets

Extent of Toilets to all Floors

| Item No. | Observation | Recommended Action Plan | Recommended Timeline |
|---|---|---|---|
| 1 | Heavy floor loading in toilet areas (slab build-up) and at cantilever slab of Building 1 (high storage) | Engage a Building Engineer to investigate the floor loading, and advise on any necessary alterations taking account of floor capacity and column capacity | 6-weeks |
| 2 | Heavy floor loading in toilet areas (slab build-up) and at cantilever slab of Building 1 (high storage) | Make any structural alterations as advised by Building Engineer | 6-months |

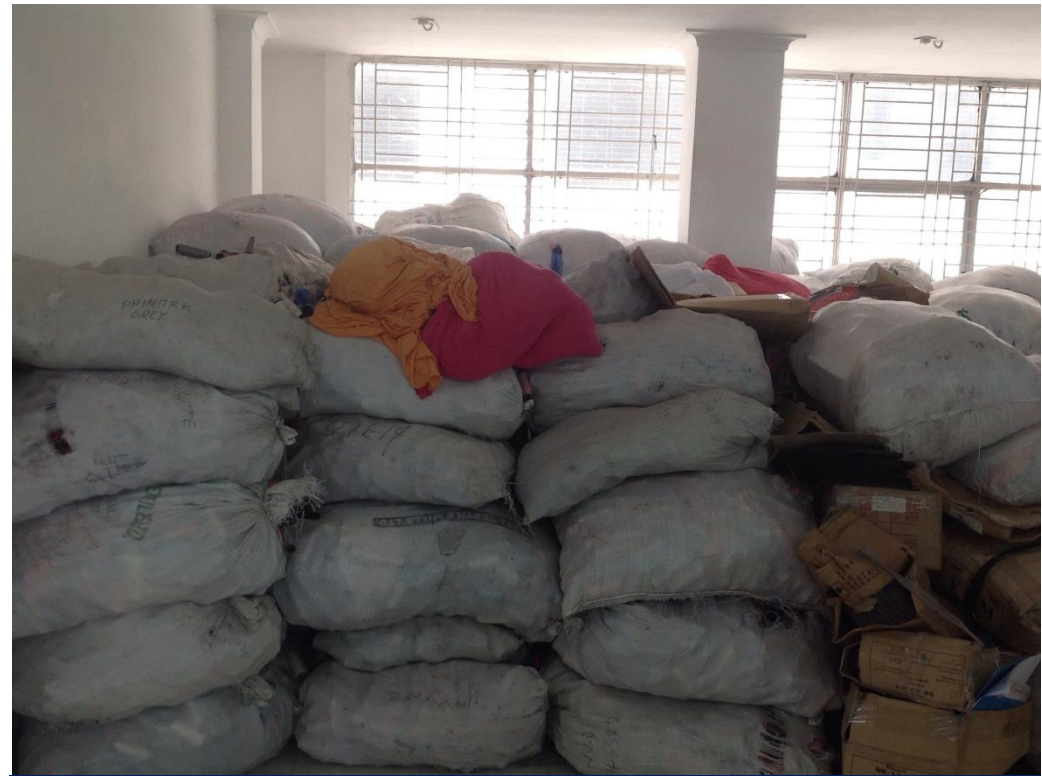
Heavy loading, in the form of temporary storage of fabric, was noted along the North elevation of Buildings 1, particularly to 4<sup>th</sup> and 5<sup>th</sup> Floor levels. Building Engineer to check that the slabs and beams have been adequately designed to accommodate these loadings, particularly at the cantilever location where there are no downstand beams.

Fabric Storage – Up to 2.5m High

Extent of Storage Loading to 4<sup>th</sup> and 5<sup>th</sup> Floors

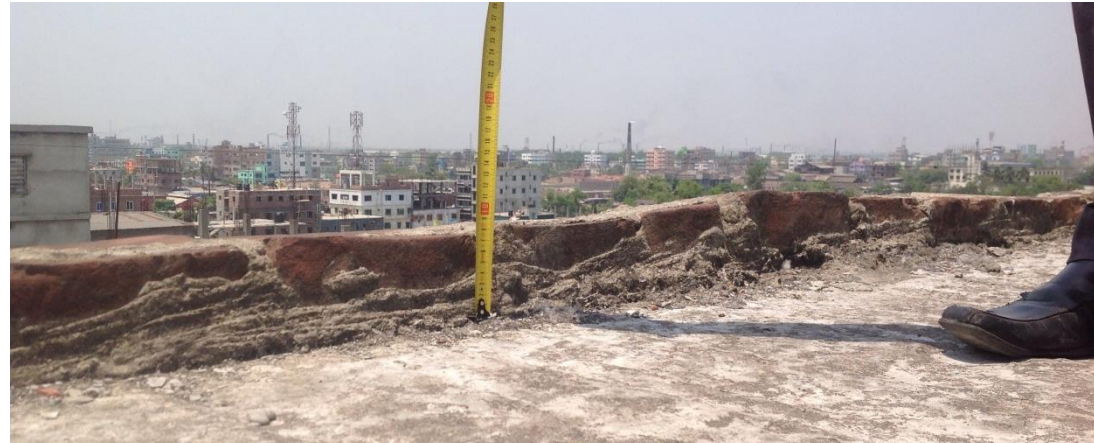
There is no edge protection to either building Roof, where construction works are ongoing. Building Engineer to install adequate fall barrier with immediate effect.

Height of Parapet to Roof

| Item No. | Observation | Recommended Action Plan | Recommended Timeline |
|---|---|---|---|
| 3 | Lack of any guarding/edge protection at Roof Level of both buildings | Provide adequate edge protection at Roof Level | 6-weeks |

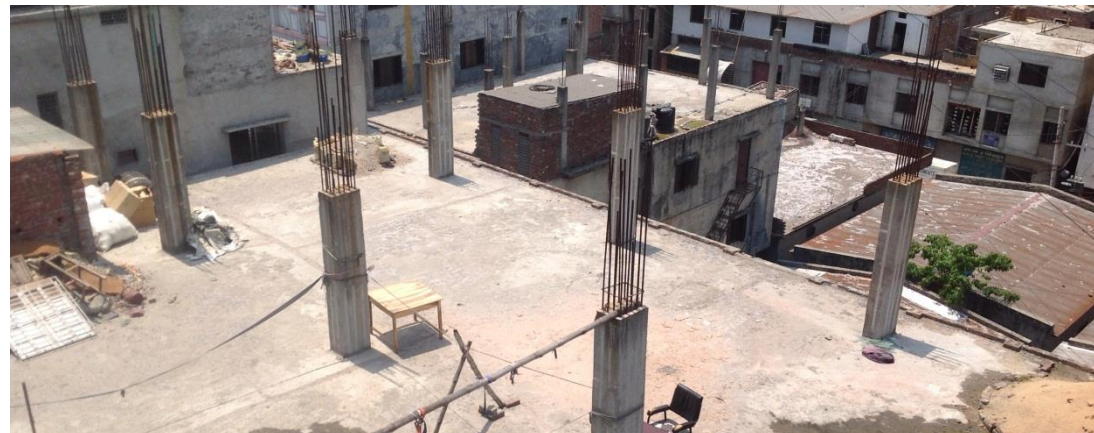
Lower Roof Parapet

Edge Protection to be Provided

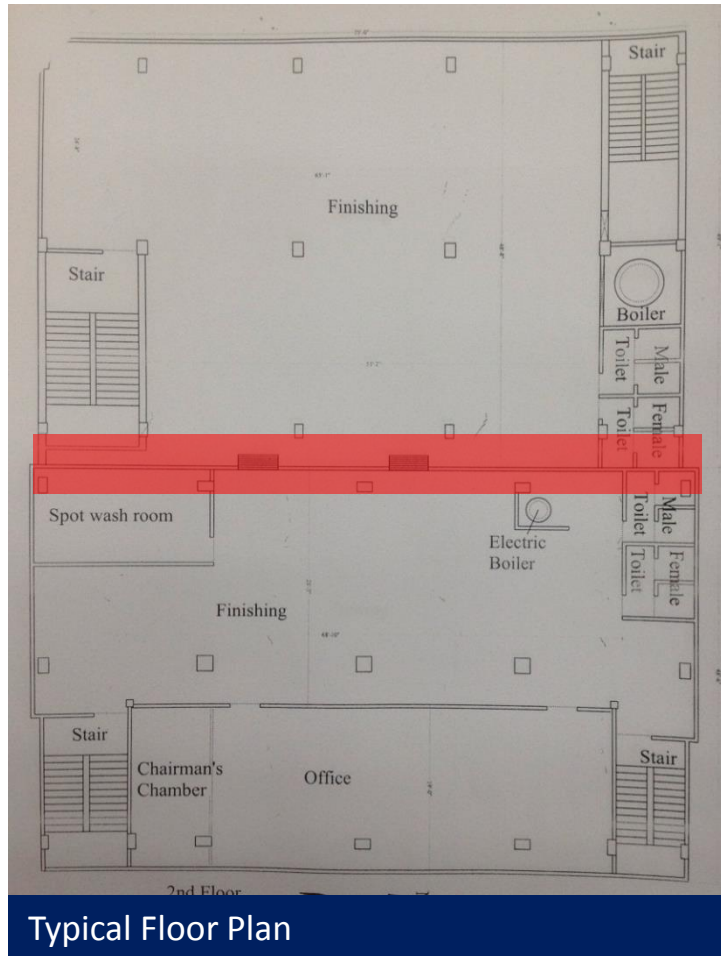
Location of connection detail bridging both buildings

The connection detail between Buildings 1 & 2 bridging the expansion joint does not appear to be robust. The detail appears to consist simply of a slab that spans onto each building, but is not connected to either. Cracking was observed at the interface of both buildings. Building Engineer to clarify design and robustness of connection detail between Buildings 1 and 2, and to carryout any remedial works as required.

| Item No. | Observation | Recommended Action Plan | Recommended Timeline |
|---|---|---|---|
| 4 | Bridging detail at buildings interface: Slab design and connection detail of slab to each building unknown | Engage a Building Engineer to check the slab design and also check the connection of the slab to each building for robustness, ties, etc | 6-months |

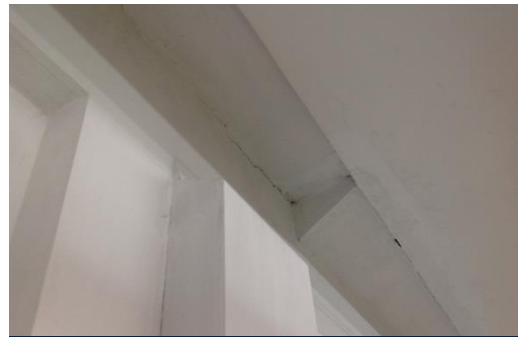
Cracking at slab interface

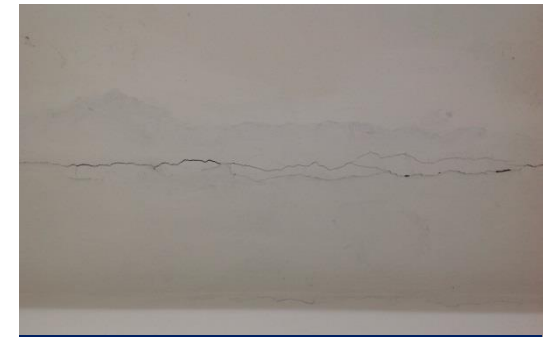
Cracking in wall

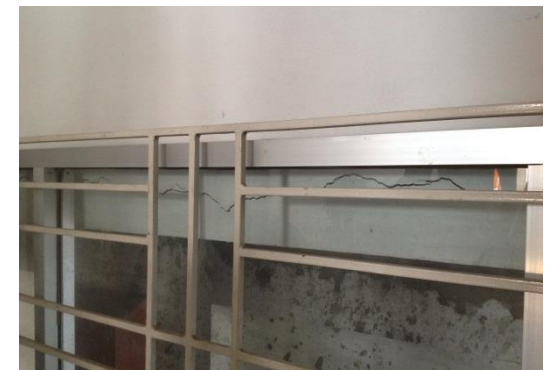
Cracking in staircore

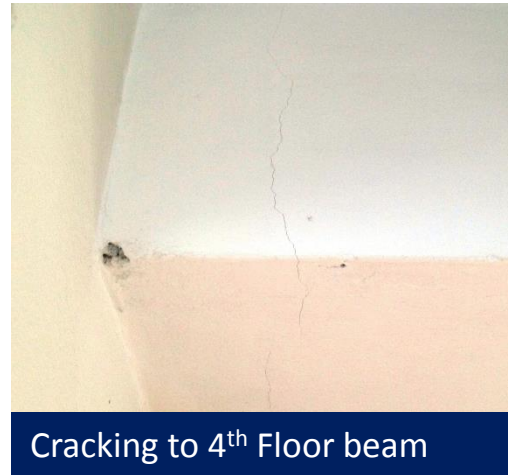
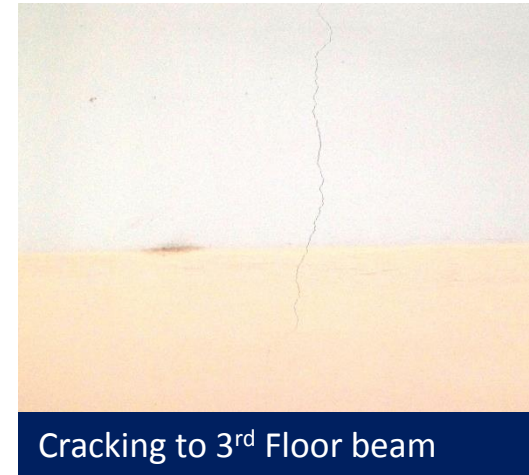
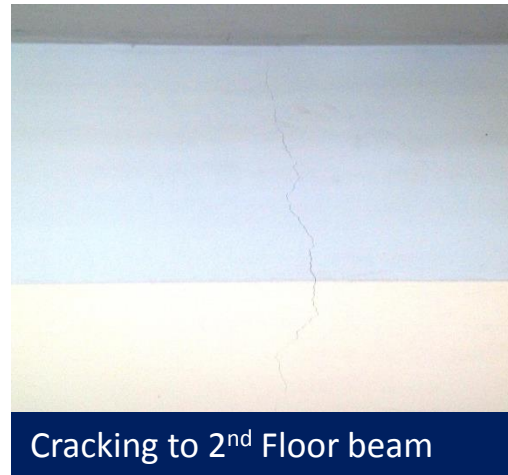
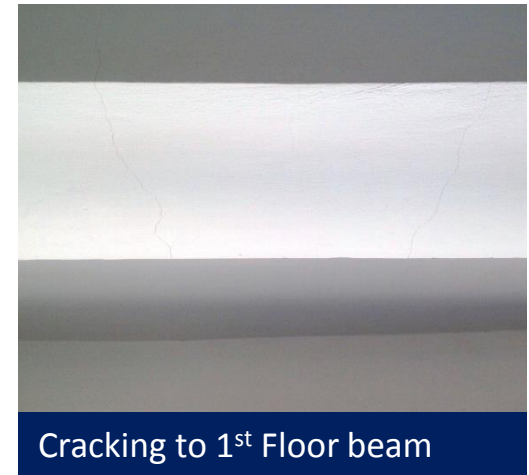
Hairline cracking was observed to the soffit of a number of beams and slabs at 1<sup>st</sup>, 2<sup>nd</sup>, 3<sup>rd</sup> and 4<sup>th</sup> Floor levels. Building Engineer to investigate and carry out remedial works to the structure as required.

| Item No. | Observation | Recommended Action Plan | Recommended Timeline |
|---|---|---|---|
| 5 | Hairline cracking in beams and slab soffits | Monitor cracks on beams. Engage a Building Engineer to investigate if cracks are only in the plastering | 6-months |
| 6 | Hairline cracking in beams and slab soffits | Engage a Building Engineer to advise on load reduction and repair and strengthening of the beams if required | 6-months |

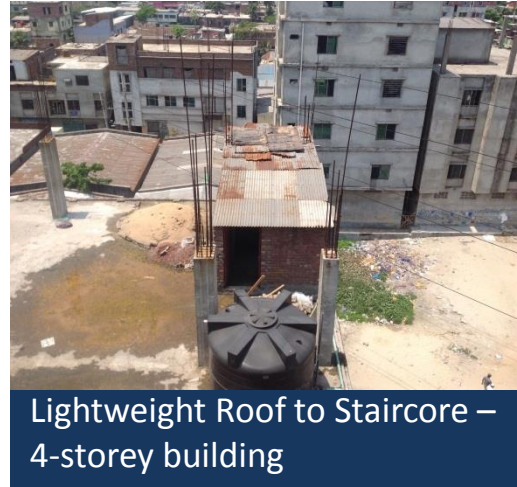
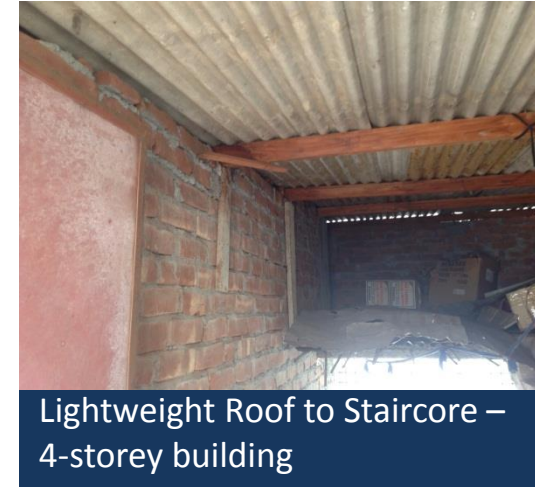
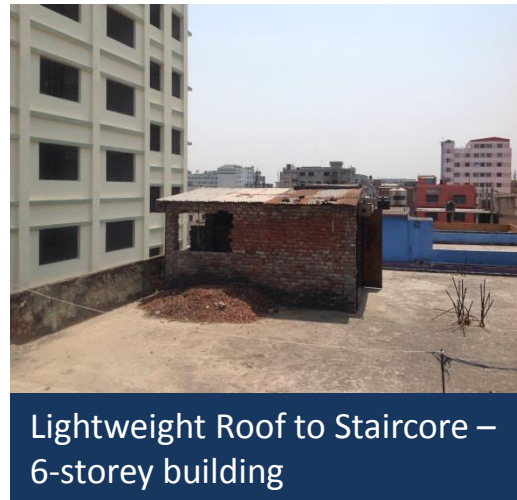
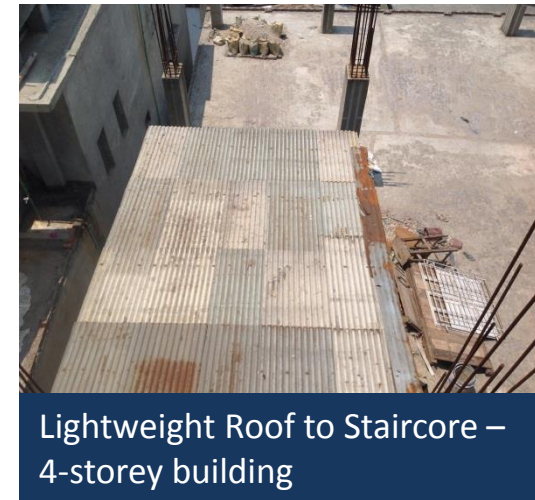
## Lightweight Steel Roofs

Building Engineer to review the design of the lightweight roof structures the staircores to both buildings, which do not appear to be engineered. Building Engineer to implement any upgrade works, including removing / securing loose metal sheeting, as required.

| Item No. | Observation | Recommended Action Plan | Recommended Timeline |
|---|---|---|---|
| 7 | Apparently non engineered roof structure to stair enclosures above main roofs | Engage a Building Engineer to check the capacity of the lightweight roof and make any necessary alterations | 6-months |

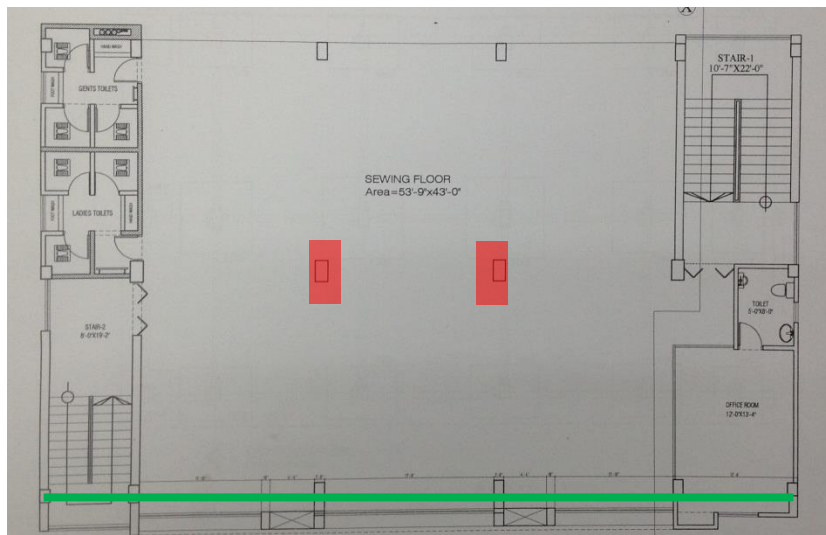
Building 2 – Typical Floor Plan

- Incorrect column sizes, particularly at Ground Floor level where the uniformity in internal column size indicated in the drawings is not apparent;
- Incorrect column reinforcement – the number of bars observed at Ground Floor level using the Ferroscanner was not in accordance with the drawings;
- The building line to the North elevation, adjacent to the South Elevation of Building 1, does not appear to be correct.

Over-sized Columns

Apparent Building Line

Building Engineer to review and provide clarification.

| Item No. | Observation | Recommended Action Plan | Recommended Timeline |
|---|---|---|---|
| 8 | Differences between actual construction and information on design drawings | Engage a Building Engineer to survey the structure and prepare a full set of accurate “as-constructed” drawings. | 6-weeks |
