# Diganta Sweaters Ltd. (Building-3)

Naoujoor, Tangail Road, Chandana Chowrasta, Gazipur- 1702

08 February 2026

1. Building-3: This is a six-storied (G+5) RC building

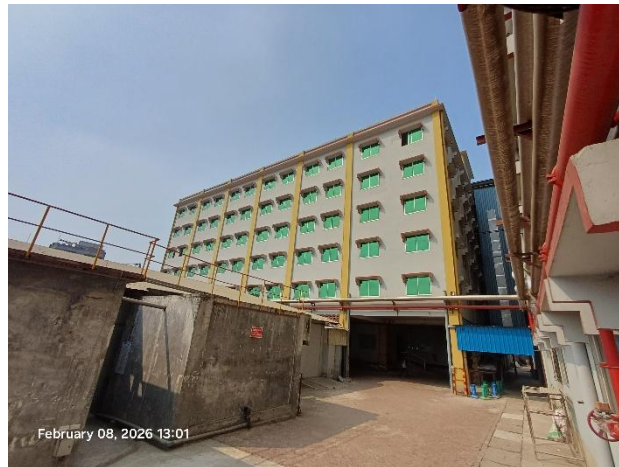
Building-3

**Observation-1:** Design report required to be reviewed by RSC for lateral loading. (Building-3)

**Description:** A complete set of design documents was available for Building-3. The building engineer is required to submit the documents to RSC for review.

| Item No. | Observation | Action Plan | Timeline |
|---|---|---|---|
| 1. | Design report required to be reviewed by RSC for lateral loading. (Building-3) | The building engineer is required to submit the documents to RSC for review. | within 6 weeks |

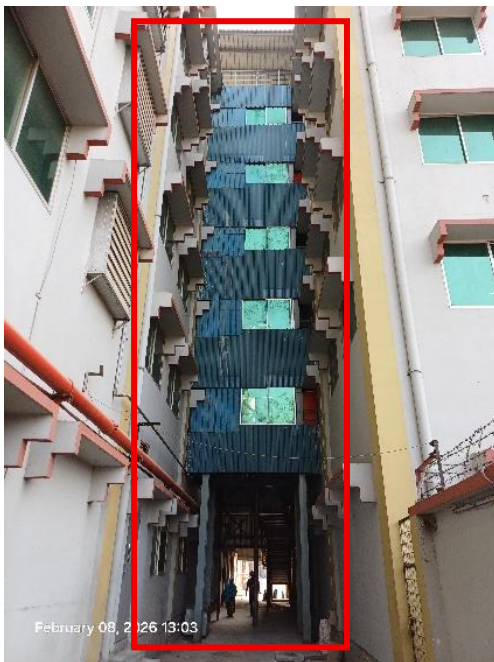
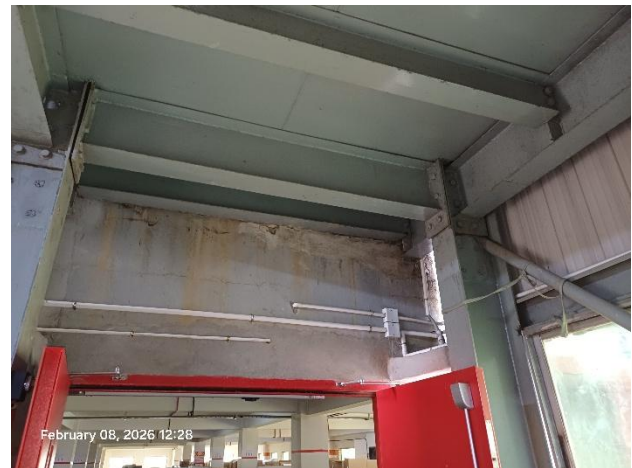
Steel connecting bridge between building 2 & 3

**Observation-2:** Lack of design documents. (Connecting bridge)

**Description:** As per BNBC, every building or structure designed shall have its design documents prepared following the provisions of Section 1.9.1. The design document shall include a design report and a set of structural drawings, prepared in compliance with sections 1.9.1.1 and 1.9.1.2 as per BNBC.

At the time of inspection, the design documents were not available. The building engineer is required to prepare the design documents in compliance with Section 1.9.1 (Part 6) of the BNBC and submit them to RSC for review.

| Item No. | Observation | Action Plan | Timeline |
|---|---|---|---|
| 3. | Lack of design documents. (Connecting bridge) | The building engineer is required to prepare the design documents in compliance with Section 1.9.1 (Part 6) of the BNBC and submit them to RSC for review. | within 6 weeks |

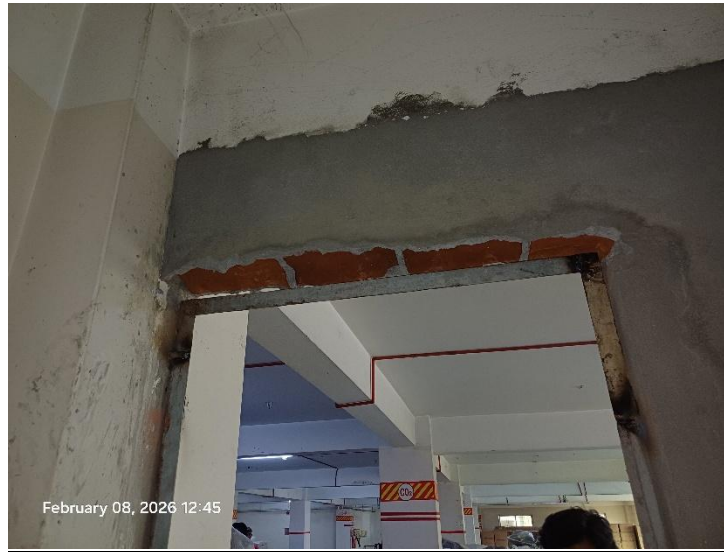
**Observation-3:** Door opening without a lintel. (Building-3)

**Description:** A door opening was found without a lintel on the 1<sup>st</sup> floor.

The building engineer is required to provide a lintel over the door opening; alternatively, the brick infill above the opening must be removed.

| Item No. | Observation | Action Plan | Timeline |
|---|---|---|---|
| 5. | Door opening without a lintel. (Building-3) | The building engineer is required to provide a lintel over the door opening; alternatively, the brick infill above the opening must be removed. | within 6 weeks |

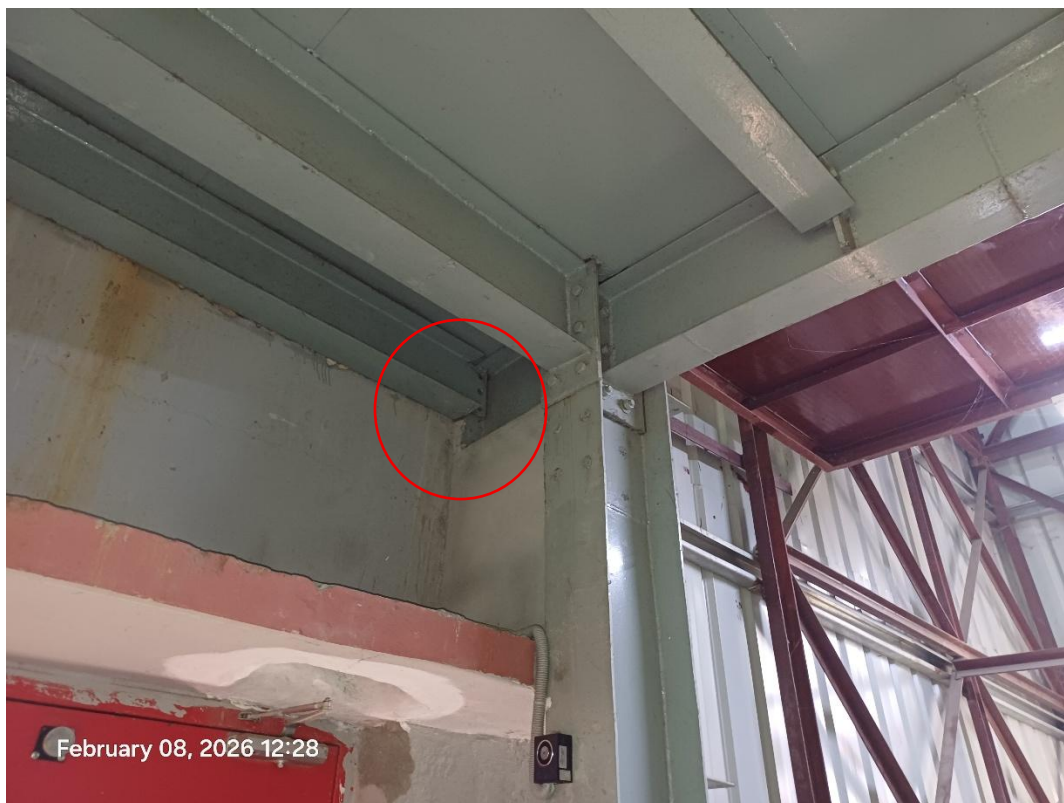
**Observation-4:** Bolt missing. (Building-3)

**Description:** Bolts are missing in several connections of the steel connecting bridge. Building engineer is required to install the missing bolts where necessary.

| Item No. | Observation | Action Plan | Timeline |
|---|---|---|---|
| 6. | Bolt missing. (Building-3) | Building engineer is required to install the missing bolts where necessary. | within 6 weeks |

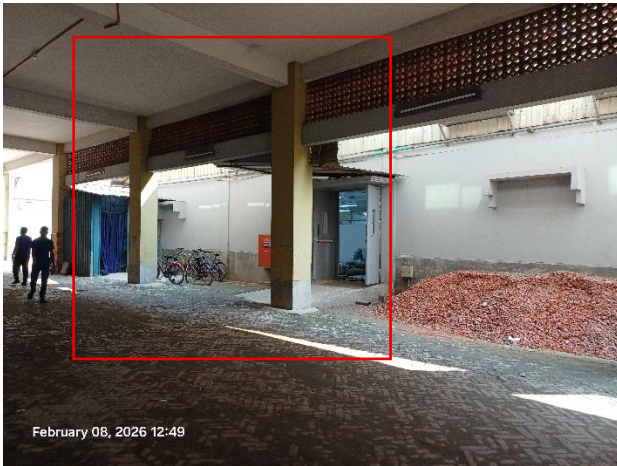
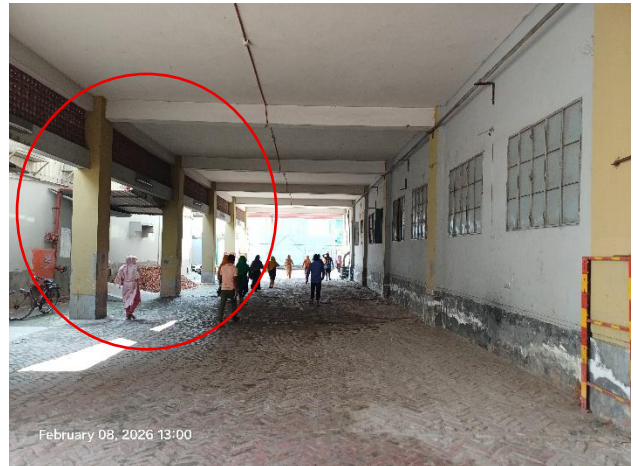
**Observation-5: Column susceptible to vehicle impact. (Building-3)**

**Description:** The part of the ground floor of this building is used as an internal road. So, columns in the ground floor area are susceptible to vehicle impact. The building engineer is required to provide separate barriers around the column to prevent vehicle impact.

| Item No. | Observation | Action Plan | Timeline |
|---|---|---|---|
| 7. | Column susceptible to vehicle impact. (Building-3) | The building engineer is required to provide separate barriers around the column to prevent vehicle impact. | within 6 weeks |

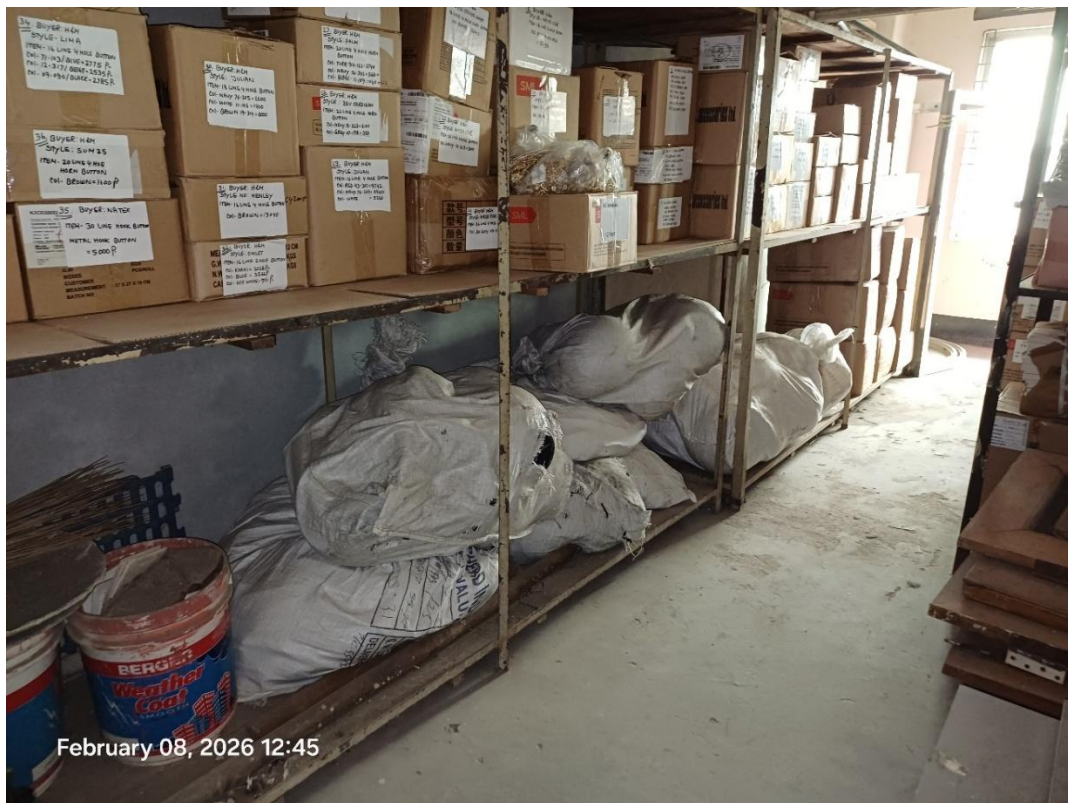
**Observation-6: Non-structural elements not anchored or braced. (Building-3)**

**Description:** Some racks on floors are not anchored or braced to resist lateral (earthquake) forces. The factory is required to anchor/brace all non-structural elements adequately to resist earthquake forces.

| Item No. | Observation | Action Plan | Timeline |
|---|---|---|---|
| 8. | Non-structural elements are not anchored or braced. (Building-3) | The factory is required to anchor/brace all non-structural elements adequately to resist earthquake forces. | within 6 weeks |
