# GENESIS FASHIONS LTD. (EXTENSION - 3)

126/1 Kadda Nandun, Kadda Bazar, Gazipur sadar, Gazipur, Bangladesh

17 February 2026

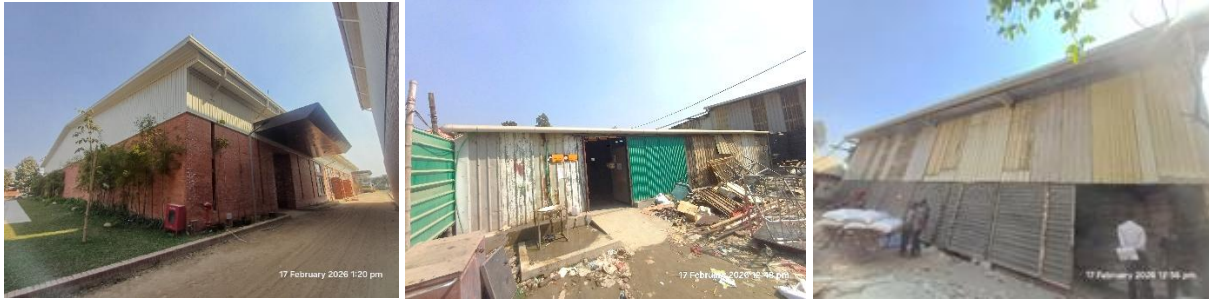
### Observation 01: Lack of building permit drawings for all structures.

**Description:** During inspection, building permit drawings from the local authority were not found for any structures.

The building engineer is required to collect permit drawings for all the structures from the local authority and submit them to RSC for review.

| Item No | Observation | Action Plan | Timeline |
|---|---|---|---|
| 1. | Lack of building permit drawings for all structures. | Collect building permit drawings from the applicable local authority. | within 6 months |

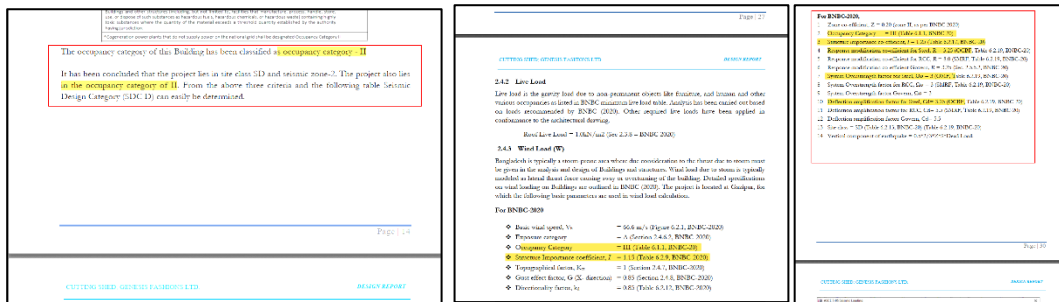
### Observation 02: Lack of information in the Design report (Cutting Shed).

**Description:** During inspection, a design report was available, but it doesn't include all types of required serviceability checks (Displacement and Drift for all types of lateral load are not provided). A detailed check/calculation for punching shear & beam shear (one-way & two-way shear failure) is not provided. In addition, inconsistent information was provided about the occupancy category & framing types of the structure.

The Building engineer is required to update the design report as per 1.9.1 of BNBC and check all types of required serviceability and submit them to RSC for review.

| Item No | Observation | Action Plan | Timeline |
|---|---|---|---|
| 2. | Lack of information & inconsistent data in the Design report (Cutting Shed). | The Building engineer is required to update the design report as per 1.9.1 of BNBC and check all types of required serviceability and submit them to RSC for review. | within 6 weeks |

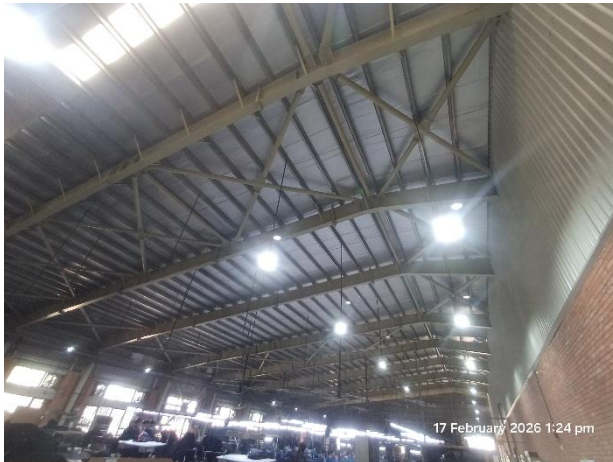
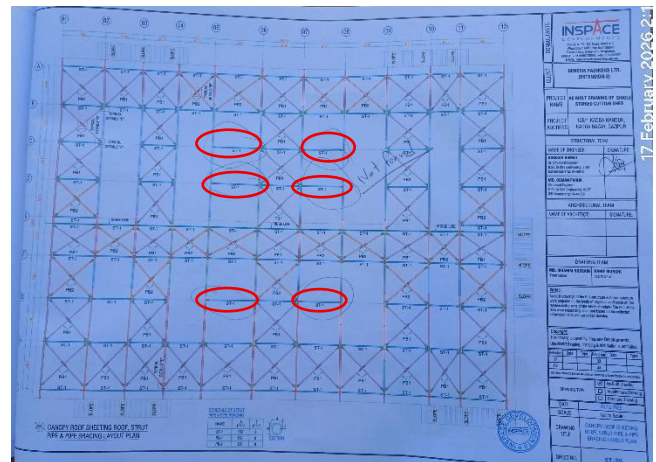
### Observation 03: Mismatch in as-built drawings [Cutting Shed]

**Description:** During inspection, mismatches were observed in the strut member layout plan of the cutting shed. Some strut members at roof frame were found missing with respect to the available as-built drawings.

The building engineer is required to survey the whole & prepare a comprehensive as-built drawing, submit it to the RSC for review.

| Item No | Observation | Action Plan | Timeline |
|---|---|---|---|
| 4. | Mismatch in the as-built drawing (Cutting Shed). | The building engineer is required to survey the whole & prepare a comprehensive as-built drawing, submit it to the RSC for review. | within 6 weeks |

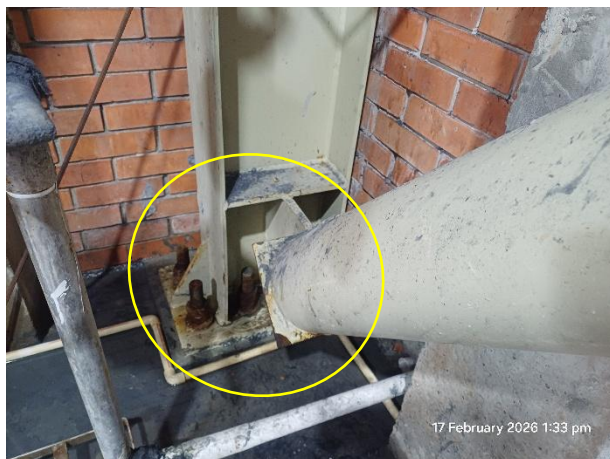
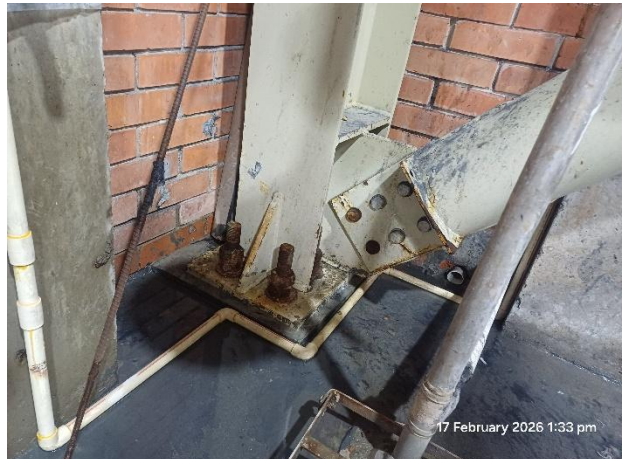
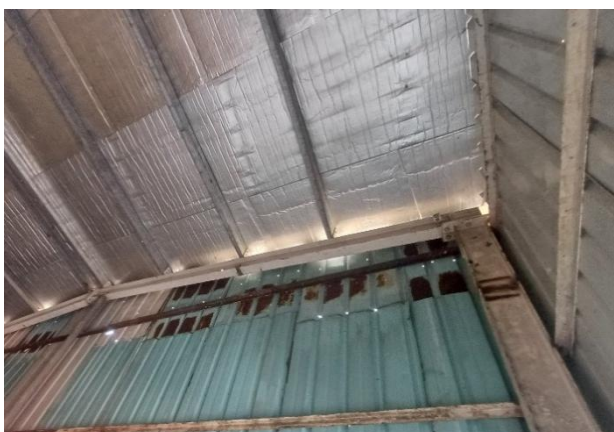
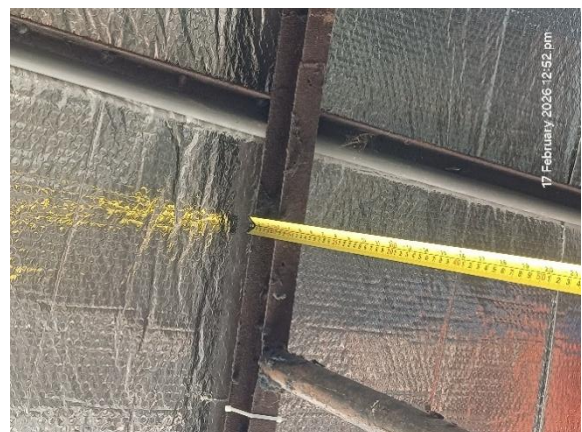
### Observation 04: Corrosion on the steel member. [Cutting shed, Wastage & Stone Shed, and Workshop Shed-2]

**Description:** Corrosion was found on the steel members of the building (Cutting shed, Wastage & Stone Shed, and Workshop Shed-2). The building engineer is required to remove rust and apply anti-

corrosive paints.

| Item No | Observation | Action Plan | Timeline |
|---|---|---|---|
| 5. | Corrosion on the steel member (cutting shed). | The building engineer is required to remove rust and apply anti-corrosive paints with suitable method. | within 6 weeks |
| 12. | Corrosion on the steel member (Workshop Shed-2). | The building engineer is required to remove rust and apply anti-corrosive paints with suitable method. | within 6 weeks |

| 16. | Corrosion on the steel member (Wastage & Stone Shed). | The building engineer is required to remove rust and apply anti-corrosive paints with suitable method. | within 6 weeks |

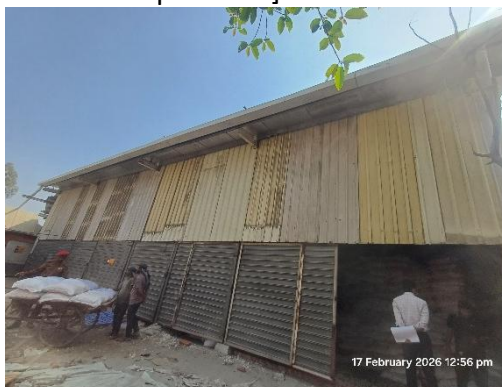
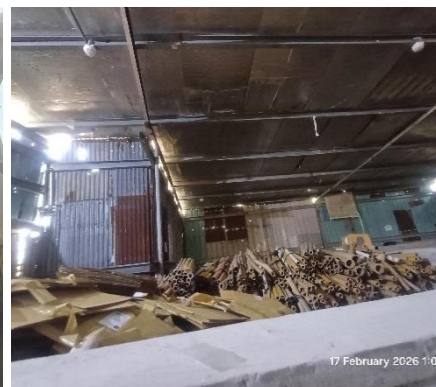
**Observation 07:** Lack of as-built drawings, material test report, and design documents. [Wastage & Stone Shed and Workshop Shed-2]

**Description:** During inspection, no as-built drawing was found for these structures. Also, there was no steel/concrete material test report and soil test report for these structures.

The building engineer is required to carry out Detail Engineering Assessment (DEA) for the structure to verify the foundation details, concrete/steel/soil material strength, and prepare an assessment report. Prepare a full set of DEA documents with a detailed remedial action plan. Submit the DEA documents to the RSC for review.

| Item No | Observation | Action Plan | Timeline |
|---|---|---|---|
| 8. | Lack of as-built drawings, material test report, and design documents (Workshop Shed-2). | The building engineer is required to survey the whole structure and prepare as-built drawings with foundation and connection details. | within 6 weeks |
| 9. | | Carry out Detail Engineering Assessment (DEA) report with remedial actions considering the as-built structural system and material strength. Submit DEA documents to the RSC for review. | within 6 weeks |
| 13. | Lack of as-built drawings, material test report, and design documents (Wastage | The building engineer is required to survey the whole structure and prepare as-built drawings with foundation and connection | within 6 weeks |

| 14. | | Carry out Detail Engineering Assessment (DEA) report with remedial actions considering the as-built structural system and material strength. Submit DEA documents to the RSC for review. | within 6 weeks |
