FIRE SAFETY INSPECTION REPORT

**VINTAGE DENIM STUDIO LTD.
PLOT 99 AND 102-128, ISHWARDI EPZ, ISHWARDI,
PABNA**

ACCORD
on Fire and Building Safety in Bangladesh

June 1, 2014

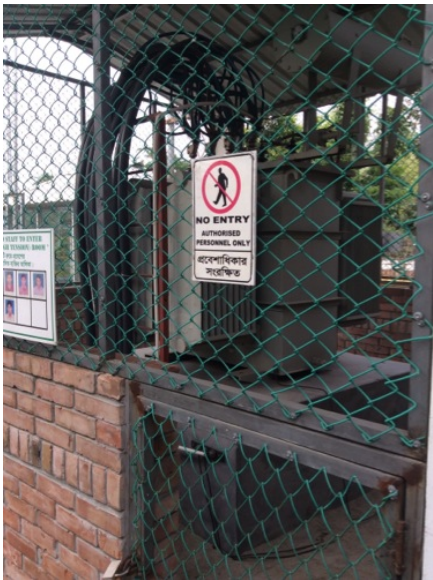
No.	Category	Finding	Recommendation	Remediation Timeframe
F-1	Fire Rated Construction	The transformer room is not separated by fire-rated construction (openings, non-rated doors, penetrations).	Separate the transformer room by a minimum 2-hr fire-rated construction. Seal and/or protected all openings to maintain the required fire separations	Within 3 months

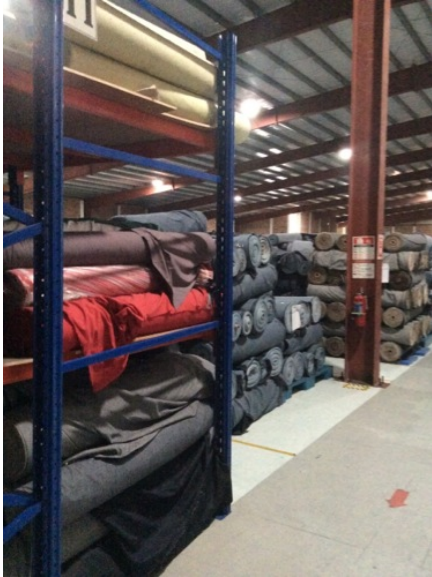
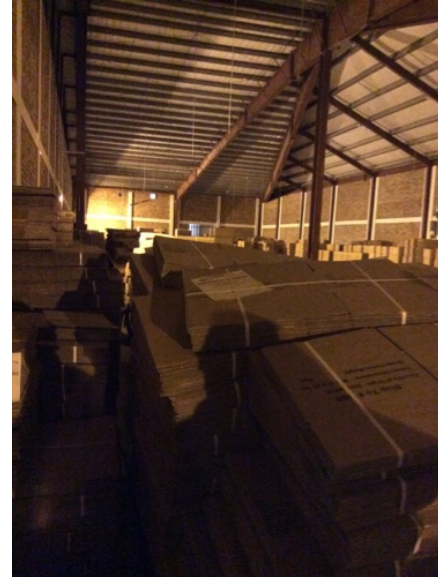
F-2	Fire Rated Construction	Rooms used for combustible storage are not separated by fire-rated construction.	Provide dedicated storage rooms separated by minimum 1-hr fire-rated construction.	Within 3 months

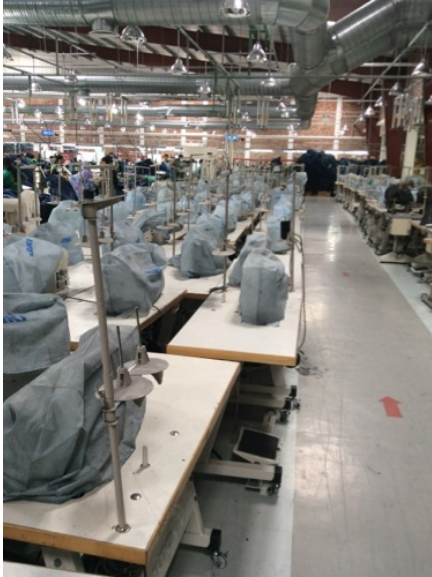
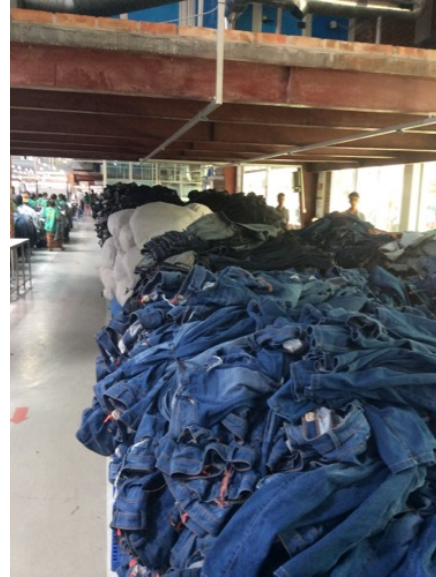
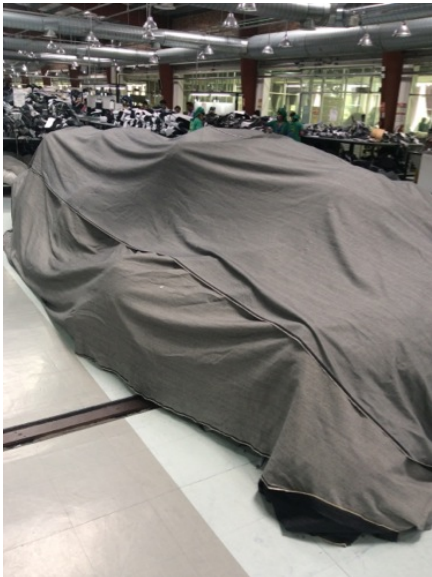
F-3	Fire Rated Construction	Areas used for combustible storage are not separated by fire-rated construction.	Provide dedicated storage rooms separated by minimum 1-hr fire-rated construction. Where separate storage rooms are not feasible, provide defined storage areas and limit the storage arrangement as follows: - Maximum height of 2.4m and maximum area of 23m ² - If sprinkler protected: maximum height of 3.66m and maximum area of 93m ² Separate areas of unenclosed combustible storage by a minimum clear distance of 3m.	Within 3 months
-----	-------------------------	--	--	-----------------

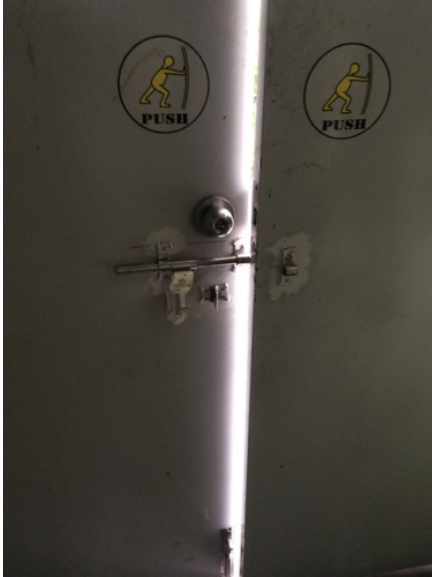
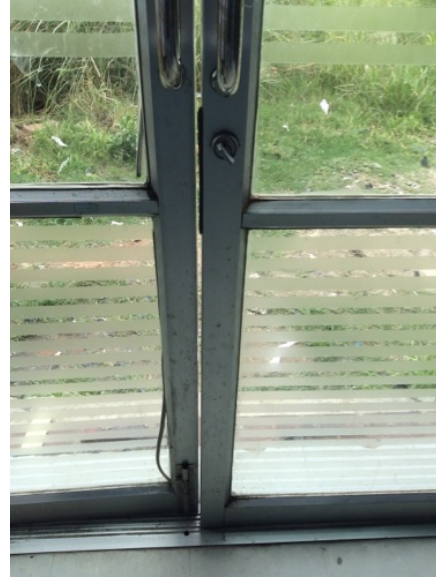
F-4	Egress	Egress doors / gates with locking features are provided at building exits and exit discharge.	Remove locking features from all egress doors / gates. If locks are required for security reasons, utilize special door locking features complying with NFPA 101.	Immediate
-----	--------	---	--	-----------

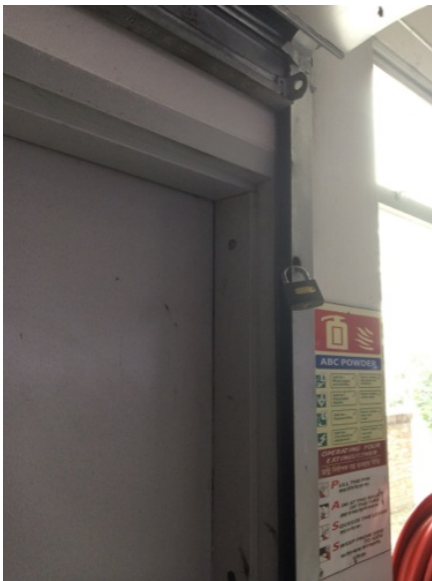
F-5 Egress

Collapsible gates / sliding doors are provided at building exits.

Replace all gates / sliding doors along the means of egress with side-hinged, swinging egress doors.

If locks are required for security reasons, utilize special door locking features complying with NFPA 101.

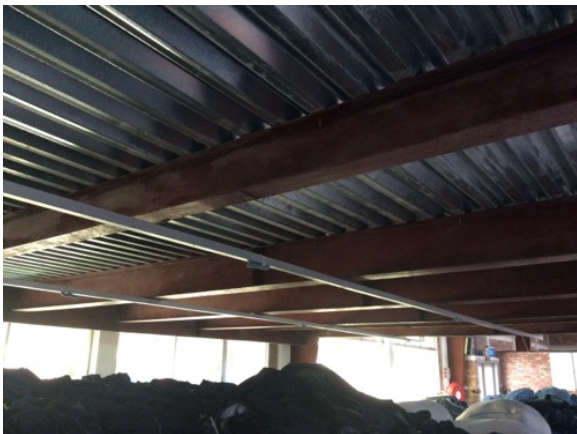
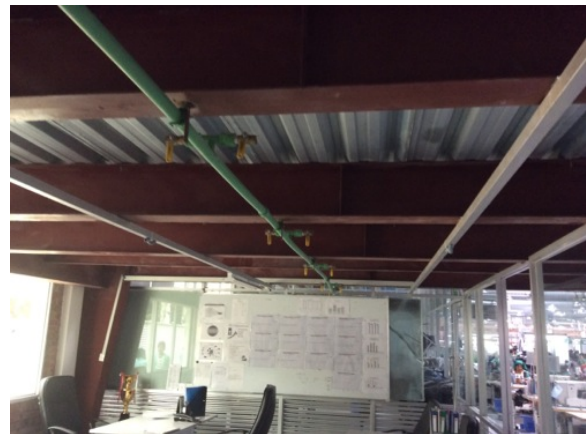
F-6	Fire Protection	Inspection, testing, and maintenance for the fire alarm system was not in accordance with NFPA 72.	Inspect, test and maintain the fire alarm system, and keep written records on-site, in accordance with NFPA 72.	Within 3 months
F-7	Fire Protection	Based off observations, the existing multi detectors tied to the fire alarm were not adequately provided in the east and west office rooms and the east storage area.	Based on ceiling configuration, provide additional detectors where needed, and space them in accordance with NFPA 72.	Within 3 months

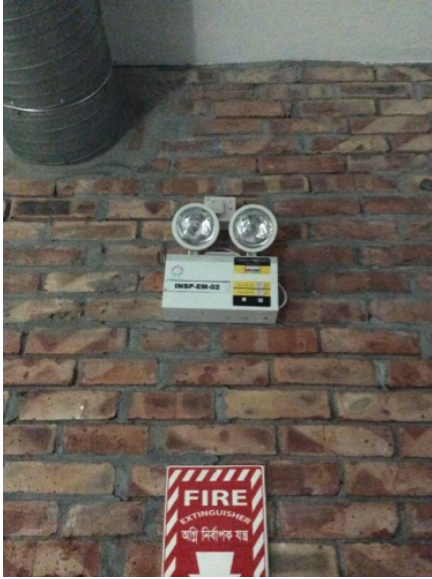
F-8	Egress Lighting	Manual on-off switch is provided for emergency lighting / exit signage units.	Remove manual on/off switches from emergency lighting / exit signage units to prevent them from being switched off.	Within 1 month
-----	-----------------	---	---	----------------

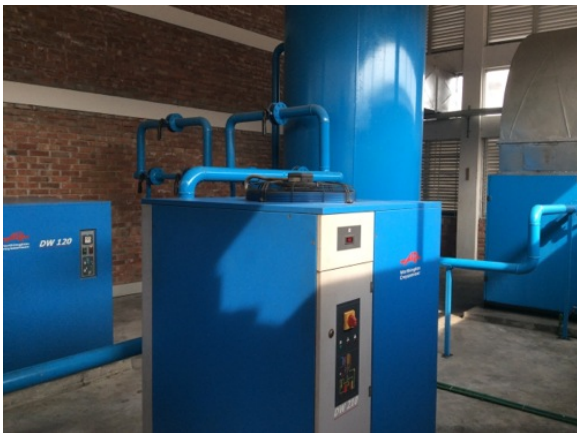
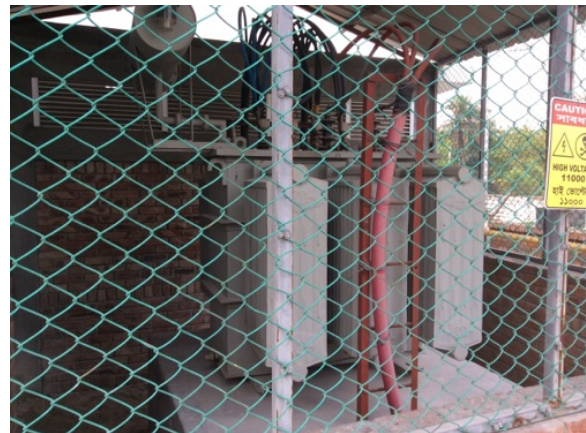
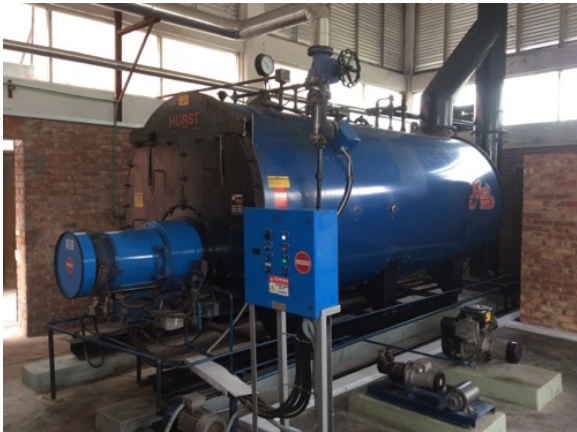
No.	Category	Finding	Recommendation	Remediation Timeframe
F-1	Fire Rated Construction	The boiler, compressor and transformer rooms are not separated by fire-rated construction (openings, non-rated doors, penetrations). The utility building is open to egress path.	Separate the boiler, generator and transformer rooms by a minimum 2-hr fire-rated construction. Seal and/or protected all openings to maintain the required fire separations	Within 3 months

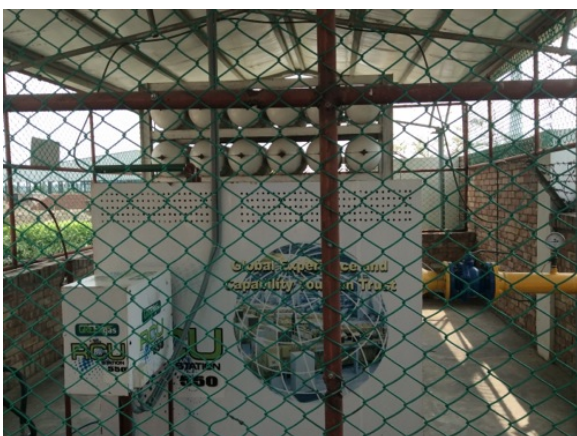
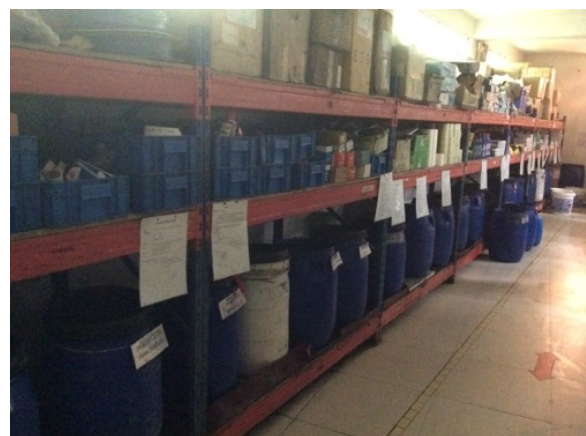
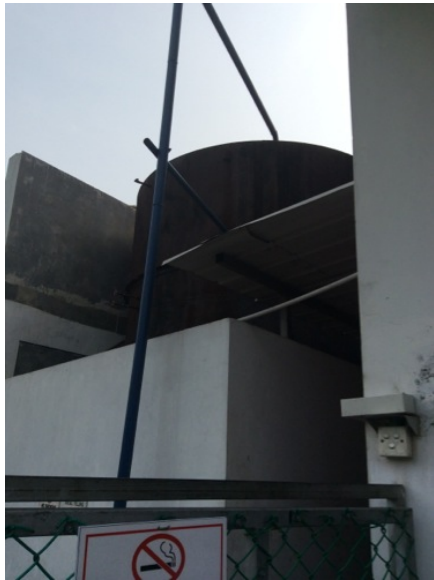
F-2	Fire Rated Construction	Hazardous materials / flammable liquid storage area in the building and assembly building is not separated by fire-rated construction (openings, non-rated doors, penetrations).	Separate the hazardous materials / flammable liquid storage room by a minimum 2-hr fire-rated construction. Seal and/or protected all openings to maintain the required fire separations.	Within 3 months
-----	-------------------------	--	---	-----------------

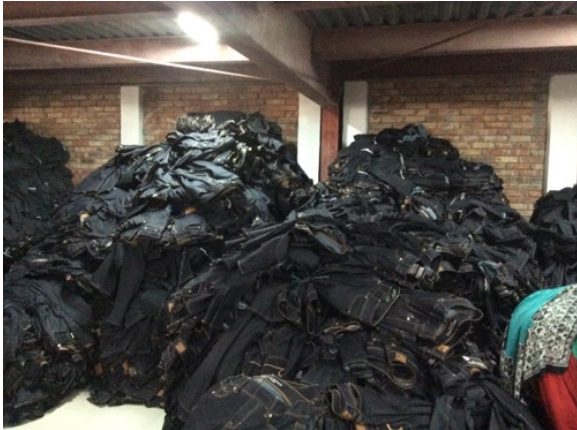
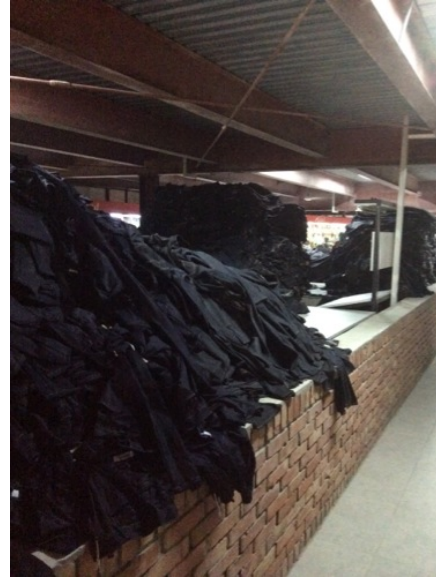
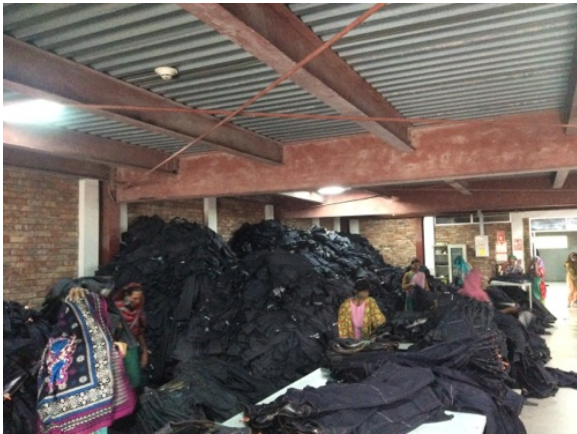
F-3	Fire Rated Construction	Areas used for combustible storage are not separated by fire-rated construction.	Provide dedicated storage rooms separated by minimum 1-hr fire-rated construction.	Within 3 months
			<p>Where separate storage rooms are not feasible, provide defined storage areas and limit the storage arrangement as follows:</p> <ul style="list-style-type: none">- Maximum height of 2.4m and maximum area of 23m²- If sprinkler protected: maximum height of 3.66m and maximum area of 93m²	
			<p>Separate areas of unenclosed combustible storage by a minimum clear distance of 3m.</p>

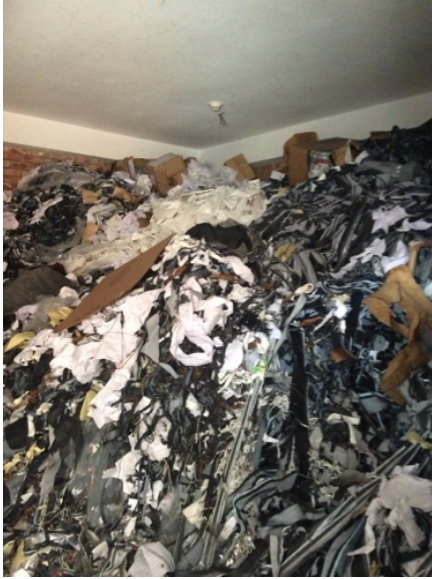
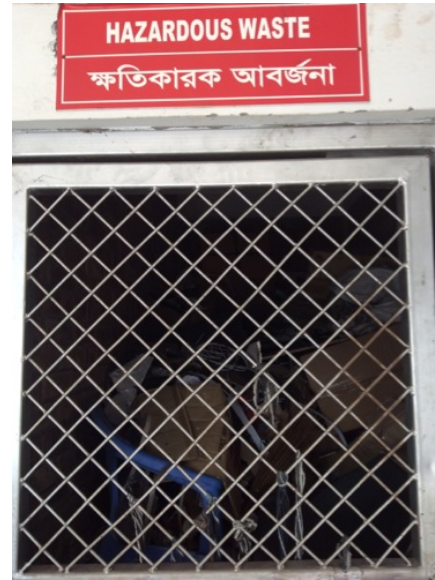
F-4

Rooms used for
combustible storage in
the assembly building
are not separated by
fire-rated construction.

Provide dedicated storage
rooms separated by minimum
1-hr fire-rated construction.

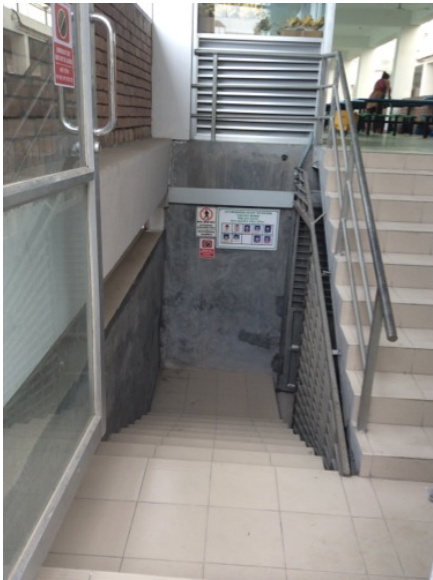
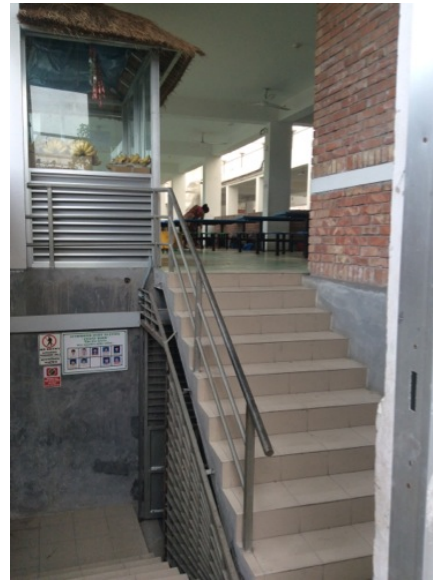
F-5	Fire Rated Construction	The exit stairs and ramp in assembly building are not separated from other spaces on each floor by fire-rated construction.	Provide minimum 1.5-hr fire rated doors and seal all unprotected openings to separate the exit stairs from work areas and other building spaces on all floor levels. Ensure that the fire doors are self-closing and positive latching and that they are provided with fire exit (panic) hardware where serving production floors.	Within 3 months
			If fire doors are required to be held open for functional reasons, provide automatic-closing devices tied to the fire alarm system.

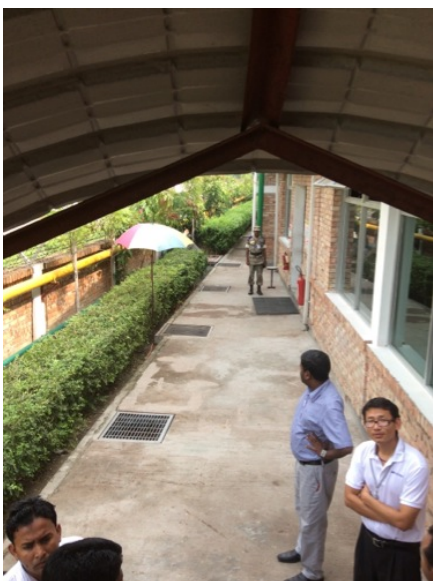
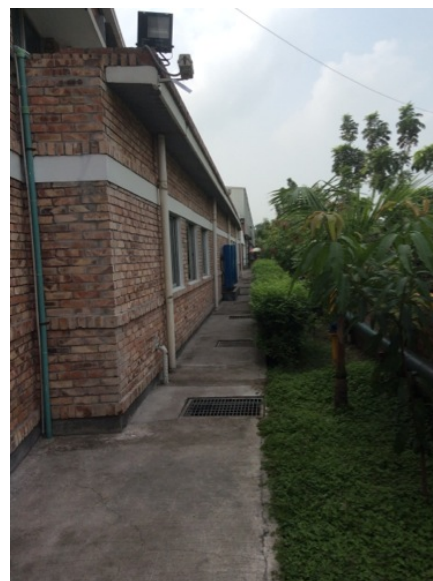
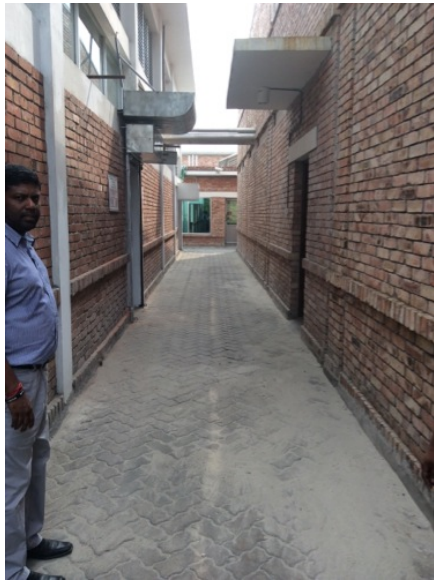
F-6 Fire Rated Construction

All exit discharge paths, except the southwest, are less than 10 ft wide and are not separated from the building interior or other building.

Seal all penetrations and openings to the interior of the building along the discharge path, up to a height of 10 ft., to provide a minimum 1-hr fire separation.

Alternatively, provide a second remote discharge path to the public way (only include this if feasible).

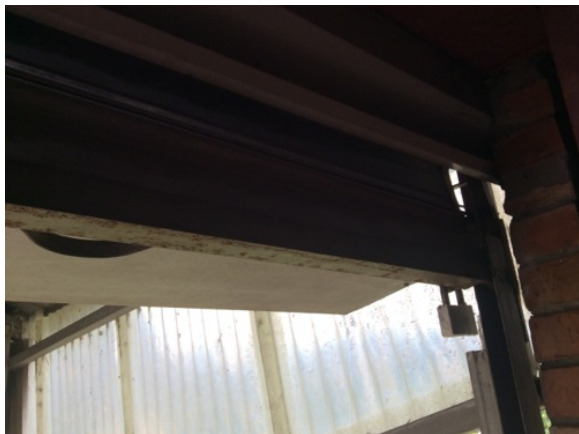
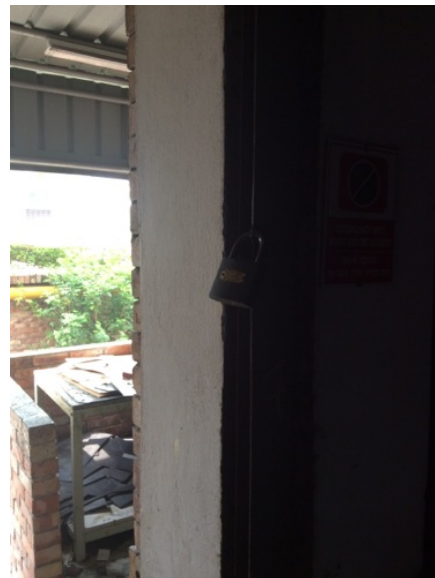
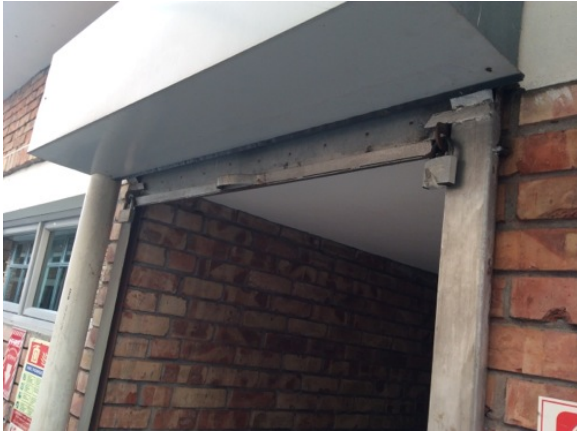
F-7	Egress	Egress doors / gates with locking features are provided at the building, assembly and office building exits and exit discharge.	Remove locking features from all egress doors / gates. If locks are required for security reasons, utilize special door locking features complying with NFPA 101.	Immediate
-----	--------	---	--	-----------

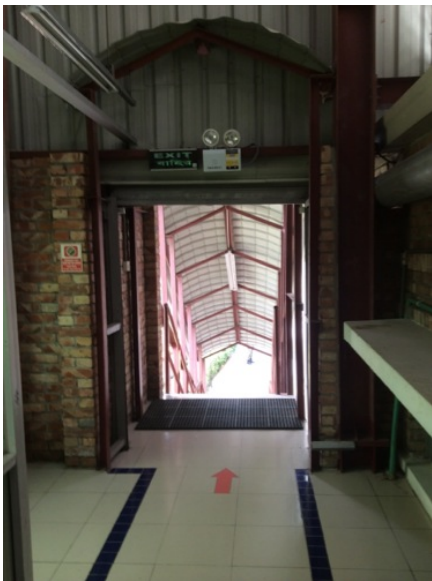
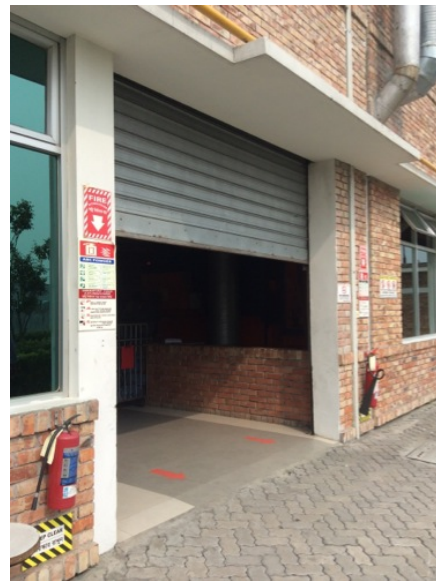
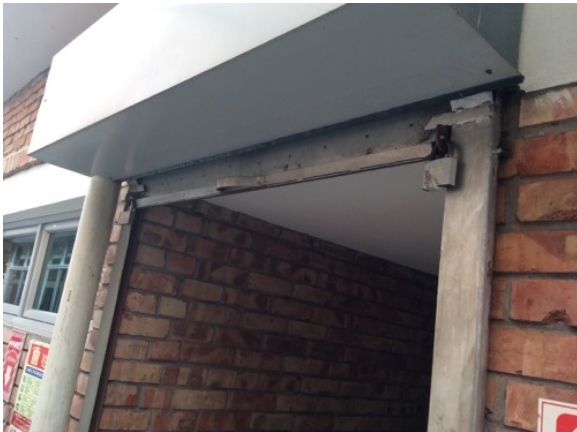
F-8 Egress

Collapsible gates / sliding doors are provided at the building and assembly building exits.

Replace all gates / sliding doors along the means of egress with side-hinged, swinging egress doors.

If locks are required for security reasons, utilize special door locking features complying with NFPA 101.

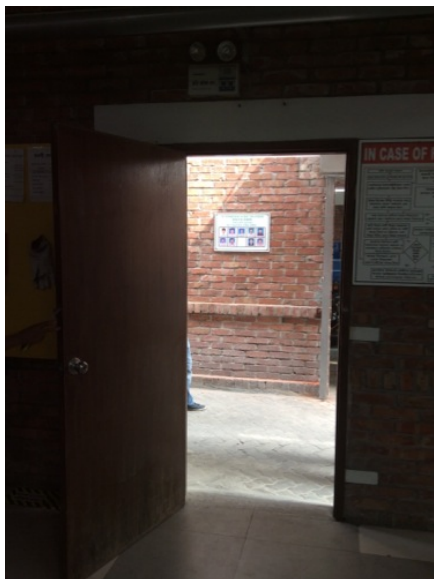
F-9	Egress	The north exit door did not swing in the direction of egress travel.	Modify the egress door to swing in the direction of egress travel.	Within 3 months
-----	--------	--	--	-----------------

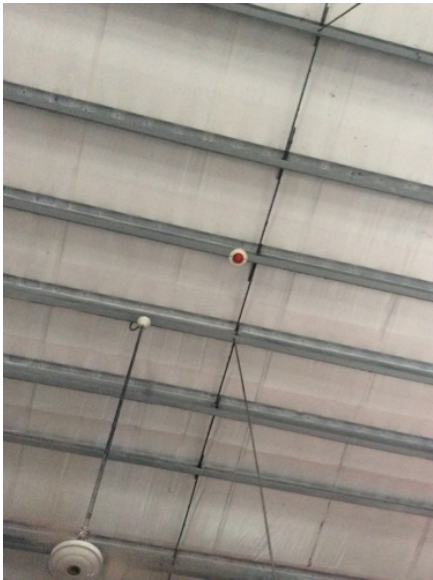
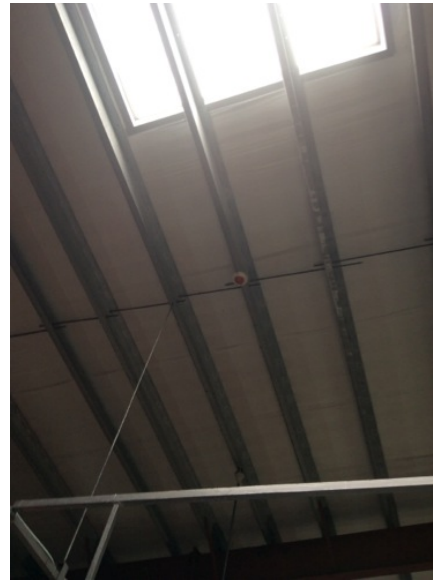
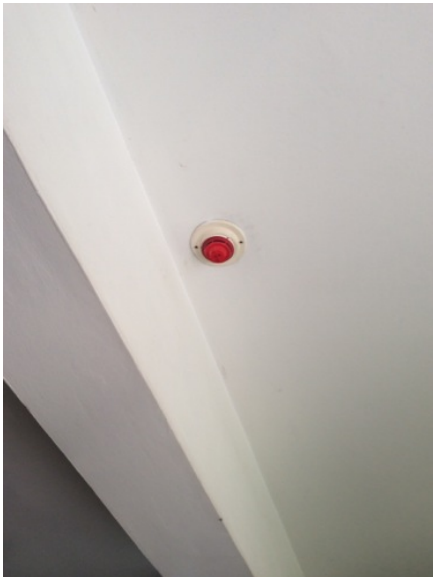
F-10	Fire Protection	Some detectors in the building and assembly building did not remove the detector cover.	Remove the detector cover.	Immediate
------	-----------------	---	----------------------------	-----------

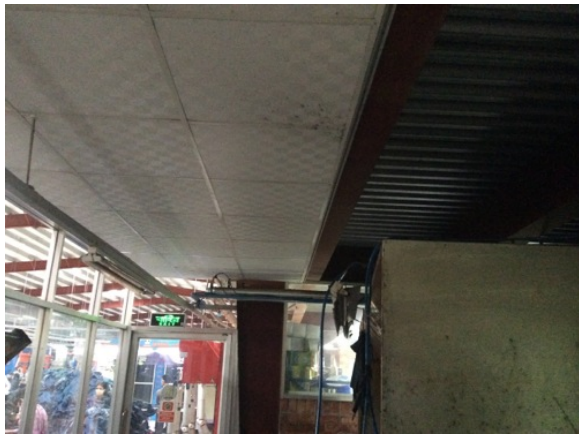
F-12	Fire Protection	Based off observations, the existing multi detectors tied to the fire alarm were not adequately provided in the northeast office room on ground floor and the office area on mezzanine floor.	Based on ceiling configuration, provide additional detectors where needed, and space them in accordance with NFPA 72.	Within 3 months
------	-----------------	---	---	-----------------

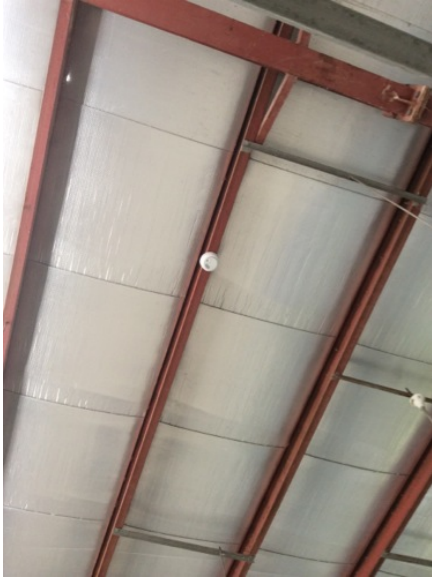
F-13	Fire Protection	The mezzanine floor is equipped with single-station smoke alarms. Smoke alarm activation sounds only a local alarm and does not provide automatic fire alarm notification of occupants.	Remove the single-station smoke alarms. Provided automatic smoke detectors throughout the building in accordance with NFPA 72.	Within 6 months
------	-----------------	---	--	-----------------

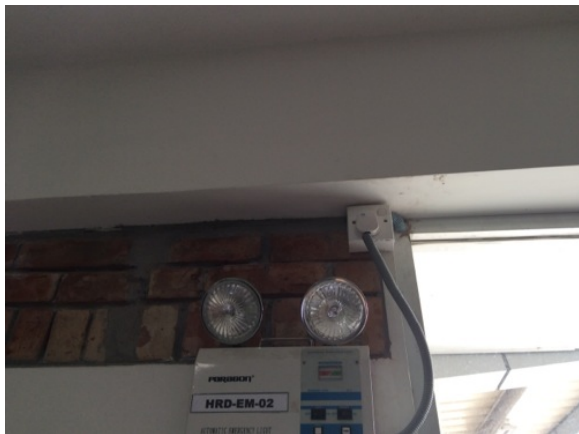
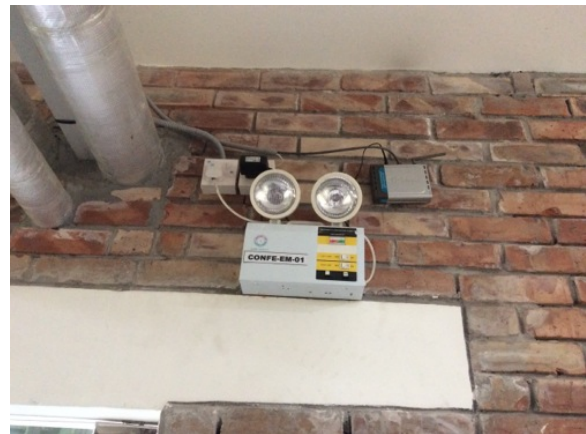
F-14	Egress Lighting	Manual on-off switch in the building, assembly and office building is provided for emergency lighting / exit signage units.	Remove manual on/off switches from emergency lighting / exit signage units to prevent them from being switched off.	Within 1 month
------	-----------------	---	---	----------------

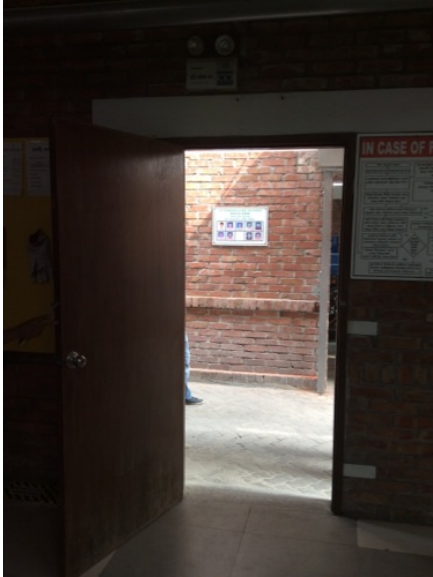
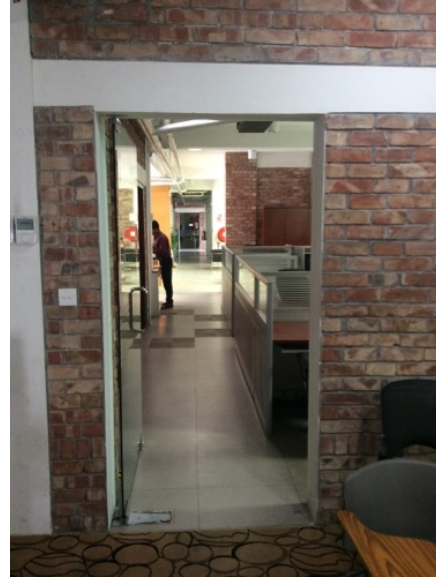
F-15	Egress Lighting	Exit sign not provided at the north exit door in building and the meeting room in office building.	Provide exit signs above all exits to the exterior and all doors to the exit stairs.	Within 1 month
------	-----------------	--	--	----------------
