# LIBERTY KNITWEAR LTD. UNIT-2 (EXTENSION 3)

23 February 2026

## 2. Observation

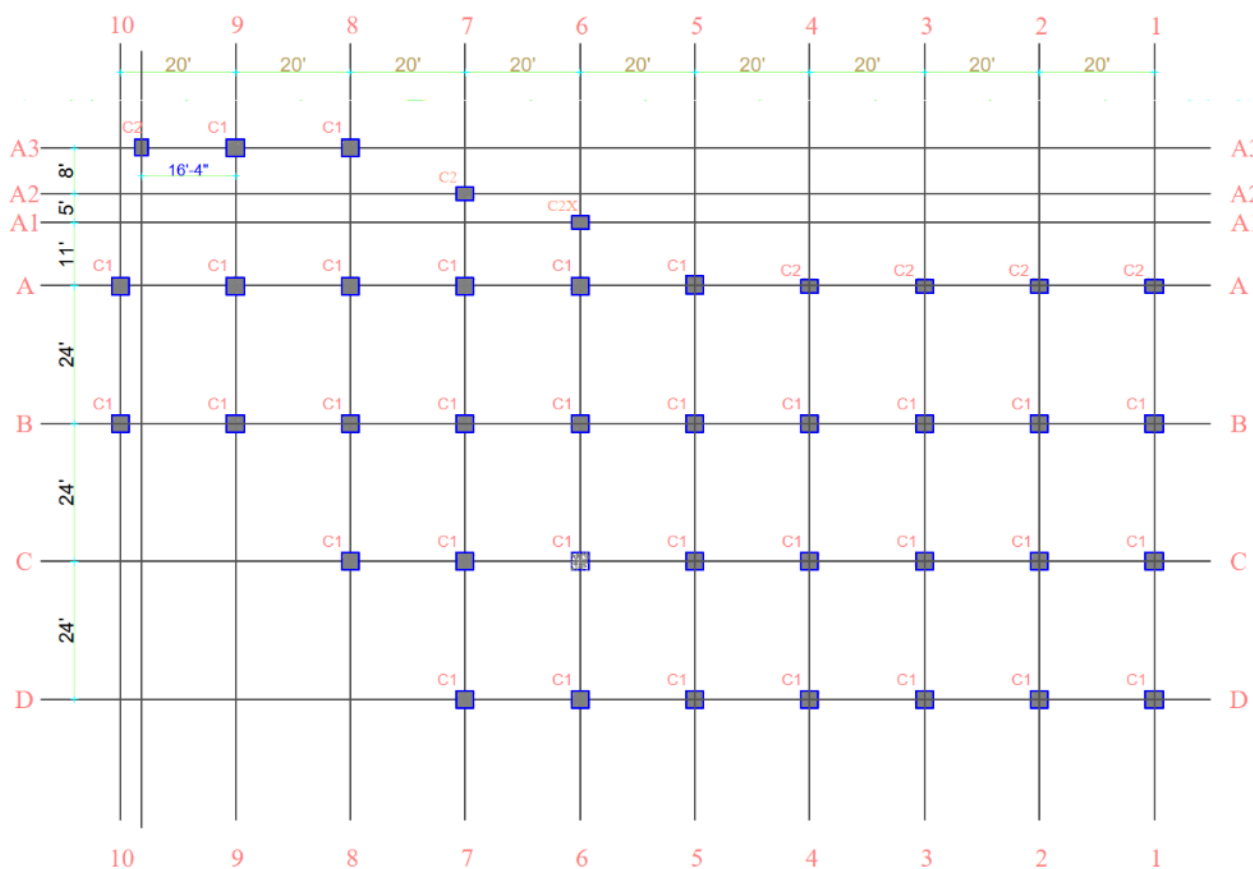
**COLUMN LAYOUT PLAN**

**Observation-01:** Stress in the column marginally above the design limit and lack of design report. (Generator Powerhouse Building & East Tower Building).

**Description:** The cursory calculation indicated that the columns are marginally stressed above the normal design limit, considering the prepared live load plan and minimum concrete strength due to an inadequate materials test report. The building engineer is required to review the design, load, and column stress, seismic requirements, framing system, and incorporate necessary measures (if necessary) as per section 2.5.8 (b)BNBC 2020 and update the analysis and design report in accordance with Section 1.9.1 of the BNBC.

Also, the building engineer is required to verify the concrete strength by taking cores (100 mm dia at least 4 nos) from the column, beam and slab for each building.

| Item No | Observation | Action Plan | Timeline |
|---|---|---|---|
| 1. | Stress in the column marginally above the design limit and a lack of design report (Generator Powerhouse Building) | Building engineer is required to review the design, load, and column stress, seismic requirements, framing system, and incorporate necessary measures (if necessary) as per section 2.5.8 (b)BNBC 2020 and update the analysis and design report in accordance with Section 1.9.1 of the BNBC. | within 6 weeks |
| 2. | | Verify the concrete strength by taking cores (100 mm dia at least 4 nos) from the column, beam, and slab. | within 6 weeks |

| 9. | Stress in the column marginally above the design limit and a lack of design report (East Tower Building) | Building engineer is required to review the design, load, and column stress, seismic requirements, framing system, and incorporate necessary measures (if necessary) as per section 2.5.8 (b)BNBC 2020 and update the analysis and design report in accordance with Section 1.9.1 of the BNBC. | within 6 weeks |
| 10. | | Verify the concrete strength by taking cores (100 mm dia at least 4 nos) from the column, beam, and slab. | within 6 weeks |

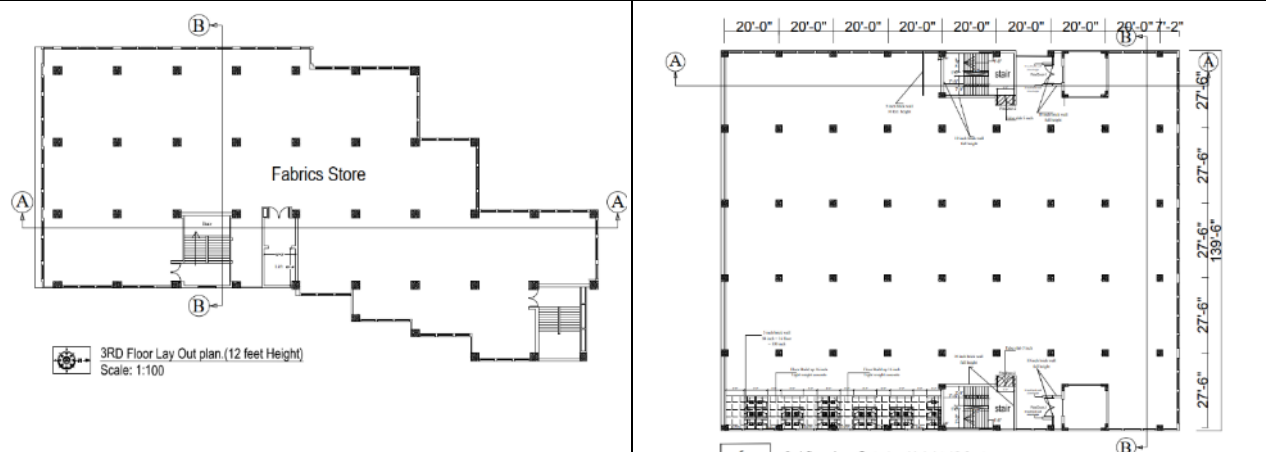
**Observation-02:** Lack of information in the provided drawing (Generator Powerhouse Building & East Tower Building).

**Description:** The thickness and height of the brick wall and the false slab are not shown in the drawing. In addition, the detailed dimensions of the wall, cantilever extension length, and wall thickness is not shown clearly in the drawings of both buildings. Also, details of the underground tank (at the Generator Powerhouse Building) are not shown clearly in the architectural drawings. The building engineer is required to survey the as-built condition and prepare an accurate set of as-built drawings and submit to RSC for review.

| Item No | Observation | Action Plan | Timeline |
|---|---|---|---|
| 4. | Missing information in the as-built drawing. (Generator Powerhouse Building) | The building engineer is required to survey the whole structure and produce an accurate & detailed as-built drawing. | within 6 weeks |

| 12. | Missing information in the as-built drawing. (East Tower Building) | The building engineer is required to survey the whole structure and produce an accurate as-built drawing. | within 6 weeks |

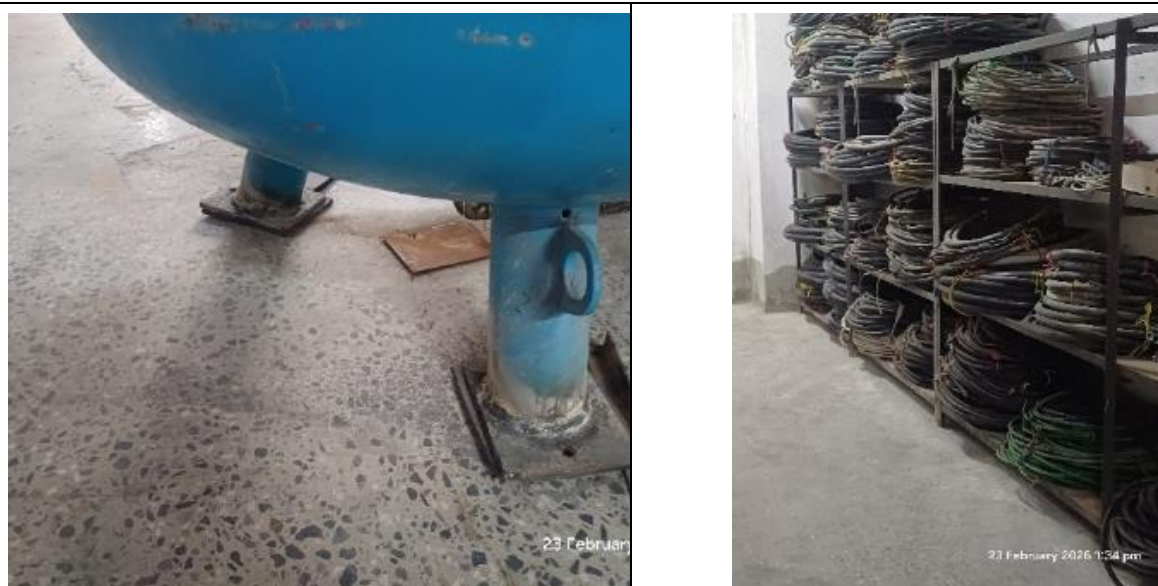
**Observation-03:** Nonstructural elements found unanchored/unbraced (Generator Powerhouse Building & East Tower Building).

**Description:** Nonstructural elements found unanchored/unbraced. Anchor/brace all nonstructural elements within the building.

| Item No | Observation | Action Plan | Timeline |
|---|---|---|---|
| 6. | Nonstructural elements found unanchored/unbraced (Generator Powerhouse Building). | Anchor/brace all nonstructural elements within the building. | within 6 weeks |

| 14. | Nonstructural elements found unanchored/unbraced (East Tower Building). | Anchor/brace all nonstructural elements within the building. | within 6 weeks |

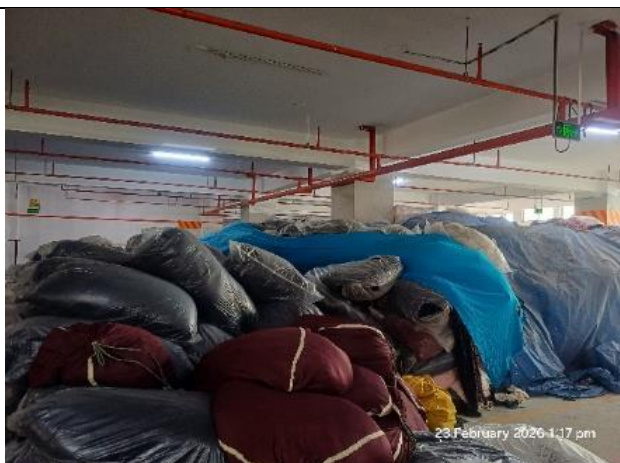
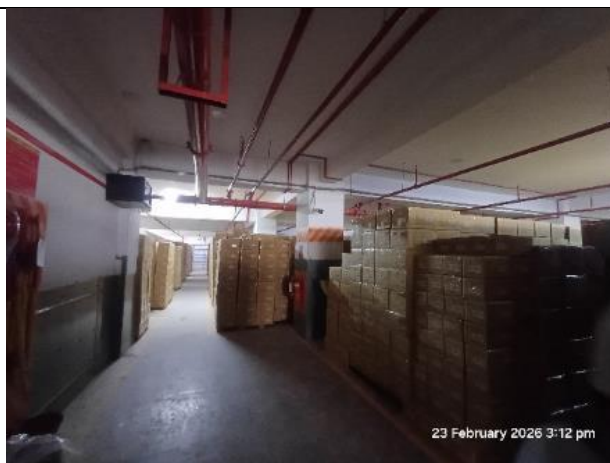
**Observation-04:** Lack of a proper load-management plan (Generator Powerhouse Building & East Tower Building).

**Description:** No load markings and proper load management were evident. The building engineer is required to post the floor load plan on each floor, provide load restriction height markings, signage on the storage area, and manage the floor load plan as per the acceptable load limits of BNBC.

| Item No | Observation | Action Plan | Timeline |
|---|---|---|---|
| 5. | Implement a proper load-management plan (Generator Powerhouse Building). | Building engineer is required to post the load plan and provide load restriction height markings, signage on the storage area and manage the floor loading as per the load plan. | within 6 weeks |

| 13. | Implement a proper load-management plan (East Tower Building). | Building engineer is required to post the load plan and provide load restriction height markings, signage on the storage area and manage the floor loading as per the load plan. | within 6 weeks |

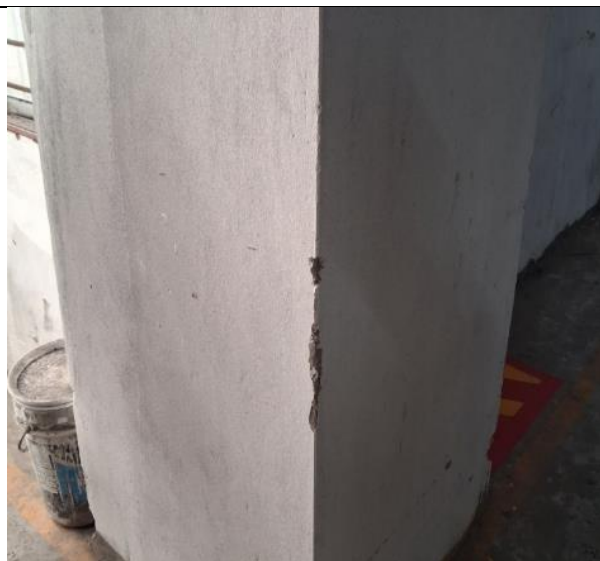
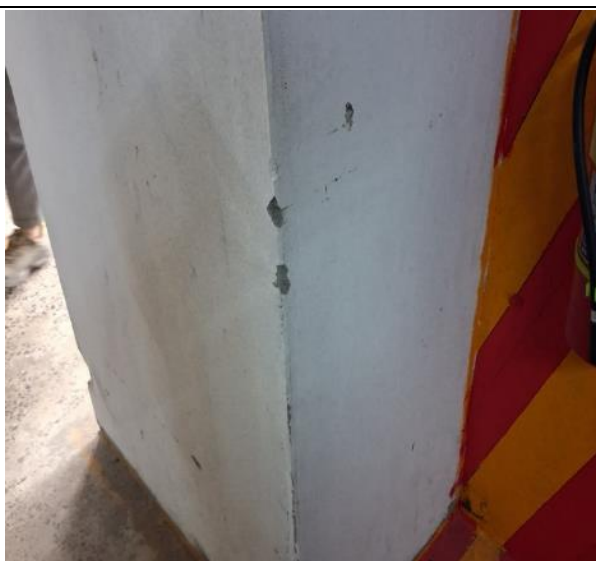
**Observation 05:** Lack of protection for trolley impact (Generator Powerhouse Building).

**Description:** During inspection, no impact protection was found in some of the columns. The factory is required to implement trolley impact protection (column guard) where required.

| Item No | Observation | Action Plan | Timeline |
|---|---|---|---|
| 8. | Lack of protection for the trolley impact (Generator Powerhouse Building). | The factory is required to implement trolley impact protection where required. | within 6 weeks |

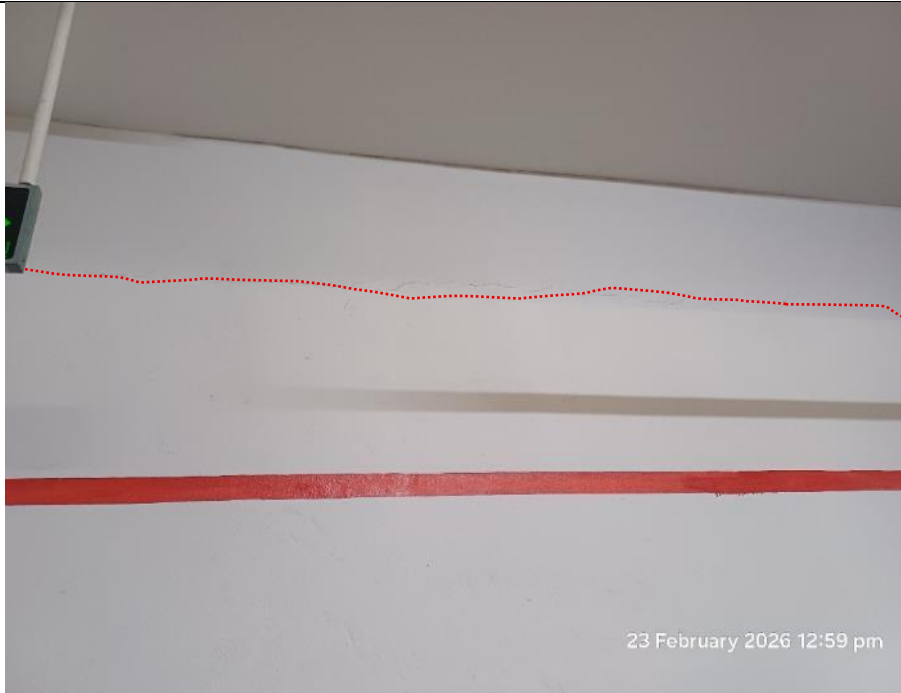
**Observation 06:** Crack between the brick wall and beam joint (Generator Powerhouse Building).

**Description:** During inspection, a non-structural crack was found between the brick wall and the floor beam joint. The building engineer is required to repair the crack with a suitable method.

| Item No | Observation | Action Plan | Timeline |
|---|---|---|---|
| 7. | Crack between the brick wall and beam joint (Generator Powerhouse Building). | Building engineer is required to repair the crack with a suitable method. | within 6 weeks |

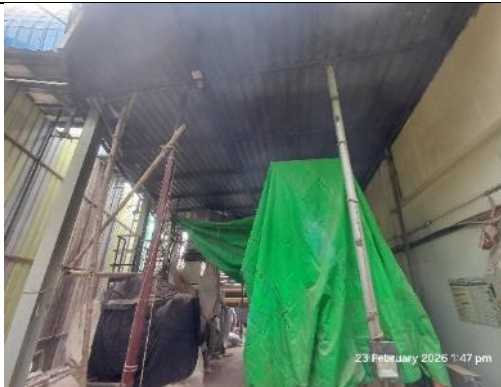
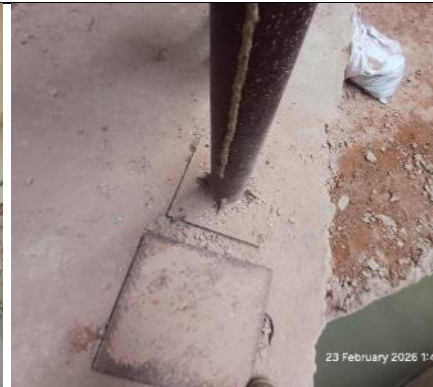
**Observation 07:** Inadequate structural members, lack of material test report, and design documents (Generator Shed).

**Description:** Inadequate framing, poor connection and a lack of stability were observed. Moreover, there was no steel/concrete material test report or soil test report for the generator shed. The building engineer is required to carry out a Detail Engineering Assessment (DEA) for the structure to verify the foundation details, concrete/steel/soil material strength, and prepare an assessment report. Prepare a full set of DEA documents with a detailed remedial action plan. Submit the DEA documents to the RSC for review.

| 15. | Inadequate structural members, lack of material test report, and design documents (Generator Shed). | Carry out the Detailed Engineering Assessment (DEA) report with remedial actions considering the as-built structural system and material strength. Submit DEA documents to the RSC for review. | within 6 weeks |
| 16. | | Implement any required remediation work after acceptance from RSC. | within 6 months |
