# Renaissance Barind Ltd (Extention)

Plot No# 61-68, 72-79 (2nd Phase), Baghail, Paksey, Ishwardi, Pabna.

5 March 2026

## 2. Observation

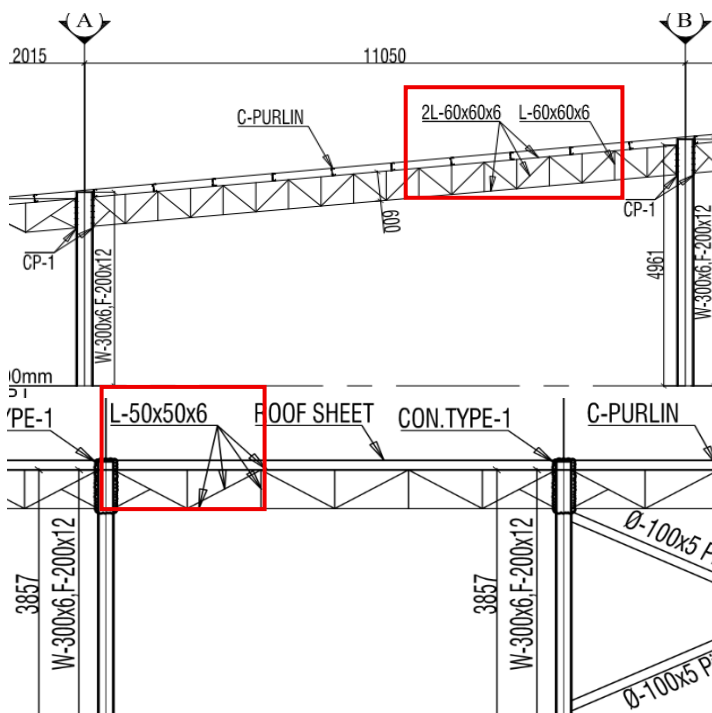
Truss chord sizes in the provided drawing

E-W Direction, Chords: 2L-60x60x6 and L-60x60x6  
N-S Direction, All Chords: L-50x50x6

**Description:** During the inspection, mismatches were observed between the provided drawing and site condition for all truss chord size details.

The building engineer is required to update as-built drawing as per actual site condition.

| Item No | Observation | Action Plan | Timeline |
|---|---|---|---|
| 1. | Discrepancy in as-built drawing. [Warehouse Shed] | The building engineer is required to update as-built drawings as per actual site condition. | within 6 weeks |

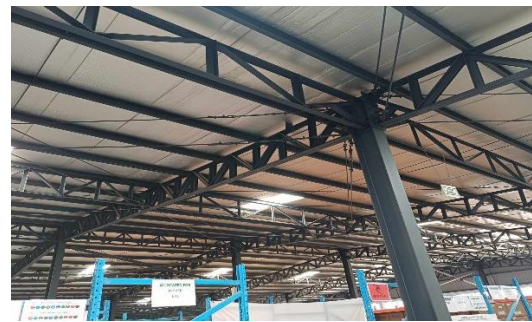
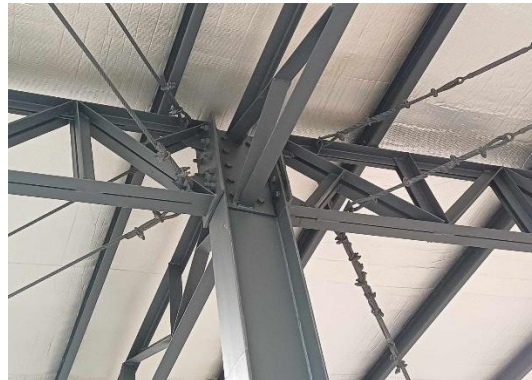
On-site condition

E-W Direction, All Chords: 2L-65x65x6  
N-S Direction, All Chords: L-75x75x6

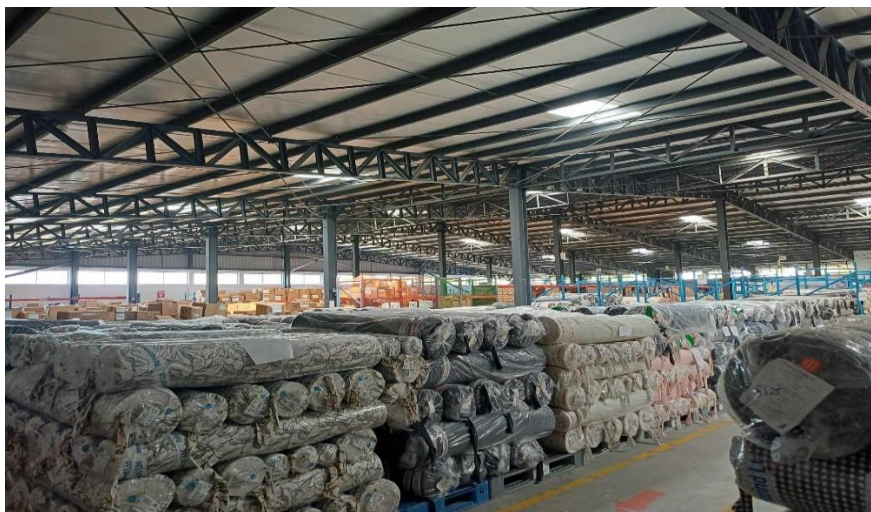
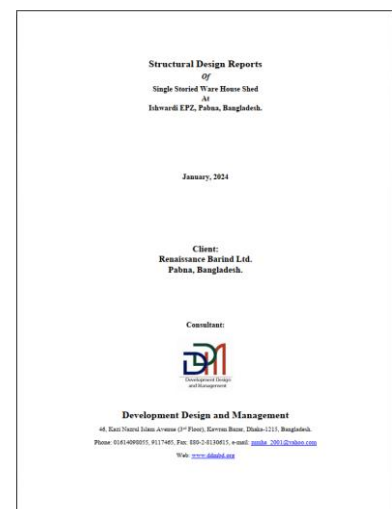
### Observation-02: Design report needs to be reviewed against lateral forces. [Warehouse Shed]

**Description:** A design report has been prepared for the single-storied shed. The prepared design report needs to be reviewed against lateral forces. Submit the design documents to the RSC for a detailed review.

| Item No | Observation | Action Plan | Timeline |
|---|---|---|---|
| 2. | Design report needs to be reviewed against lateral forces. [Warehouse Shed] | The prepared design report needs to be reviewed against lateral forces. Submit the design report to the RSC for detailed review. | within 6 weeks |
| 3. | | Implement the recommendations of the design report. | within 6 months |

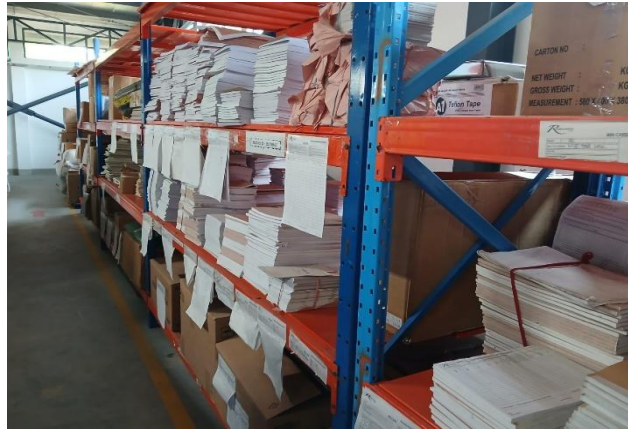
**Observation-03:** Unbraced storage racks. [Warehouse Shed]

**Description:** During the inspection, some storage racks were found unbraced. The factory is required to brace/anchor all storage racks.

| Item No | Observation | Action Plan | Timeline |
|---|---|---|---|
| 4. | Unbraced storage racks. [Warehouse Shed] | The factory is required to brace/anchor all storage racks. | within 6 weeks |

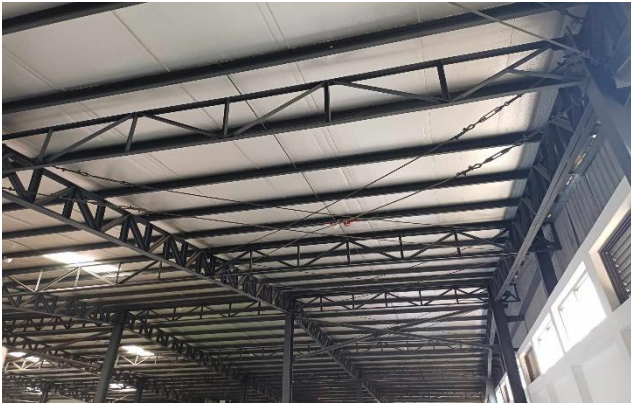
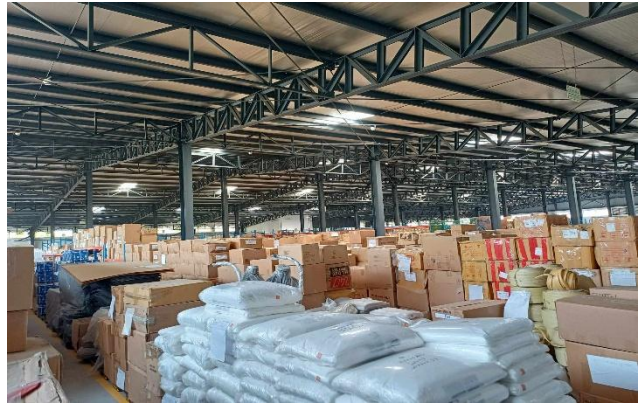
**Observation-04:** Loose cable bracing. [Warehouse Shed]

**Description:** During the inspection, some cable bracings were found loose. The factory is required to tighten all loose bracings.

| Item No | Observation | Action Plan | Timeline |
|---|---|---|---|
| 5. | Loose cable bracing. [Warehouse Shed] | The factory is required to tighten all loose bracings. | within 6 weeks |

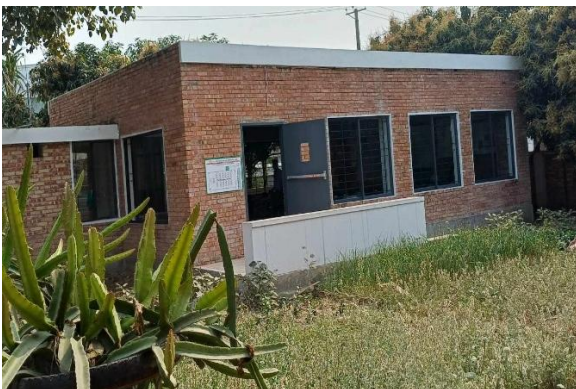
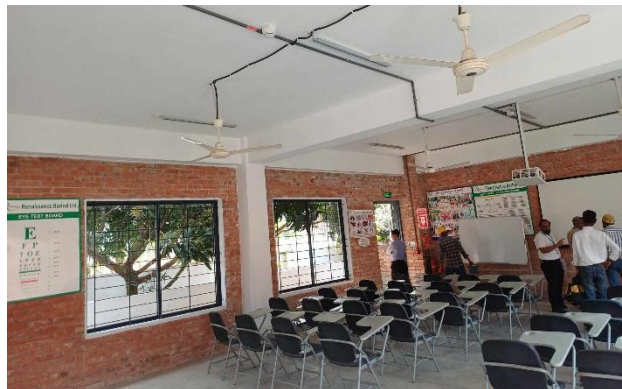
**Observation-05:** Lack of design report. [Training Room-2]

**Description:** As per BNBC, every building or structure designed shall have its design documents prepared in accordance with the provision of Section 1.9.1. The design document shall include a design report, and a set of structural drawings, which shall be prepared in compliance with section 1.9.1.1 and section 1.9.1.2 as per BNBC.

At the time of inspection, design documents (design report and material test reports) were not available which are required to be prepared in compliance with section 1.9.1 (part-6, BNBC).

| Item No | Observation | Action Plan | Timeline |
|---|---|---|---|
| 6. | Lack of design documents. [Training Room-2] | The building engineer is required to prepare design documents in compliance with BNBC 2020 and submit them to RSC for detailed review. | within 6 weeks |
| 7. | | Implement the recommendations of the design report. | within 6 months |
