# HAMS GARMENTS LTD. (EXTENSION 2)

South Vangnahati, Chapilapara, Sreepur, Gazipur  
(24.194313, 90.452568)

16 February 2026

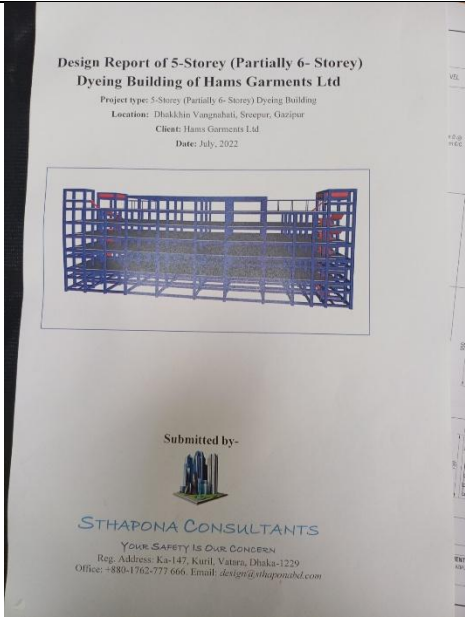
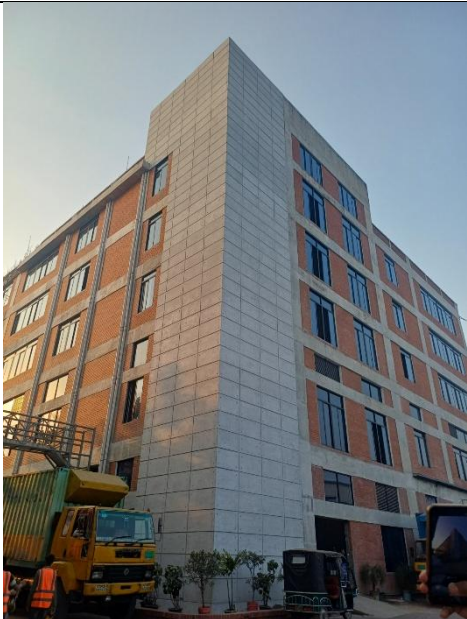
**Observation-1:** Design report required to be reviewed by RSC against lateral loading. New RCC Dyeing Building)

| <p><b>Description:</b> A set of design reports was available for the RCC Main Factory Building. Design report need to be reviewed against lateral loading.</p> | |

| Item No. | Observation | Action Plan | Timeline |
|---|---|---|---|
| 1. | Design report required to be reviewed by RSC against lateral loading. New RCC Dyeing Building) | Prepared design report to be checked against lateral loads following BNBC 2020 by RSC. | within 6 weeks |

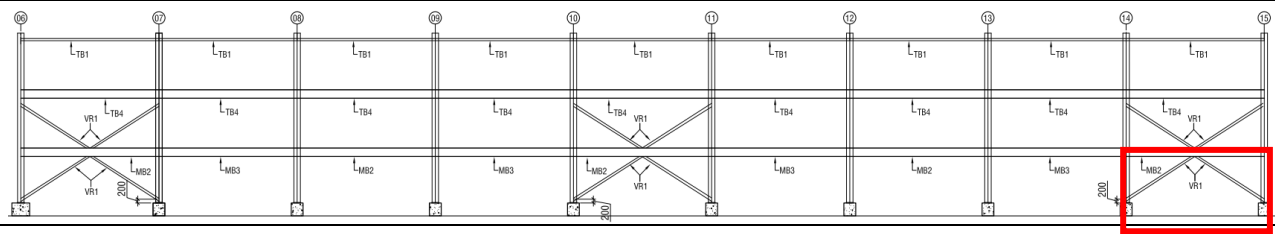
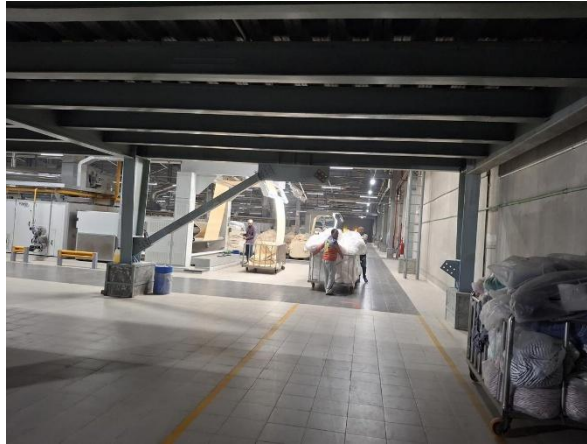
Wall bracing is missing in grid D

**Description:** Stability system is not complete, missing bracing found on site. Building engineer is required to check the lateral stability of the shed.

| Item No. | Observation | Action Plan | Timeline |
|---|---|---|---|
| 3. | Incomplete lateral stability. (New Dyeing Shed) | As part of the Engineering Assessment (EA) Building engineer is required to check the lateral stability of the building | within 6 weeks |

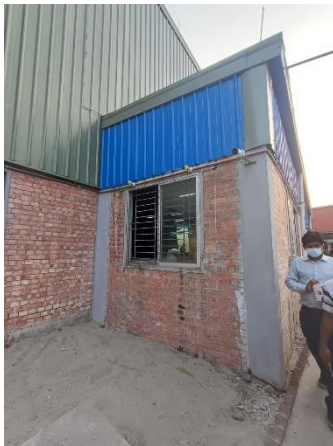
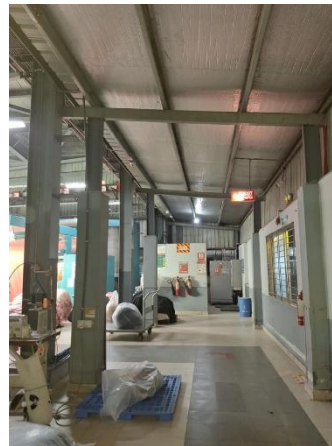
**Observation-3: Undocumented extension (Dyeing shed extension)**

**Description:** Undocumented extension found in north side of Dyeing shed extension. Update all the design documents considering the extension and submit to RSC for review.

| Item No. | Observation | Action Plan | Timeline |
|---|---|---|---|
| 5. | Undocumented extension (Dyeing shed extension) | Building engineer is required to update all the design documents considering the extension and submit to RSC for review. | within 6 weeks |

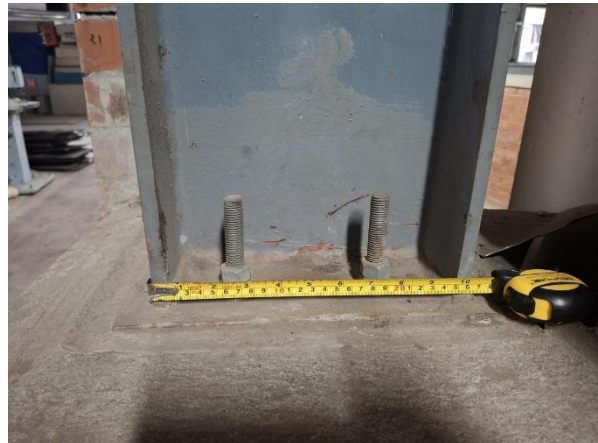
SC3 steel column web found 260 instead of 275

**Description:** Building engineer is required to survey the whole structure and prepare a full set of accurate as-built drawings and submit to RSC for review. Also, update the design report considering the updated as-built drawing and submit to RSC for review.

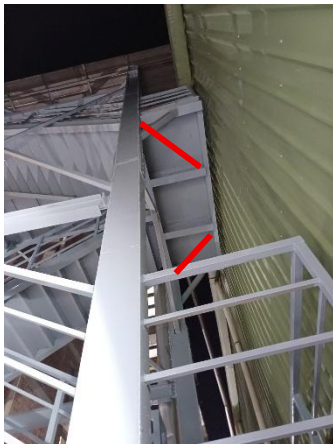
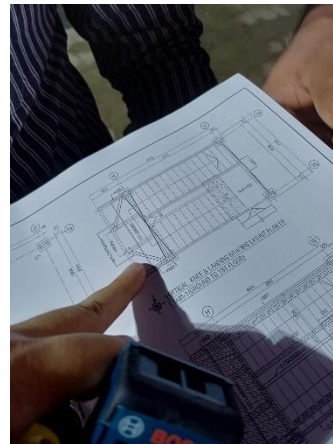
Horizontal member not found in the as-built condition in the New ETP steel stair

**Description:** Building engineer is required to survey the whole structure and prepare a full set of accurate as-built drawings.

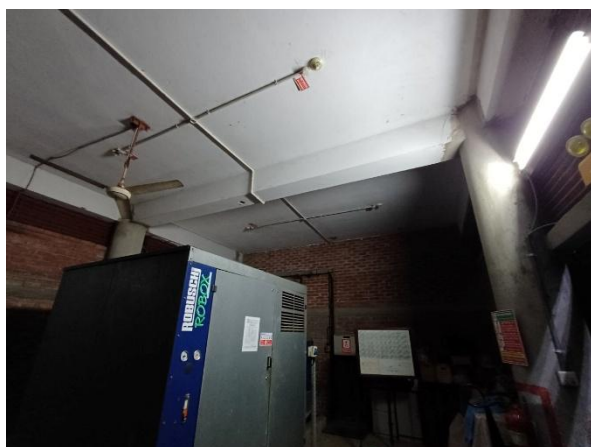
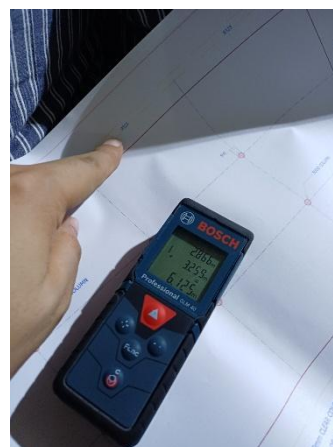
Grid spacing mismatch in Old ETP control rooms

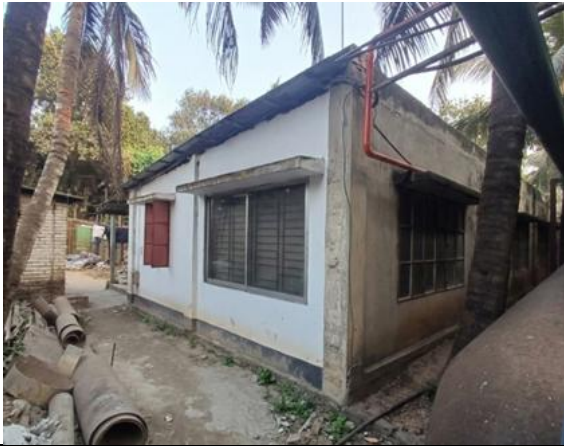
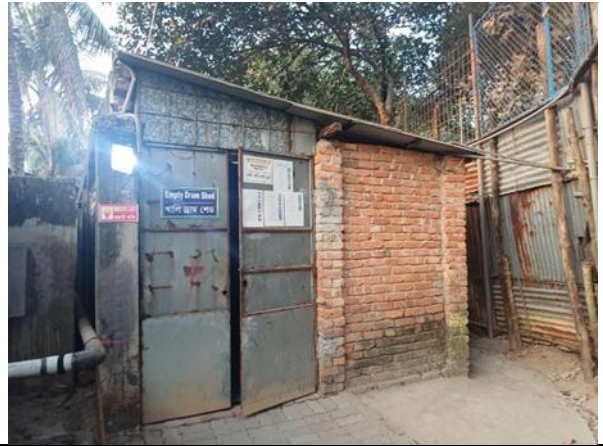
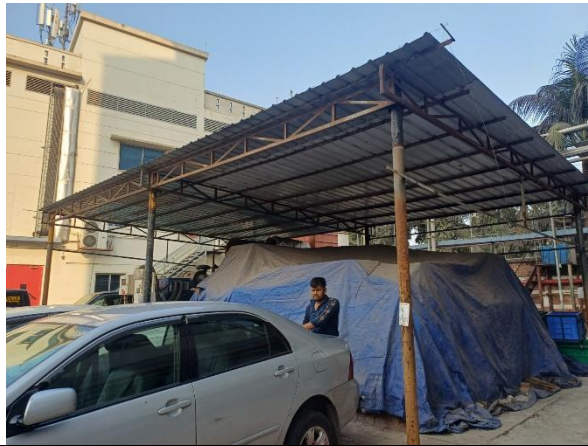
**Observation-6:** Lack of design documents (Empty Drum Store, Temporary Generator Shed, Security Barrack)

**Description:** No design document was found for these three structures. Building engineer is required to prepare as-built drawings and EA report for these structures.

| Item No. | Observation | Action Plan | Timeline |
|---|---|---|---|
| 11. | Lack of design documents (Empty Drum Store, Temporary Generator Shed, Security Barrack) | Building engineer is required to prepare as-built drawing and EA report for these structures. | within 6 weeks |

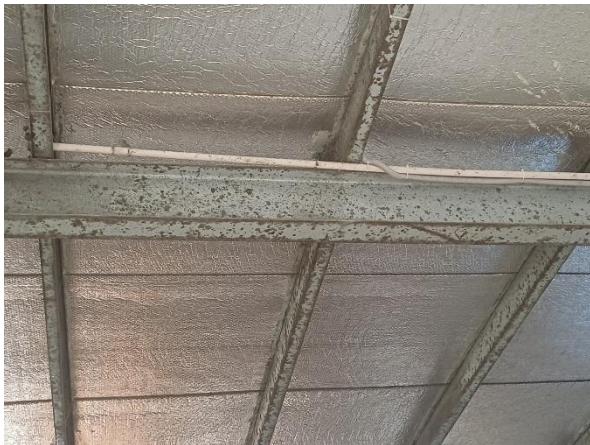
Corrosion on the rafter of the Dining Shed

**Description:** Building engineer is required to remove the corrosion and apply anti-corrosive coating on affected steel members.

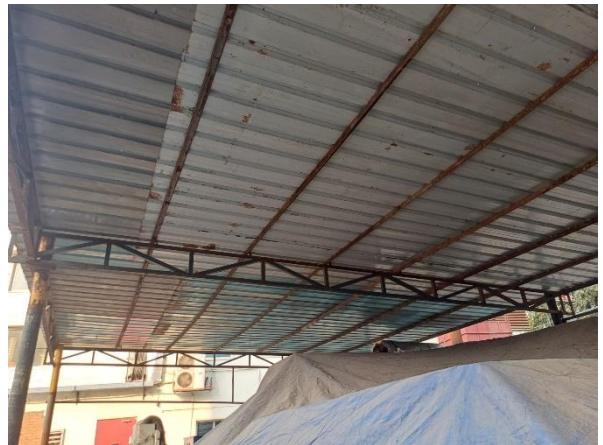
Corrosion on the truss & purlin of the Temporary Generator shed

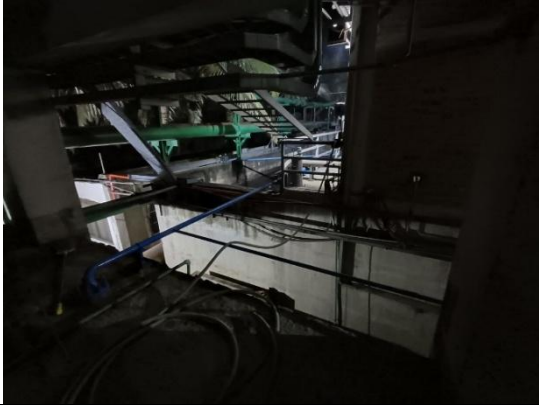
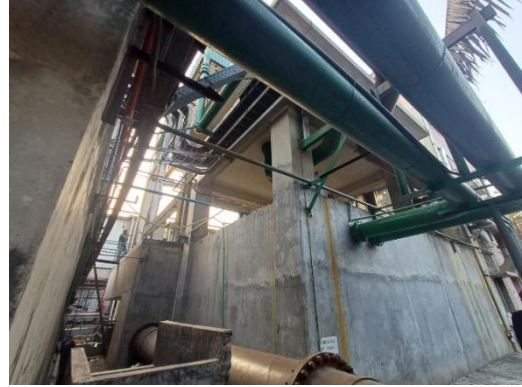
No protection at the slab edge

**Description:** Building engineer is required to provide adequate protection at the slab edge to prevent falling.

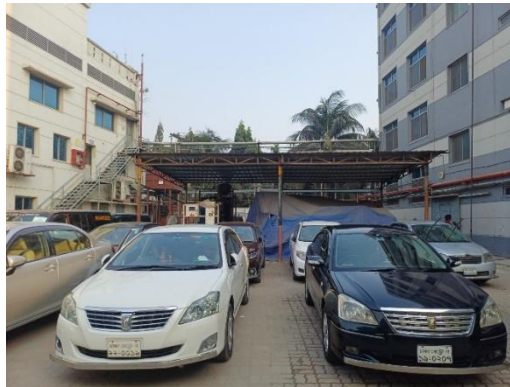
**Observation-10:** Steel column found susceptible to vehicle impact (Temporary Generator Shed)

**Description:** Building engineer is required to provide a column guard to protect the column from vehicle impact.

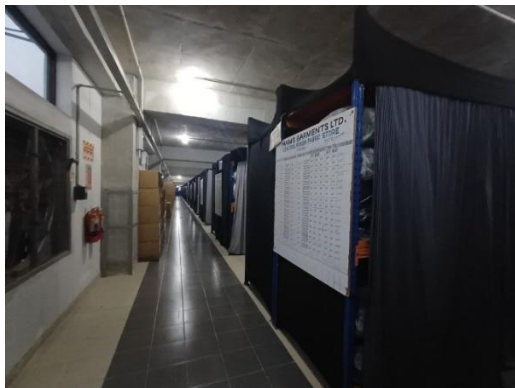
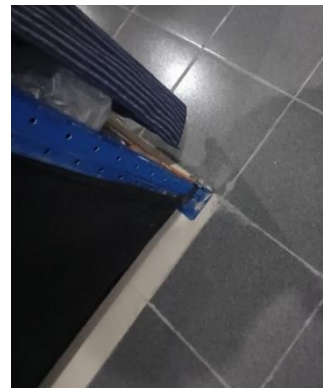
**Observation-11:** Non-structural elements found unbraced/not anchored. (New RCC Dyeing Building)

**Description:** Storage rack found unbraced or not anchored. Factory is required to brace/anchor all non-structural elements.

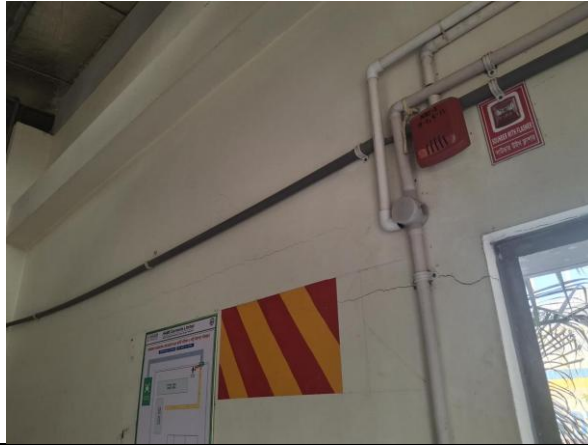
**Observation-9: Non-structural crack found on brick wall (Dining Shed)**

**Description:** Factory engineer is required to repair the cracks with adequate methodology.
