# Lavender Fashion Ltd (Unit-01)

8 February 2026

## Structural Inspection Report

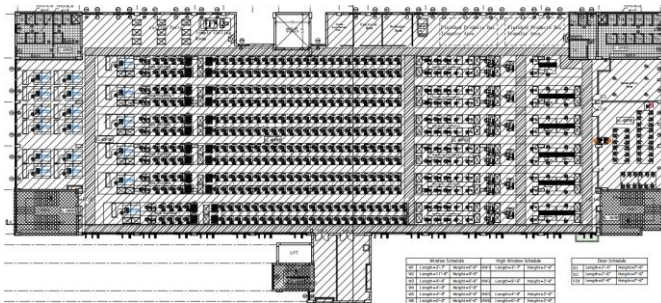
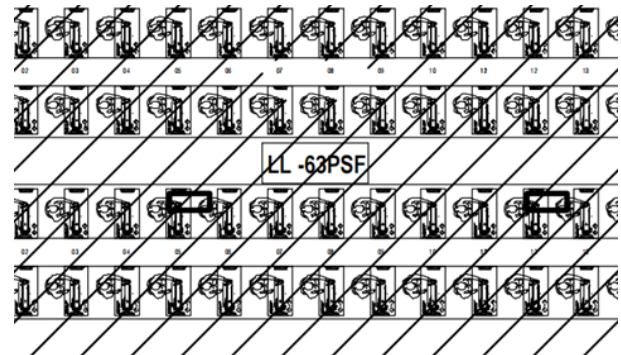
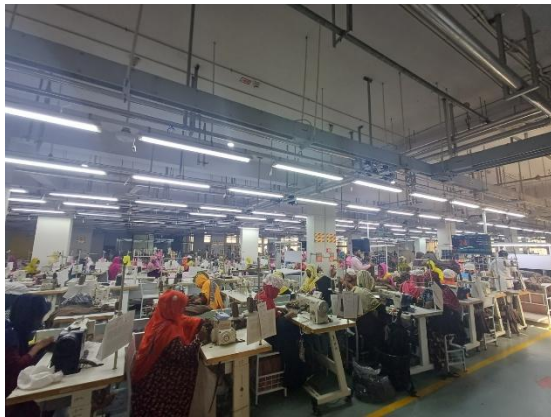
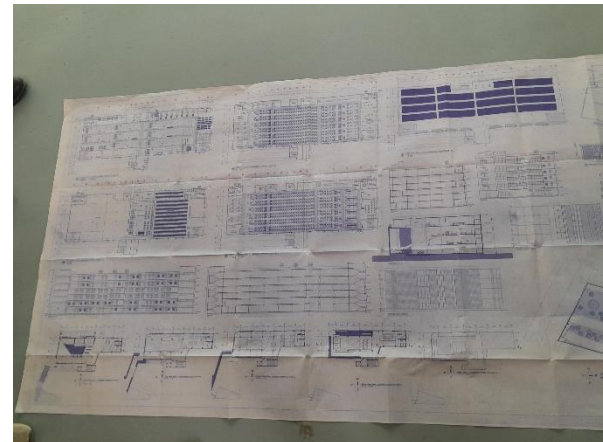
### Observation 1: Inconsistencies in the design report and load plan. (Production Building)

**Description:** Permit drawing was approved after February 2021. The design documents were prepared for the building considering BNBC-06 and design live load was considered as 3.0 kPa for the production area. However, as per the BNBC 2020, the required live load for a "garments manufacturing floor" is 4.0 kPa.

The building engineer is required to revise the load plan in compliance with BNBC 2020, update the design report according to BNBC 2020 and submit the complete set of documents, including the lift core and roof top shed to RSC for review.

| Item No. | Observation | Action Plan | Timeline |
|---|---|---|---|
| 1. | Inconsistencies in the design report and load plan. (Production Building) | The factory engineer is required to revise the load plan as per the BNBC 2020 requirement and check the design accordingly. | within 6 weeks |
| 2. | | The building engineer is required to submit the updated design documents, including the lift core and roof top shed. | within 6 weeks |

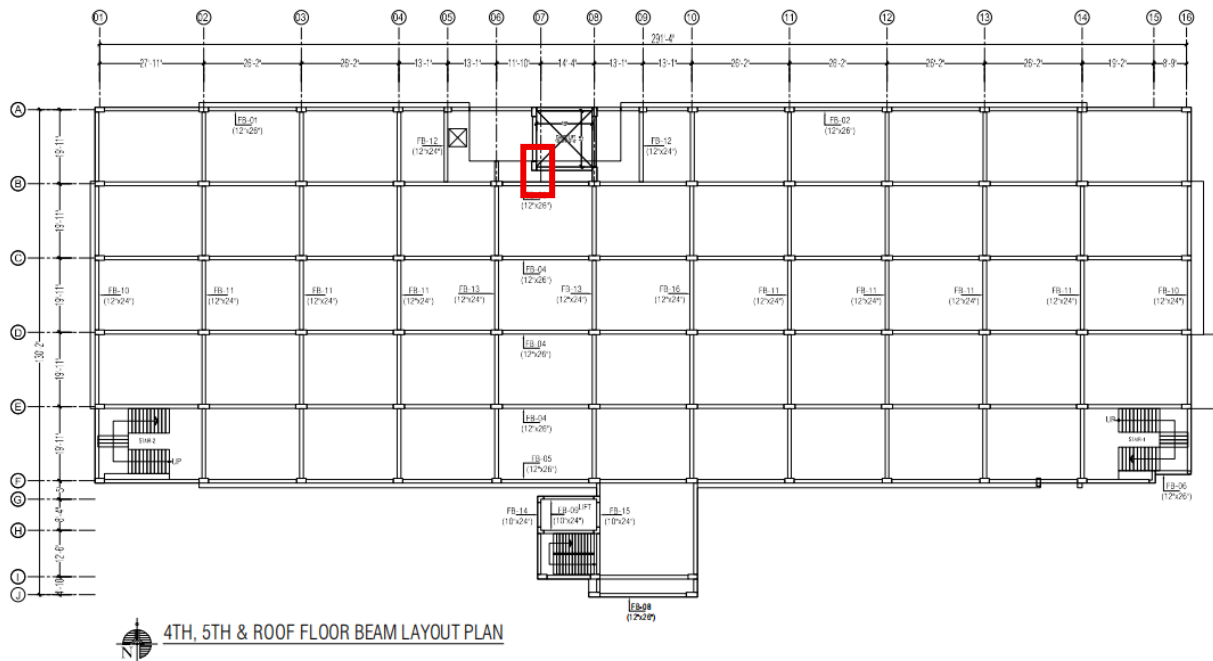
RC Beam found connected with main structure in this location on all floors not shown in drawing

**Description:** During inspection, mismatch was found in between as-built drawing and onsite condition of Production Building. Also, no credible structural construction drawing was found to verify the foundation information. Factory engineer is required to verify foundation information and prepare accurate as-built drawings.

| Item No. | Observation | Action Plan | Timeline |
|---|---|---|---|
| 4. | Mismatch in as-built drawing and no credible structural construction drawing (Production Building). | Factory engineer is required to verify foundation information and prepare accurate as-built drawings. | within 6 weeks |

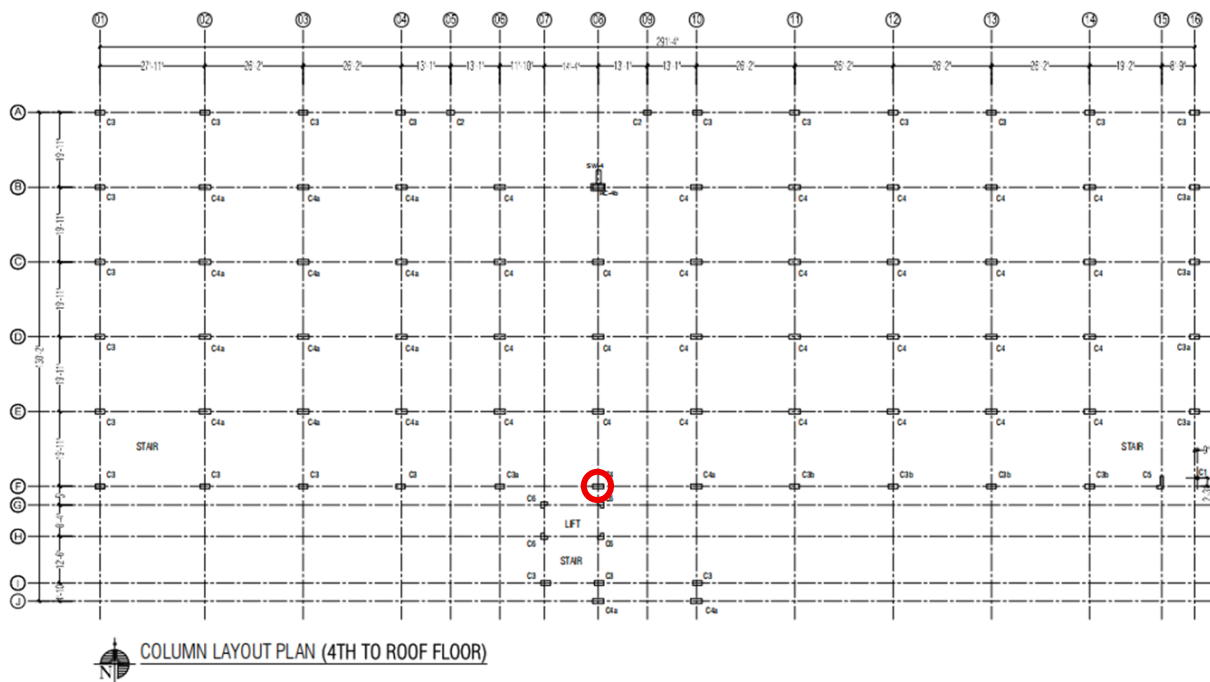
Marked RC column size was found 375X750 mm instead of 375X900 mm

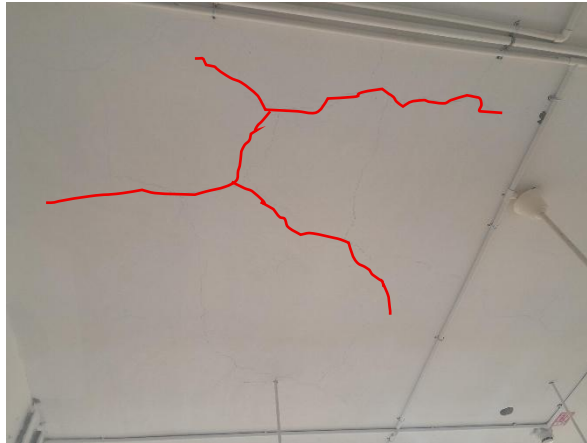
**Observation-3:** Crack found on 2<sup>nd</sup> floor roof slab (Production Building)

**Description:** The building engineer is required to investigate the extent and reason of crack and prepare a crack investigation report along with appropriate remediation measures. Necessary repairs must be carried out as per recommendation.

| Item No. | Observation | Action Plan | Timeline |
|---|---|---|---|
| 5. | Crack found on 2nd floor roof slab (Production Building) | The building engineer is required to investigate the extent and reason of crack and prepare a crack investigation report along with appropriate remediation measures. Necessary repairs must be carried out as per recommendation. | within 6 weeks |

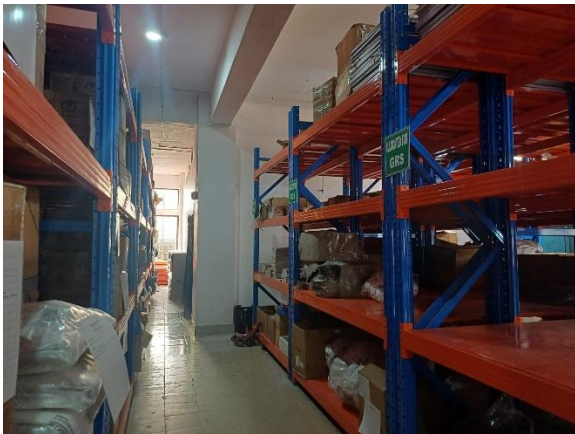
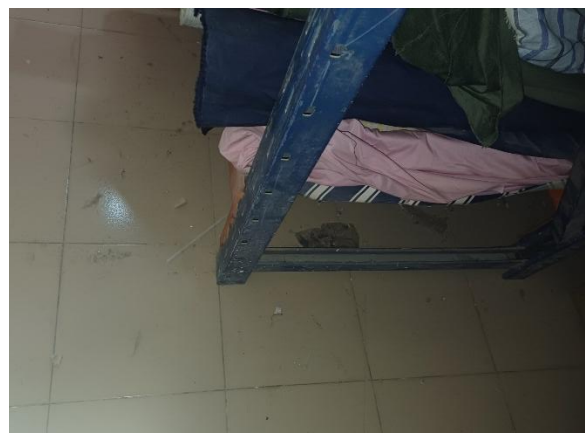
**Observation-4:** Non-structural elements not anchored or braced. (Production Building)

**Description:** Some racks on floors are not anchored or braced to resist lateral (earthquake) forces. The factory engineer is required to anchor/brace all non-structural elements adequately to resist earthquake forces.

| Item No. | Observation | Action Plan | Timeline |
|---|---|---|---|
| 6. | Non-structural elements are not anchored or braced. (Production Building) | Factory engineers are required to brace/anchor all non-structural elements. | within 6 weeks |

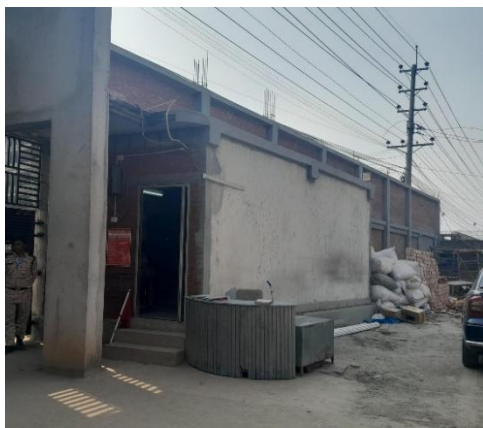
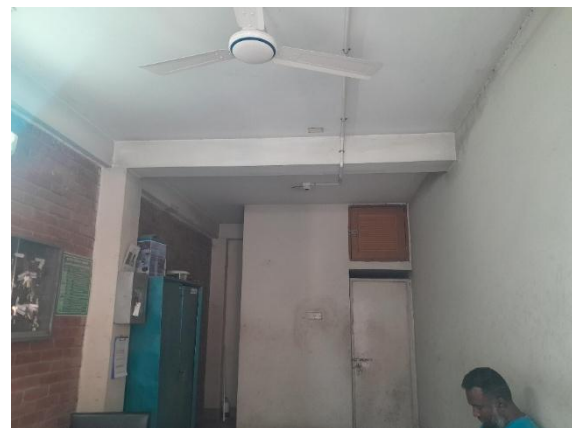
**Observation 5:** Lack of as-built drawing (Security Post)

**Description:** No as-built drawing was found during inspection. The building engineer is required to prepare a full set of as-built drawings for this structure.

| Item No. | Observation | Action Plan | Timeline |
|---|---|---|---|
| 7. | Lack of as-built drawing (Security Post) | Factory engineer is required to prepare a full set of as-built drawings for this structure. | within 6 weeks |
