# INITIAL FIRE SAFETY INSPECTION REPORT

**Renaissance Barind Ltd (Extention)**

**RSC ID: 26629**

**Date: 5-March-2026**

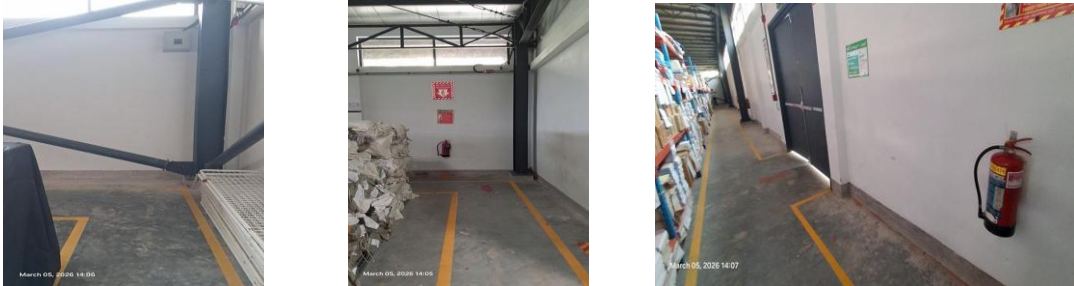
| Sl No. | Category | Findings | Required Action | Remediation Time Frame |
|---|---|---|---|---|
| F-1 | Means of Egress | Directional signs are not provided where direction of the path of travel to an exit has changed.<br><br>Location: Warehouse shed. | Illuminated directional signs shall be provided where there is a change in the direction for the path of travel and the direction to an exit is not obvious in accordance with RSC Technical Guidelines (Standard) <sup>1</sup> V1.0 Section 6.11.3. | Within 1 Month |

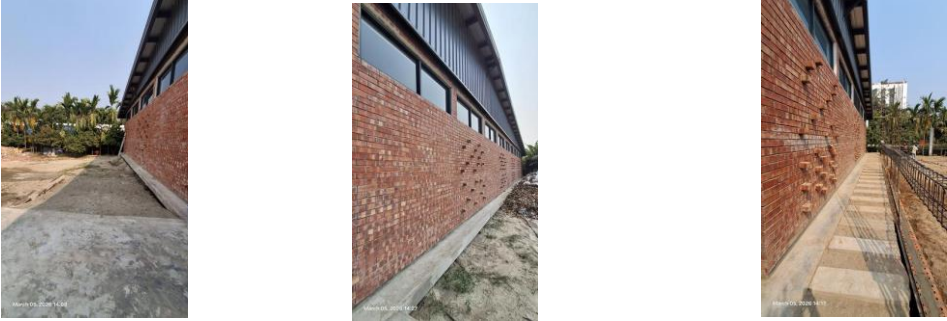
| F-2 | Means of Egress | <p>Abrupt changes in the elevation of walking surfaces were observed, not meeting the RSC Technical Guidelines (Standard)<sup>1</sup> V1.0 Section 6.3.4.</p> <p>Location: North and south side of the Warehouse shed.</p> | <p>Abrupt changes in elevation of walking surfaces shall not exceed ¼ in. unless provided with a beveled slope of 1 in 2 that do not exceed ½ in. Changes greater than ½ in. shall meet the requirements for RSC Technical Guidelines (Standard)<sup>1</sup> V1.0 Section 6.3.5.</p> | Within 3 Months |

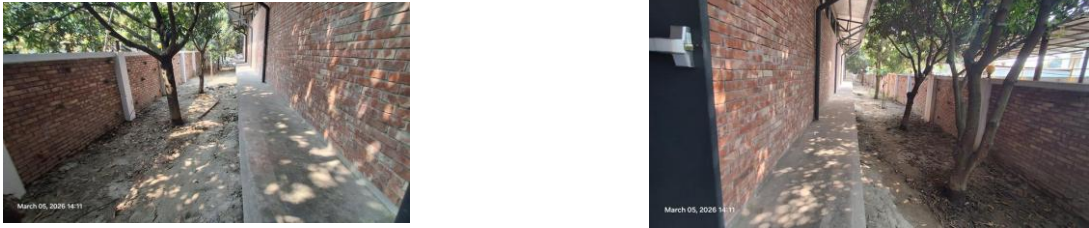
| F-3 | Means of Egress | <p>Minimum required width of corridor has not been provided on the exit discharge path. Available width 39 inch.</p> <p>Location: West exit at Warehouse shed.</p> | <p>Provide minimum required width of 1.1m (44 in.) at the corridor.</p> | Within 3 Months |

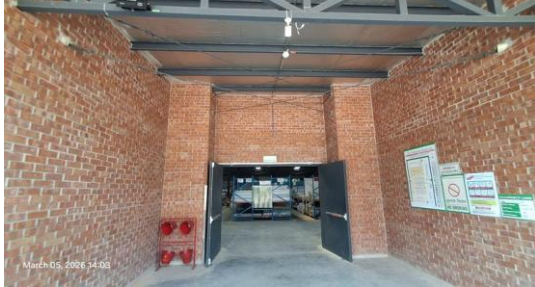
| F-4 | Means of Egress | Building does not have stair / exit level designation signs at required locations.<br>Location: Warehouse shed. | Provide stair/exit designation sign at each floor entrance from the stair to the floor in English and Bengali. Signs shall indicate the name of the stair and the floor level. Signs shall be posted adjacent to the door in accordance with RSC Technical Guidelines (Standard) <sup>1</sup> V1.0 Section 6.9.3. | Within 1 Month |

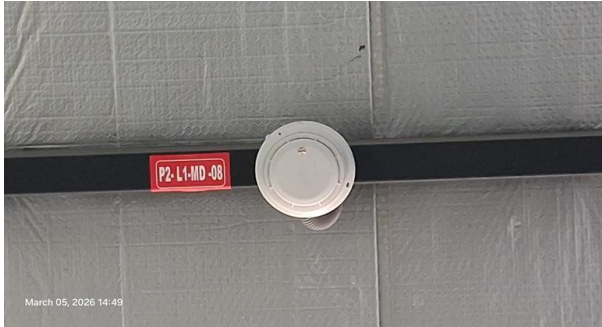
| F-6 | Fire Alarm & Detection System (FADS) | <p>An addressable fire alarm and detection system found installed in the inspected areas, which requires detailed review to confirm compliance with NFPA 72 and RSC Technical Guidelines (Standard).</p> <p><b>Location:</b> Warehouse Shed &amp; Training Room-2</p> | <p>Submit the proposed fire alarm system &amp; detection system design to RSC for initial review. Once the design is reviewed, install the fire detection and alarm system throughout the buildings in accordance with review comment, RSC Technical Guidelines (Standard) and NFPA 72.</p> <p>After installation the factory shall conduct internal testing and commissioning and then contact the RSC for witness of final acceptance testing. Also inspect, test and maintain the fire alarm system, and keep written records on-site, in accordance with Table-14.3.1 of NFPA 72.</p> | <p>Design Review within 2 months and installation/modification within 4 months.</p> |

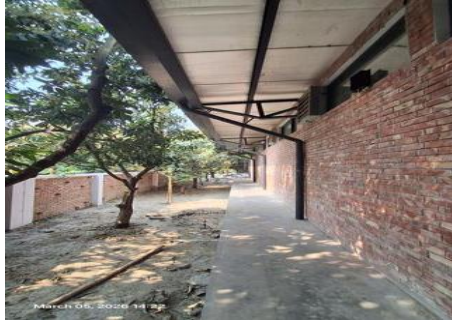
| F-9 | Fire Rated Construction | <p>The required fire separation distance for Building does not comply with the requirements of BNBC 2020.</p> <p>Location: Warehouse Shed,<br/>Height: Peak 24' 3" Eve 14' 3",<br/>Open space at South 35' from other ancillary building,<br/>North minimum 100" from open space, East 48' from utility building and 100' to 146' from production building, West 13'11" from boundary wall.</p> | The exterior walls shall have a fire resistance and opening protection as specified in BNBC 2020 Part 3 Table 3.2.2 & 3.2.3 and BNBC 2020 Part 3 Section 2.4.1.3. | Within 6 Months |
