# RIB LINE LTD NEW LOCATION

H-332, Enayetnagar, Fatullah, Narayanganj

3 March 2026

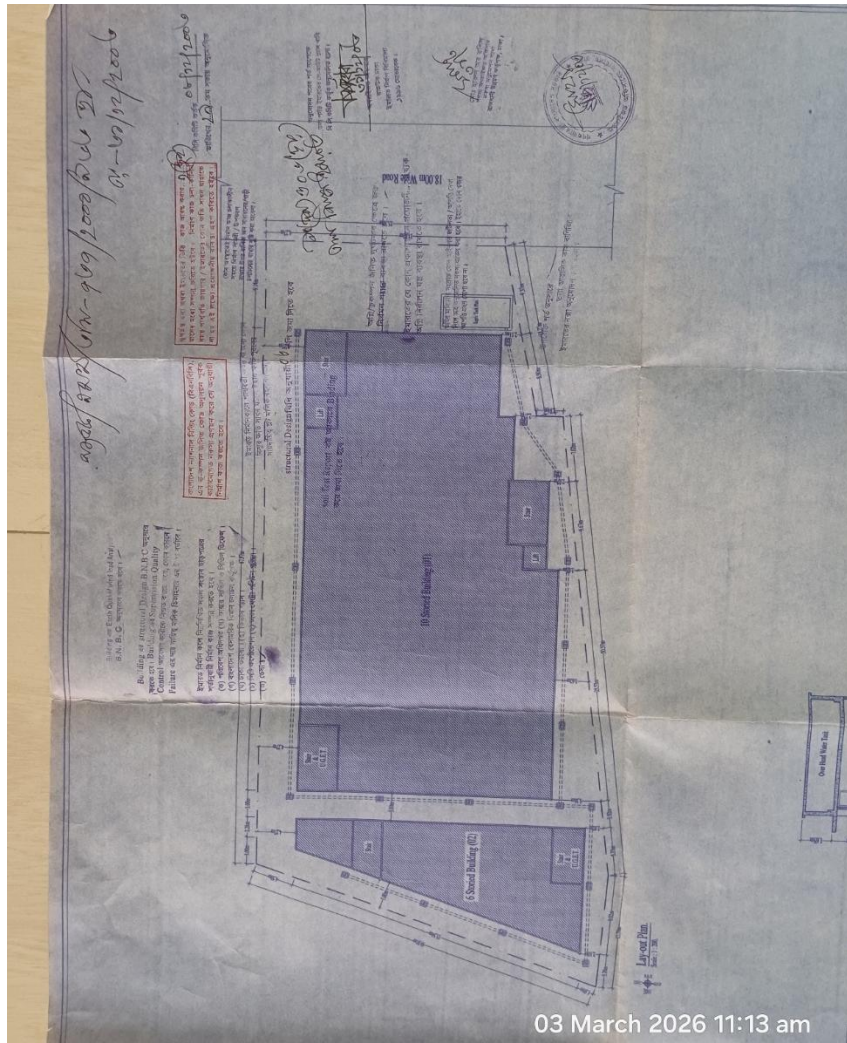
### Observation-01: Lack of Approval Drawings. (All Structures).

**Description:** A permit drawing from RAJUK was found on-site, dated 31<sup>st</sup> December 2003, and the building was constructed in 2023, thus the local permit was invalid. The factory is required to collect a fresh permit from local authority for all buildings and share with RSC.

| Item No | Observation | Action Plan | Timeline |
|---|---|---|---|
| 1. | Lack of Approval Drawings. (All Structures). | The factory is required to collect a local authority permit for all buildings and submit it to RSC for review. | within 6 months |

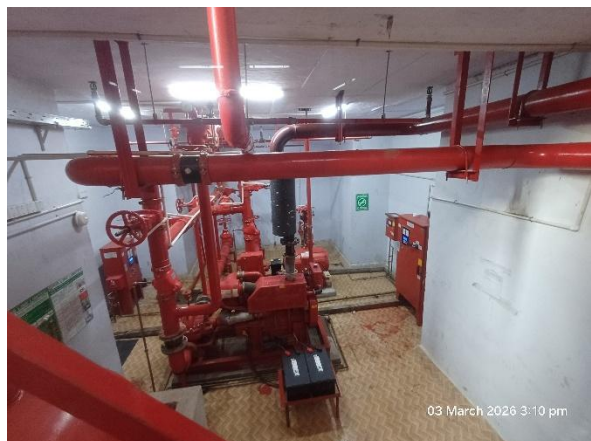
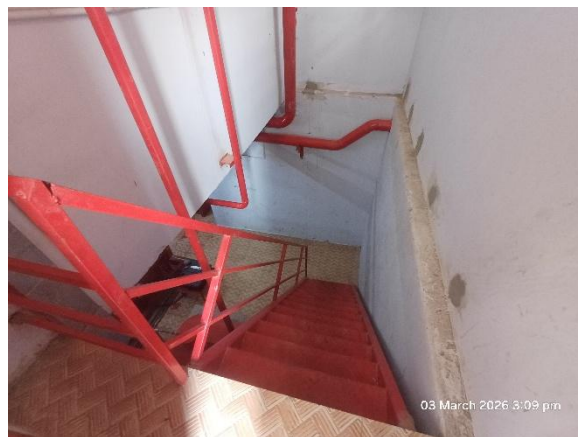
**Observation-02: Discrepancy and lack of information in as-built drawings (Main Building).**

**Description:** The thickness and height of the brick wall and the false slab, and the soil thickness in the garden area, are not shown in the drawing. In addition, the detailed dimensions of the wall, wall thickness, cantilever extension length, and details of the front side steel façade frame are not shown clearly in the drawings. Also, details of the underground fire pump are not shown clearly in the architectural & Structural drawings. The building engineer is required to survey the as-built condition and prepare an accurate set of as-built drawings and submit them to RSC for review.

| Item No | Observation | Action Plan | Timeline |
|---|---|---|---|
| 6. | Discrepancy and lack of information in as-built drawings (Main Building) | The building engineer is required to survey the as-built condition and prepare an accurate set of as-built drawings and submit them to RSC for review. | within 6 weeks |

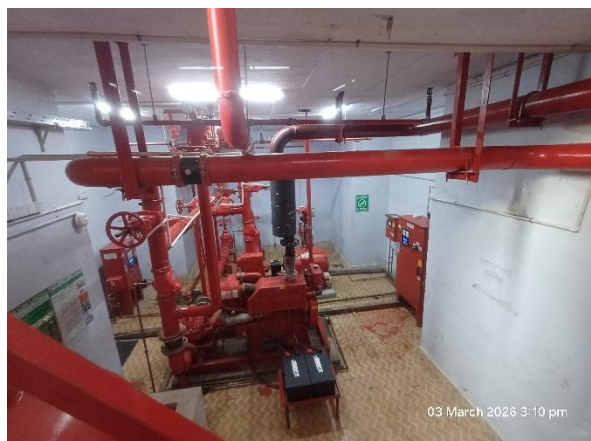
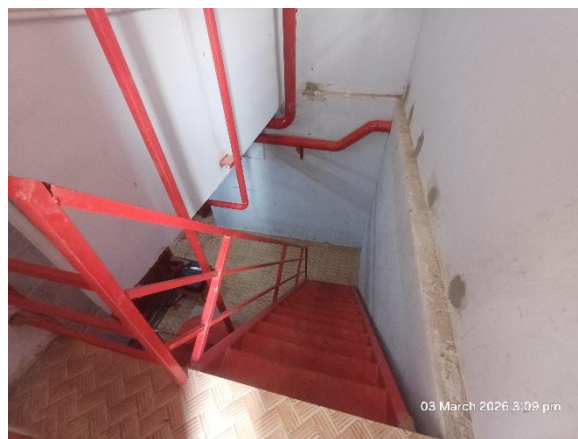
**Observation-03: Discrepancy and lack of information in as-built drawings (Utility Building).**

**Description:** The thickness and height of the brick wall and the false slab, and the soil thickness in the garden area, are not shown in the drawing. In addition, the detailed dimensions of the wall, wall thickness, and cantilever extension length are not shown clearly in the drawings. The building engineer is required to survey the as-built condition and prepare an accurate set of as-built drawings and submit them to RSC for review.

| 15. | Discrepancy and lack of information in as-built drawings (Utility Building) | The building engineer is required to survey the as-built condition and prepare an accurate set of as-built drawings and submit them to RSC for review. | within 6 weeks |

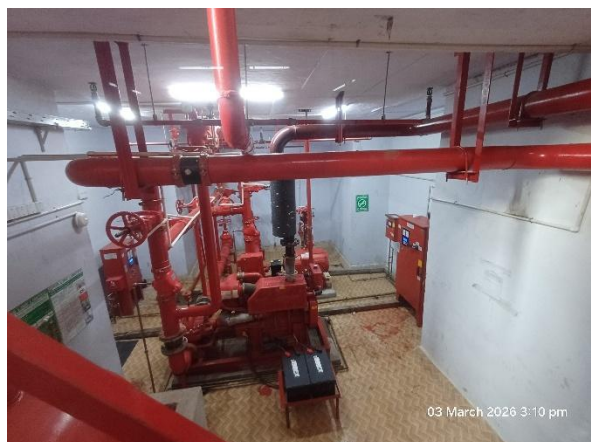
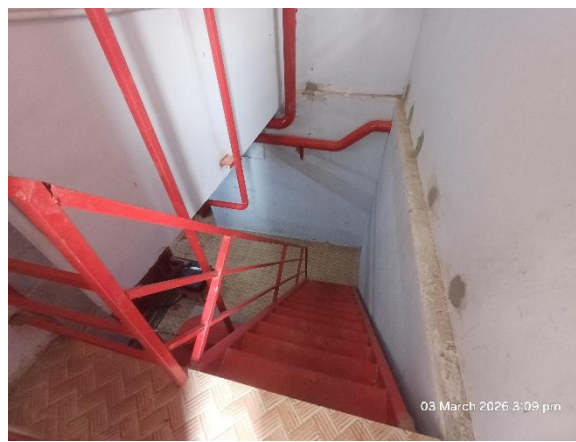
**Observation-04:** Lack of as-built drawing (Utility Shed & LPG Store Shed).

**Description:** No as-built drawings were found for the Utility Shed & LPG Store Shed. The building engineer is required to survey the as-built condition and prepare an accurate set of as-built drawings and submit them to RSC for review.

| 21. | Lack of as-built drawings, material test report, and design documents (Utility Shed). | The building engineer is required to survey the whole structure and prepare as-built drawings with foundation and connection details. | within 6 weeks |
| 24. | Lack of as-built drawings, material test report, and design documents (LPG Store Shed). | The building engineer is required to survey the whole structure and prepare as-built drawings with foundation and connection details. | within 6 weeks |

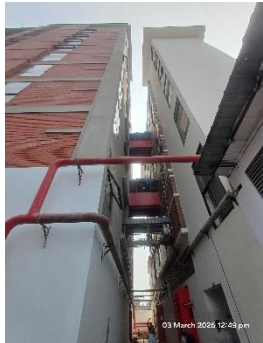
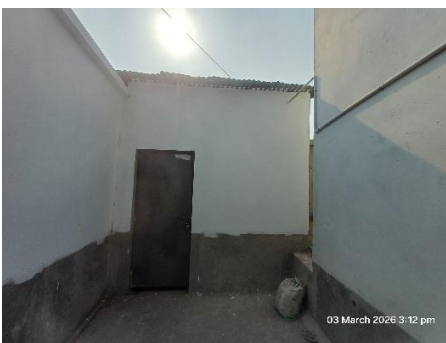
**Observation-05:** Lack of design report, load plan, and inadequate materials test report (All structures).

**Description:** A design report was found for the Main Building only. However, it doesn't satisfy the requirements of the BNBC 2020 provisions. Also, the available set of cylinder test reports didn't satisfy the frequency of testing. The building engineer is required to review the design, load, seismic requirements, framing system, and incorporate necessary measures (if necessary) as per section 2.5.8 (b)BNBC 2020 and update the analysis and design report in accordance with Section 1.9.1 of the BNBC.

Also, the building engineer is required to verify the concrete strength by taking cores (100 mm dia at least 4 nos) from the column, beam, and slab for the Main Building & Utility Building.

| Item No | Observation | Action Plan | Timeline |
|---|---|---|---|
| 2. | Lack of design report, load plan, and inadequate materials test report (Main Building). | The building engineer is required to review the design, load, seismic requirements, framing system, and incorporate necessary measures (if necessary) as per section 2.5.8 (b)BNBC 2020 and update the analysis and design report in accordance with Section 1.9.1 of the NBC. | within 6 weeks |
| 3. | | Verify the concrete strength by taking cores (100 mm dia at least 4 nos) from the column, beam, and slab. | within 6 weeks |

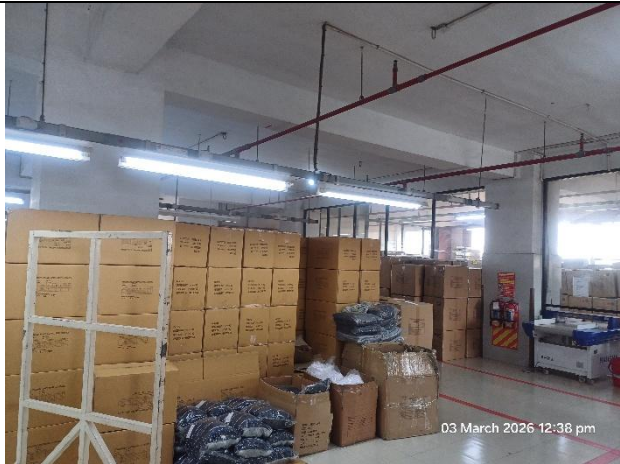
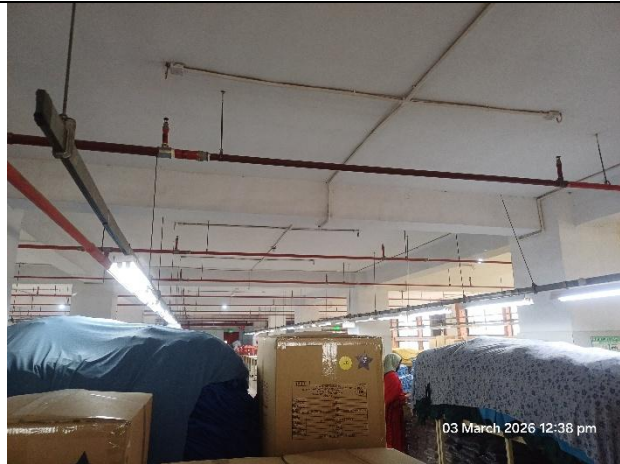
**Observation-06:** Lack of a proper load-management plan (Main Building & Utility Building).

**Description:** No load markings and proper load management were evident. The building engineer is required to post the floor load plan on each floor, provide load restriction height markings, signage on the storage area, and manage the floor load plan as per the acceptable load limits of BNBC.

| Item No | Observation | Action Plan | Timeline |
|---|---|---|---|
| 5. | Lack of a proper load-management plan (Main Building). | Building engineer is required to post the load plan and provide load restriction height markings, signage on the storage area and manage the floor loading as per the load plan. | within 6 weeks |

| 14. | Lack of a proper load-management plan (Utility Building). | Building engineer is required to post the load plan and provide load restriction height markings, signage on the storage area and manage the floor loading as per the load plan. | within 6 weeks |

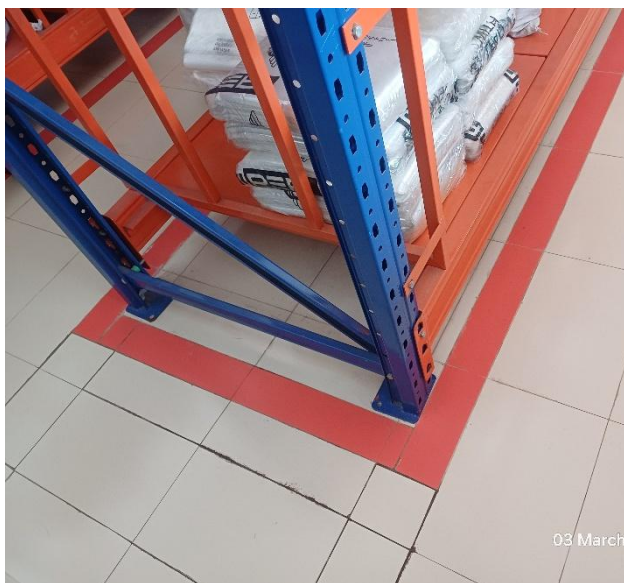
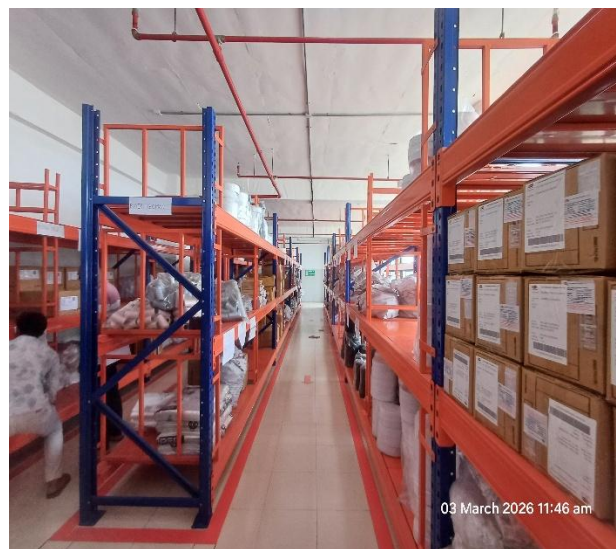
**Observation-07:** Nonstructural elements found unanchored/unbraced (Main Building).

**Description:** Nonstructural elements found unanchored/unbraced. Anchor/brace all nonstructural elements within the building.

| Item No | Observation | Action Plan | Timeline |
|---|---|---|---|
| 7. | Nonstructural elements found unanchored/unbraced (Main Building). | Anchor/brace all nonstructural elements within the building. | within 6 weeks |

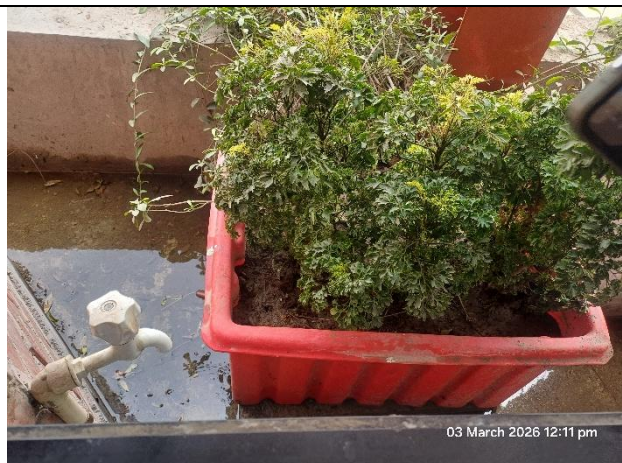
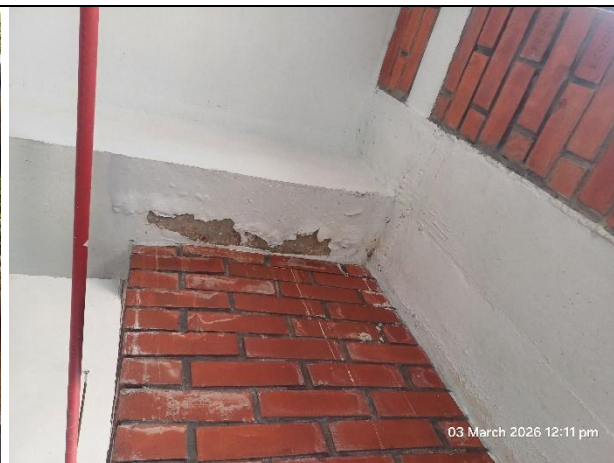
**Observation-08:** Water ponding on the cantilever garden area on each floor (Main Building).

**Description:** Water ponding and water-related damage were found on the wall and floor slab. The building engineer is required to provide waterproofing and improve drainage at all the concerned locations and repair the water-related dampness with a suitable method.

| Item No | Observation | Action Plan | Timeline |
|---|---|---|---|
| 8. | Water ponding on the cantilever garden area on each floor (Main Building). | The building engineer is required to provide waterproofing and improve drainage at all the concerned locations and repair the water-related dampness with a suitable method. | within 6 weeks |

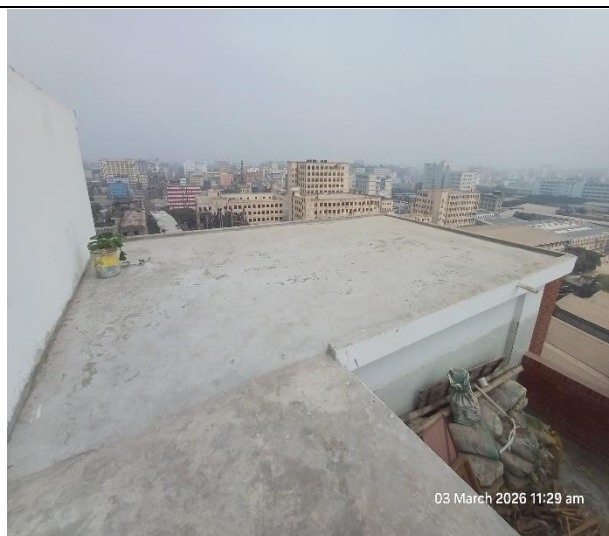
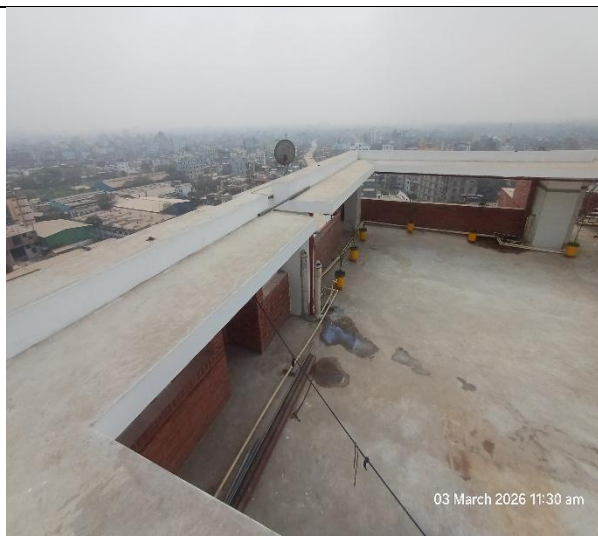
**Observation 09:** Lack of fall protection on the rooftop (Main Building).

**Description:** During inspection, access was available on the rooftop area but there is no safety barrier railings were found. The factory is required to install safety railings/barrier where required.

| Item No | Observation | Action Plan | Timeline |
|---|---|---|---|
| 9. | Lack of fall protection on the rooftop (Main Building). | The factory is required to install safety railings/barrier where required. | within 6 weeks |

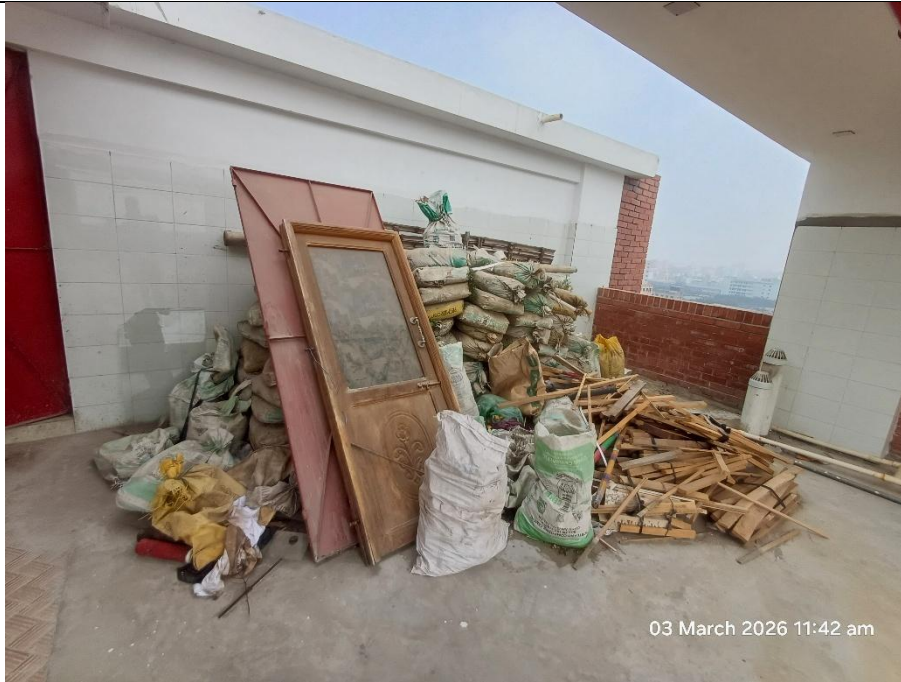
**Observation 10:** Stockpile of Construction debris on the roof (Main Building).

**Description:** During inspection, stockpiles of construction debris were found on the roof. The factory is required to remove the construction debris and maintain the floor load plan.

| Item No | Observation | Action Plan | Timeline |
|---|---|---|---|
| 10. | Stockpile of Construction debris on the roof (Main Building). | The factory is required to remove the construction debris and maintain the floor load plan. | within 6 weeks |

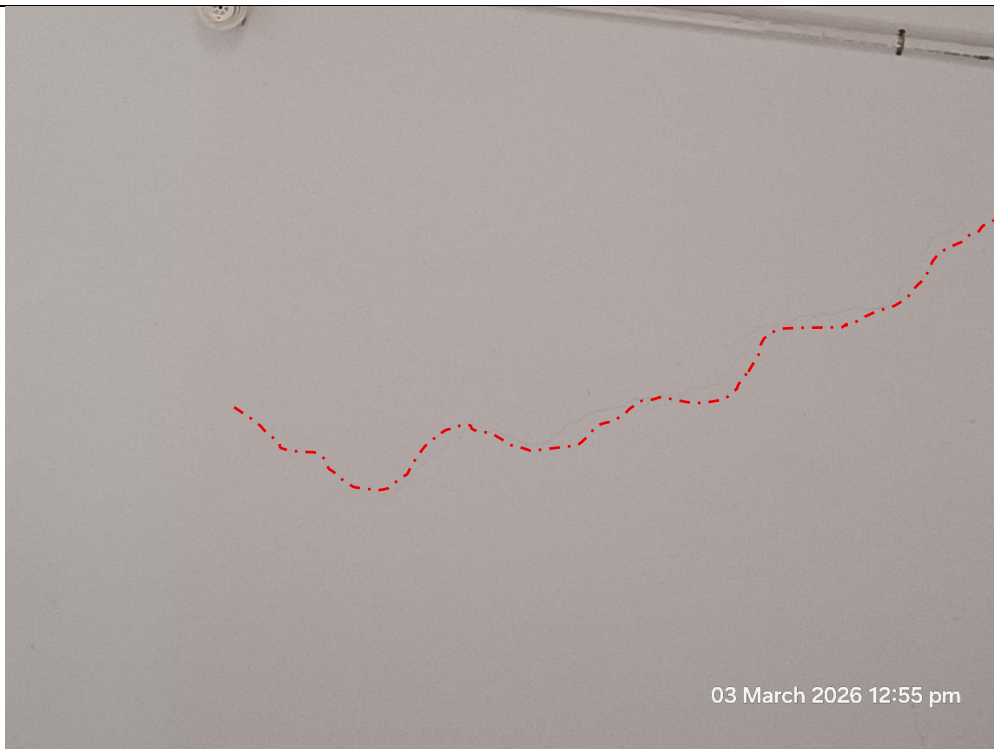
**Observation 11:** Crack on the roof slab soffit of the boiler room of the utility building.

**Description:** During inspection, cracks were found on the roof slab soffit of the boiler room at the utility building. The building engineer is required to investigate the crack, prepare an investigation report and submit it to RSC for review. Carryout necessary remedial works as per the investigation report.

| 16. | Crack on the roof slab soffit of the boiler room of the utility building. | The building engineer is required to investigate the crack and repair it with a suitable method. | within 6 weeks |

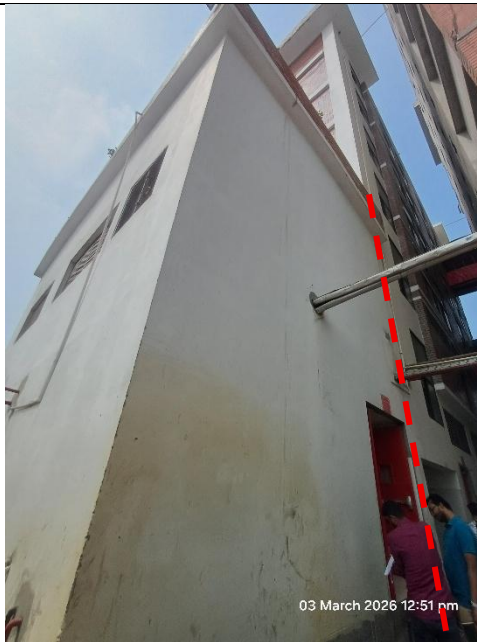
**Observation 12:** Improper expansion joint gap between the utility building and boiler room.

**Description:** An expansion joint was evident from the drawings of the utility building and boiler room. However, no separation gap was observed. The building engineer is required to clear the expansion gap and fill it with flexible fire-rated material. Otherwise, analyze the boiler room and the utility building as a whole structure.

| 17. | Improper expansion joint gap between the utility building and boiler room. | The building engineer is required to clear the expansion gap and fill it with flexible fire-rated material. Otherwise, analyze the boiler room and the utility building as a whole structure. | within 6 weeks |

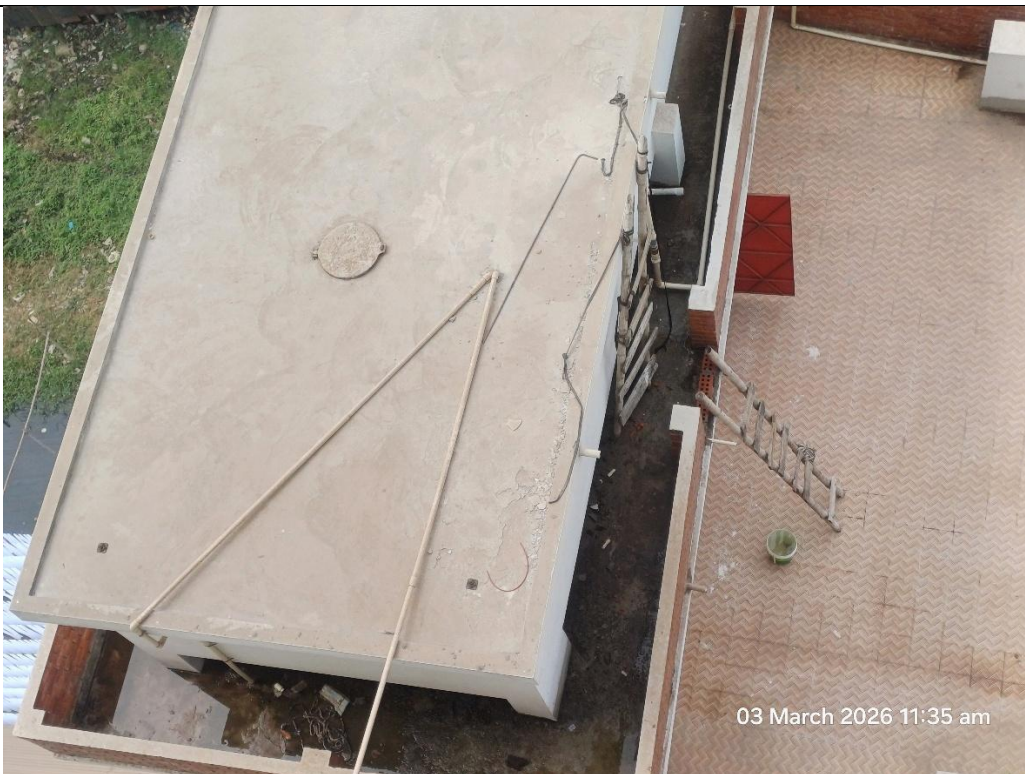
**Observation-13:** Water ponding on the stair top roof (Utility Building).

**Description:** Water ponding was found on the wall and the stair top roof slab. The building engineer is required to provide waterproofing and improve drainage at all the concerned locations.

| 20. | Water ponding on the stair top roof (Utility Building). | The building engineer is required to provide waterproofing and improve drainage at all the concerned locations. | within 6 weeks |

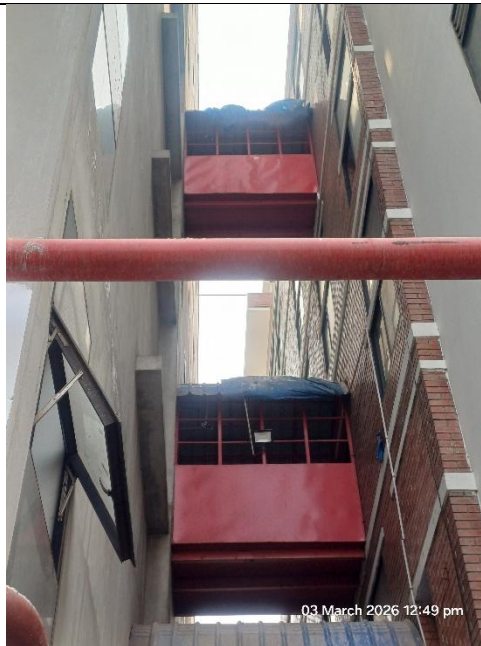
**Observation 14:** Undocumented connection bridge between the Main building and Utility Building.

**Description:** Undocumented connection bridges were observed between the Main building and the Utility Building. The building engineer is required to prepare drawings of the connecting bridge, along with connection details, and provide an adequacy check report.

| 18. | Undocumented connection bridge between the Main building and Utility Building. | The building engineer is required to prepare drawings of the connecting bridge, along with connection details, and provide an adequacy check report. | within 6 weeks |
| 19. | | Implement remediation work if required. | within 6 months |
