# Creative Outerwear Ltd

1 March 2026

## Structural Inspection Report

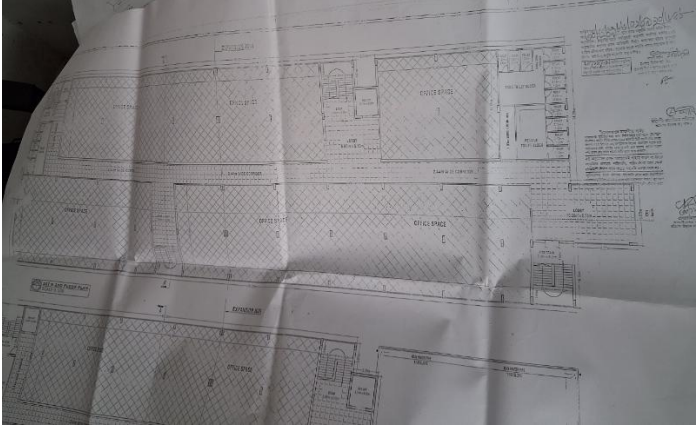
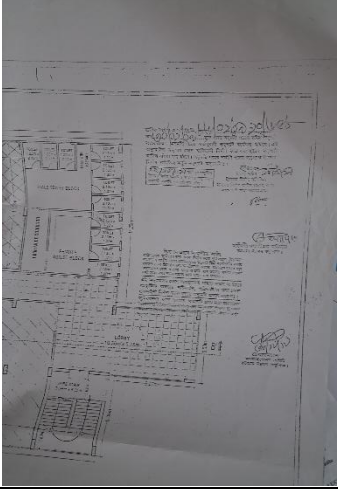
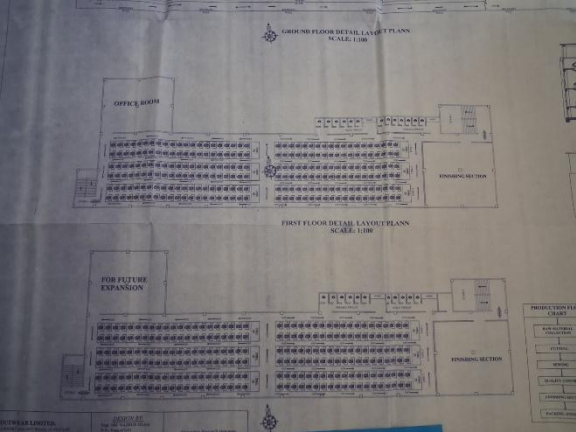
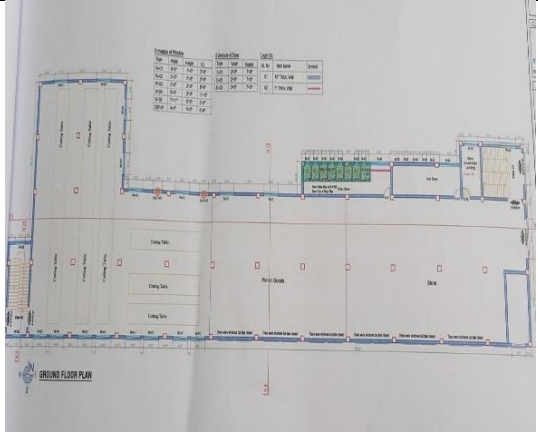
| Permit drawing layout plan obtained from the local authority (CDA) | Permit for the proposed 5-storied commercial building |
| Industrial layout plan from DIFE | As-built layout plan |
| <p><b>Description:</b> The building approval/ permit drawing layout plan was provided by the Chittagong Development Authority (CDA) (Local Authority) for the 5-storied commercial building. The layout, area and type of building are not indicative to the as-built construction.</p> <p>The building engineer is required to seek a fresh approval/permit drawing from the concerned local authority and its implementation on the building code determination.</p> | |

| Item No. | Observation | Action Plan | Timeline |
|---|---|---|---|
| 1. | Inconsistencies in the permit drawing. (Production Building) | The building engineer is required to seek a fresh approval/permit drawing from the concerned local authority and its implementation on the building code determination. | within 6 months |

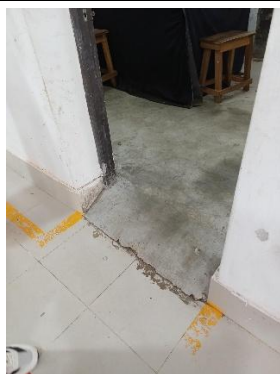
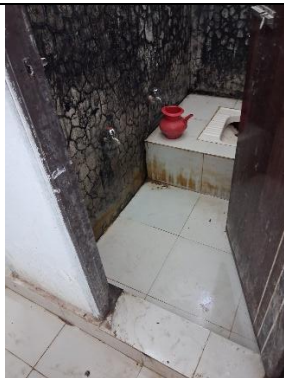
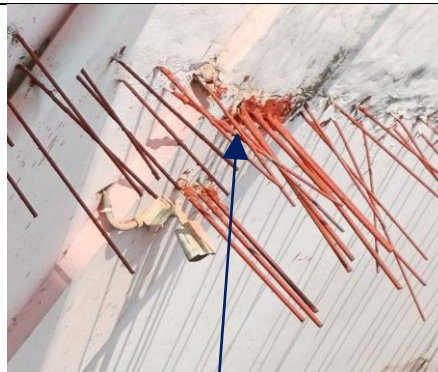
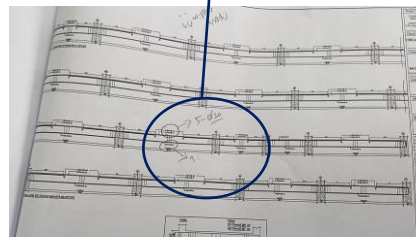
**Observation-4:** Discrepancies in the as-built drawings. (Production Building)

Undocumented floor build-up

Rebar at top found 5 nos instead of 6 nos.

**Description:** During inspection, undocumented 12 inch (300 mm) floor build-up was found at the toilet zone. Also, 6 inch undocumented floor build-up found at 2<sup>nd</sup> floor Maintenance room. Moreover, top rebar at typical floor beam was found 5 nos. instead of 6. No stair top slab or beam details found in the structural drawing. The building engineer is required to update the as-built drawings as per actual site condition and submit them to RSC for review.

| Item No. | Observation | Action Plan | Timeline |
|---|---|---|---|
| 8. | Discrepancies in the as-built drawings. (Production Building) | The building engineer is required to update the as-built drawings as per actual site condition and submit them to RSC for review. | within 6 weeks |

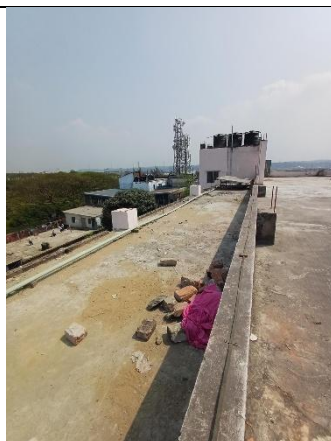
**Observation-5:** Absence of water proofing membrane at roof. (Production Building)

**Description:** The roof is constructed by MCAC. During inspection, no water proofing membrane was found at north side roof portion. Building engineer is required to provide water proofing membranes with proper slopes and improve the drainage system.

| Item No. | Observation | Action Plan | Timeline |
|---|---|---|---|
| 9. | Absence of water proofing membrane at roof. (Production Building) | Building engineer is required to provide water proofing membranes with proper slopes and improve the drainage system. | within 6 months |

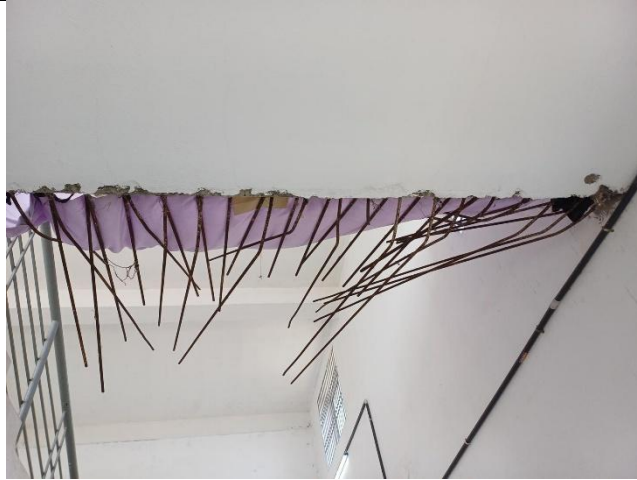
**Observation-6:** Exposed rebar. (Production Building)

**Description:** During inspection, exposed rebar was found at several locations. Building engineer is required to apply anti-corrosive coating on the exposed rebar to prevent corrosion.

| Item No. | Observation | Action Plan | Timeline |
|---|---|---|---|
| 10. | Exposed rebar. (Production Building) | Building engineer is required to apply anti-corrosive coating on the exposed rebar to prevent corrosion. | within 6 weeks |

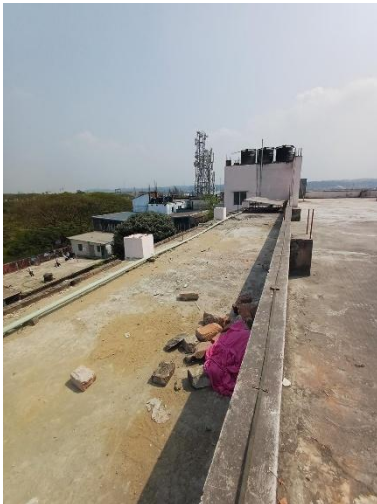
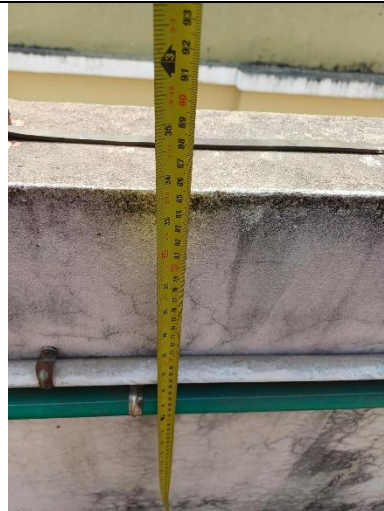
**Observation-7:** Low height parapet and falling hazard at roof. (Production Building)

**Description:** During inspection, falling hazard was found at roof. Also, low parapet height was found at roof. Building engineer is required to provide adequate railing/parapet to prevent falling hazard.

| Item No. | Observation | Action Plan | Timeline |
|---|---|---|---|
| 11. | Low height parapet and falling hazard at roof. (Production Building) | Building engineer is required to provide adequate railing/parapet to prevent falling hazard. | within 6 weeks |

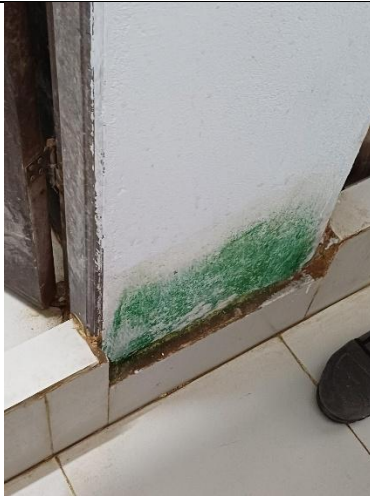
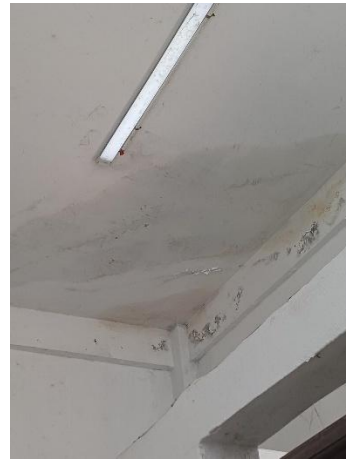
**Observation-8: Dampness on walls and slab. (Production Building)**

**Description:** During inspection, dampness was found on walls and slab at several locations. The building engineer is required to investigate the reason of dampness and repair with suitable methods for walls. Additionally, the building engineer is required to prepare an investigation report along with the proposed repair methodology for slab. The investigation report is required to be submitted to RSC for review.

| Item No. | Observation | Action Plan | Timeline |
|---|---|---|---|
| 12. | Dampness on walls and slab. (Production Building) | The building engineer is required to investigate the reason of dampness and repair with suitable methods for walls. Additionally, the building engineer is required to prepare an investigation | within 6 weeks |

| | | report along with the proposed repair methodology for slab. The investigation report is required to be submitted to RSC for review. | |

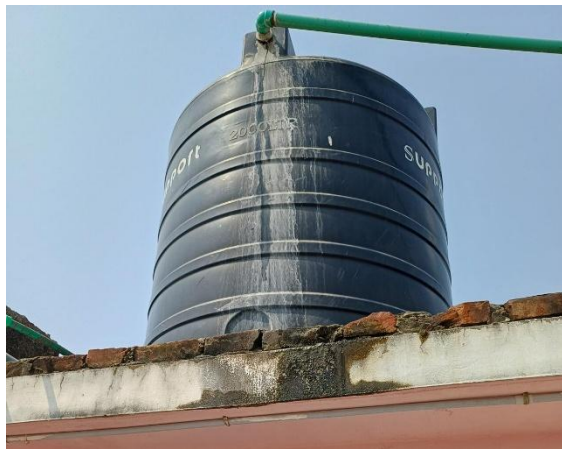
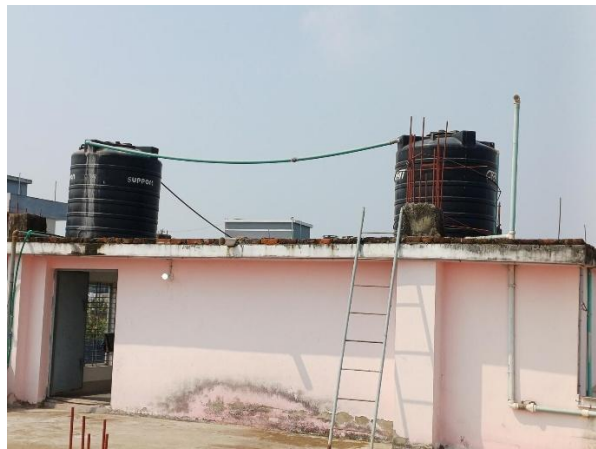
**Observation-9: Non-structural elements not anchored or braced. (Production Building)**

**Description:** PVC tanks at roof are not anchored or braced to resist lateral (earthquake) forces. The factory is required to anchor/brace all non-structural elements adequately to resist earthquake forces.

| 13. | Non-structural elements not anchored or braced. (Production Building) | The factory is required to anchor/brace all non-structural elements adequately to resist earthquake forces. | within 6 weeks |

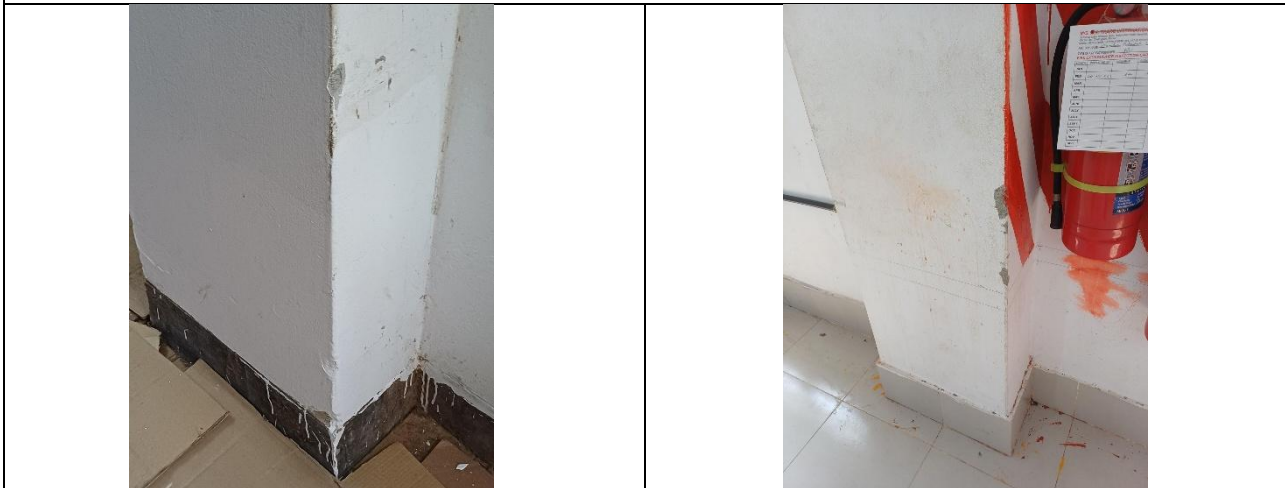
**Observation-10:** Trolley impacts on typical floor columns. (Production Building)

**Description:** During inspection, trolley impact was found on typical floor columns. The building engineer is required to repair the column surface and install column guards to prevent trolley impact.

| 14. | Trolley impacts on typical floor columns. (Production Building) | The building engineer is required to repair the column surface and install column guards to prevent trolley impact. | within 6 weeks |

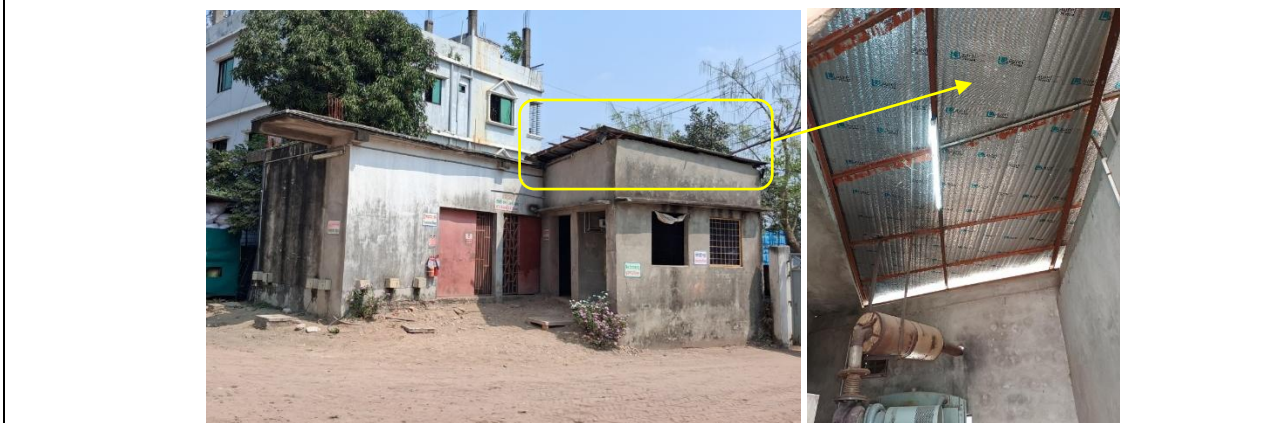
**Observation 11:** Lack of design report. (Utility Building)

**Description:** As per BNBC, every building or structure designed shall have its design documents prepared under the provisions of Section 1.9. At the time of inspection, no design report and material test reports were available on-site. Also, lack of lateral stability and poor connection details were found in the roof shed. The building engineer is required to prepare an Engineering Assessment (EA) report as per BNBC and submit to RSC for review.

| 15. | Lack of design report. (Utility Building) | The building engineer is required to prepare an Engineering Assessment (EA) report as per BNBC and submit to RSC for review. | within 6 weeks |
| 16. | | Carryout suggested remedial works (if required) | within 6 months |

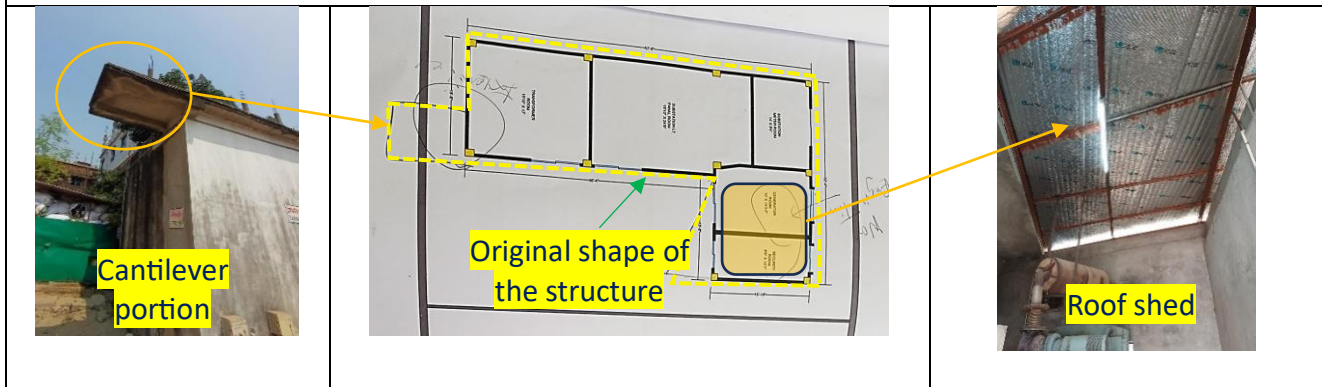
**Observation 12:** Incomplete as-built drawing. (Utility Building)

**Description:** During the inspection, no details were found for the south side roof shed. Also, building's dimension doesn't match with the actual site condition. Additionally, west side cantilever portion also not shown in the as-built drawings. Building engineer is required to update the as-built drawings as per actual site condition and submit to RSC.

| 17. | Incomplete as-built drawing. (Utility Building) | Building engineer is required to update the as-built drawings as per actual site condition and submit to RSC. | within 6 weeks |

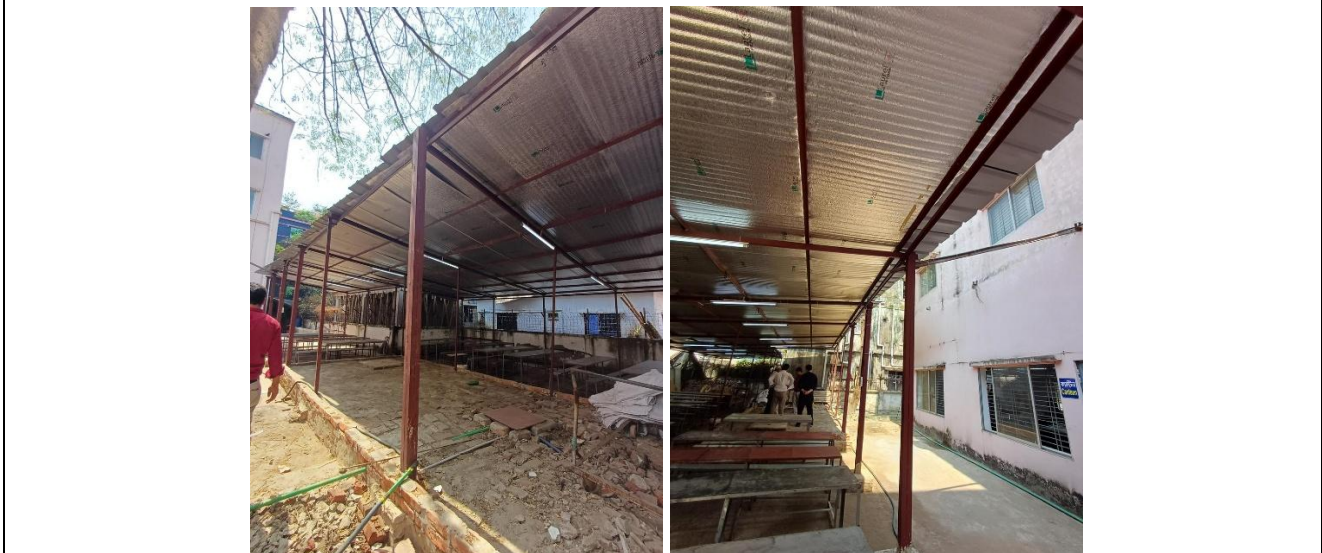
**Observation 13:** Lack of lateral stability, light weight structure, and poor connection details. (Dining & Medical Shed)

**Description:** During inspection, lack of lateral stability and poor connection details were found at the Dining & Medical Shed. The building engineer is required to carry out Engineering Assessment (EA) to check the lateral stability, connection adequacy and submit the EA documents to RSC for review.

| 18. | Lack of lateral stability, light weight structure and poor connection details. (Dining & Medical Shed) | The building engineer is required to carry out Engineering Assessment (EA) to check the lateral stability, connection adequacy and submit the EA documents to RSC for review. | within 6 weeks |
| 19. | | Carryout suggested remedial works (if required) | within 6 months |

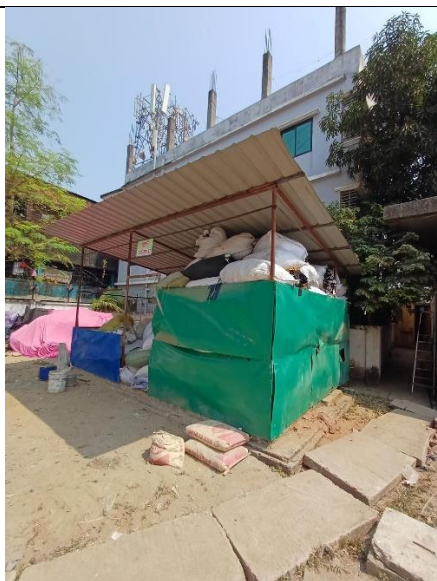
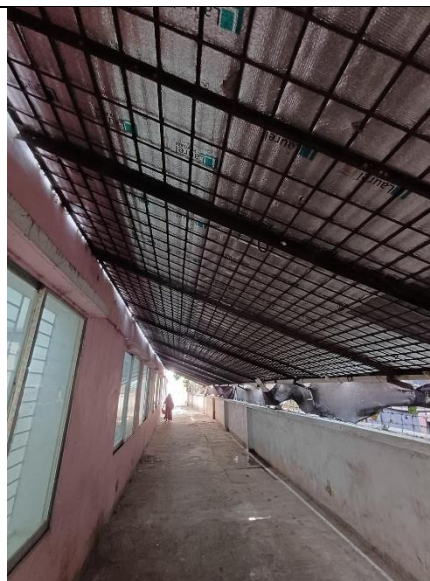
**Observation 14:** Apparently non-engineered Shed. (Jhut shed and Walkway shed)

**Description:** The members of the sheds are inadequate, and the connections are non-engineered. The building engineer is required to carry out Engineering Assessment (EA) and implement necessary remediation, otherwise replace these sheds with engineering ones.

| 20. | Apparently non-engineered Shed. (Jhut shed and Walkway shed) | The building engineer is required to carry out Engineering Assessment (EA), otherwise replace these sheds with engineering ones. | within 6 weeks |
| 21. | | Carryout suggested remedial works (if required) | within 6 months |
