Issue-01

# Danys Knit wear Limited (Extension)

Surabari, Kashimpur, Gazipur Sadar, Gazipur

16 April 2026

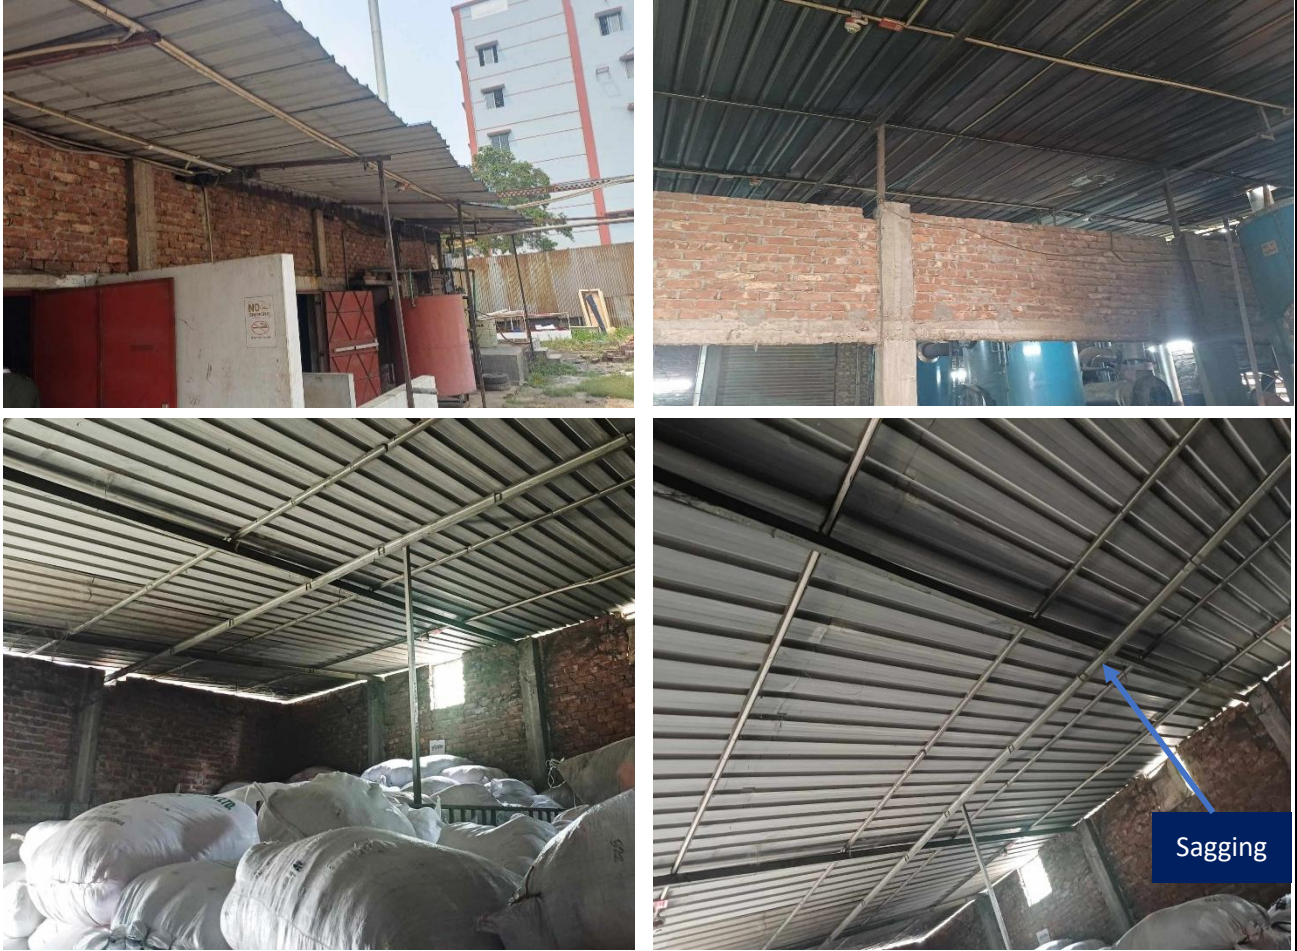
**Observation-01:** Non-engineered structure – inadequate member size, poor connection details, deflected and sagged members. [Shed-01]

**Description:** At the time of inspection, non-engineered structural system including inadequate member size, poor connection details, deflected and sagged members were observed for the mentioned structures.

- 1) Building engineer is required to carry out Engineering Assessment (EA) to check for the member adequacy and connection details against lateral and vertical loading.
- 2) The building engineer is required to investigate the sagged and deflected members and carry out the required remedial works.

| Item No | Observation | Action Plan | Timeline |
|---|---|---|---|
| 1. | Non-engineered structure – inadequate member size, poor connection details, deflected and sagged members. [Shed-01] | Building engineer is required to carry out engineering assessment (EA) to check the member adequacy and connection details against lateral loading and vertical loading. | within 6 weeks |
| 2. | | The building engineer is required to investigate the sagged and deflected members and carry out the required remedial works. | within 6 weeks |
| 3. | | Implement the recommendations of the EA after acceptance from RSC. | within 6 months |

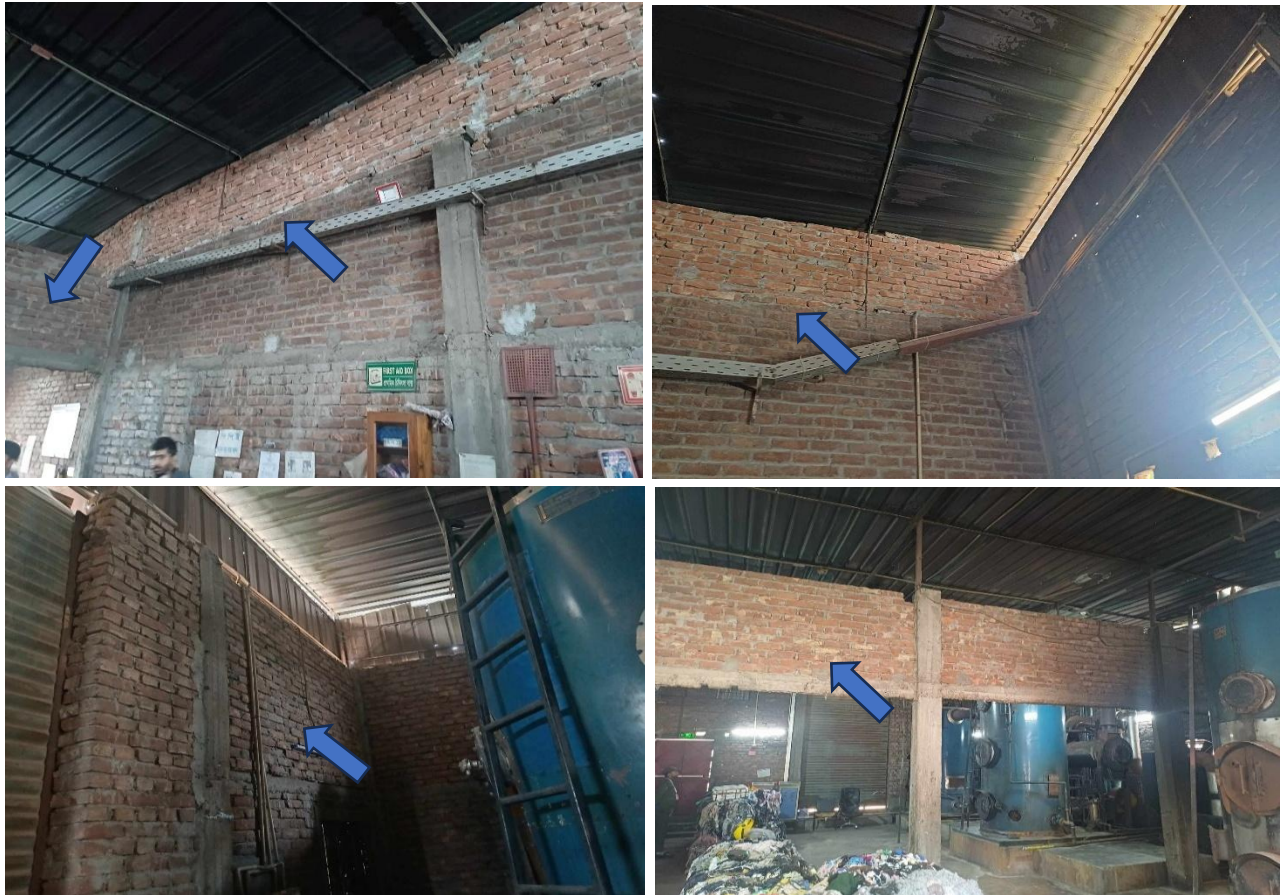
**Observation-02: Unrestrained brick wall. [Shed-01]**

**Description:** At the time of inspection, 3m to 5m high brick wall observed without head restraint. Building engineer is required to provide necessary alternatives to stabilize the unrestrained brick wall.

| Item No | Observation | Action Plan | Timeline |
|---|---|---|---|
| 4. | Unrestrained brick wall. [Shed-01] | Building engineer is required to provide necessary alternatives to stabilize the unrestraint brick wall. | within 6 weeks |

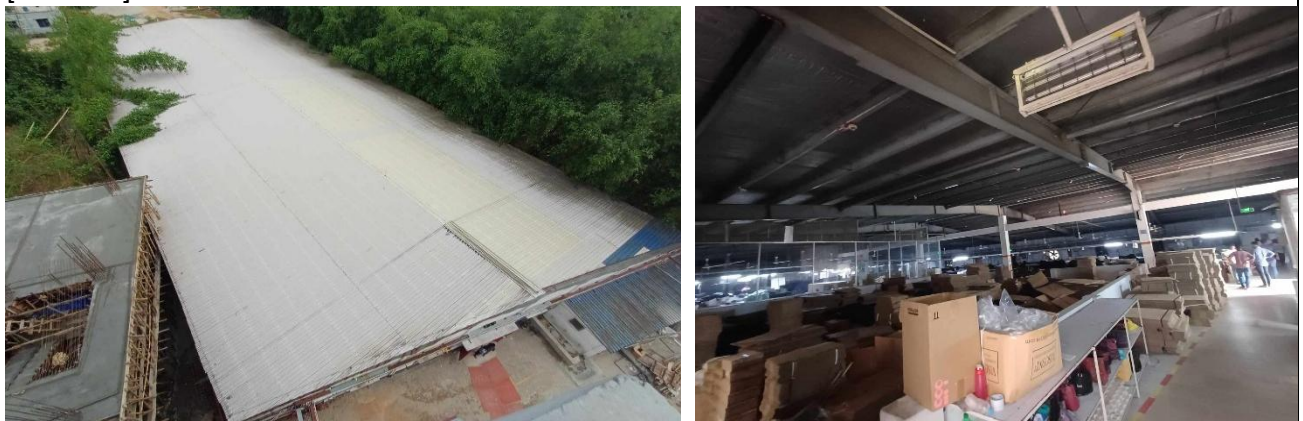
**Observation-03: Lack of design report and stability system in the long direction at periphery. [Shed-02]**

**Description:** Every building or structure designed shall have its design documents prepared in accordance with the provision of Section 1.9.1. The design document shall include a design report, and a set of structural drawings, which shall be prepared in compliance with section 1.9.1.1 & section 1.9.1.2 of BNBC (part-6).

At the time of inspection, no design report was available for captioned structure. Also, tie beam was missing in the long direction for RC columns at periphery. The building engineer is required to check the structure and prepare a set of design documents in compliance with BNBC and submit to RSC for detailed review.

| Item No | Observation | Action Plan | Timeline |
|---|---|---|---|
| 5. | Lack of design report and stability system in the long direction at periphery. [Shed-02] | The building engineer is required to check the structure and prepare a set of design documents in compliance with BNBC and submit to RSC for detailed review. | within 6 weeks |
| 6. | | Implement the recommendations of the design documents after acceptance from RSC. | within 6 months |

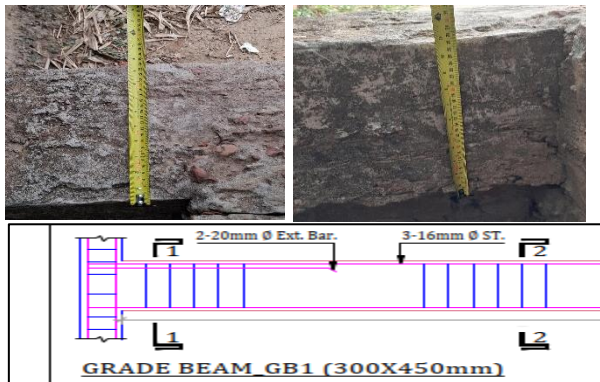
**Observation-04:** Mismatch and lack of information in the as-built drawings. [Shed-02]

GB size found 240X270mm (without plaster)

The building engineer is required to survey the whole structure and update the as-built drawings reflecting the on-site condition.

| Item No | Observation | Action Plan | Timeline |
|---|---|---|---|
| 7. | Mismatch and lack of information in the as-built drawings. [Shed-02] | The building engineer is required to survey the whole structure and update the as-built drawings reflecting the on-site condition. | within 6 weeks |

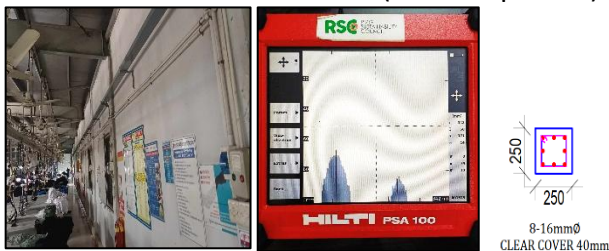
Peripheral column re-bar profile found 2/3 instead of 3/3

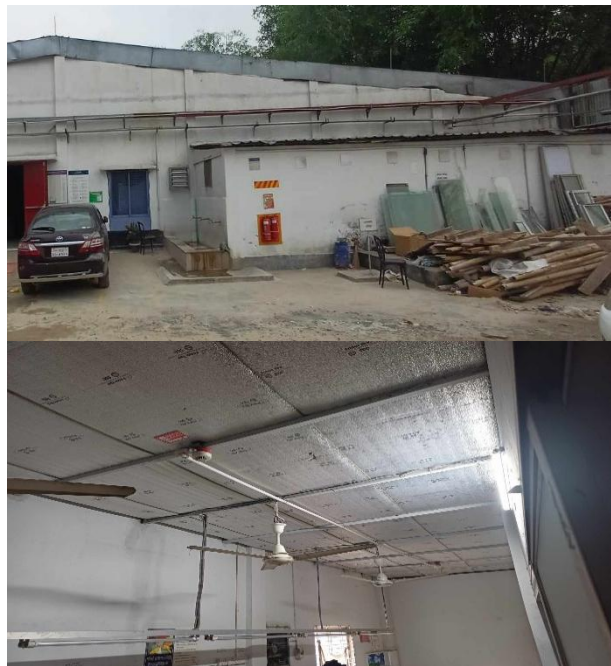
Lack information in the structural drawing for the toilet part and Spot removing shed

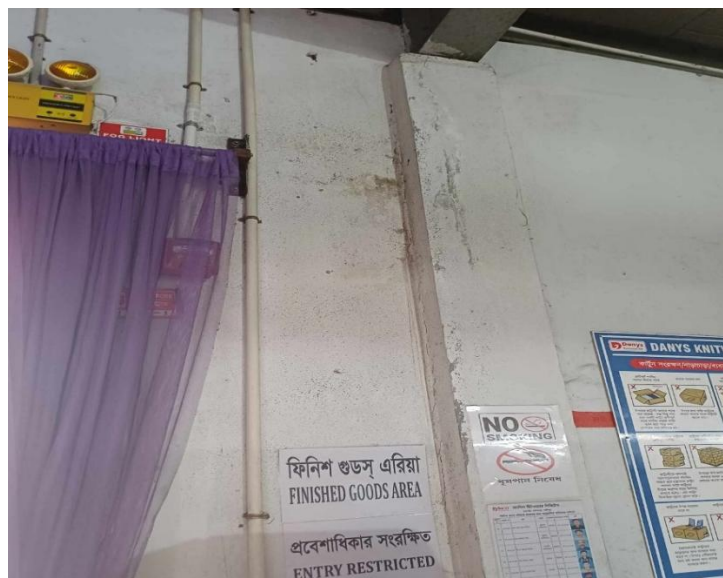
**Observation-05:** Dampness on the brick wall. [Shed-02]

**Description:** At the time of inspection, dampness was observed on the brick wall. The factory is required to remove the dampness with suitable method.

| Item No | Observation | Action Plan | Timeline |
|---|---|---|---|
| 8. | Dampness on the brick wall. [Shed-02] | The factory is required to remove the dampness with suitable method. | within 6 weeks |

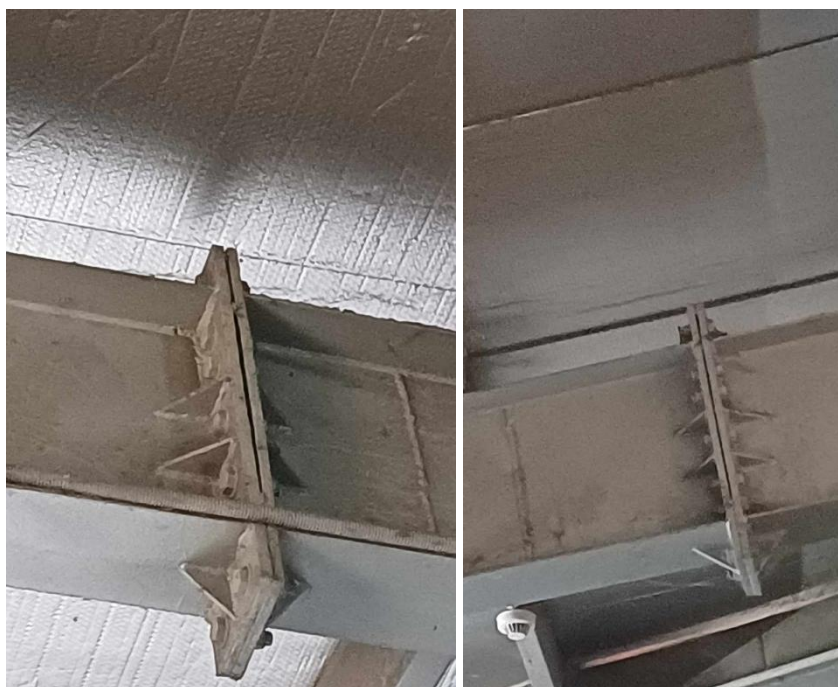
**Observation-06:** Connection gap in the rafters. [Shed-02]

**Description:** At the time of inspection, connection gaps were observed on the rafters. The factory is required to fill the connection gap with a suitable method.

| Item No | Observation | Action Plan | Timeline |
|---|---|---|---|
| 9. | Connection gap in the rafters. [Shed-02] | The factory is required to fill connection gaps with a suitable method. | within 6 weeks |

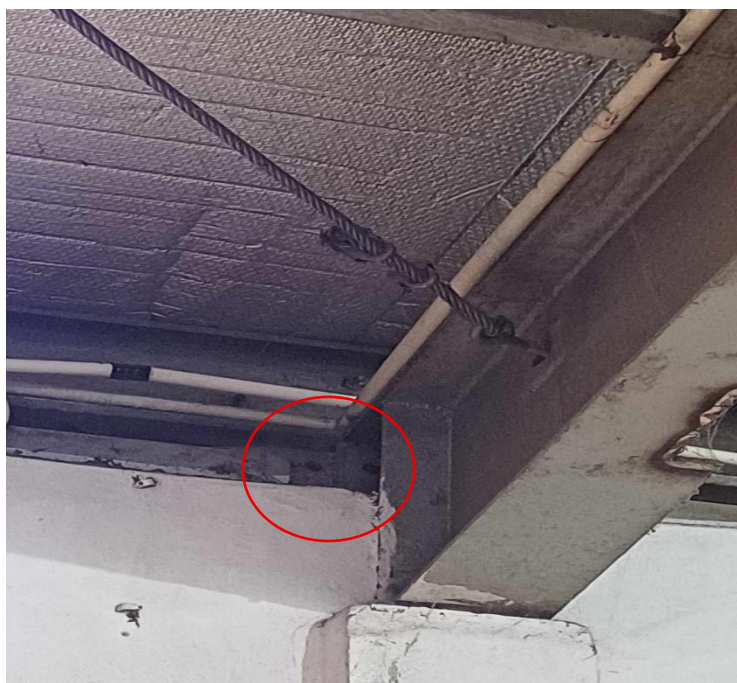
**Observation-07:** Missing bolts in the steel connections. [Shed-02]

**Description:** At the time of inspection, missing bolts were observed on the strut connections. The factory is required to identify the locations and install all missing bolts.

| Item No | Observation | Action Plan | Timeline |
|---|---|---|---|
| 10. | Missing bolts in the steel connections. [Shed-02] | The factory is required to identify the locations and install all missing bolts. | within 6 weeks |

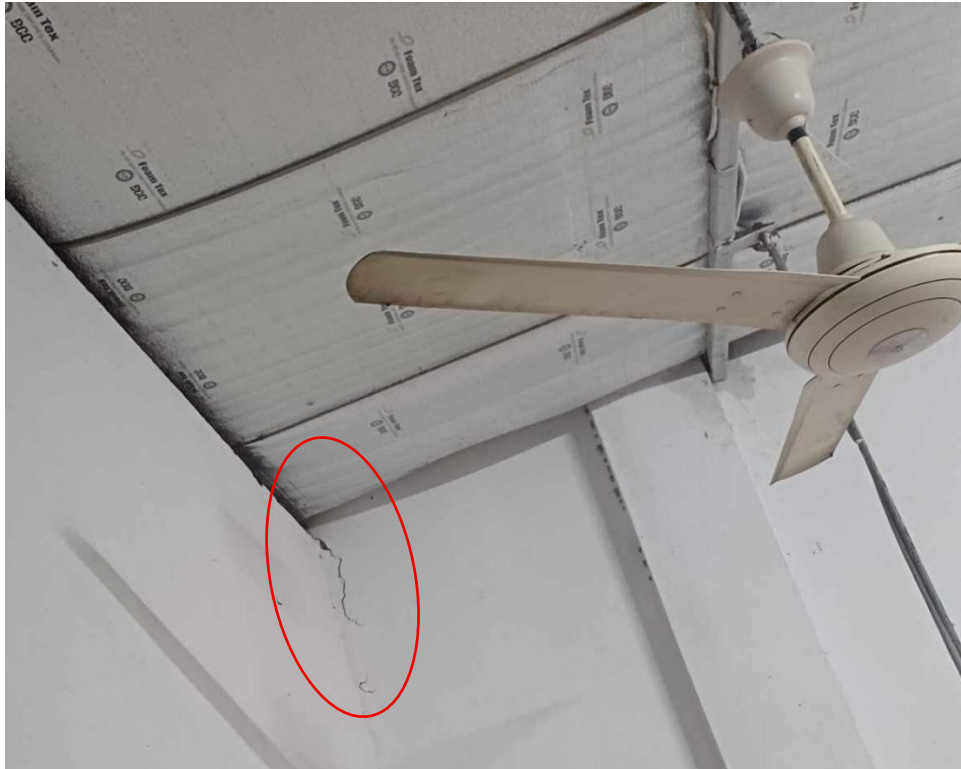
**Observation-08:** Crack on brick wall. [Shed-02]

**Description:** At the time of inspection, crack on brick wall observed on the spot removing room wall. The factory is required to repair the crack with suitable a method.

| Item No | Observation | Action Plan | Timeline |
|---|---|---|---|
| 11. | Crack on brick wall. [Shed-02] | The factory is required to repair the crack with a suitable method. | within 6 weeks |

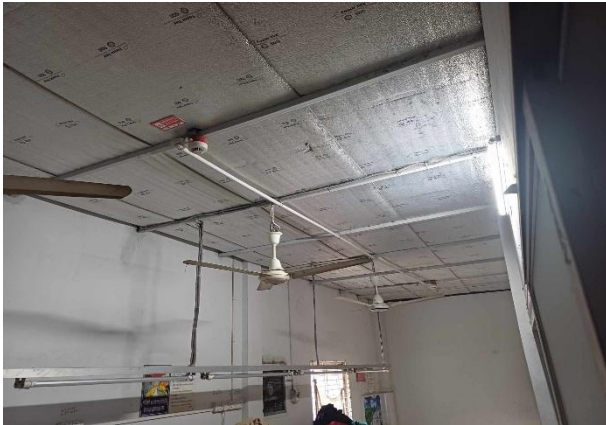
Spot Removing Room

**Observation-09:** Inadequate member size, poor connection details. [Extension of Shed-02]

**Description:** At the time of inspection, non-engineered structural system including inadequate member size, poor connection details were observed for the mentioned structure.

The building engineer is required to carry out Safety Check for members & connection adequacy.

| Item No | Observation | Action Plan | Timeline |
|---|---|---|---|
| 12. | Inadequate member size, poor connection details. [Extension of Shed-02] | The building engineer is required to carry out Safety Check for member & connection adequacy. | within 6 weeks |
| 13. | | Implement the recommendations of Safety Check report after acceptance from RSC. | within 6 months |

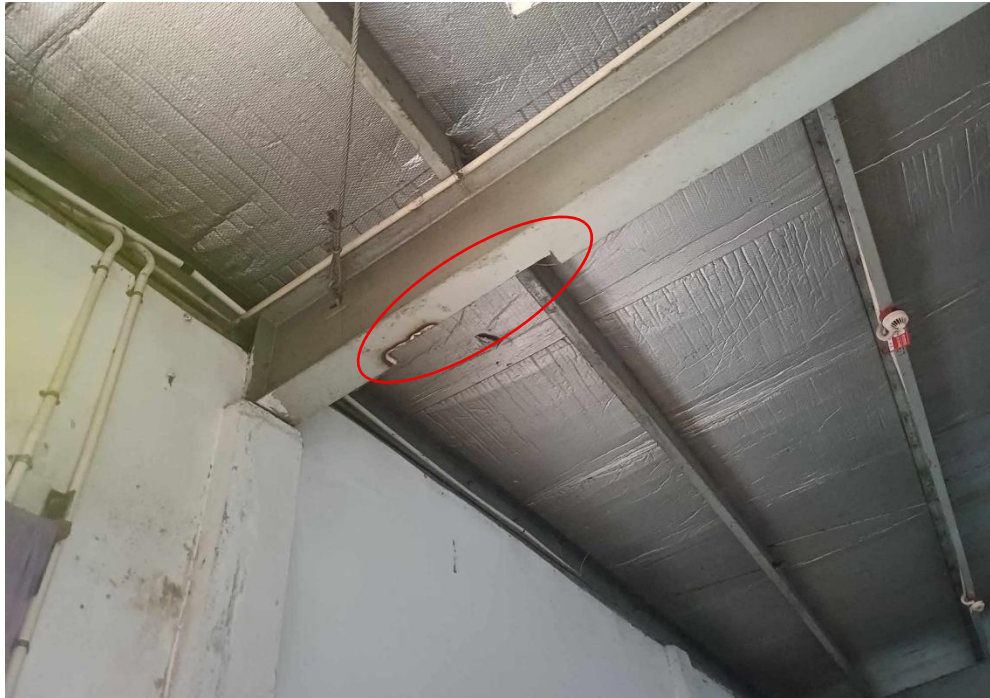
**Observation-10:** Cut off plate test sample location not filled yet. [Shed-02]

**Description:** The sample cut for the plate test has not been filled in yet. The factory is required to fill the sample cut locations using the same type of plate section.

| Item No | Observation | Action Plan | Timeline |
|---|---|---|---|
| 14. | Cut off plate test sample location not filled yet. [Shed-02] | The factory is required to fill the sample cut locations using the same type of plate section. | within 6 weeks |

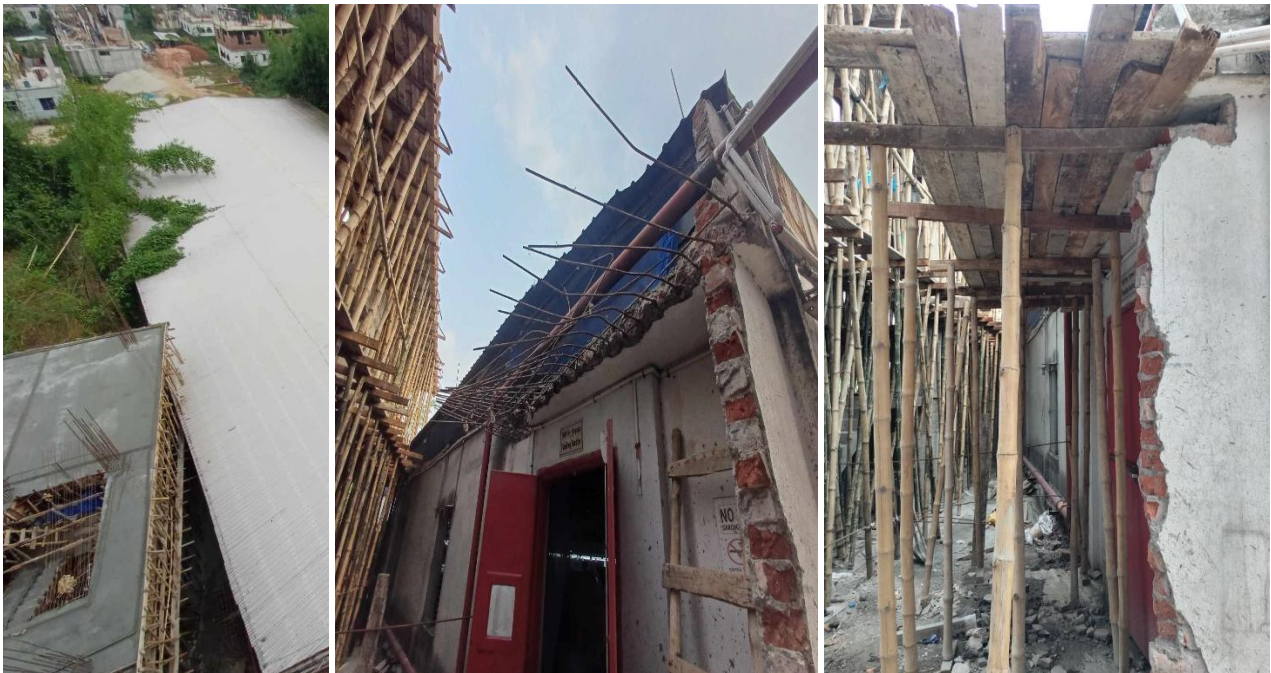
**Observation-11:** Standard construction safety practices. [Shed-02]

**Description:** At the time of inspection, construction safety practices were not up to the mark. i.e. inadequate fall protection, safety training influence, caution mark etc. The factory is required to follow construction safety guidelines as per the BNBC (Part-7, Chapter 3&4).

| Item No | Observation | Action Plan | Timeline |
|---|---|---|---|
| 15. | Standard construction safety practices. [Shed-02] | The factory is required to follow construction safety guidelines as per the BNBC (Part-7, Chapter 3&4). | within 6 weeks |

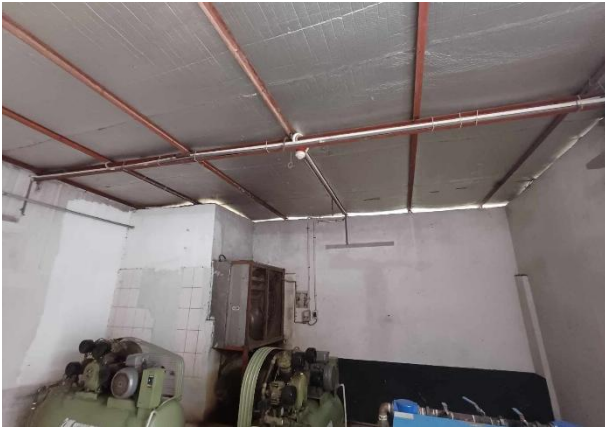
Shed-03: Compressor Room

**Observation-12:** Inadequate member size & poor connection details. [Shed-03; Shed-04]

**Description:** At the time of inspection, inadequate member size, poor connection details were observed for the mentioned structures.

The building engineer is required to carry out Safety Check for members & connection adequacy.

| Item No | Observation | Action Plan | Timeline |
|---|---|---|---|
| 16. | Inadequate member size & poor connection details. [Shed-03] | The building engineer is required to carry out Safety Check for members & connection adequacy. | within 6 weeks |
| 17. | | Implement the recommendations of Safety Check report after acceptance from RSC. | within 6 months |

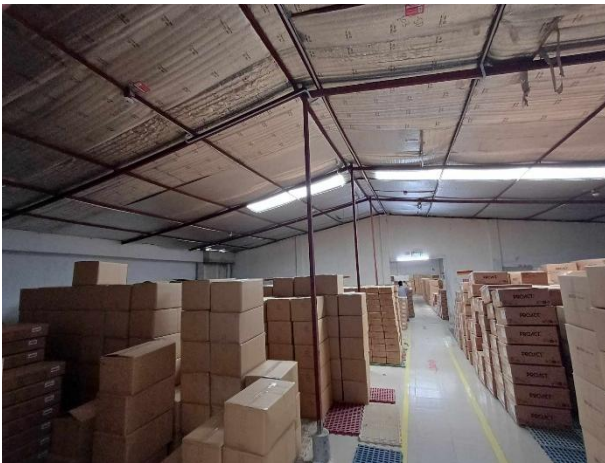
Non-engineered structure

**Description:** At the time of inspection, non-engineered structural system including inadequate member size, poor connection details were observed for part-2. Also, inadequate framing section size observed in the long direction.

The building engineer is required to carry out Engineering Assessment (EA) to check the member adequacy and connection details against lateral loading and vertical loading.

| Item No | Observation | Action Plan | Timeline |
|---|---|---|---|
| 20. | Non-engineered structure and inadequate framing in long direction. [Shed-05] | Building engineer is required to carry out EA to check the member adequacy and connection details against lateral and vertical loading. | within 6 weeks |
| 21. | | Implement the recommendations of the EA after acceptance from RSC. | within 6 months |

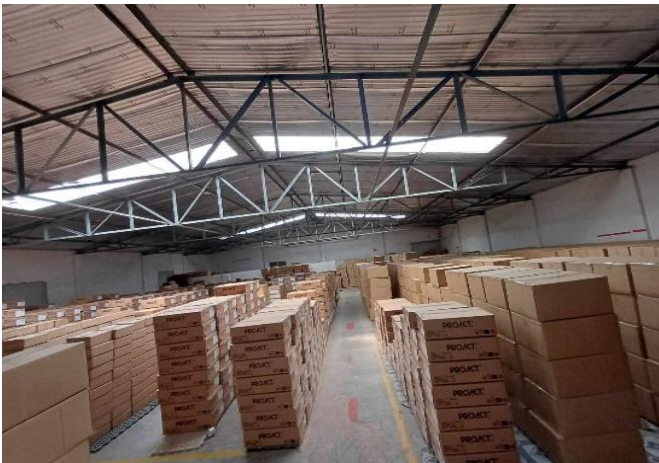
Inadequate framing in long direction

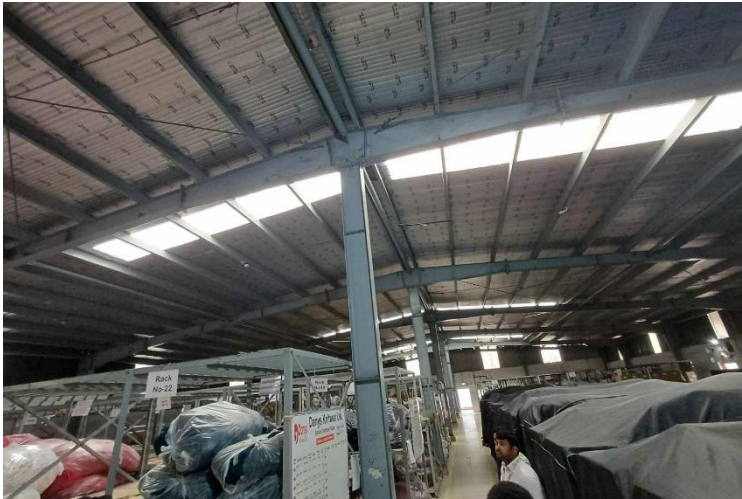
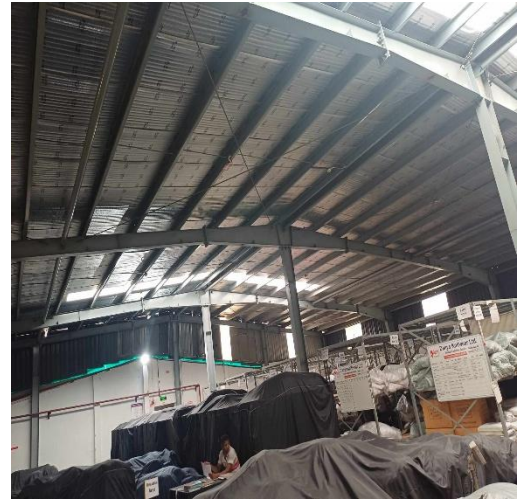
**Observation-14:** Lack of design report and stability in long direction. [Shed-06]

**Description:** Every building or structure designed shall have its design documents prepared in accordance with the provision of Section 1.9.1. The design document shall include a design report, and a set of structural drawings, which shall be prepared in compliance with section 1.9.1.1 & section 1.9.1.2 of BNBC (part-6).

At the time of inspection, no design report was available for the captioned structure. Also, vertical bracing was missing in the long direction. The building engineer is required to check the structure and prepare a set of design documents in compliance with BNBC and submit to RSC for detailed review.

| Item No | Observation | Action Plan | Timeline |
|---|---|---|---|
| 22. | Lack of design report and stability in long direction. [Shed-06] | The building engineer is required to check the structure and prepare a set of design documents in compliance with BNBC and submit to RSC for detailed review. | within 6 weeks |
| 23. | | Implement the recommendations of the design documents after acceptance from RSC. | within 6 months |

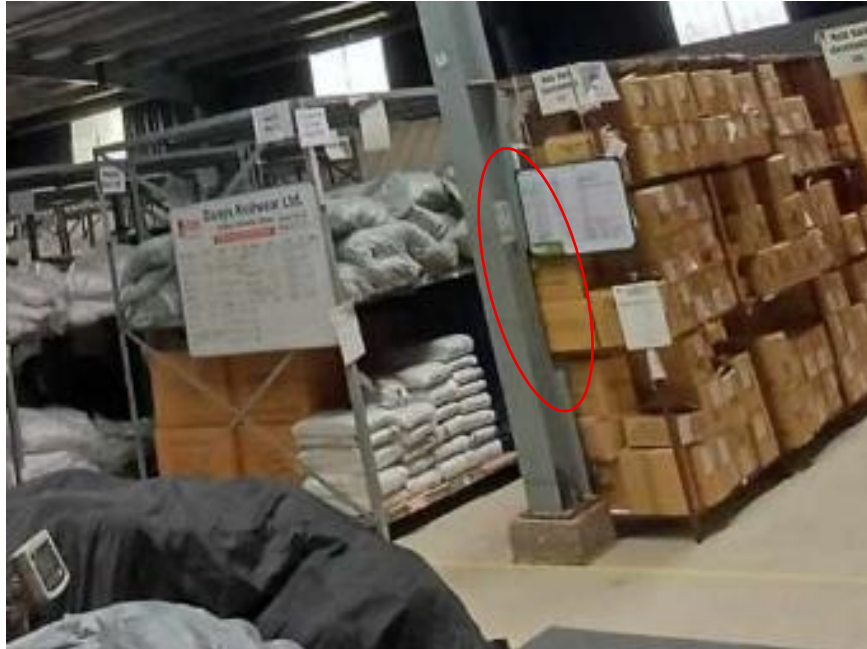
**Observation-15:** Cut off plate test sample location not filled yet. [Shed-06]

**Description:** The sample cut for the plate test has not been filled in yet. The factory is required to fill the sample cut locations using the same type of plate section.

| Item No | Observation | Action Plan | Timeline |
|---|---|---|---|
| 24. | Cut off plate test sample location not filled yet. [Shed-06] | The factory is required to fill the sample cut locations using the same type of plate section. | within 6 weeks |

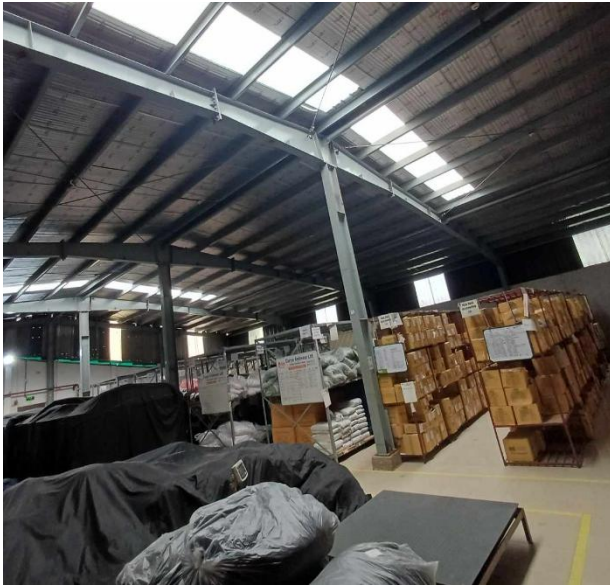
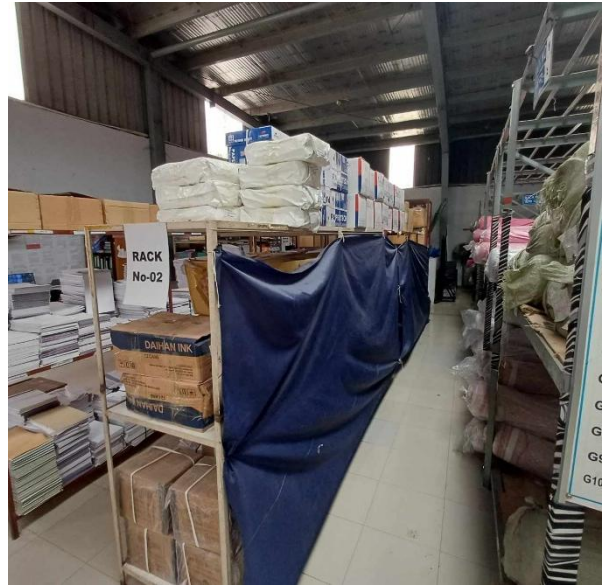
**Observation-16:** Anchorage of non-structural elements. [Shed-06]

**Description:** At the time of inspection, anchorage was missing at some storage racks. Non-structural elements suspended from, attached to, or resting atop the structure shall be adequately anchored and braced to resist earthquake forces.  
The factory is required to brace/anchor all non-structural elements.

| Item No | Observation | Action Plan | Timeline |
|---|---|---|---|
| 25. | Anchorage of non-structural elements. [Shed-06] | The factory is required to brace/anchor all non-structural elements. | within 6 weeks |

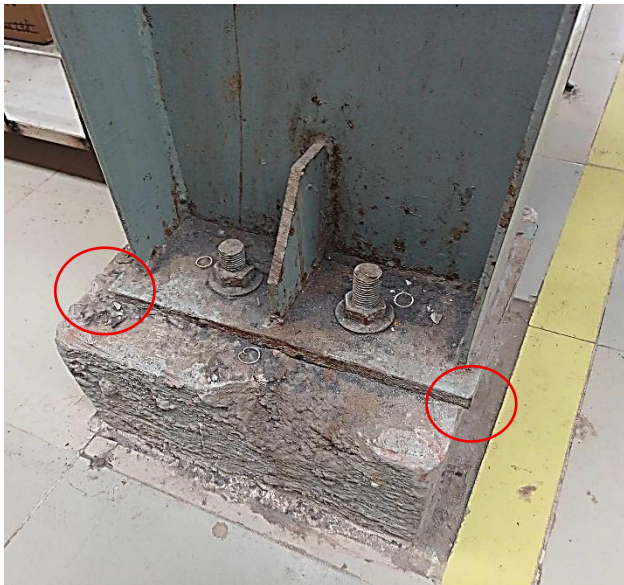
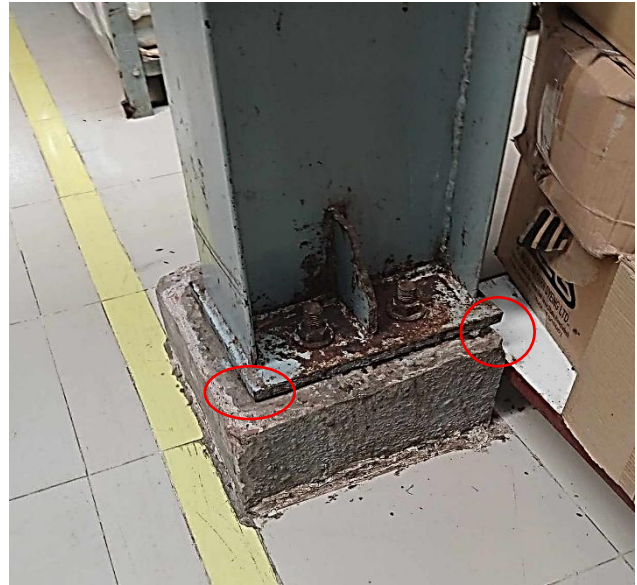
**Observation-17:** Less pedestal column support on the baseplate. [Shed-06]

**Description:** At the time of inspection, steel column baseplate was observed displaced and less support on the RC pedestal columns.  
The building engineer is required to check the adequacy of the connection of the base plate and pedestal columns.

| Item No | Observation | Action Plan | Timeline |
|---|---|---|---|
| 26. | Less pedestal column support on the baseplate. [Shed-06] | The building engineer is required to check the adequacy of the connection between the base plate and pedestal columns and submit to RSC for detailed review. | within 6 weeks |
| 27. | | Implement the recommendations after acceptance from RSC. | within 6 months |

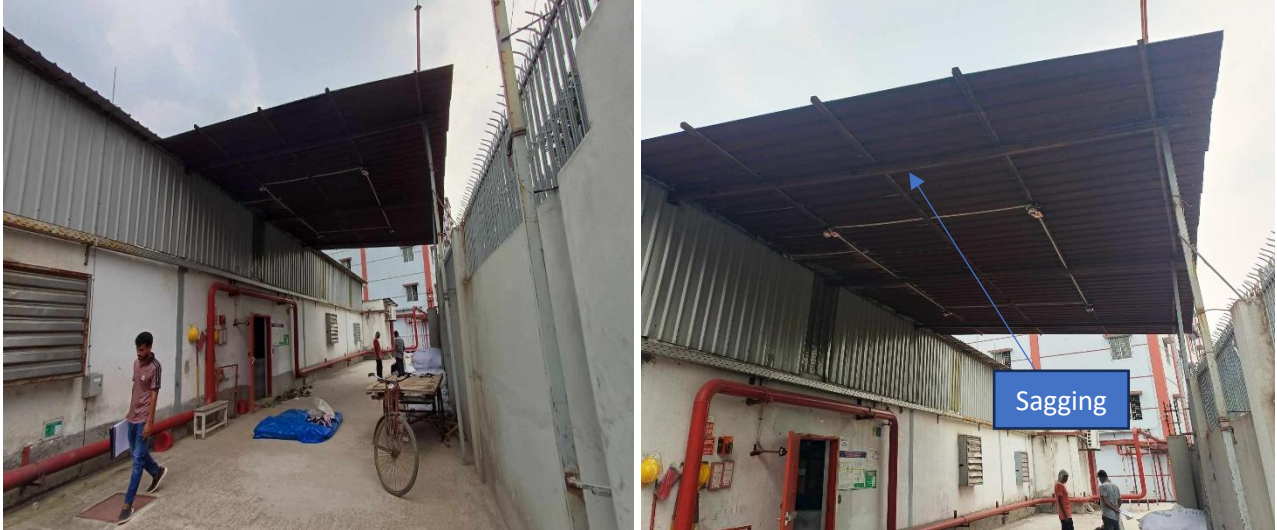
**Observation-18:** Non-engineered structure – inadequate member size, poor connection details, deflected and sagged members. [Canopy of Shed-06]

**Description:** At the time of inspection, non-engineered structural system including inadequate member size, poor connection details, deflected and sagged members were observed for the mentioned structures.

- 1) Building engineer is required to carry out Engineering Assessment (EA) to check for the member adequacy and connection details against lateral and vertical loading.
- 2) The building engineer is required to investigate the sagged and deflected members and carry out the required remedial works.

| Item No | Observation | Action Plan | Timeline |
|---|---|---|---|
| 28. | Non-engineered structure – inadequate member size, poor connection details, deflected and sagged members. [Canopy of Shed-06] | Building engineer is required to carry out engineering assessment (EA) to check the member adequacy and connection details against lateral and vertical loading. | within 6 weeks |
| 29. | | The building engineer is required to investigate the sagged and deflected members and carry out the required remedial works. | within 6 weeks |
| 30. | | Implement the recommendations of the EA after acceptance from RSC. | within 6 months |

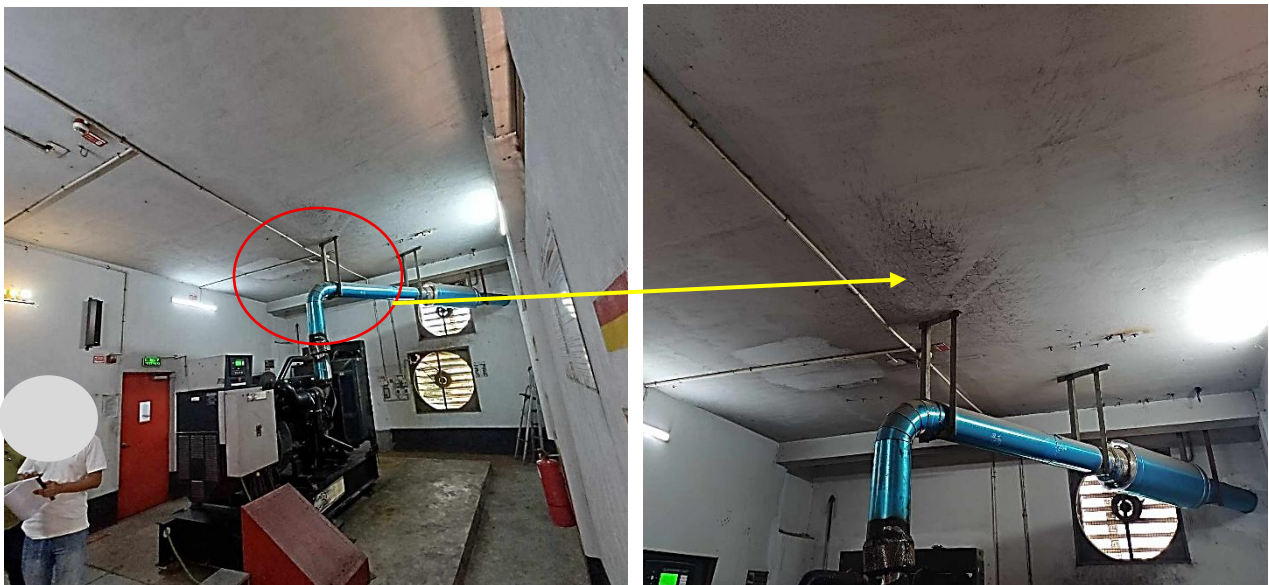
**Observation-19:** Heat damage to the roof slab. [Utility Building]

**Description:** At the time of inspection, heat damage was observed on the roof slab. The building engineer is required to investigate heat damage and carry out the required NDT including carbonation test. Prepare and submit the investigation report with remedial action to the RSC.

| Item No | Observation | Action Plan | Timeline |
|---|---|---|---|
| 31. | Heat damage to the roof slab.<br>[Utility Building] | The building engineer is required to investigate the heat damage and carry out the required NDT tests. Prepare and submit the investigation report to the RSC. | within 6 weeks |
| 32. | | Carry out the remedial works as per the recommendations of investigation report after acceptance from RSC. | within 6 months |

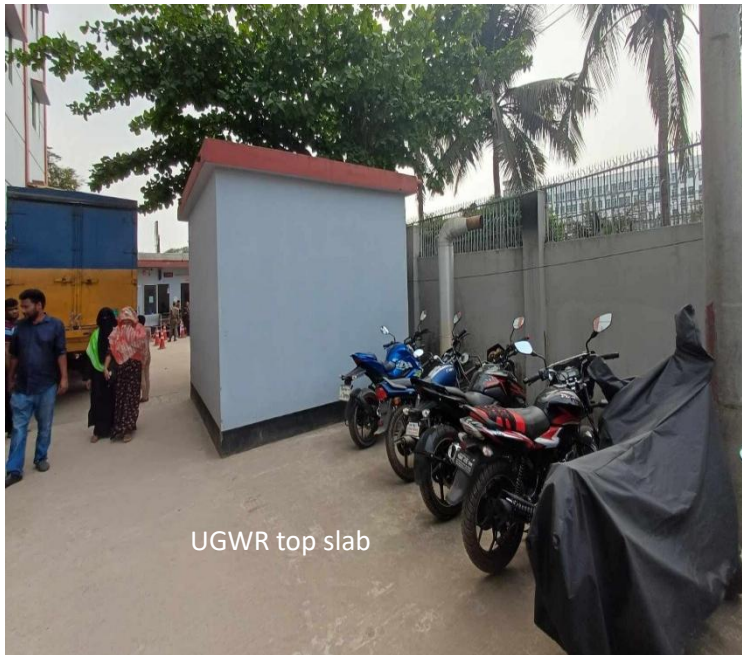
UGWR top slab

**Observation-20: Lack of design report. [Pump Room]**

**Description:** Every building or structure designed shall have its design documents prepared in accordance with the provision of Section 1.9.1. The design document shall include a design report, and a set of structural drawings, which shall be prepared in compliance with section 1.9.1.1 & section 1.9.1.2 of BNBC (part-6).

Parking was observed on the ground slab of the pump room and underground water reservoir. At the time of inspection, no design report was available for the captioned structure. The building engineer is required to prepare a set of design documents including floor load plan for parking zone in compliance with BNBC and submit to RSC for detailed review.

| Item No | Observation | Action Plan | Timeline |
|---|---|---|---|
| 33. | Lack of design report.<br>[Pump Room] | The building engineer is required to prepare a set of design documents in compliance with BNBC and submit to RSC for detailed review. | within 6 weeks |
| 34. | | Produce and actively manage a set of floor loading plan considering foundation, column and floor capacity. | within 6 weeks |
| 35. | | Implement the recommendations of the design report after acceptance from RSC. | within 6 months |

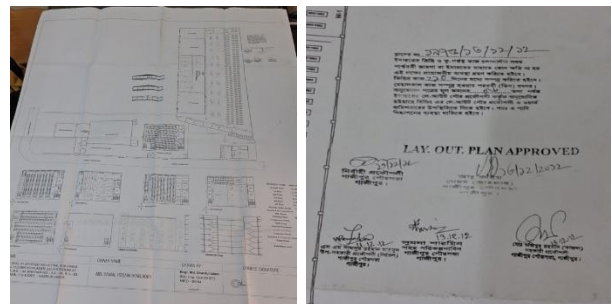
BNBC 2006: Duration of the building permit

All structure permit on December-2012

**Description:** The construction was started after 2018 for Shed-01, Shed-02, Shed-06, and Building-3. However, the building permit was taken on December-2012. So, the mentioned structures were constructed after the validity period of the building permit.

The factory is required to obtain fresh permit from the local authority, the structures shall be subjected to reassessment based on the obtained Building permit in accordance with the applicable provisions of the Code.

| Item No | Observation | Action Plan | Timeline |
|---|---|---|---|
| 36. | Validity and duration of building permit. [Shed-01, Shed-02, Shed-06, Building-3] | The factory is required to obtain fresh permit from the local authority, the structures shall be subjected to reassessment based on the obtained Building permit in accordance with the applicable provisions of the Code. | within 6 months |
