# CBM International Ltd

9 March 2026

## 1. Building Information

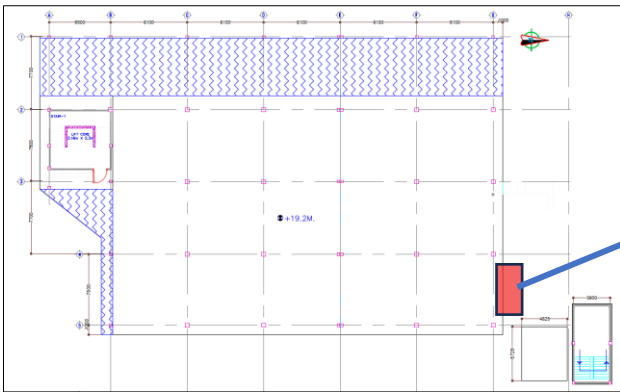
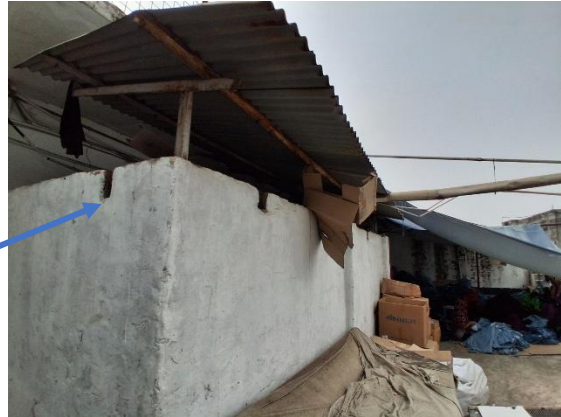
**Observation 2:** Undocumented lightweight structures on the 5<sup>th</sup> floor (Production Building).

**Description:** Undocumented lightweight extensions were observed on the 5<sup>th</sup> floor. Building engineer is required to remove the light-weight structures or revise the design documents for the whole building (including connection and member adequacy check) and submit to RSC.

| 08 | Undocumented lightweight structures on the 5 <sup>th</sup> floor (Production Building). | Building engineer is required to remove the lightweight structures or revise the design documents for the whole building (including connection and member adequacy check) and submit to RSC. | within 6 weeks |

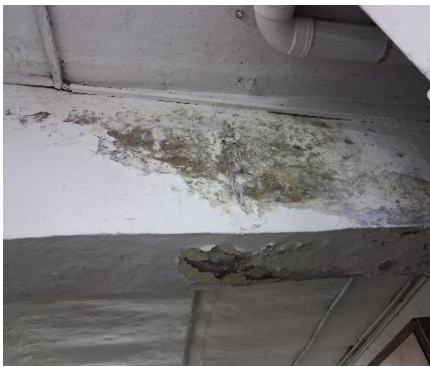
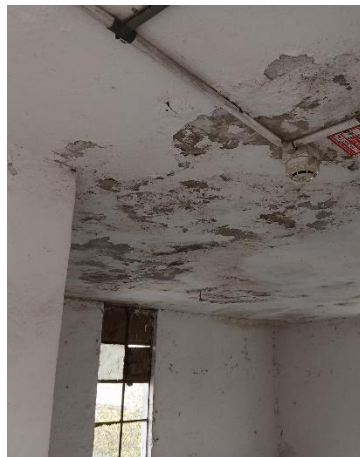
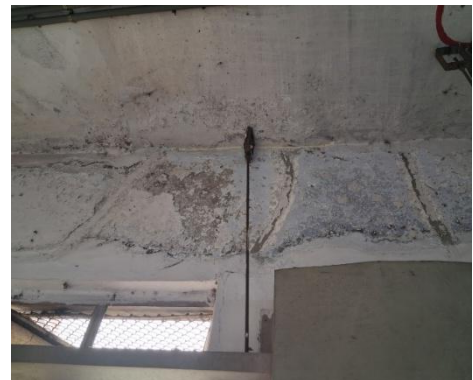
**Observation-3:** Severe dampness on beam-slab and walls (Production Building).

**Description:** Dampness was found on the beam-slab and walls in several locations of the building. Building engineer is required to investigate the source of dampness and prepare an investigation report with suitable repair methods. Carry out remedial work in accordance with the investigation report.

| 09 | Severe dampness on beam-slab and walls (Production Building). | Building engineer is required to investigate the source of dampness and prepare an investigation report with suitable repair methods. Submit the investigation report to RSC for review. | within 6 weeks |
| 10 | | Carry out remedial work in accordance with the investigation report. | within 6 weeks |

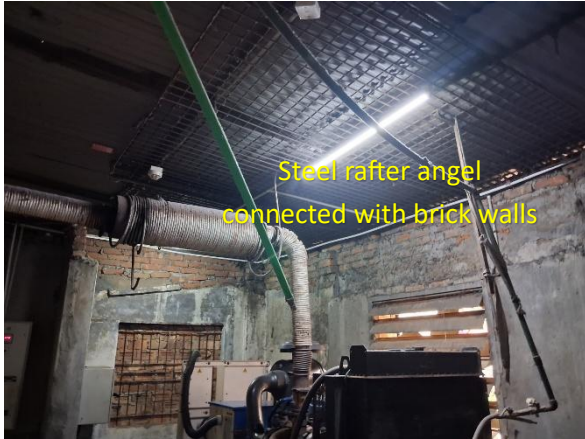
CMB Generator shed

**Observation-5:** Improper connection and missing lateral load transfer media (CMB Generator Shed, Fire Hydrant Room).

**Description:** Truss frames or steel angles are connected with brick walls. Also, lateral load transfer media (bracing & strut) were found missing. The building engineer is required to check the basic level safety for the connection & stability system for the whole structure, following the Accord Building Standard and suggest proper alternatives accordingly.

| 12 | Improper connection and missing lateral load transfer media (CMB Generator Shed). | The building engineer is required to check the basic level safety for the connection & stability system for the whole structure, following the Accord Building Standard and suggest proper alternatives accordingly. Submit the safety check report to the RSC for review. | within 6 weeks |
| 13 | | Implement remediation work as required. | within 6 months |

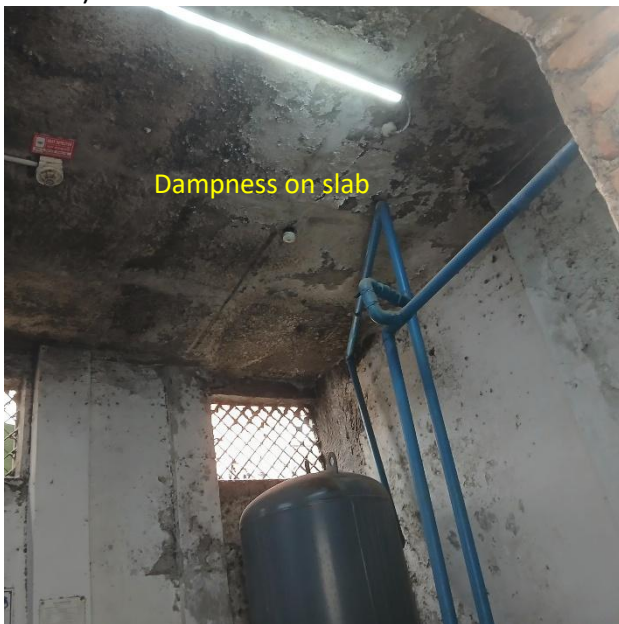
CMB Boiler Room

**Observation 6:** Dampness on the slab and cracks in the walls (CMB Boiler Room, Fire Control Room).

**Description:** Significant dampness on the slab and cracks were found on the walls. Building engineer is required to investigate the cause of dampness and repair it with a suitable method. Also, repair the cracks in the walls.

| 15 | Dampness on the slab and cracks in the walls (CMB Boiler Room). | Building engineer is required to investigate the cause of dampness and repair with a suitable method. | within 6 weeks |
