# Pioneer Casual Wear Ltd. (Extension)

10 March 2026

## Structural Inspection Report

| <b>Building-C</b> | Two storied RC building. |

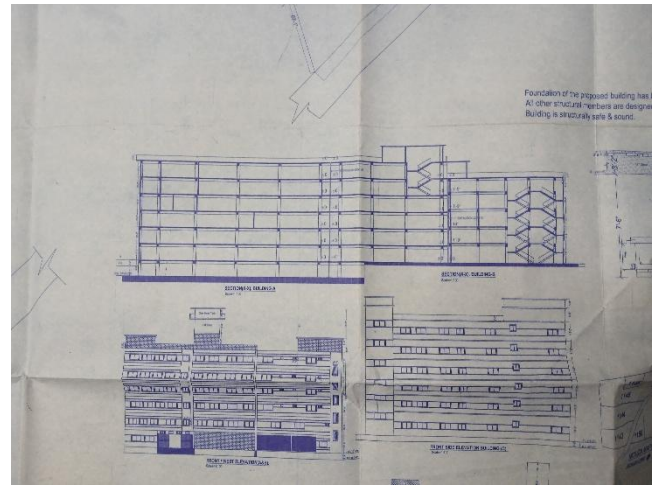
### Observation-01: Inadequate material test report, possible vertical and horizontal extension (Building C)

**Description:** During the inspection, the design report was found on-site, where concrete design strength was considered 4500 psi. 6 sets of cylinder test reports [Foundation = 3; Column = 1; Beam-Slab = 2] were available, which did not meet the frequency of testing requirements as per BNBC 2020. The building was approved for a 6-storied structure, and design documents were also prepared for 6-storied structures. The building engineer is required to address all the inconsistencies in the revised design report and submit them to RSC for detailed review.

| Item No | Observation | Action Plan | Timeline |
|---|---|---|---|
| 1. | Inadequate material test report, possible vertical and horizontal extension (Building C) | The building engineer is required to verify in-situ concrete strength by taking 4 cores (minimum) from the ground floor columns and beams confirm rebar strength. | within 6 weeks |
| 2. | | The building engineer is required to revise the design report and submit it to RSC for review. | within 6 months |
| 3. | | Prepare a design report considering the proposed extension prior to any future extension work | within 6 weeks |
| 4. | | Implement remediation work (if required) after acceptance from RSC. | within 6 months |

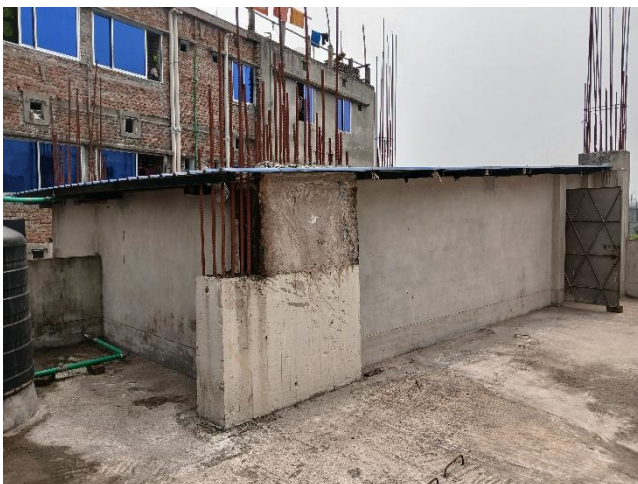
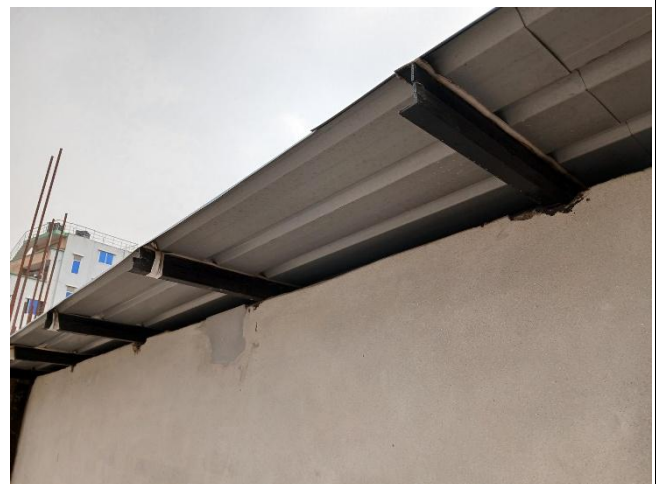
### Observation-02: Non engineering roofing system on steel stair top with poor connection. (Building C)

**Description:** Non engineering roofing system on steel stair top with poor connection. Building engineer is required to check the connection and member adequacy as part of EA and transform it into an engineered roofing system.

| Item No | Observation | Action Plan | Timeline |
|---|---|---|---|
| 5. | Non engineering roofing system on steel stair top with poor connection. (Building C) | Building engineer is required to check the connection and member adequacy as part of EA and transform it into an engineered roofing system. | within 6 weeks |
| 6. | | Implement remediation work (if required) after acceptance from RSC. | within 6 months |

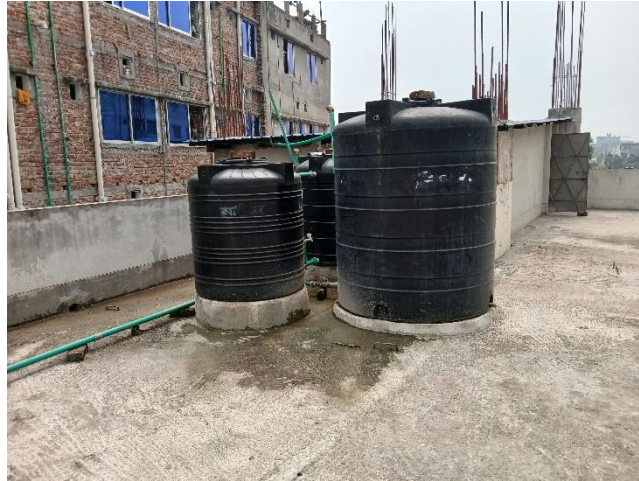
**Observation-03:** Nonstructural elements found not anchored/braced (Building C).

**Description:** Nonstructural elements (PVC tanks on roof) were found not anchored/braced. The building engineer is required to anchor/brace all nonstructural elements within the factory.

| Item No | Observation | Action Plan | Timeline |
|---|---|---|---|
| 7. | Non-structural elements found unbraced / unanchored. (Building C) | The building engineer is required to brace/anchor all non-structural elements. | within 6 months |

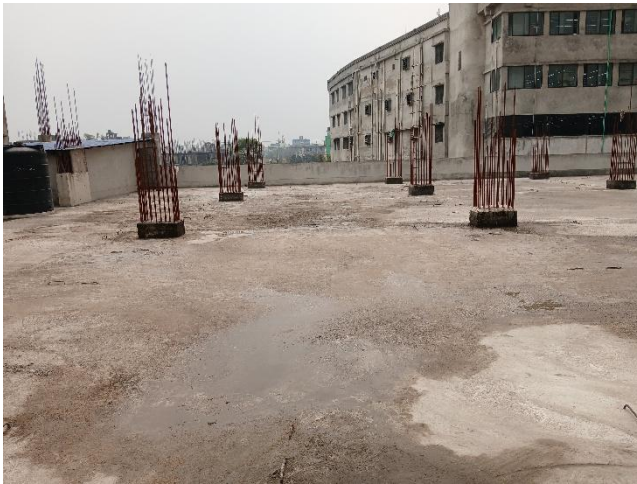
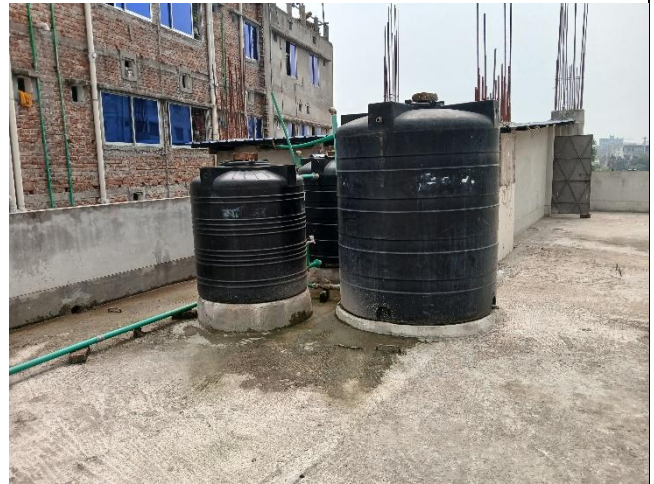
**Observation-04:** Sign of water ponding on roof (Building C).

**Description:** During inspection, signage of water ponding on roof was observed. Building engineer is required to remove stagnant water and improve the drainage system.

| Item No | Observation | Action Plan | Timeline |
|---|---|---|---|
| 8. | Sign of water ponding on the roof (Building C). | Building engineer is required to remove stagnant water and improve the drainage system. | within 6 months |

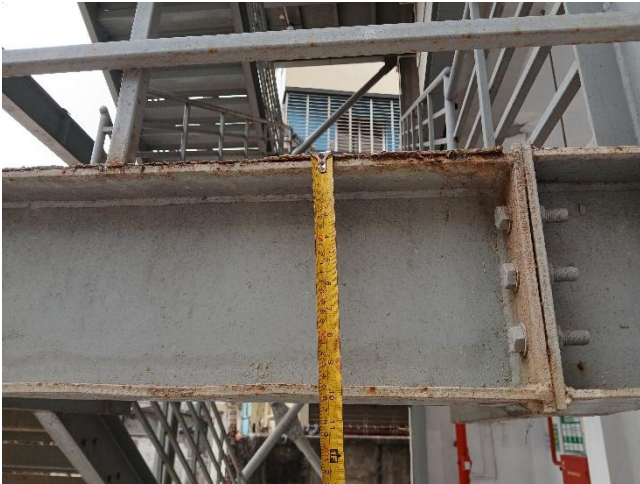
**Observation-05:** Mismatches in as-built drawings. (Steel stair)

**Description:** During inspection, MB01 was found W: 300x6; F: 145X8 which was shown in drawing W: 250x6; F: 145X8. Building engineer is required to prepare full set of as-built drawings as per onsite condition.

| Item No | Observation | Action Plan | Timeline |
|---|---|---|---|
| 9. | Mismatches in as-built drawings. (Steel stair) | Building engineer is required to survey the whole structure and prepare as-built structural drawings with complete structural details. | within 6 weeks |

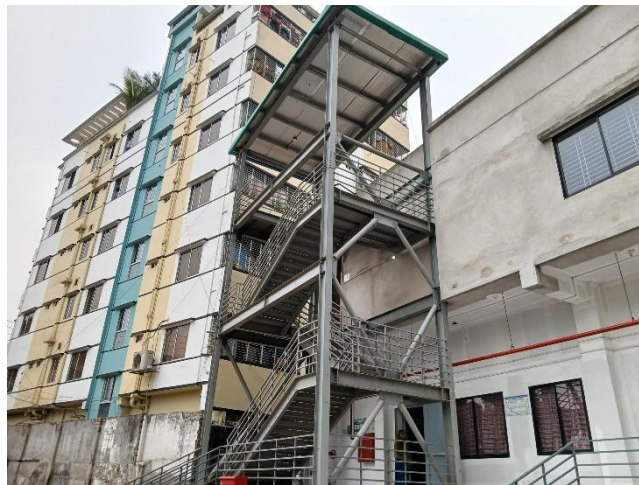
Steel stair

**Observation-06:** Absence material test report and design documents. (Steel stair)

**Description of observation:** As per BNBC, every building or structure designed shall have its design documents prepared in accordance with the provision of Section 1.9.1. The design document shall include a design report, and a set of structural drawings, material test report which shall be prepared in compliance with section 1.9.1.1 and section 1.9.1.2 as per BNBC. At the time of inspection, design report, material test report were not available which is required to be prepared in compliance with section 1.9.1.1 (part-6, BNBC).

| <b>10.</b> | Absence of material test report and design documents. (Steel stair) | Verify in-situ material strength and steel member strength by the plate test report to confirm tensile strength. | within 6 weeks |
| <b>11.</b> | | The building engineer is required to prepare the design report and submit it to RSC for review. | within 6 weeks |
| <b>12.</b> | | Implement remediation work (if required) after acceptance from RSC. | within 6 months |

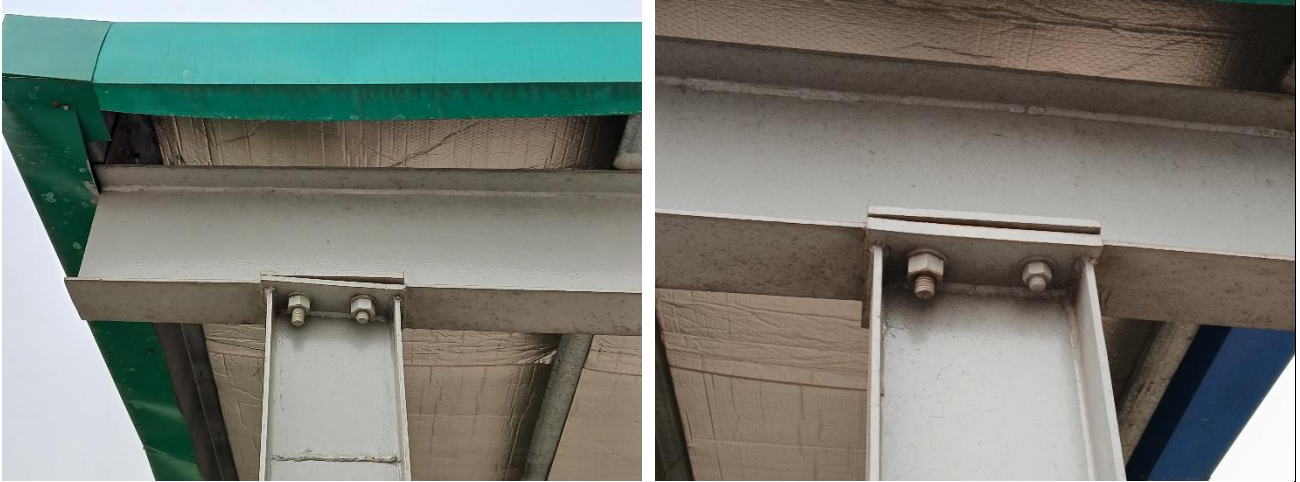
**Observation-07: Steel connection gaps (steel stair)**

**Description:** During inspection, connection gaps were observed in steel stairs. Building engineer is required to fill up all the connections with shim plates.

| <b>13.</b> | Steel connection gaps (steel stair) | Building engineer is required to fill up all the connections with shim plates. | within 6 weeks |
