# JERICO IMEX LTD. (Extention 2)

Dag no# 1726 & 856, Montree bari road, south shaln, Shalna bazar, Gazipur-1703

15 April 2026

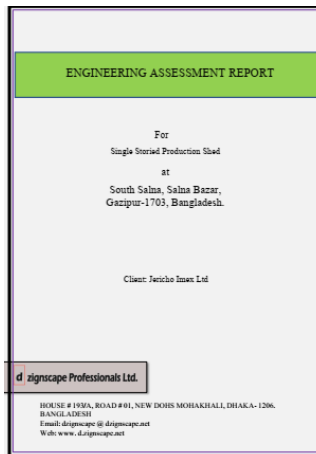
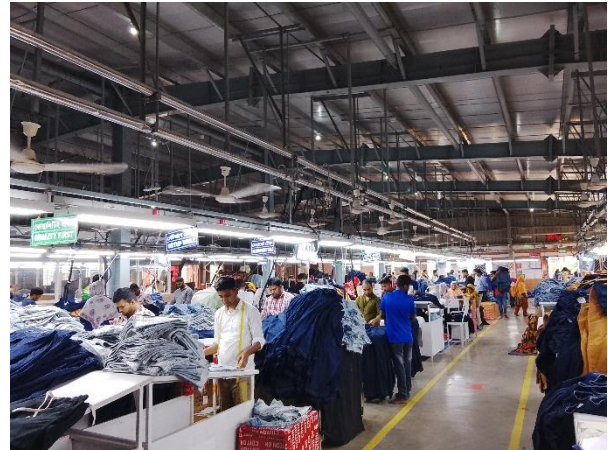
### Observation-01: Inconsistencies in design documents. (Finishing Shed).

**Description:** The determination of soil site classification along with seismic design category is missing in EA report, seismic compactness is not provided for all types of steel members and connection adequacy checks are missing for many of the joints. Additionally structural system and seismic parameters and detailing are missing for the RC parts.

Building engineer is required to update the EA documents and submit to RSC to review the against lateral loading in compliance with BNBC 2020.

| Item No | Observation | Action Plan | Timeline |
|---|---|---|---|
| 1. | Inconsistencies in design documents. (Finishing Shed). | Building engineer is required to update the EA document and submit to RSC for further review. | within 6 weeks |
| 2 | Inconsistencies in design documents. (Finishing Shed). | Carry out the remedial works if required | within 6 months |

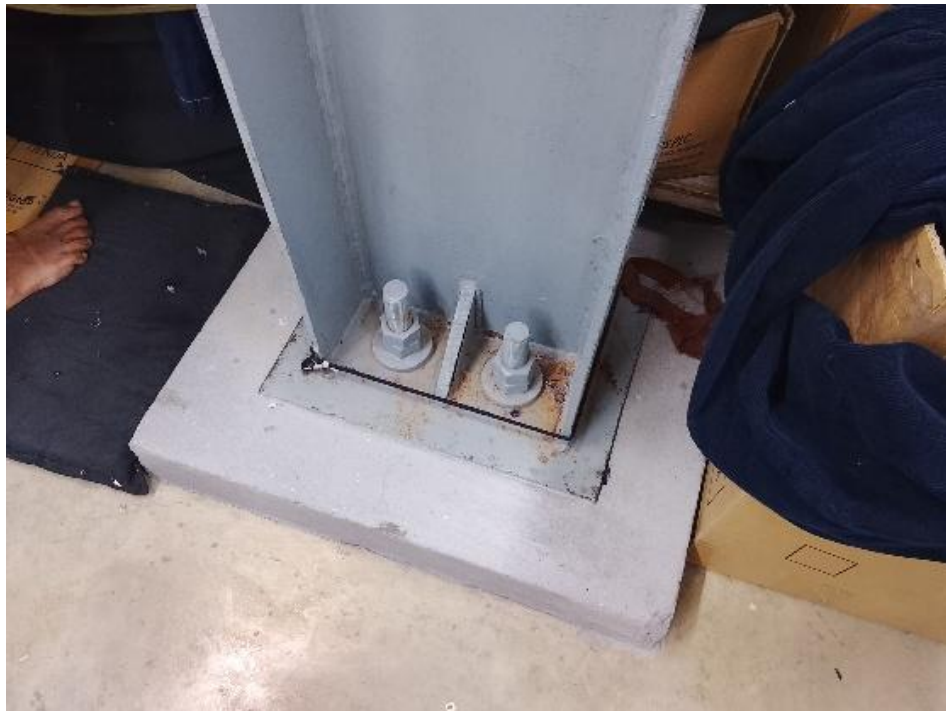
### Observation-02: Appearance of corrosion in steel section. (Finishing Shed).

**Description:** Appearance of corrosion observed at the bottom of steel columns during inspection. The building engineer is required to carry out periodic maintenance and implement necessary corrective measures to prevent further progression of the corrosion.

| Item No | Observation | Action Plan | Timeline |
|---|---|---|---|
| 3 | Appearance of corrosion in steel section. (Finishing Shed). | The factory engineer needs to take necessary corrective measures to repair the corrosion, observed and ensure regular maintenance. | within 6 weeks |

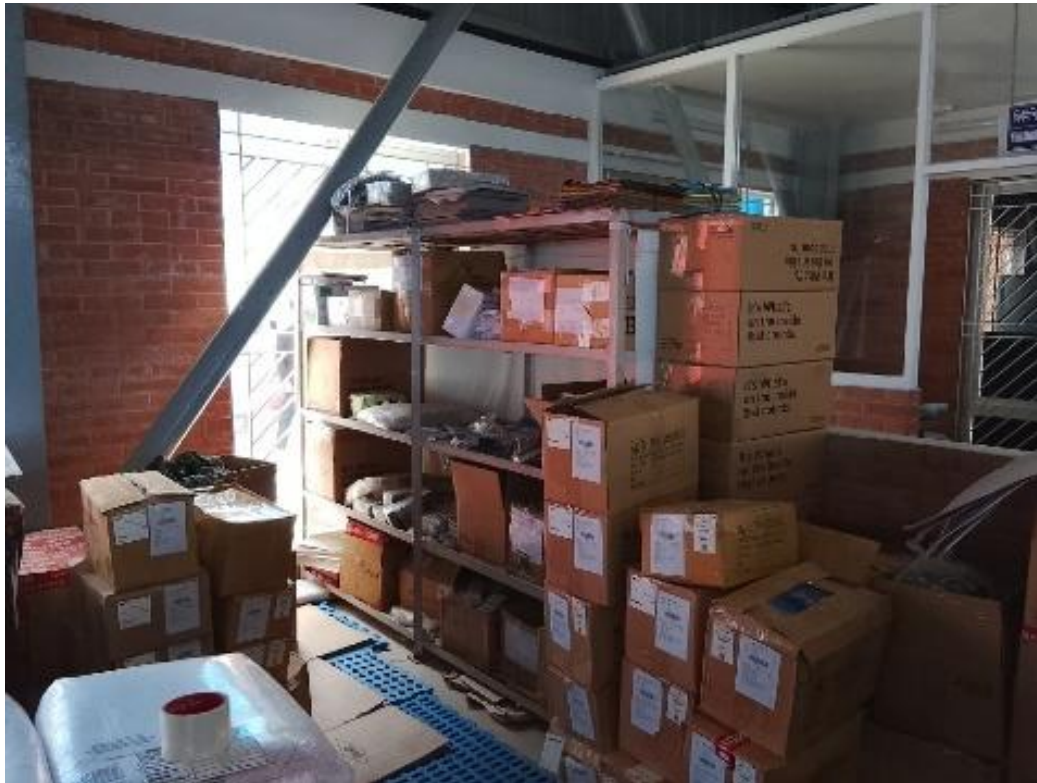
**Observation-03:** Lack of anchorage in non-structural elements. (Finishing Shed).

**Description:** Unanchored racks observed on the production floor. The building engineer is required to provide adequate anchorage to those racks to provide stability.

| Item No | Observation | Action Plan | Timeline |
|---|---|---|---|
| 4 | Lack of anchorage in non-structural elements. (Finishing Shed). | The factory engineer is required to brace/anchor all non-structural elements. | within 6 weeks |

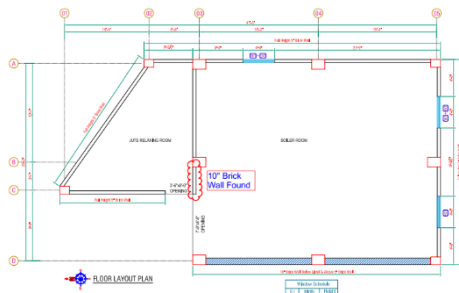
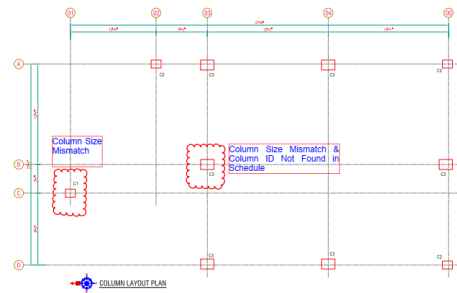
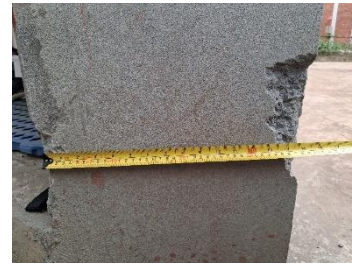
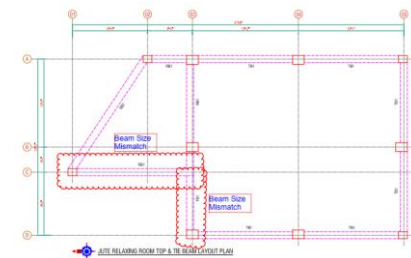
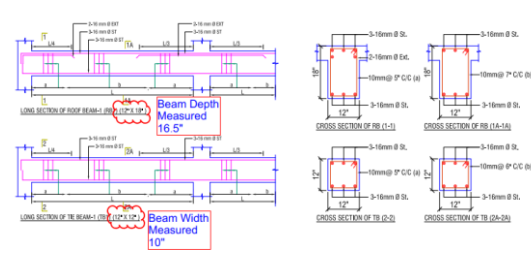
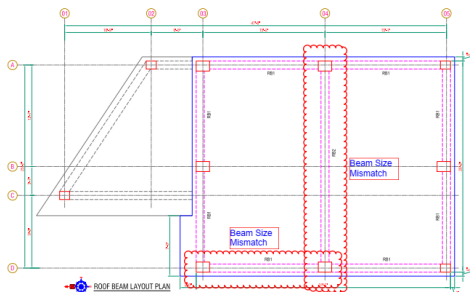
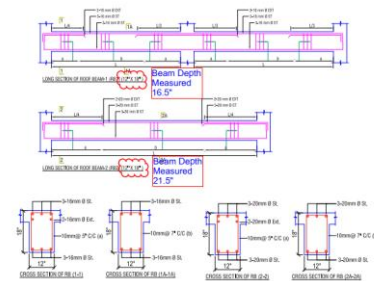
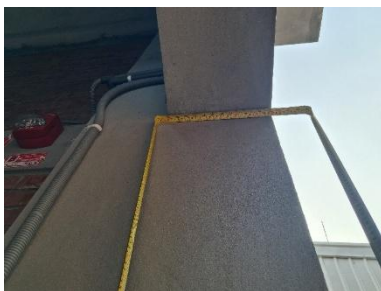
**Observation-04:** Mismatch found in-between provided as-built drawing and actual site condition. (Boiler Building).

Column ID C3 is Missing

**Description:** Mismatch in between as-built drawings and actual site condition observed in multiple locations. E.g. 10"thick brick wall observed in floor layout plan at grid 3-B~C, but 5" wall is shown in the as-built drawing. Column size mismatch observed in C1 and C3 column. In addition, C3 ID was missing in the column schedule in as-built drawing. Beam size mismatch found in Beam ID RB1, RB2 And TB1 at different locations.

The building engineer is required survey the whole structure and address all the discrepancies in the as-built drawing and correct it accordingly.

| Item No | Observation | Action Plan | Timeline |
|---|---|---|---|
| 5 | Mismatch found in-between provided as-built drawing and actual site condition. (Boiler Building). | The building engineer is required to survey the full structure, update the as-built drawings, and submit them to RSC. | within 6 weeks |

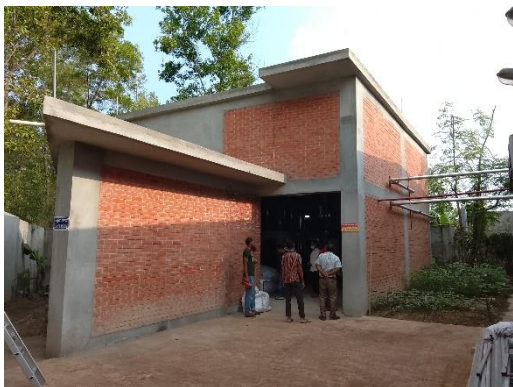
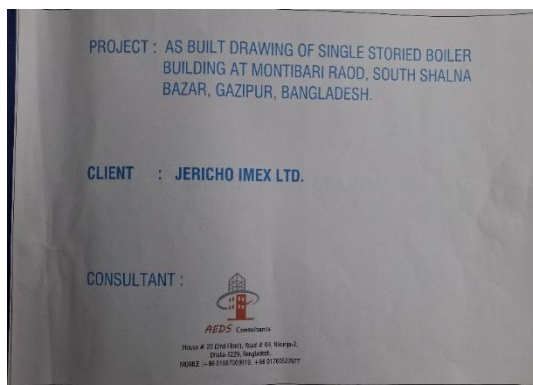
**Observation-05: Lack of design documents. (Boiler Building).**

**Description:** A set of as-built architectural and structural drawings was provided during the inspection. However, the building engineer is required to perform engineering assessment in accordance with BNBC 2020 and EA documents need to be submitted to RSC for review.

| Item No | Observation | Action Plan | Timeline |
|---|---|---|---|
| 6 | Lack of design documents. (Boiler Building). | The building engineer is required to prepare Engineering Assessment (EA) report following BNBC-2020 and submit to RSC for review | within 6 weeks |
| 7 | Lack of design documents. (Boiler Building). | Carry out the remedial works if required | within 6 months |

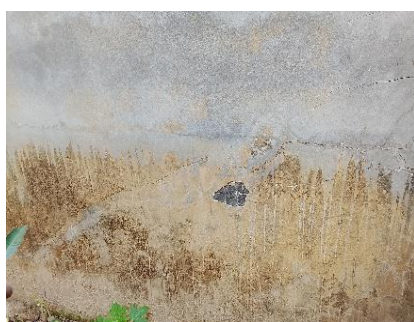
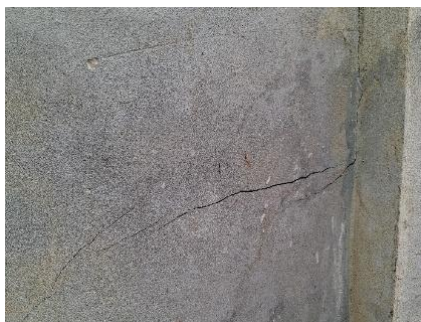
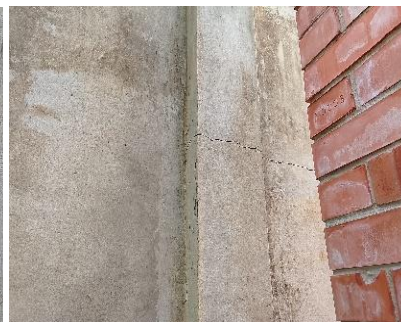
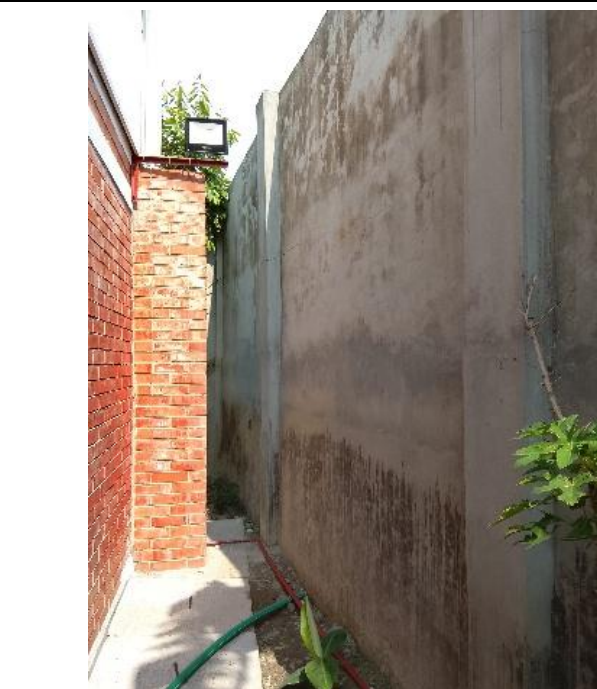
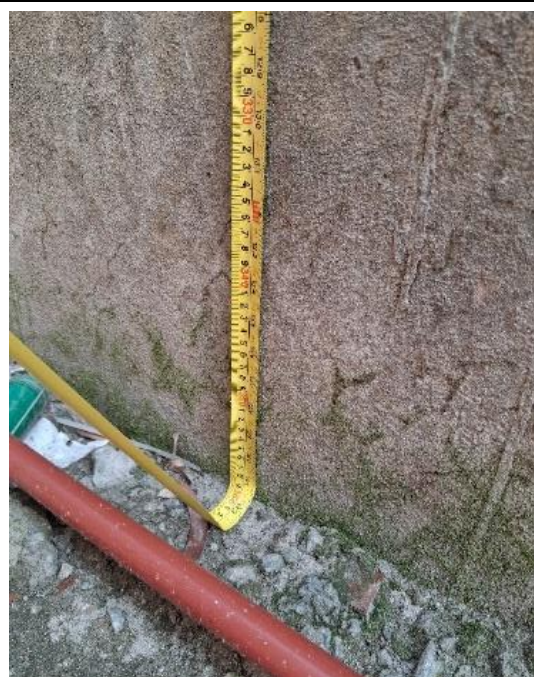
**Observation-06: Crack observed in Boundary wall.**

**Description:** Diagonal and horizontal cracks were observed at multiple locations on the boundary wall at sound side of the Finishing shed and back side of the Boiler building. The height of the wall was measured around 12 feet. The building engineer is required to investigate the cause of the cracks and implement appropriate remedial measures accordingly.

| Item No | Observation | Action Plan | Timeline |
|---|---|---|---|
| 8 | Crack observed in Boundary wall | The building engineer is required to investigate the cause of the cracks and implement appropriate remedial measures accordingly. | within 6 weeks |

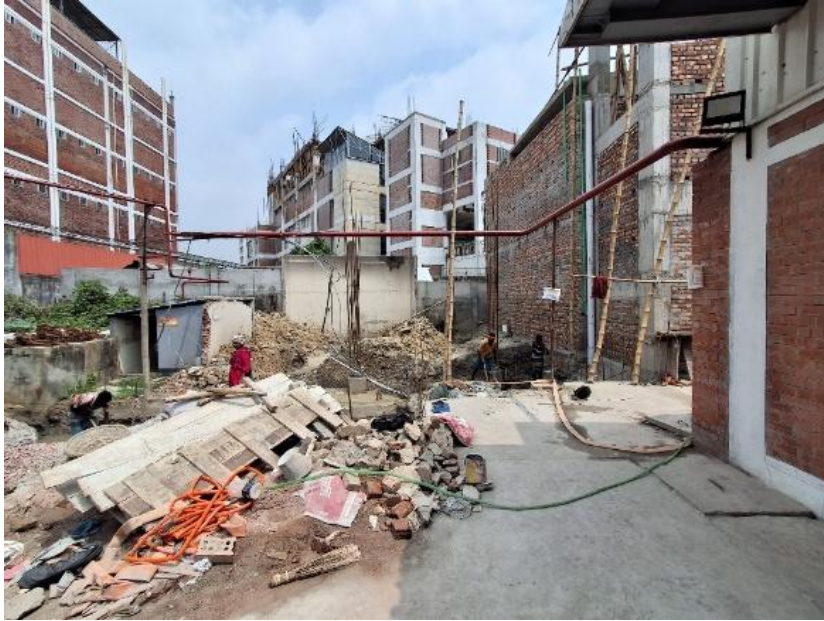
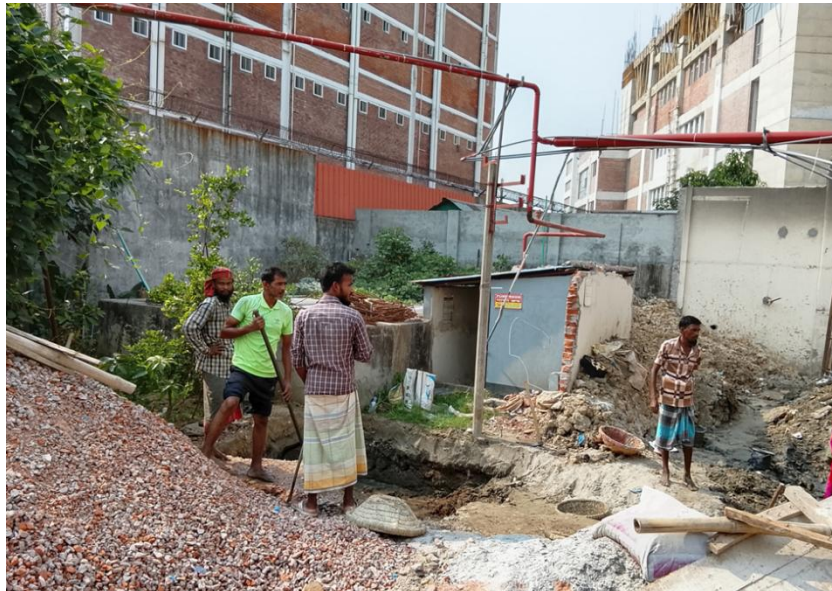
**Observation-07:** Lack of construction safety precaution. (Under Construction Building)

**Description:** Under-construction site was observed within the factory premises, which were not adequately secured to restrict worker access. Also, the construction worker were not following the construction safety precautions like PPE, safety shoes etc.

The safety engineer is required to ensure proper separation of the construction area to prevent unauthorized entry and ensure all the construction safety precautions following BNBC-2020 (Part-VII; Ch-3).

| Item No | Observation | Action Plan | Timeline |
|---|---|---|---|
| 9 | Lack of construction safety precaution (Under Construction Building) | The construction safety engineer is required to enforce construction safety practices and secure the site to prevent unauthorized access and accidents and ensure all the construction safety precautions following BNBC-2020 (Part-VII; Ch-3). | Immediate |
