# SQ Celsius Limited (Unit 04)

Plot No CS 224, 225, 242 & 243 Jamirdia, Bhaluka, Mymensingh

29 April 2026

## 2. Observation

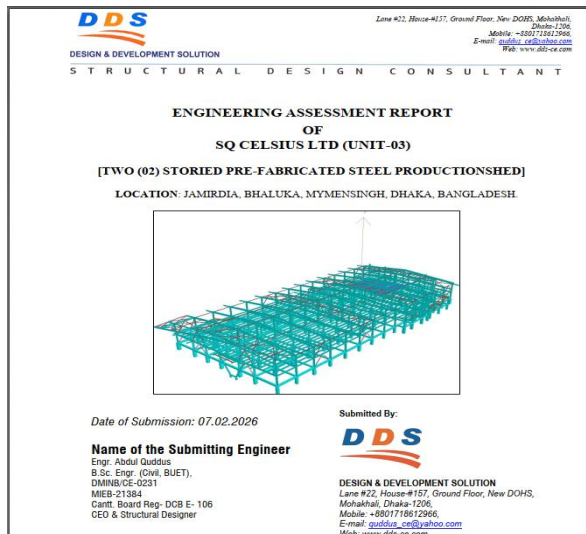
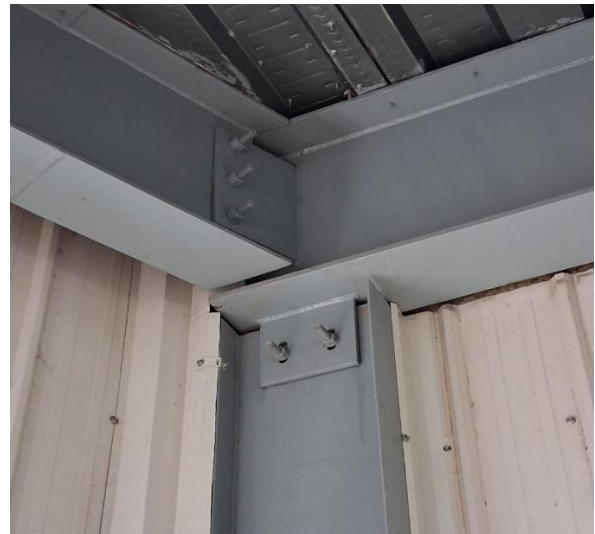
### Observation-01: Inconsistency in design report and design philosophy. [Production Building]

**Description:** In the design report, the calculation for the frequency of testing as per BNBC 5.12.1 is not incorporated. In addition, inconsistency between connection design philosophy and the actual connection arrangement at the north-side end grid steel connection. Column discontinued to rafter bottom flange and a visible gap was found between the steel column and the rafter connection plate/interface, which may affect the intended load transfer mechanism, connection behavior, and overall structural integrity of the connection system.

- 1) Building engineer is required to review the design report, incorporating the calculation on the requirements of frequency of testing as per BNBC section 5.12.1.
- 2) Building engineer is required to review the connection details of the north side end grid and the design philosophy of the connections.

Submit the updated design documents to RSC for detailed review.

| Item No | Observation | Action Plan | Timeline |
|---|---|---|---|
| 1. | Inconsistency in design report and design philosophy. [Production Building] | Building engineer is required to review the design report, incorporating the calculation on the requirements of frequency of testing as per BNBC section 5.12.1. | within 6 weeks |
| 2. | | Building engineer is required to review the connection details of the north side end grid and the design philosophy of the connections. | within 6 weeks |
| 3. | | Carry out remedial work if required. | within 6 months |

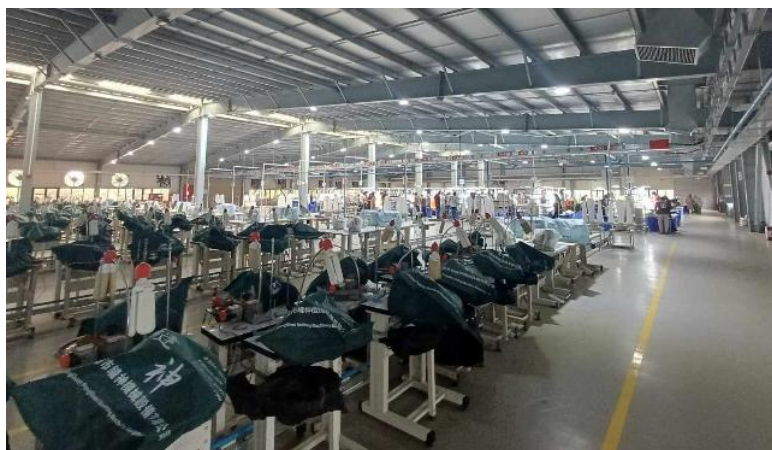
### Observation-02: Missing load plan on the floor. [Production Building]

**Description:** During the inspection, the load plan was not found posted on the floors. The factory is required to post the load plan and implement the floor load management system.

| Item No | Observation | Action Plan | Timeline |
|---|---|---|---|
| 4. | Missing load plan on the floor. [Production Building] | The factory is required to post the load plan and implement the floor load management system. | within 6 weeks |

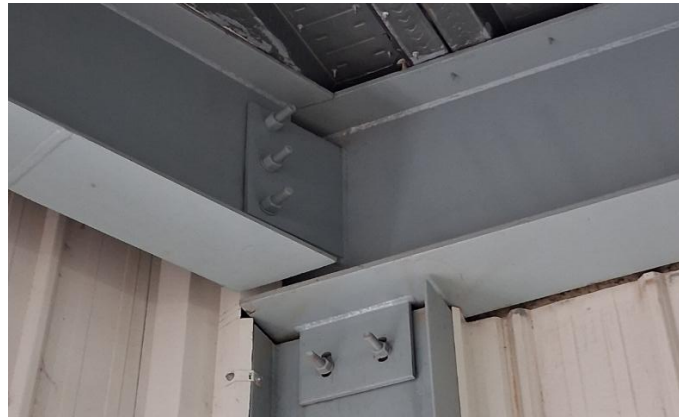
**Observation-03:** Enlarged slot holes and gap between column-rafter joints. [Production Building]

**Description:** During the inspection, enlarged slot holes and gaps between column-rafter joints at the north side end of the grid. The factory is required to repair the connection gaps with a suitable method.

| Item No | Observation | Action Plan | Timeline |
|---|---|---|---|
| 5. | Enlarged slot holes and gap between column-rafter joints. [Production Building] | The factory is required to repair the connection gaps with a suitable method. | within 6 weeks |

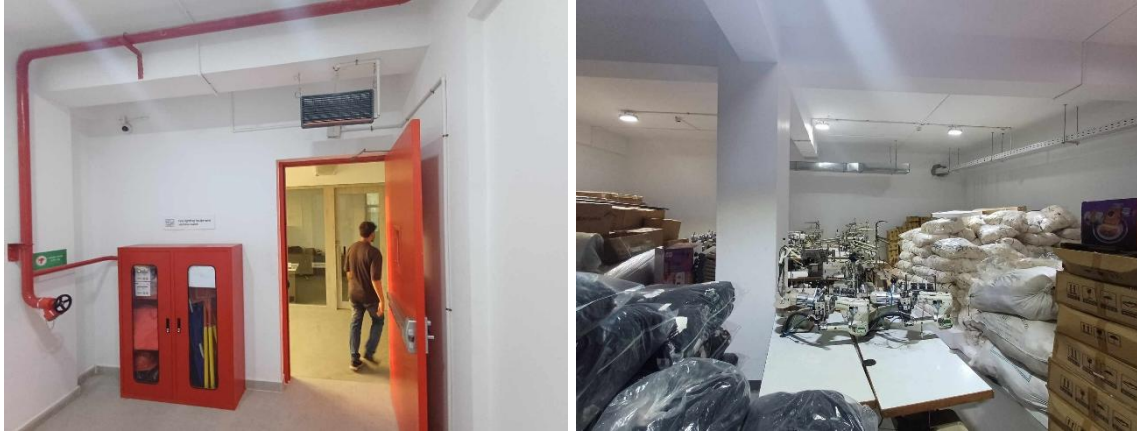
**Observation-05: Missing load plan on the floor. [Annex Building]**

**Description:** During the inspection, the load plan was not found posted on the floors. The factory is required to post the load plan and implement the floor load management system.

| Item No | Observation | Action Plan | Timeline |
|---|---|---|---|
| 9. | Missing load plan on the floor. [Annex Building] | The factory is required to post the load plan and implement the floor load management system. | within 6 weeks |

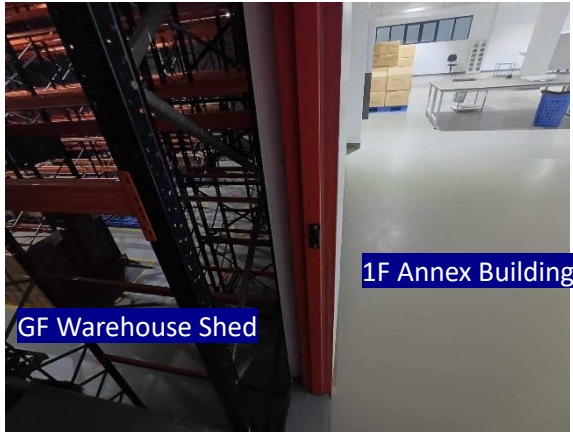
**Observation-06: Falling Hazard. [Annex Building]**

No fall protection at the 1F level

**Description:** Possible falling hazards were observed at the 1F and GF.

The factory is required to implement fall protection on the proposed operation passage with the warehouse shed. Also, provide fall protection on the loading-unloading area.

| Item No | Observation | Action Plan | Timeline |
|---|---|---|---|
| 10. | Falling Hazard.<br>[Annex Building] | The factory is required to implement fall protection on the proposed operation passage with the warehouse shed. Also, provide fall protection on the loading-unloading area. | within 6 weeks |

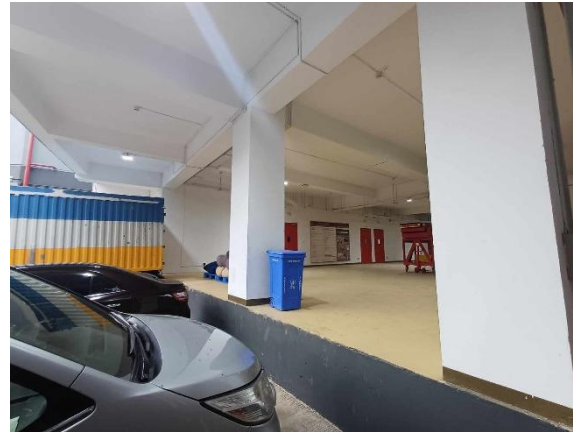
No fall protection at the loading-unloading zone

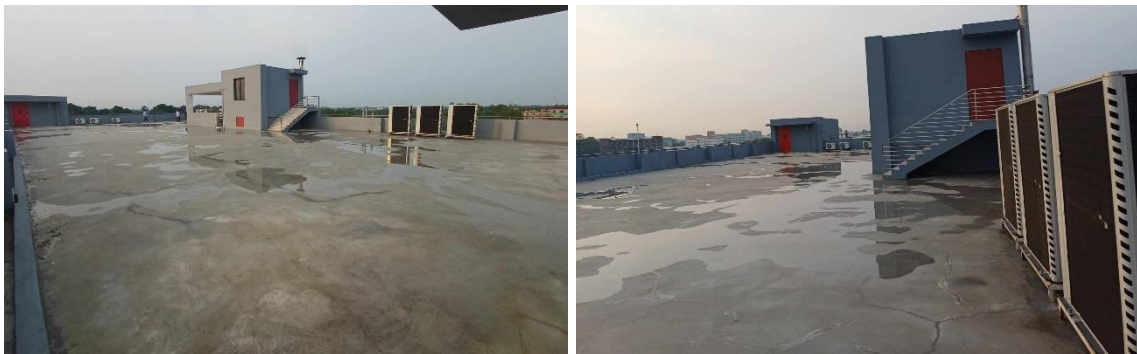
**Observation-07: Stagnant water on the roof. [Annex Building]**

**Description:** Stagnant water was observed on the roof. The factory is required to improve the drainage slope on the roof.

| Item No | Observation | Action Plan | Timeline |
|---|---|---|---|
| 11. | Stagnant water on the roof.<br>[Annex Building] | The factory is required to improve the drainage slope on the roof. | within 6 weeks |

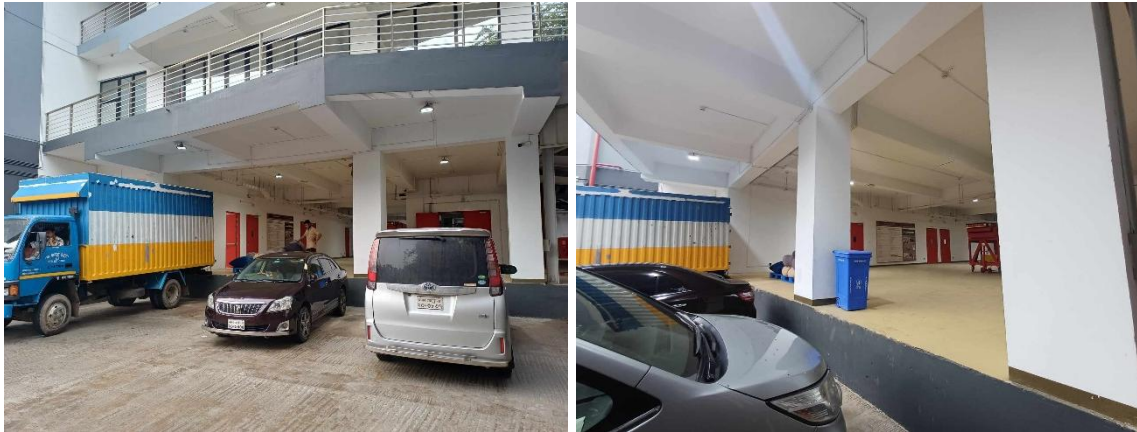
**Observation-08:** Column susceptible to vehicle impact. [Annex Building]

**Description:** Possible vehicle impact was observed on the loading-unloading zone. The factory is required to provide vehicle impact protection on the ground floor columns.

| Item No | Observation | Action Plan | Timeline |
|---|---|---|---|
| 12. | Column susceptible to vehicle impact. [Annex Building] | The factory is required to provide vehicle impact protection on the ground floor columns. | within 6 weeks |

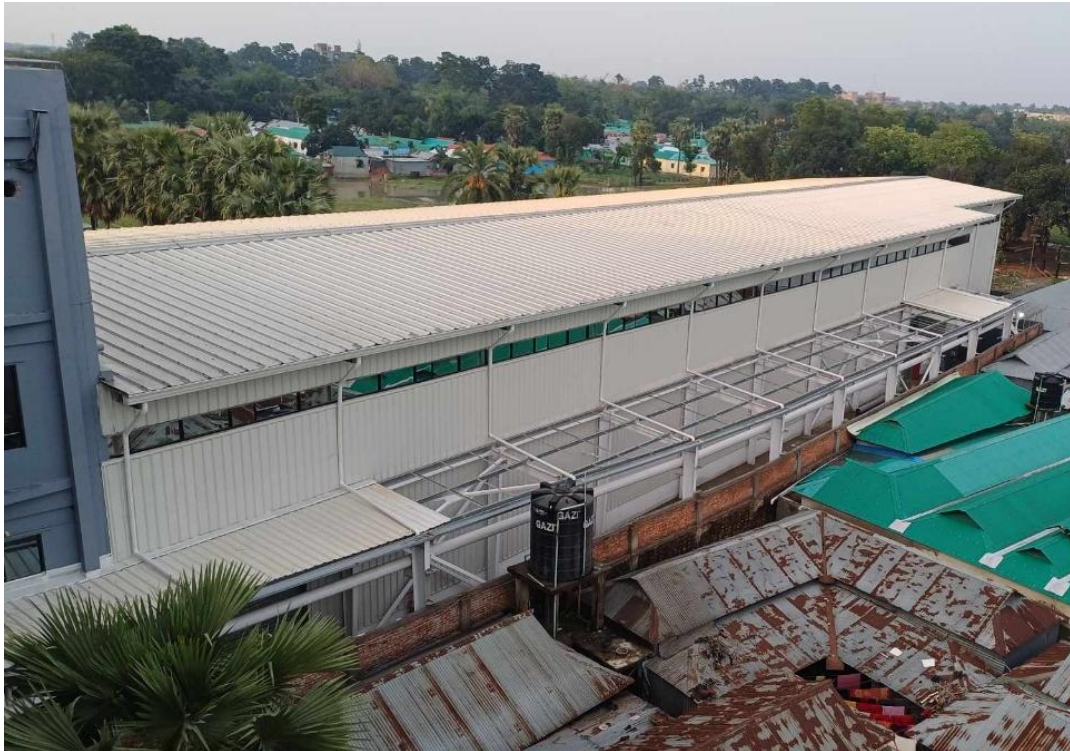
**Observation-09:** Review requirements for the lateral loading. [Warehouse Shed; Canopy Shed]

**Description:** A design report has been prepared for the structures. The prepared design report needs to be reviewed against lateral forces. The building engineer is required to submit the design report to the RSC for detailed review.

| Item No | Observation | Action Plan | Timeline |
|---|---|---|---|
| 13. | Review requirements for the lateral loading.<br>[Warehouse Shed] | The building engineer is required to submit the design report to the RSC for detailed review. | within 6 weeks |
| 14. | | Carry out remedial work if required. | within 6 months |
| 17. | Review requirements for the lateral loading. [Canopy Shed] | The building engineer is required to submit the design report to the RSC for detailed review. | within 6 weeks |
| 18. | | Carry out remedial work if required. | within 6 months |

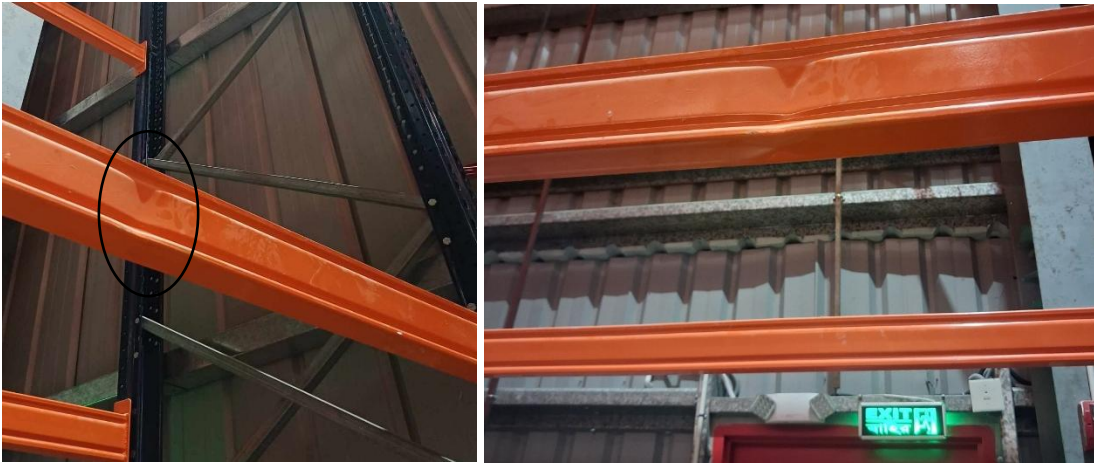
**Observation-10:** Damaged rack member. [Warehouse Shed]

**Description:** During the inspection, a rack member was found damaged. The factory is required to Repair the damaged rack member with a suitable method or replace it if required.

| Item No | Observation | Action Plan | Timeline |
|---|---|---|---|
| 15. | Damaged rack member.<br>[Warehouse Shed] | Repair the damaged rack member with suitable method or replace it if required. | within 6 weeks |

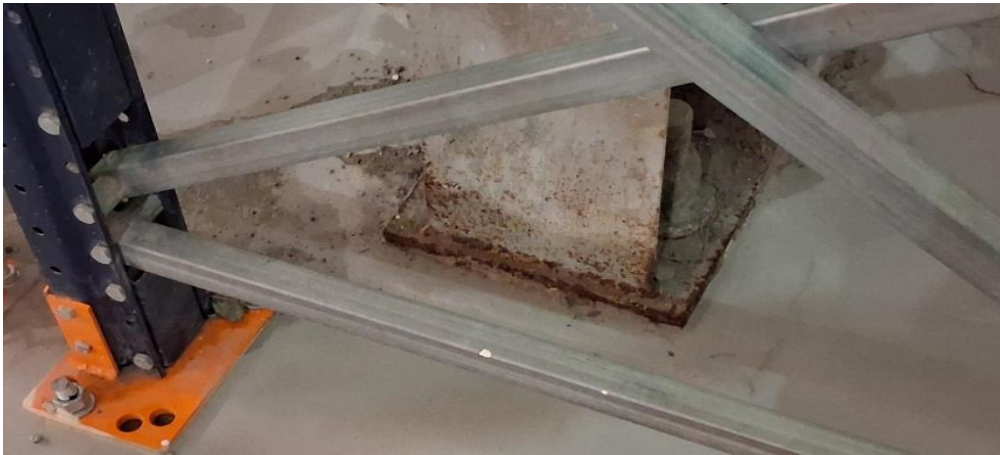
**Observation-11:** Rust on the steel member. [Warehouse Shed]

**Description:** Rust was observed on the steel members. The factory is required to remove rust and provide anti-rust proofing.

| Item No | Observation | Action Plan | Timeline |
|---|---|---|---|
| 16. | Rust on the steel member.<br>[Warehouse Shed] | The factory is required to remove rust and provide anti-rust proofing. | within 6 weeks |

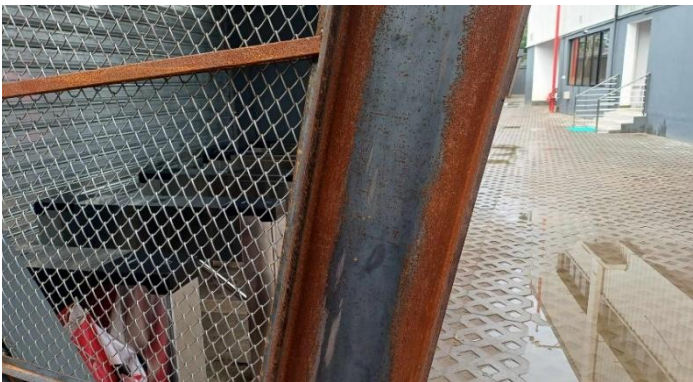
Security Gate 1

**Observation-12:** Corrosion on the steel member. [Security Gate 1 and 2]

**Description:** During the inspection, rust was observed on the steel members. The factory is required to remove rust and provide anti-rust proofing.

| Item No | Observation | Action Plan | Timeline |
|---|---|---|---|
| 19. | Rust on the steel member.<br>[Security Gate 1] | The factory is required to remove rust and provide anti-rust proofing. | within 6 weeks |
