# Aptech Caswire (Extension) Ltd.

21 April 2026

## Structural Inspection Report

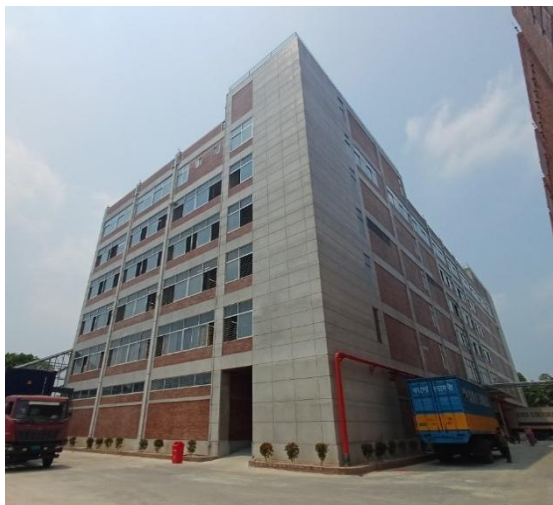
### Observation-01: Lack of Design Report (Warehouse Building)

**Description:** At the time of inspection, the design report for this building was not available on site. Additionally, irregularity in stiffness observed in the building as ground to 4<sup>th</sup> floor is beam column frame and 5<sup>th</sup> floor is column-flat plate slab system.

Moreover, number of cylinder test report for column and beam-slab was found inadequate. Building engineer is required to verify the in-situ concrete strength by taking 100 mm diameter concrete cores (minimum 4 no's) from the lower tier columns and from beams.

Based on the in-situ material strength, the building engineer is required to prepare the Engineering Assessment (EA) in compliance with section 1.9.1.1 and section 1.9.1.2, part-6 of BNBC which includes vertical and horizontal irregularity checks.

| Item No | Observation | Action Plan | Timeline |
|---|---|---|---|
| 1. | Lack of Design Report (Warehouse Building) | The building engineer is required to prepare the design report as per 1.9.1 BNBC which includes vertical & horizontal irregularity checks and submit it to RSC for detailed review. | within 6 weeks |
| 2. | Lack of Design Report (Warehouse Building) | Building engineer is required to verify the in-situ concrete strength by taking 100 mm diameter concrete cores (minimum 4 no's) from the lower tier columns and from beams. | within 6 weeks |
| 3. | Lack of Design Report (Warehouse Building) | Implement remediation work if required. | within 6 months |

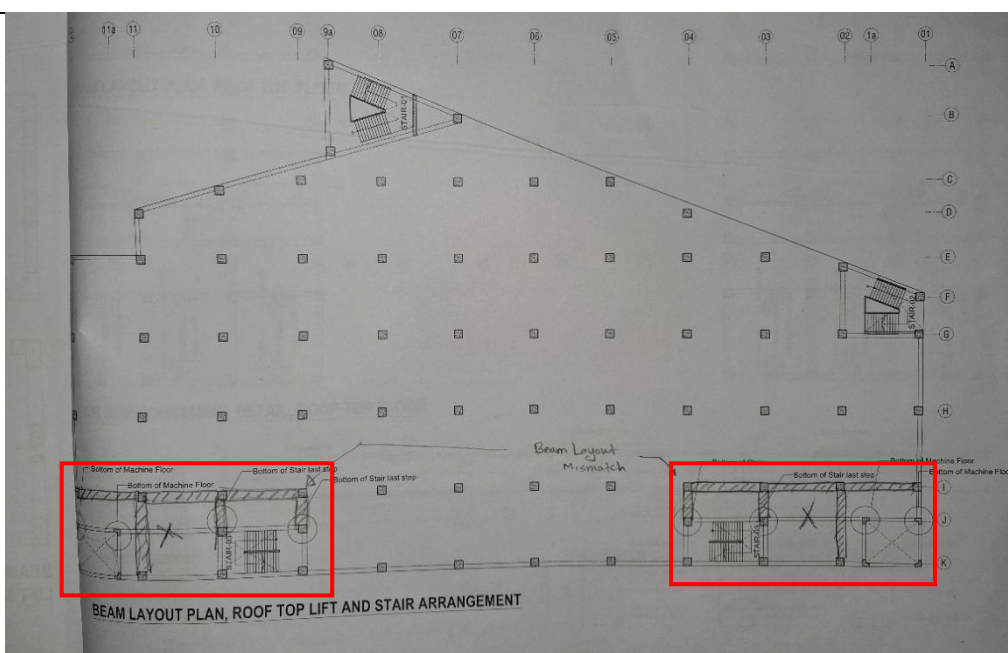
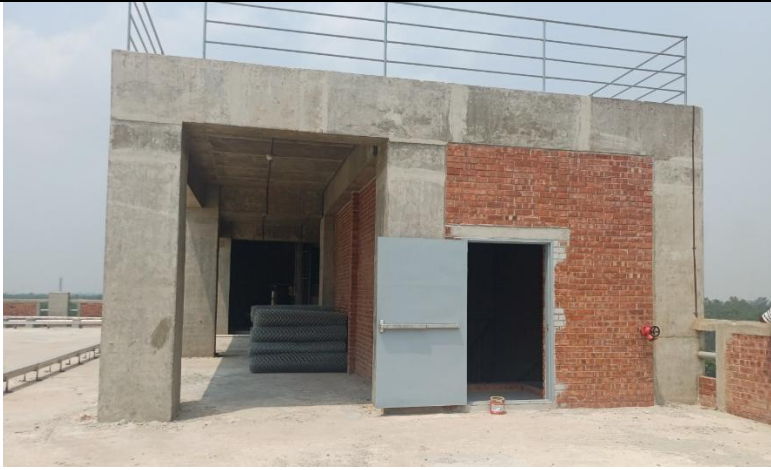
### Observation-02: Mismatch in as-built drawing (Warehouse Building)

**Description:** Beam found at Stair top and lift top level but not shown in the drawing.  
Factory engineer is required to survey the whole structure and prepare accurate as-built drawing.

| Item No | Observation | Action Plan | Timeline |
|---|---|---|---|
| 4. | Mismatch in as-built drawing (Warehouse Building) | Building engineer is required to survey the whole structure and prepare accurate as-built drawing. | within 6 weeks |

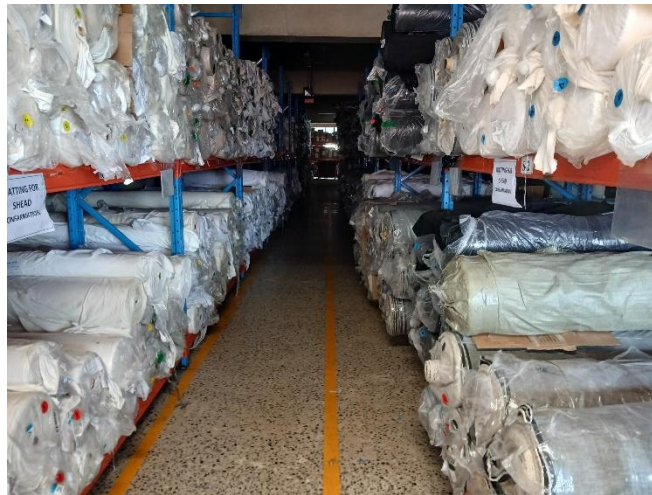
**Observation-03:** Incomplete load management program (including load plan posting, marking storage and maintaining loads) (Warehouse Building)

**Description:** Incomplete load management program (missing load plan, no height marking) observed in Warehouse Building.  
Factory engineer is required to post the accepted load plan to all floor level, mark storage area & height and maintain floor loading within limit.

| Item No | Observation | Action Plan | Timeline |
|---|---|---|---|
| 5. | Incomplete load management program (Warehouse Building) | Factory engineer is required to post accepted load plan to all floor level, mark storage area & height and maintain floor loading within limit. | within 6 weeks |

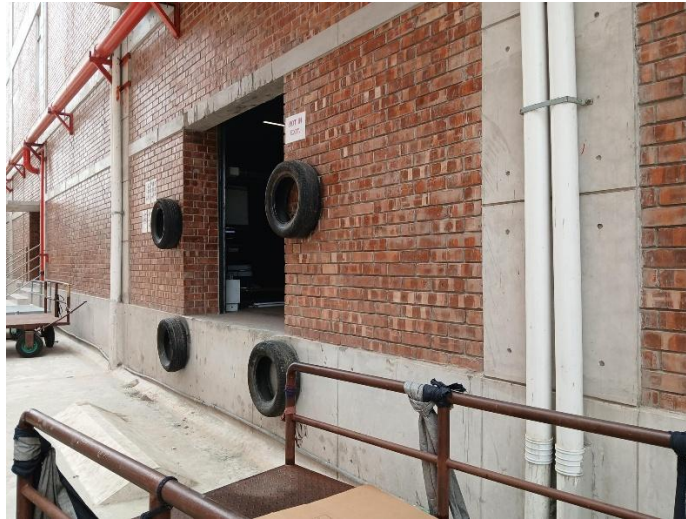
**Observation-04: Column susceptible to vehicle impact (Warehouse Building)**

**Description:** RC column found susceptible to vehicle impact during inspection. Factory engineer required to provide separate barriers in front of the columns to avoid impact on columns.

| Item No | Observation | Action Plan | Timeline |
|---|---|---|---|
| 6. | Column susceptible to vehicle impact (Warehouse Building) | Factory engineer required to provide separate barriers in front of the columns to avoid impact on columns. | within 6 weeks |

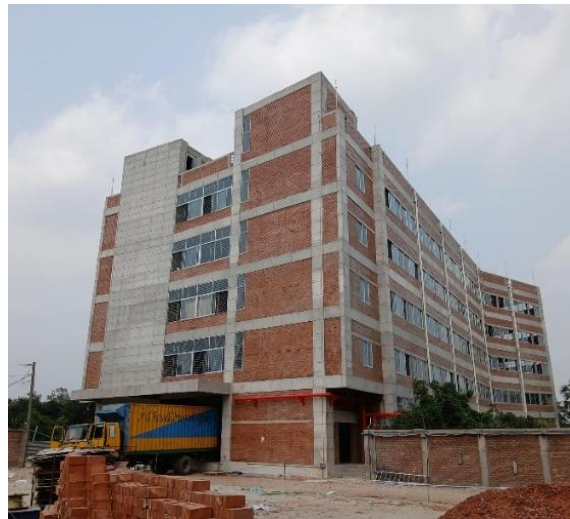
**Observation-05: Lack of Design Report (ACL Extension Building)**

**Description:** At the time of inspection, the design report for this building was not available on site. As per BNBC, every building or structure designed shall have its design documents prepared following the provisions of Section 1.9.1. The design document shall include a design report and a set of structural drawings, which shall be prepared in compliance with section 1.9.1.1 and section 1.9.1.2 as per BNBC.

Moreover, number of cylinder test report for column and beam-slab was found inadequate. Building engineer is required to verify the in-situ concrete strength by taking 100 mm diameter concrete cores (minimum 4 no's) from the lower tier columns and from beams.

Based on the in-situ material strength, the building engineer is required to prepare the Engineering Assessment (EA) in compliance with section 1.9.1.1 and section 1.9.1.2, part-6 of BNBC.

| Item No | Observation | Action Plan | Timeline |
|---|---|---|---|
| 7. | Lack of Design Report (ACL Extension Building) | The building engineer is required to prepare the design report as per 1.9.1 BNBC and submit it to RSC for detailed review. | within 6 weeks |
| 8. | Lack of Design Report (ACL Extension Building) | Building engineer is required to verify the in-situ concrete strength by taking 100 mm diameter concrete cores (minimum 4 no's) from the lower tier columns and from beams. | within 6 weeks |
| 9. | Lack of Design Report (ACL Extension Building) | Implement remediation work if required. | within 6 months |

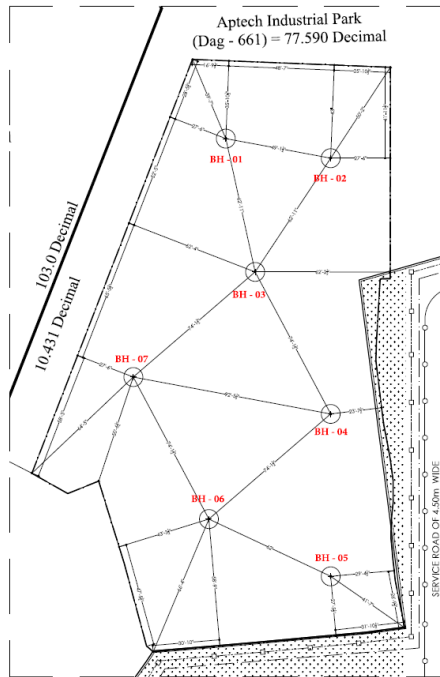
**Observation-06: Lack of Geotechnical investigation report (ACL Extension Building)**

**Description:** A geotechnical investigation report found on site and bore hole layout of which does not represent the in-situ sub-soil condition of this building.

Building engineer is required to perform a geotechnical investigation in the vicinity of the structure and check the integrity of the foundation, considering the in-situ sub-soil condition.

Based on the test reports, the building engineer is required to prepare the Engineering Assessment (EA) in compliance with section 1.9.1.1 and section 1.9.1.2, part-6 of BNBC.

| 10. | Lack of Geotechnical investigation report (ACL Extension Building) | Building engineer is required to perform a geotechnical investigation report for close vicinity of the structure and check the foundation adequacy. | within 6 weeks |

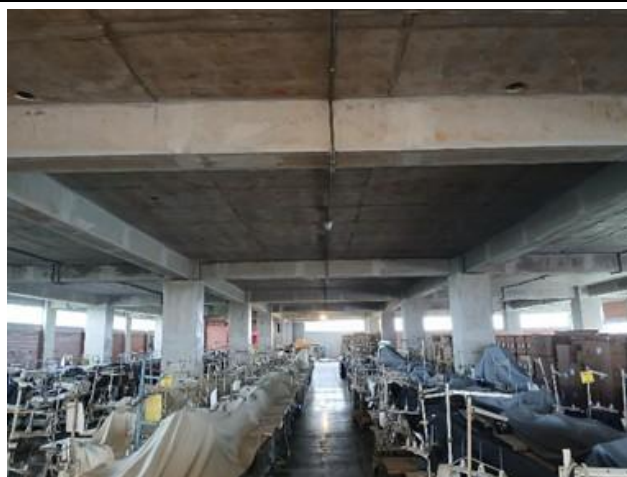
**Observation-07: Incomplete load management program (including load plan posting, marking storage and maintaining loads) (ACL Extension Building)**

**Description:** Incomplete load management program (missing load plan, no height marking) observed in ACL Extension Building

Factory engineer is required to post the accepted load plan to all floor levels, mark the storage area & height and maintain floor loading within the limit.

| 11. | Incomplete load management program (ACL Extension Building) | Factory engineer is required to post accepted load plan to all floor level, mark storage area & height and maintain floor loading within limit. | within 6 weeks |
