# JM Fabrics Ltd. (Extension 2)

South Nayapara, 6 No Dogri, Bhawal, Mirzapur

05 and 30 March 2026

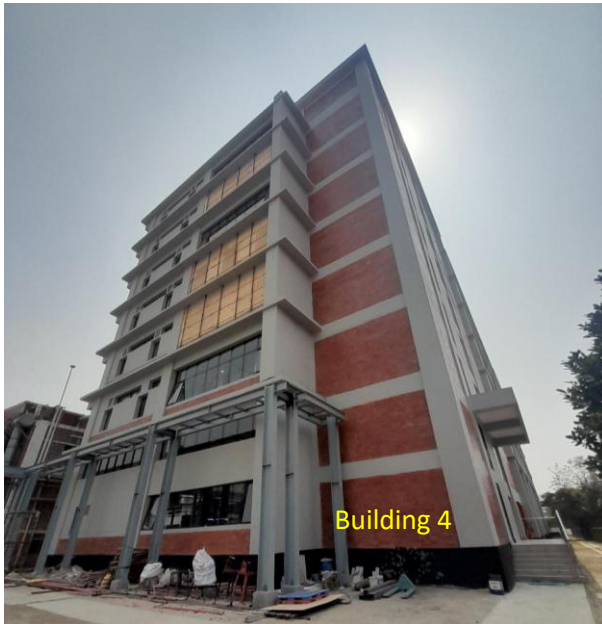
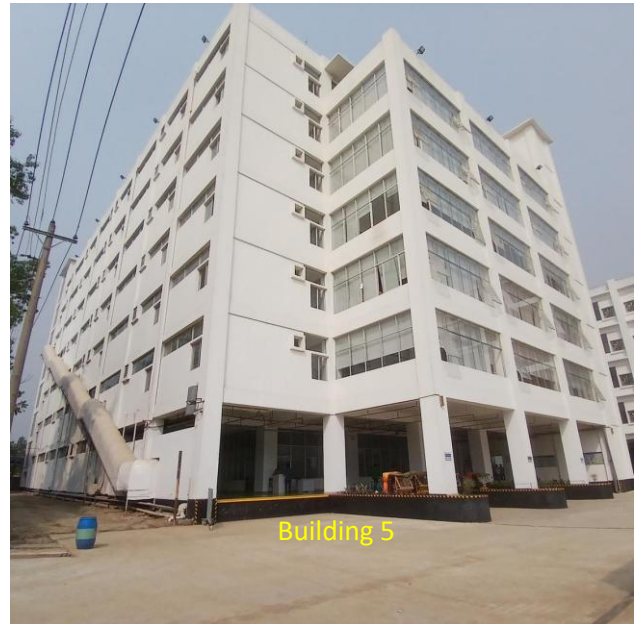
**Observation-1:** Design report needs to be reviewed against lateral forces. (Building 4,5)

**Description:** A design report has been prepared for the seven-storied Production Building. The prepared design report needs to be reviewed against lateral forces. The building engineer is required to submit the design report to the RSC for detailed review.

| Item No | Observation | Action Plan | Timeline |
|---|---|---|---|
| 1. | Design report needs to be reviewed against lateral forces. (Building 4) | The building engineer is required to submit the design report to the RSC for detailed review. | within 6 weeks |
| 7. | Design report needs to be reviewed against lateral forces. (Building 5) | The building engineer is required to submit the design report to the RSC for detailed review. | within 6 weeks |

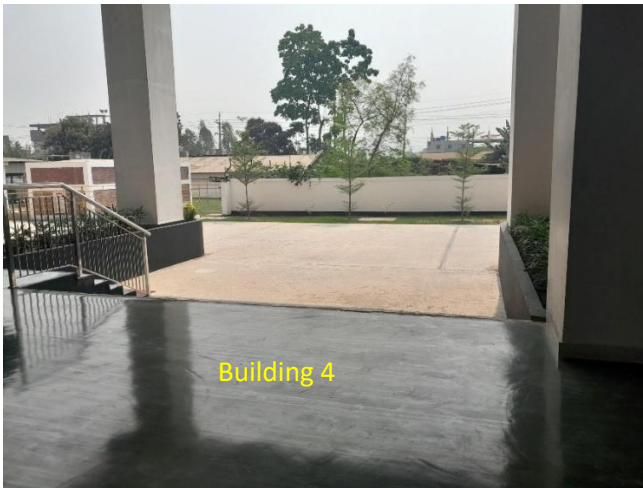
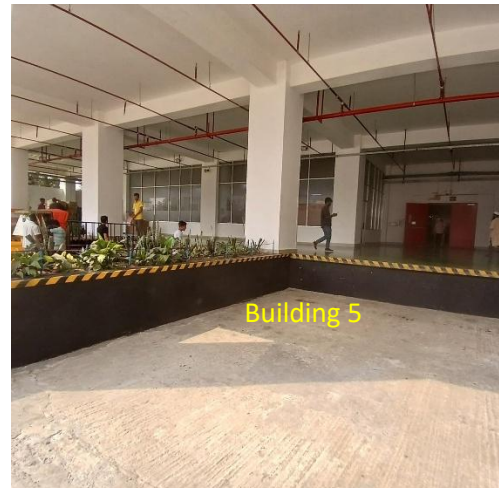
**Observation-2:** Possible falling hazard at the loading and unloading platform. (Building 4,5)

**Description:** No barrier was found at elevated platform of loading unloading zone. Building engineer is required to provide barrier/railing to the elevated platform to mitigate the falling hazard.

| Item No | Observation | Action Plan | Timeline |
|---|---|---|---|
| 4. | Possible falling hazard at the loading and unloading platform. (Building 4) | Building engineer is required to provide barrier/railing to the elevated platform to mitigate the falling hazard. | within 6 weeks |
| 10. | Possible falling hazard at the loading and unloading platform. (Building 5) | Building engineer is required to provide barrier/railing to the elevated platform to mitigate the falling hazard. | within 6 weeks |

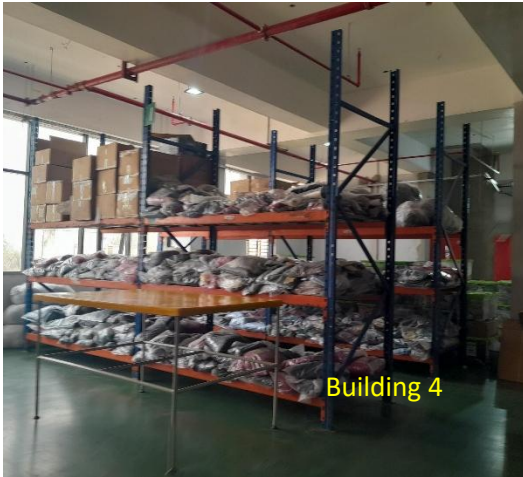
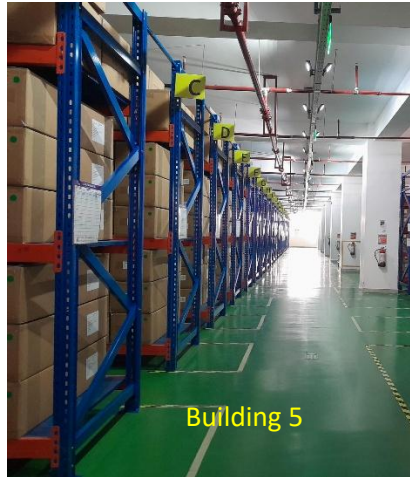
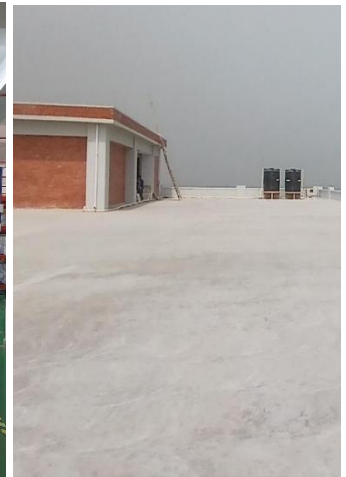
**Observation-3:** Lack of anchorage of nonstructural elements. (Building 4,5)

**Description:** Storage rack and PVC tanks were found unanchored and unbraced. Building engineer is required to anchor/brace all nonstructural elements including storage racks, water tanks, within the factory to resist possible falling hazard.

| Item No | Observation | Action Plan | Timeline |
|---|---|---|---|
| 5. | Lack of anchorage of nonstructural elements. (Building 4) | The building engineer needs to check all base plate connections, identify the loose nut bolts, and tighten them properly. | within 6 weeks |
| 11. | Lack of anchorage of nonstructural elements. (Building 5) | The building engineer needs to check all base plate connections, identify the loose nut bolts, and tighten them properly. | within 6 weeks |

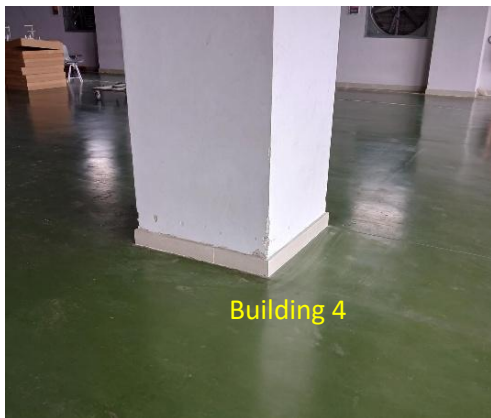
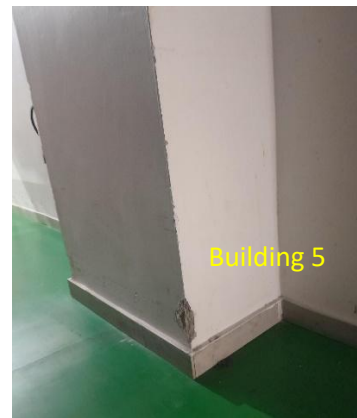
**Observation-4:** Trolley impact on columns. (Building 4,5)

**Description:** Sign of trolley impacts were found on column surface in several locations. The building engineer is required to provide column guard to protect from impact.

| Item No | Observation | Action Plan | Timeline |
|---|---|---|---|
| 6. | Trolley impact on columns. (Building 4) | The building engineer is required to provide column guard to protect from impact. | within 6 weeks |
| 12. | Trolley impact on columns. (Building 5) | The building engineer is required to provide a column guard to protect from impact. | within 6 weeks |

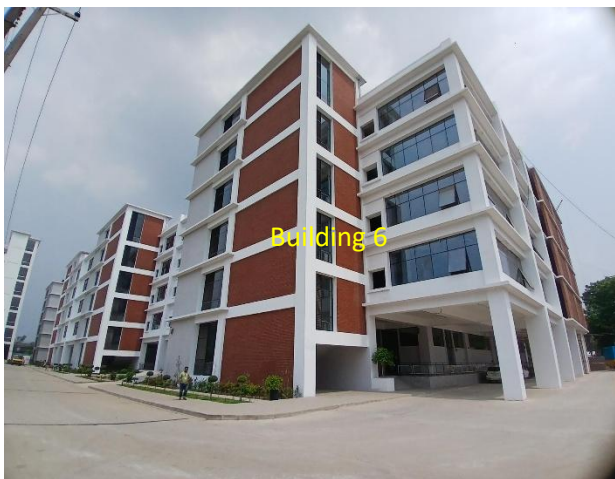
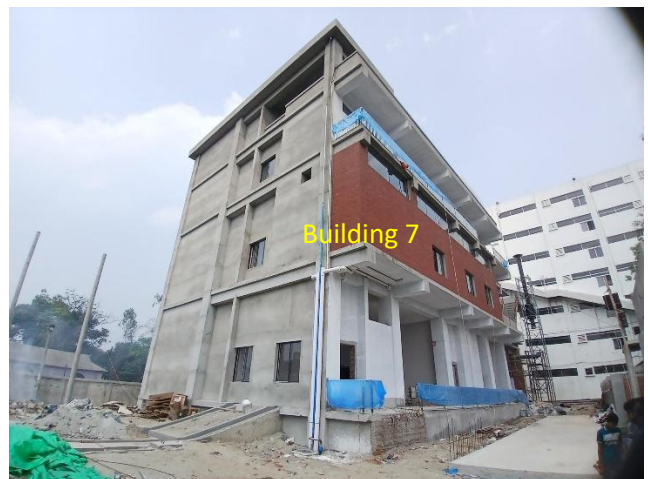
**Observation-5:** Design report needs to be reviewed against lateral forces. (Building 6,7)

**Description:** A design report has been prepared for the seven storied Production Building. The prepared design report needs to be reviewed against lateral forces. The building engineer is required to submit the design report to the RSC for detailed review.

| Item No | Observation | Action Plan | Timeline |
|---|---|---|---|
| 13. | Design report needs to be reviewed against lateral forces. (Building 6) | The building engineer is required to submit the design report to the RSC for detailed review. | within 6 weeks |

| Item No | Observation | Action Plan | Timeline |
|---|---|---|---|
| 17. | Design report needs to be reviewed against lateral forces. (Building 7) | The building engineer is required to submit the design report to the RSC for detailed review. | within 6 weeks |

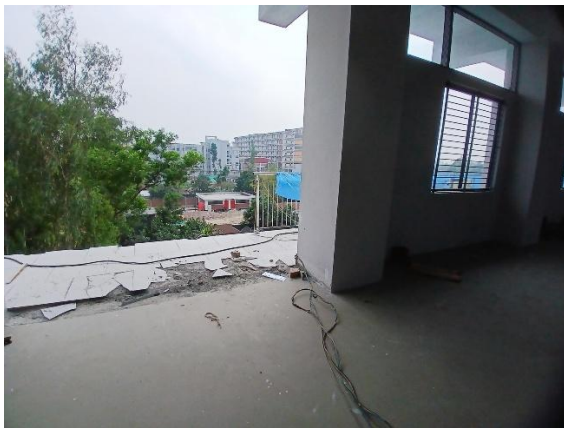
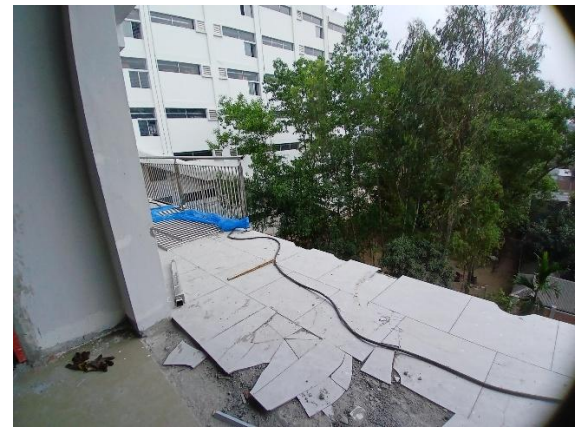
**Observation-7:** Falling hazard risk on 2<sup>nd</sup> floor. (Building 7)

**Description:** No barrier was found at cantilever portion. Building engineer is required to provide barrier/railing to the unprotected edge to mitigate the falling hazard.

| Item No | Observation | Action Plan | Timeline |
|---|---|---|---|
| 21. | Falling hazard risk on the 2 <sup>nd</sup> floor. (Building 7) | Building engineer is required to provide barrier/railing to the unprotected edge to mitigate the falling hazard. | Immediate |

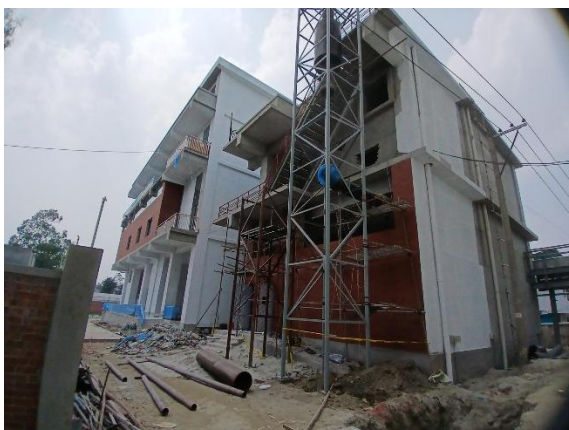
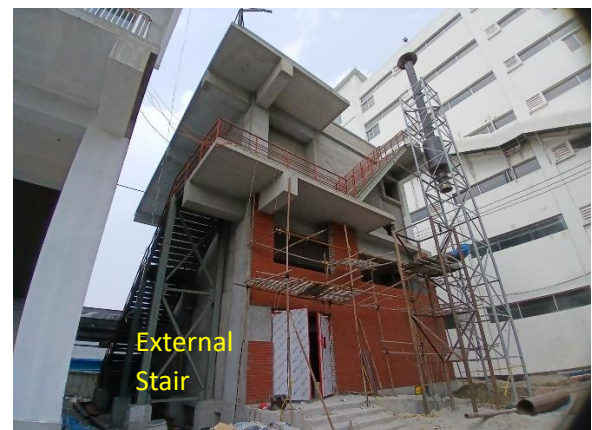
**Observation-8:** Lack of design report. (External steel stair, Building 8)

**Description:** As per BNBC, every building or structure designed shall have its design documents prepared following the provision of Section 1.9.1. The design document shall include a design report and a structural drawing. At the time of inspection, no design report was available which is required to be prepared (including roof shed) in compliance with section 1.9.1.1 and section 1.9.1.2 (part 6, BNBC).

| Item No | Observation | Action Plan | Timeline |
|---|---|---|---|
| 22. | Lack of design report. (External steel stair, Building 8) | The building engineer is required to prepare design report following BNBC 2020 and submit it to RSC for detailed review. | within 6 weeks |

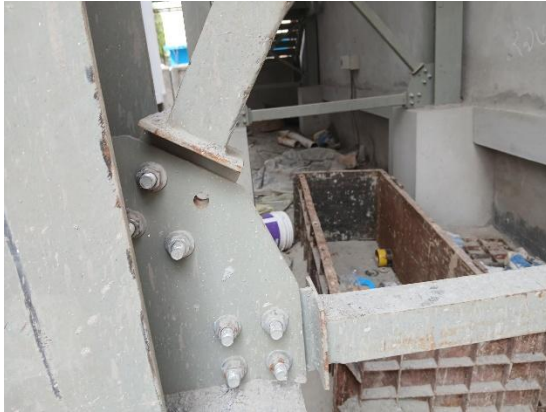
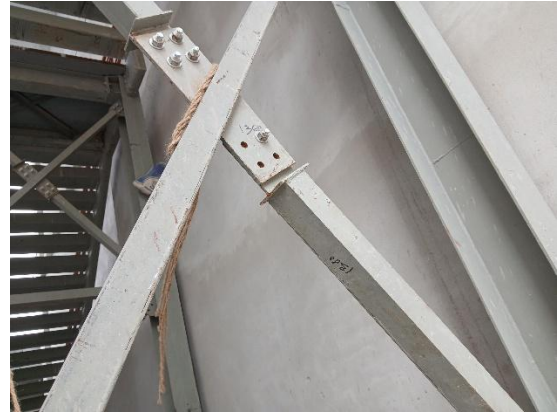
**Observation-9: Bolt missing. (External steel stair, Building 8)**

**Description:** Bolts missing were found in several locations. Building engineer is required to install all the missing bolts where necessary.

| Item No | Observation | Action Plan | Timeline |
|---|---|---|---|
| 26. | Bolt missing. (External steel stair, Building 8) | Building engineer is required to install all the missing bolts where necessary. | within 6 weeks |

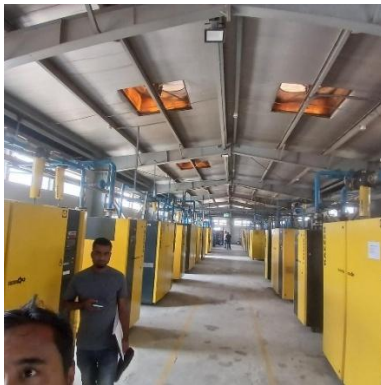
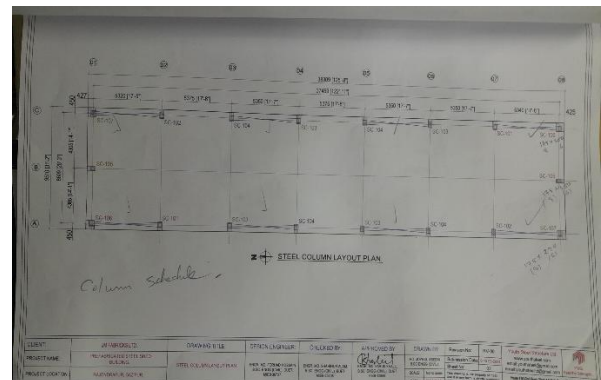
**Observation-10: Incomplete as-built drawings. (Compressor Shed)**

**Description:** Connection details and steel column schedule were not found in the provided drawings. Also, 16 mm cable bracings were found whereas drawings show 20 mm. Building engineer is required to survey the whole structure and prepare full set of as-built drawings.

| Item No | Observation | Action Plan | Timeline |
|---|---|---|---|
| 27. | Incomplete as-built drawings. (Compressor Shed) | Building engineer is required to survey the whole structure and prepare full set of as-built drawings. | within 6 weeks |

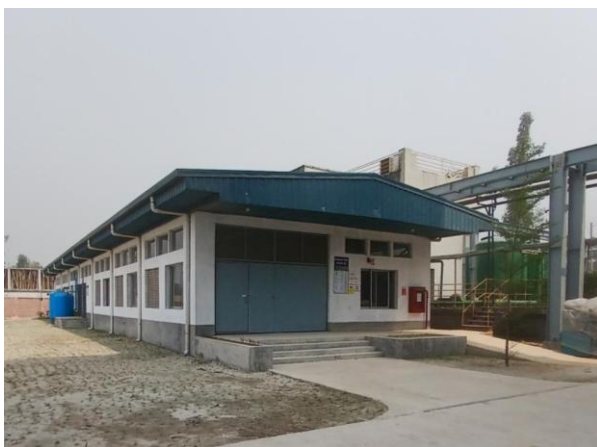
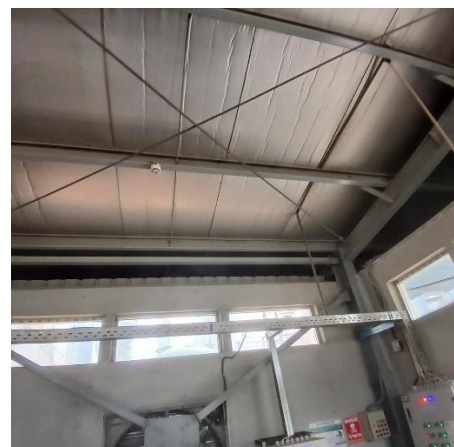
**Observation-11: Lack of design report. (Compressor Shed)**

**Description:** As per BNBC, every building or structure designed shall have its design documents prepared following the provision of Section 1.9.1. The design document shall include a design report and a structural drawing. At the time of inspection, no design report was available which is required to be prepared (including roof shed) in compliance with section 1.9.1.1 and section 1.9.1.2 (part 6, BNBC).

| Item No | Observation | Action Plan | Timeline |
|---|---|---|---|
| 28. | Lack of design report. (Compressor Shed) | The building engineer is required to prepare a design report following BNBC 2020 and submit to RSC for detailed review. | within 6 weeks |

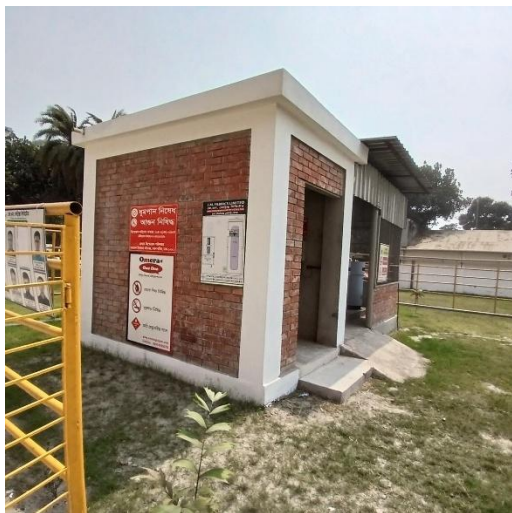
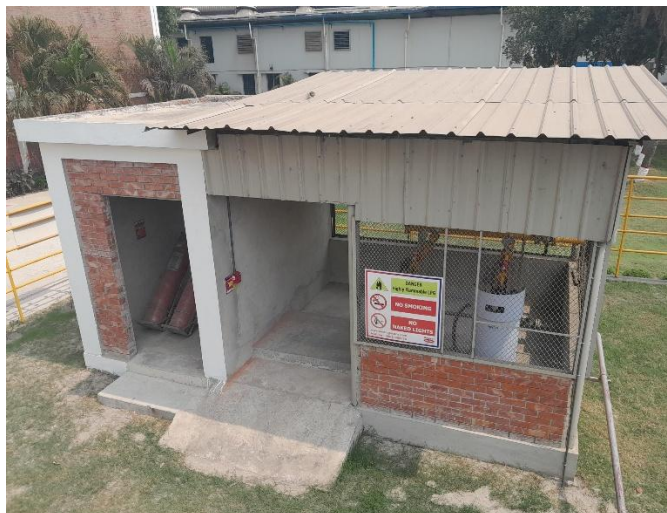
**Observation-12:** Lack of information in as-built drawings. (LPG Shed)

**Description:** Stair base, steel part and sectional details were not found in the provided as-built drawings. Building engineer is required to prepare full set of as-built drawings.

| Item No | Observation | Action Plan | Timeline |
|---|---|---|---|
| 30. | Lack of information in the as-built drawings. (LPG Shed) | Building engineer is required to prepare full set of as-built drawings. | within 6 weeks |
