# Sweatertech Ltd. (Extension 2)

Plot # 898,1351, Gacha Road, Gazipur Sadar, Gazipur-1704

22 April 2026

### Observation-01: Mismatches in as-built drawing (Warehouse Shed)

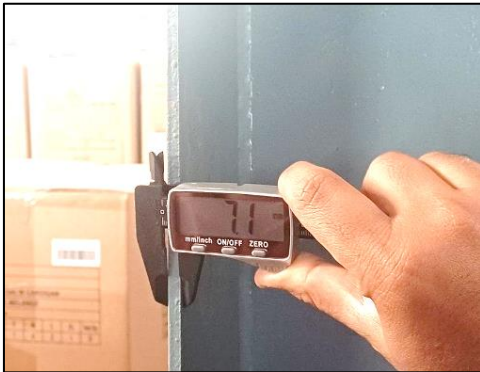
Flange thickness of steel columns were found 7.1 mm instead of 8 & 10 mm

**Description:** During inspection several mismatches including mismatches in connection details & flange thickness of steel columns, missing in flange brace & wall girt were observed.

The building engineer is required to survey the structure, update the as-built drawing as per onsite conditions, revise design report accordingly and submit updated design report to RSC.

| Item No | Observation | Action Plan | Timeline |
|---|---|---|---|
| 1. | Mismatches in as-built drawing (Warehouse Shed) | Update the as-built drawing as per onsite conditions | within 6 weeks |
| 2. | | Revise design report as per updated as-built drawing | within 6 weeks |
| 3. | | Implement remediation work if required. | within 6 months |

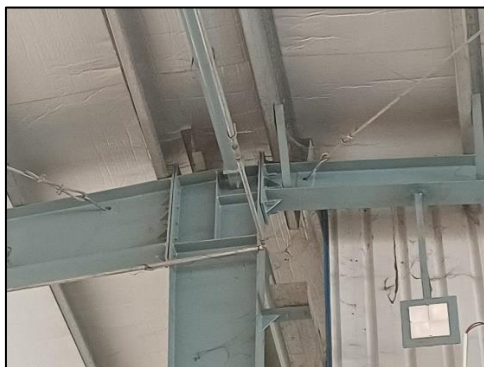
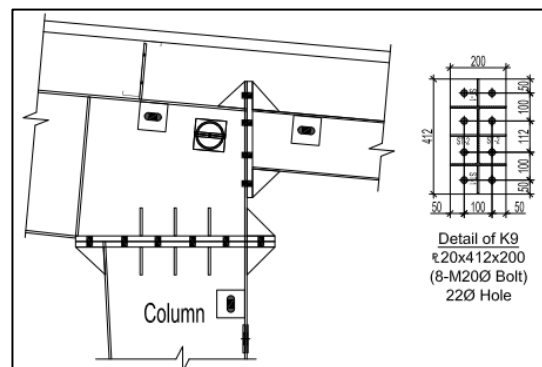
Side face joint found instead of bottom joint at grid I-5

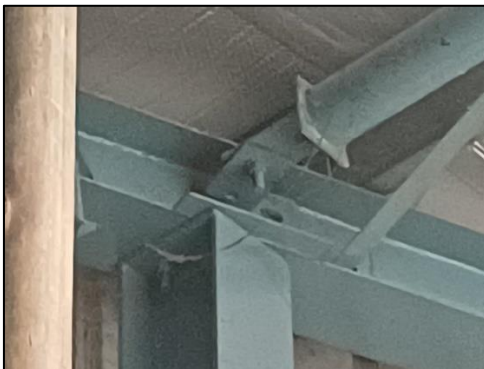
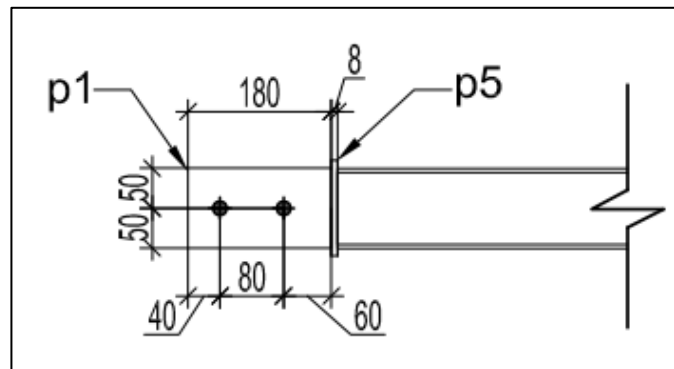
One instead of two bolts in compression strut connection

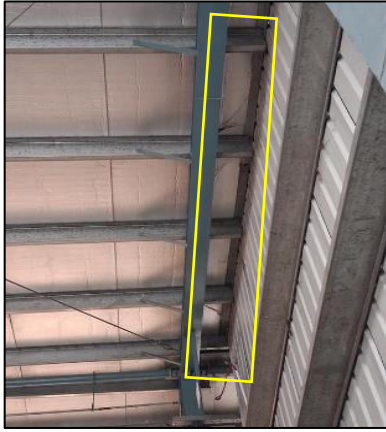
Flange brace missing at end grid

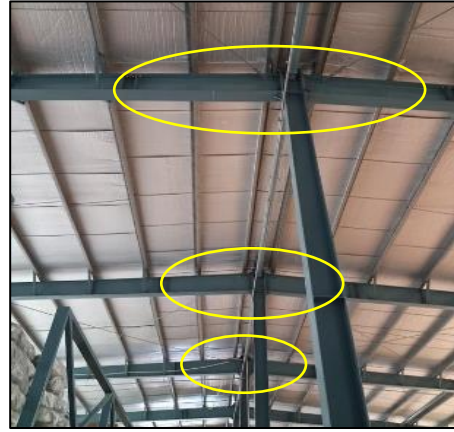
Flange brace missing adjacent to ridge

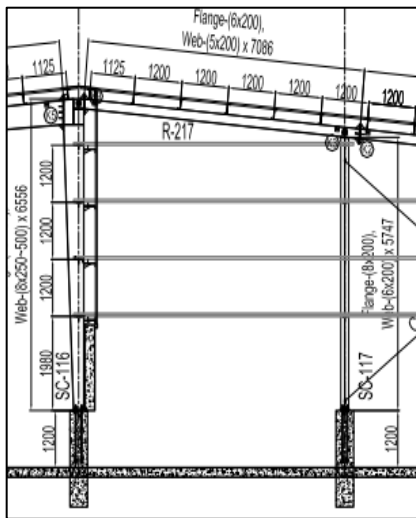
Wall girt missing at grid I

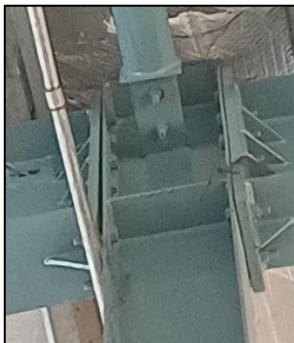
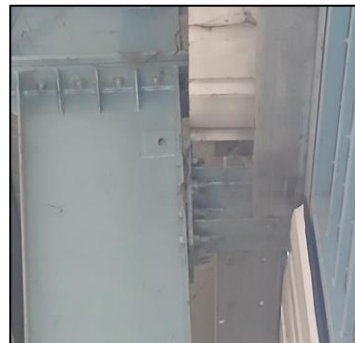
**Observation-02:** Significant gap in connection (Warehouse Shed)

**Description:** Significant gaps were observed at several connections. The building engineer is required to fill the connection gaps using shim plate.

| Item No | Observation | Action Plan | Timeline |
|---|---|---|---|
| 4. | Significant gap in connection (Warehouse Shed) | The building engineer is required to fill the connection gaps using shim plate. | within 6 weeks |

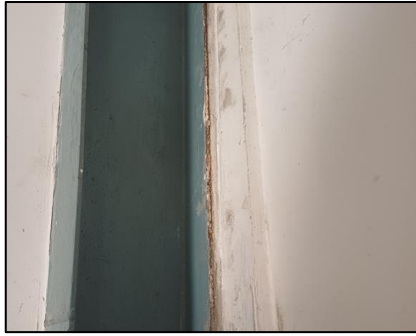
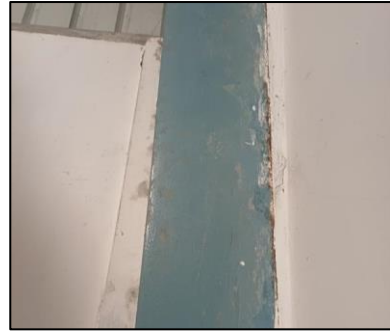
**Observation-03: Corrosion of steel members (Warehouse Shed)**

**Description:** Corrosion was observed on steel members at several locations. The building engineer is required to remove rust and apply anti-corrosive paint on steel members.

| Item No | Observation | Action Plan | Timeline |
|---|---|---|---|
| 5. | Corrosion of steel members (Warehouse Shed) | The building engineer is required to remove rust and apply anti-corrosive paint on steel members. | within 6 weeks |

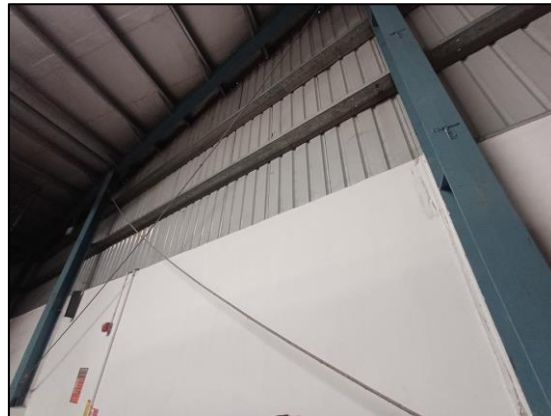
**Observation-04: Loose cable bracing (Warehouse Shed)**

**Description:** Several bracings were found in loose condition. The building engineer is required to tighten the loose bracings.

| Item No | Observation | Action Plan | Timeline |
|---|---|---|---|
| 6. | Loose cable bracing (Warehouse Shed) | The building engineer is required to tighten the loose bracings. | within 6 weeks |

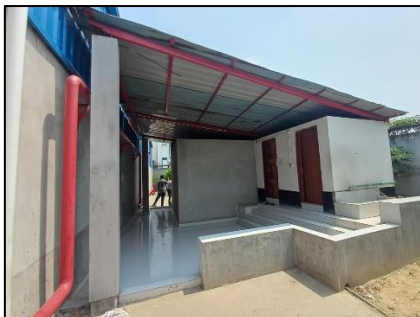
Driver Rest Room

**Observation-05: Lack of as-built drawings (Driver Rest Room, Wastage Room, Transformer Control Room)**

**Description:** As-built drawing was not available during inspection. The building engineer is required to survey the whole structures and produce as-built drawings.

| Item No | Observation | Action Plan | Timeline |
|---|---|---|---|
| 7. | Lack of as-built drawings (Driver Rest Room) | The building engineer is required to survey the whole structures and produce as-built drawings. | within 6 weeks |

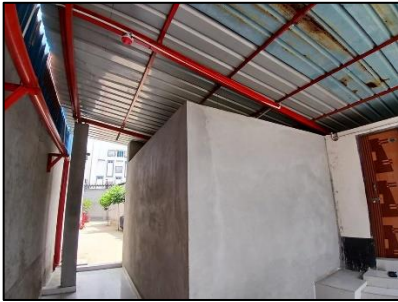
Driver Rest Room

**Observation-06:** Poor connection and inadequate member size (Driver Rest Room, Wastage Room, Jute Boiler Room)

**Description:** Inadequate member size and poor connection were observed. The building engineer is required to assess the structures and produce design report following BNBC 2020.

| Item No | Observation | Action Plan | Timeline |
|---|---|---|---|
| 8. | Poor connection and inadequate member size (Driver Rest Room) | The building engineer is required to assess the structures and produce design reports following BNBC 2020. | within 6 weeks |
| 9. | Poor connection and inadequate member size (Driver Rest Room) | Implement remediation work if required. | within 6 months |

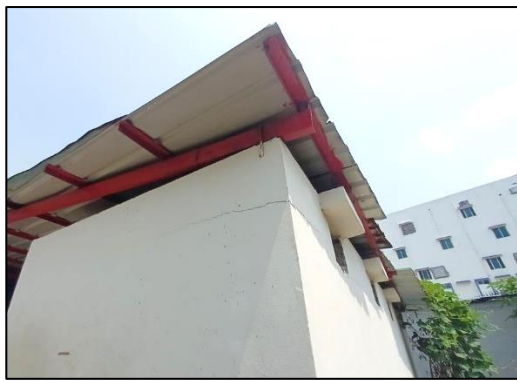
Driver Rest Room

**Observation-07:** Crack on brick wall (Driver Rest Room, ETP)

**Description:** Cracks were found on brick wall. The building engineer is required to investigate the reason & extent of crack and repair with suitable methods.

| Item No | Observation | Action Plan | Timeline |
|---|---|---|---|
| 16. | Crack in brick wall (Driver Rest Room) | The building engineer is required to investigate the reason & extent of crack and repair with suitable methods. | within 6 weeks |

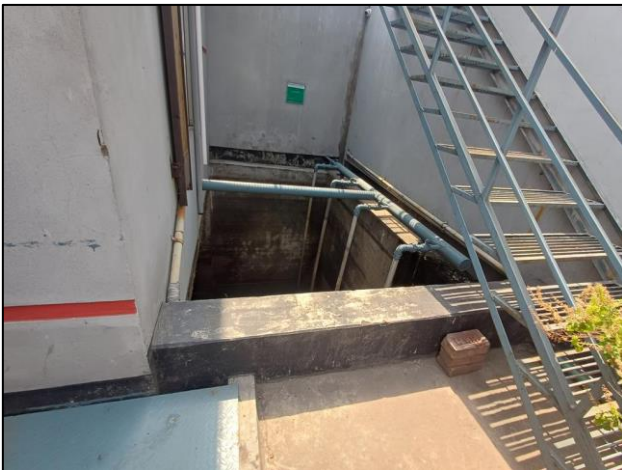
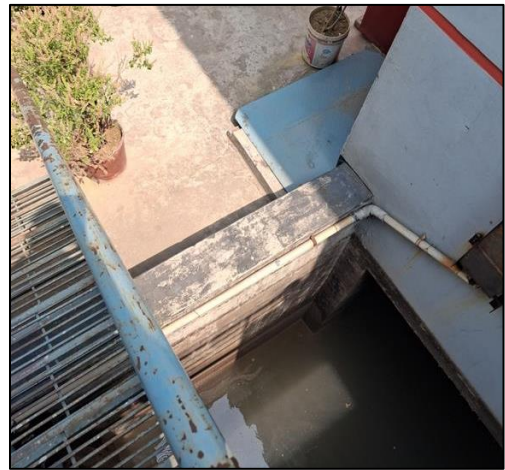
**Observation 08:** Falling hazard (ETP).

**Description:** During inspection, falling hazard was identified at ground level near ETP tank. The factory is required to provide railing to prevent falling.

| Item No | Observation | Action Plan | Timeline |
|---|---|---|---|
| 18. | Falling hazard (ETP). | The factory is required to provide railing to prevent falling. | within 6 weeks |
