# Essential Clothing Ltd. (Nagchala Campus)

Nagchala, Sakashor, Maddha Para, Kaliakoir, Gazipur

23 April 2026

## 2. Observation

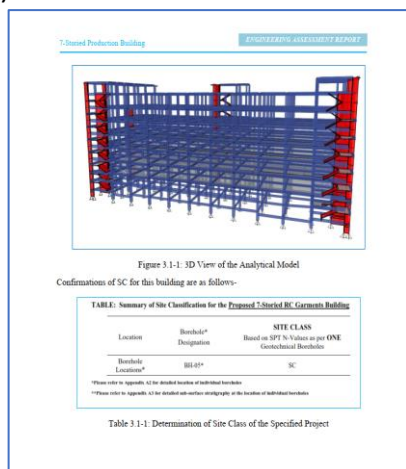
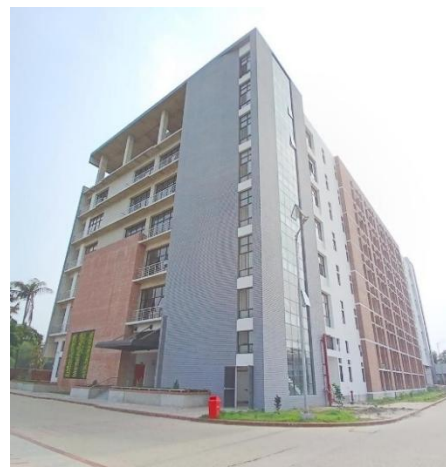
**Observation-01:** Assessment report needs to be reviewed against lateral forces. (Production Building)

**Description:** A design report has been prepared for the seven-storied Production Building. The prepared design report needs to be reviewed against lateral forces. The building engineer is required to submit the design report to the RSC for detailed review.

| Item No | Observation | Action Plan | Timeline |
|---|---|---|---|
| 1. | Assessment report needs to be reviewed against lateral forces. (Production Building) | The building engineer is required to submit the design report to the RSC for detailed review. | within 6 weeks |

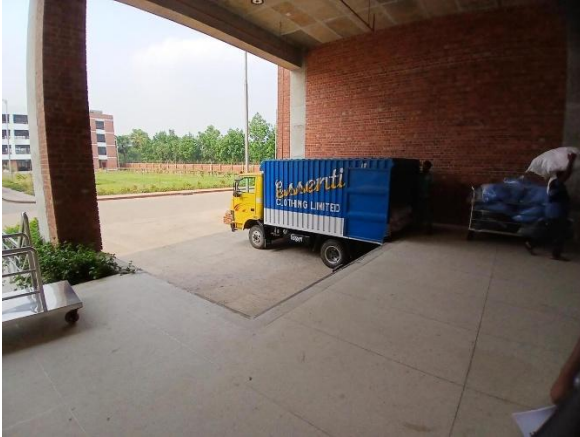
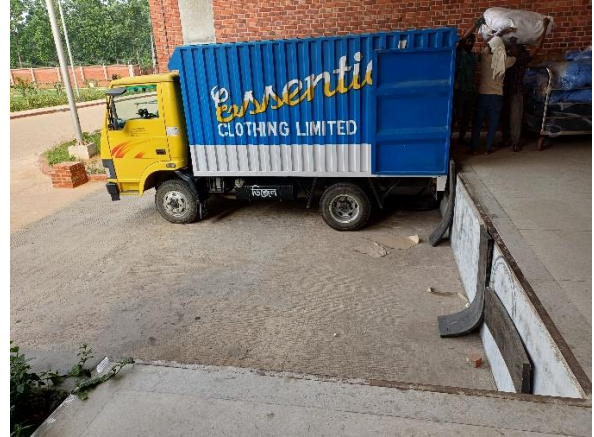
**Observation-03:** Possible falling hazard at loading unloading platform. (Production Building)

**Description:** No barrier was found at elevated platform of loading unloading zone. Building engineer is required to provide barrier/railing to the elevated platform to mitigate the falling hazard.

| Item No | Observation | Action Plan | Timeline |
|---|---|---|---|
| 5. | Possible falling hazard at the loading and unloading platform. (Production Building) | The building engineer is required to provide a suitable barrier/railing to the elevated platform to mitigate the falling hazard. | within 6 weeks |

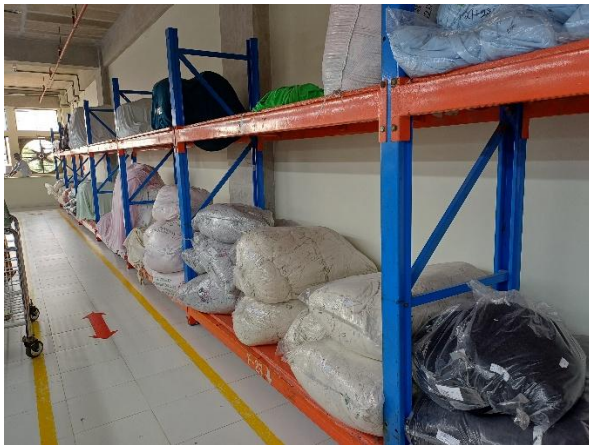
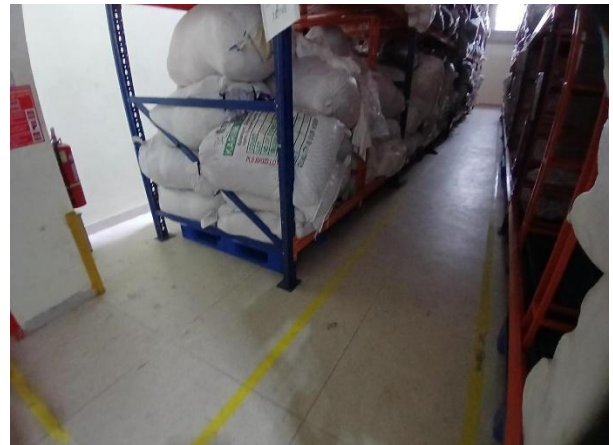
**Observation-04:** Lack of anchorage of nonstructural elements. (Production Building)

**Description:** Storage racks were found unanchored and unbraced. Building engineers are required to anchor/brace all nonstructural elements including storage racks within the factory to resist possible falling hazard.

| Item No | Observation | Action Plan | Timeline |
|---|---|---|---|
| 6. | Lack of anchorage of nonstructural elements. (Production Building) | The building engineer is required to anchor/brace all nonstructural elements, including storage racks within the factory to resist possible falling hazard. | within 6 weeks |

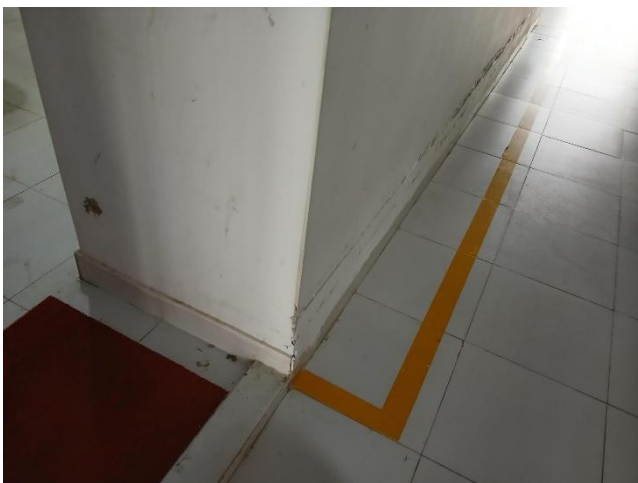
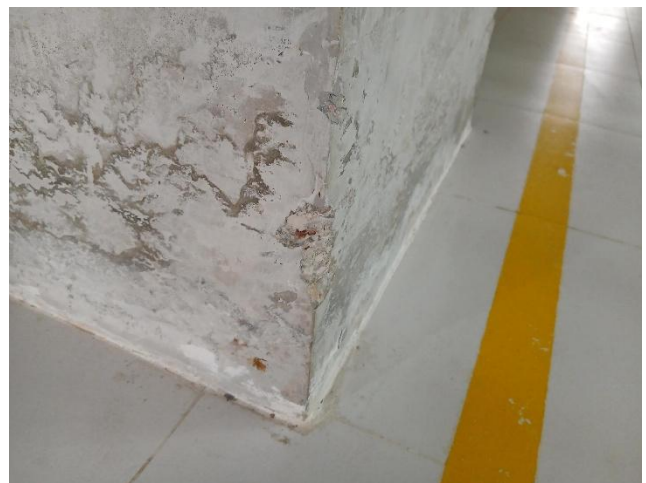
**Observation-05:** Trolley impact on columns. (Production Building)

**Description:** Sign of trolley impacts were found on column surface in several locations. The building engineer is required to provide column guard to protect from impact.

| Item No | Observation | Action Plan | Timeline |
|---|---|---|---|
| 7. | Trolley impact on columns. (Production Building) | The building engineer is required to provide column guard to protect from impact. | within 6 weeks |

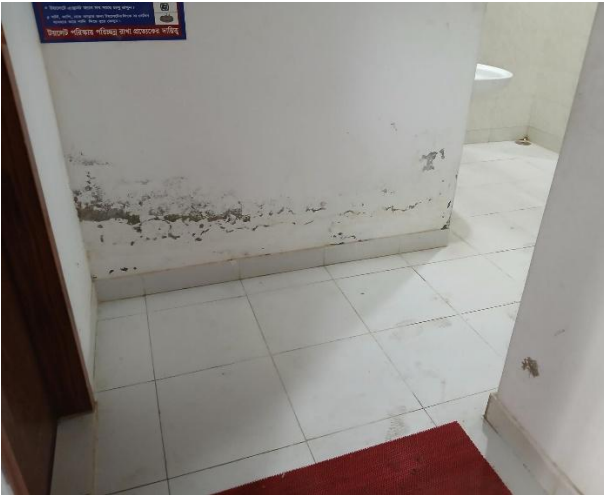
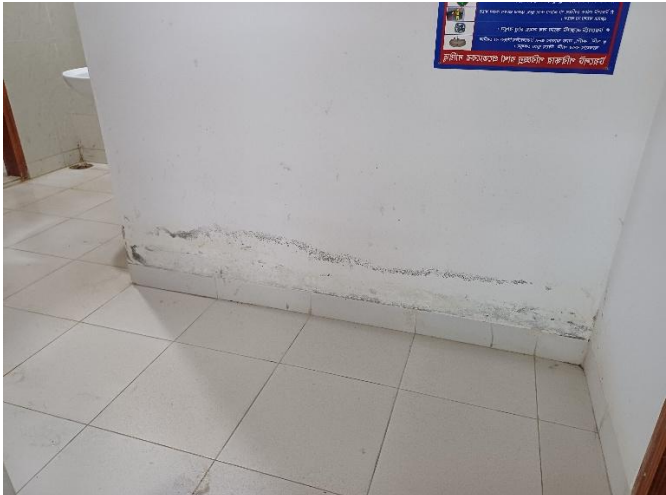
**Observation-06:** Dampness on walls. (Production Building)

**Description:** Dampness was observed in brick walls near toilet zone. Building engineer is required to repair the damp area with suitable method.

| Item No | Observation | Action Plan | Timeline |
|---|---|---|---|
| 8. | Dampness on walls. (Production Building) | Building engineer is required to repair the damp area with suitable method. | within 6 weeks |

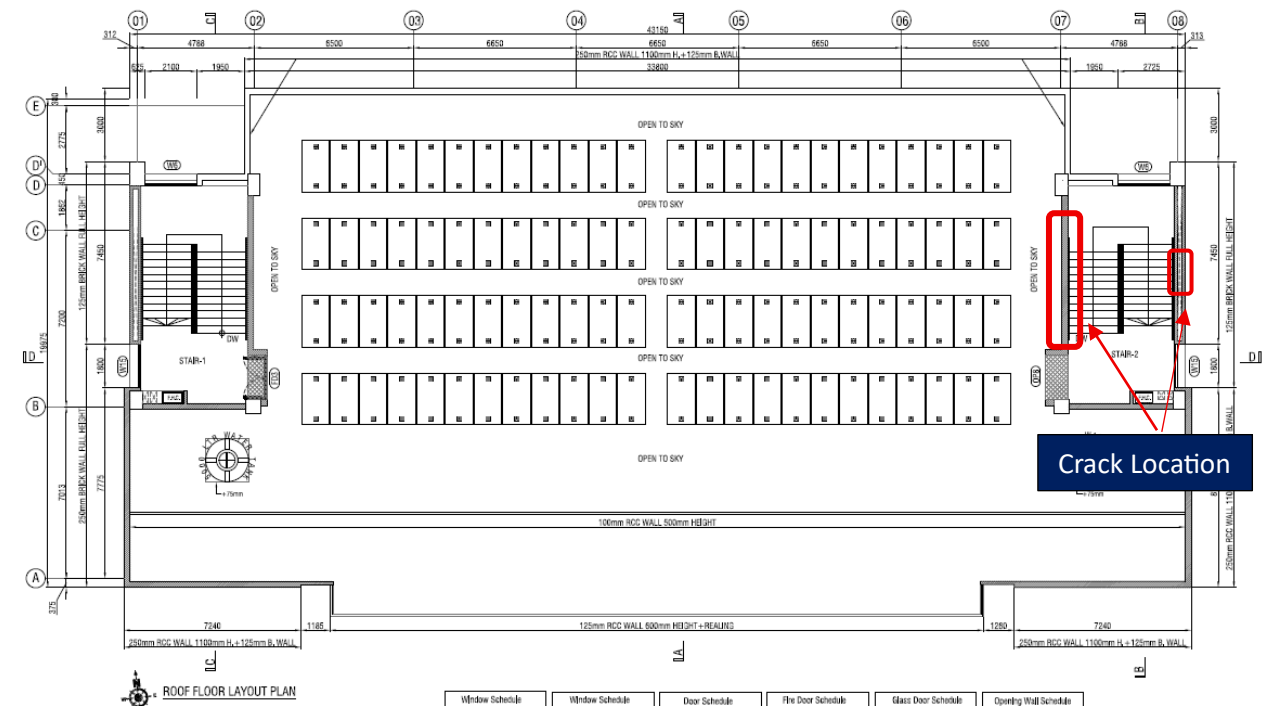
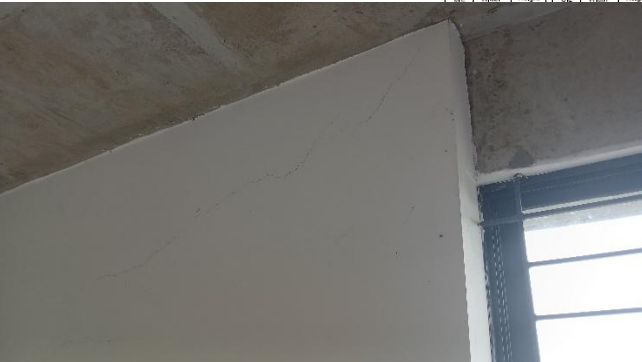
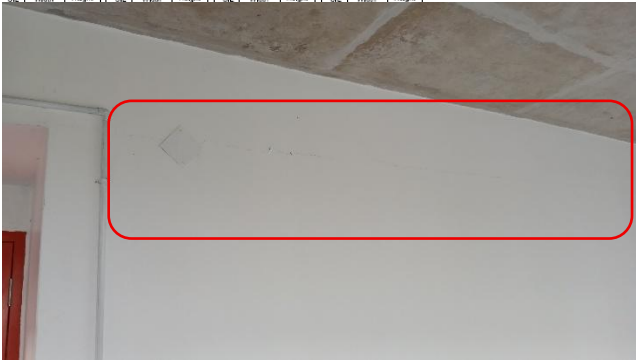
**Observation-08: Crack on beam and brick wall joint (Dining Building)**

**Description:** Cracks were observed on the beam and the brick wall joint and brick wall at stair roof. The building engineer is required to investigate the reason for the crack and repair it with a suitable method.

| Item No | Observation | Action Plan | Timeline |
|---|---|---|---|
| 11. | Crack on beam and brick wall joint (Dining Building) | The building engineer is required to investigate the reason for the crack and repair it with a suitable method. | within 6 weeks |

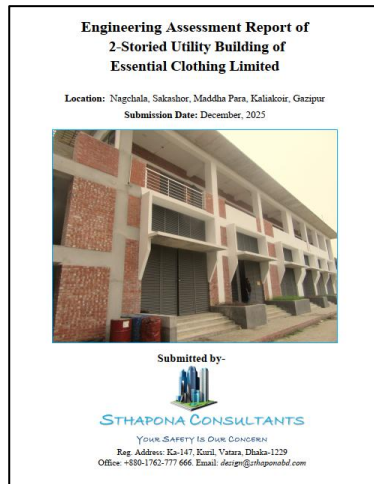
**Observation-09:** Lack of information in the Engineering Assessment (EA) (Utility Building).

**Description:** During the inspection, the Engineering Assessment (EA) report was found on-site as per BNBC 2020, and the following observations were noted:

- The structural system is reported as a Dual System (Intermediate moment resisting frame (IMRF) with special concrete shear wall). However, no joint shear (beam-column joint) checks have been provided. Calculation provided for confinement, but not supported by the picture or scan report.
- P-delta check is not provided.
- Factor of safety (FoS) check for the foundation was not provided.

The building engineer is required to address all the inconsistencies in the revised EA report as per 1.9.1 BNBC and submit to RSC.

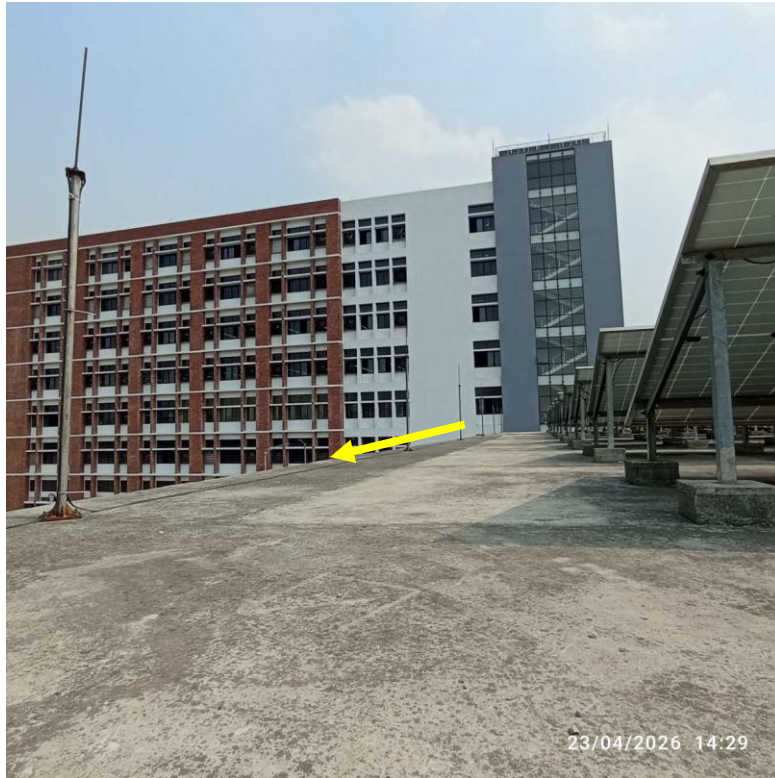
**Observation-11:** Falling hazard at roof level (Utility Building).

**Description:** No parapet/railing is provided at the roof level. Provide edge protection to avoid falling hazards.

| Item No | Observation | Action Plan | Timeline |
|---|---|---|---|
| 15. | Falling hazard at roof level (Utility Building). | Provide edge protection to avoid falling hazards. | within 6 weeks |

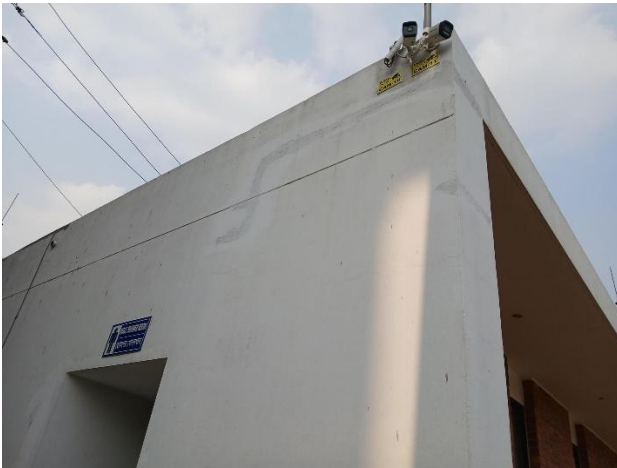
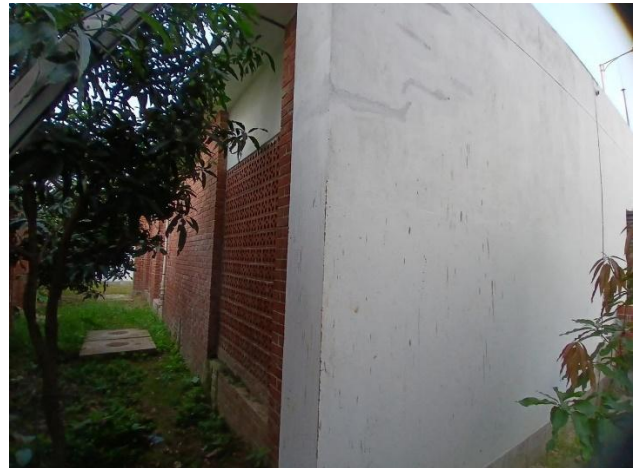
**Observation-12:** Cracks on façade walls. (Shower Building)

**Description:** Cracks were observed in façade walls. The factory has repaired some areas but still cracks were found in few areas. Building engineer is required to repair the cracks with suitable methods.

| <b>16.</b> | Cracks on façade walls.<br>(Shower Building) | The building engineer is required to repair the cracks with suitable methods. | within 6 weeks |

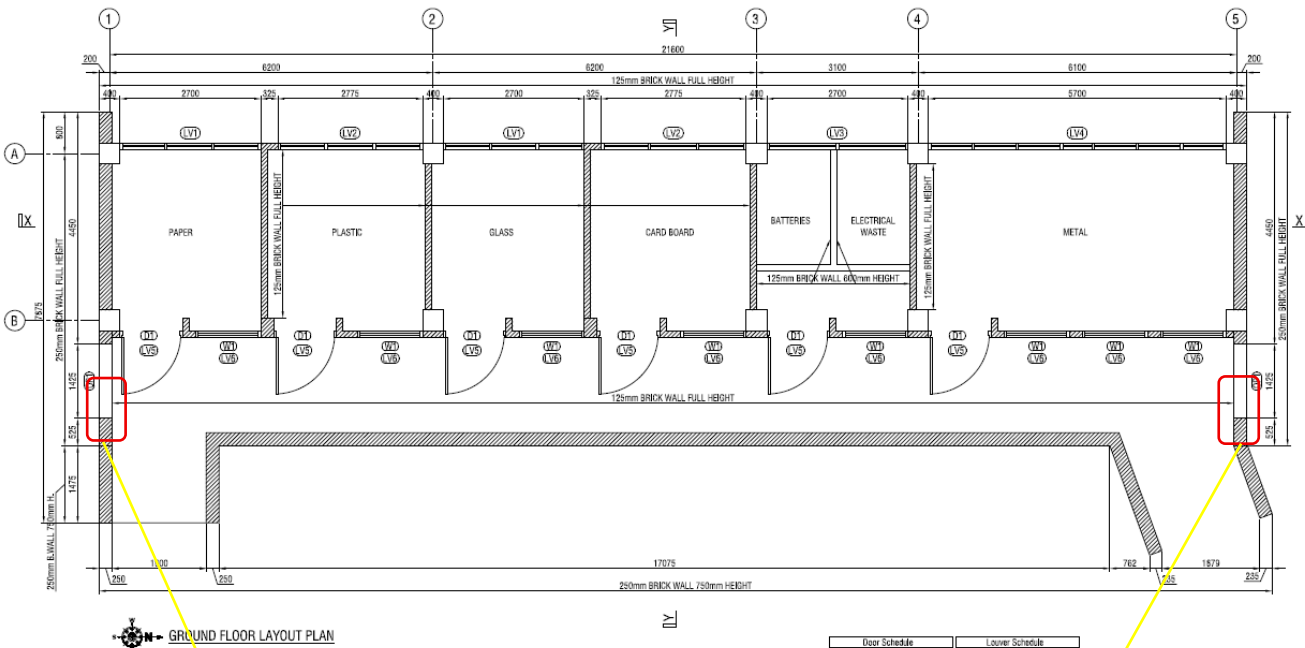
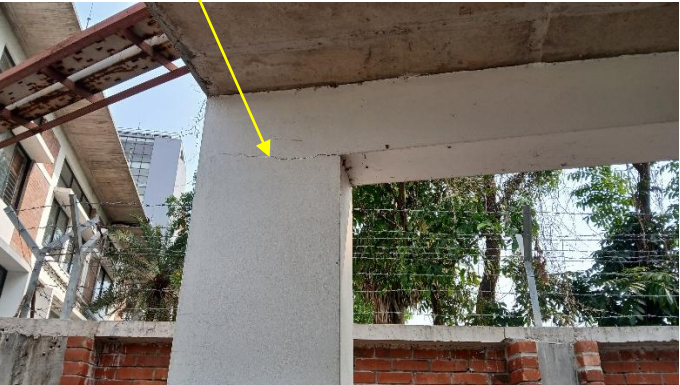
**Observation-14: Crack on brick wall (Bin Center)**

**Description:** Cracks were observed on the brick wall. The building engineer is required to investigate the reason for the crack and repair it with a suitable method.

| <b>19.</b> | Crack on the brick wall<br>(Bin Center) | The building engineer is required to investigate the reason for the crack and repair it with a suitable method. | within 6 weeks |
