# RIPON KNITWEAR LTD (EXTENSION)

Jarun, Konabari, Gazipur

7 May 2026

## **1. Building Information**

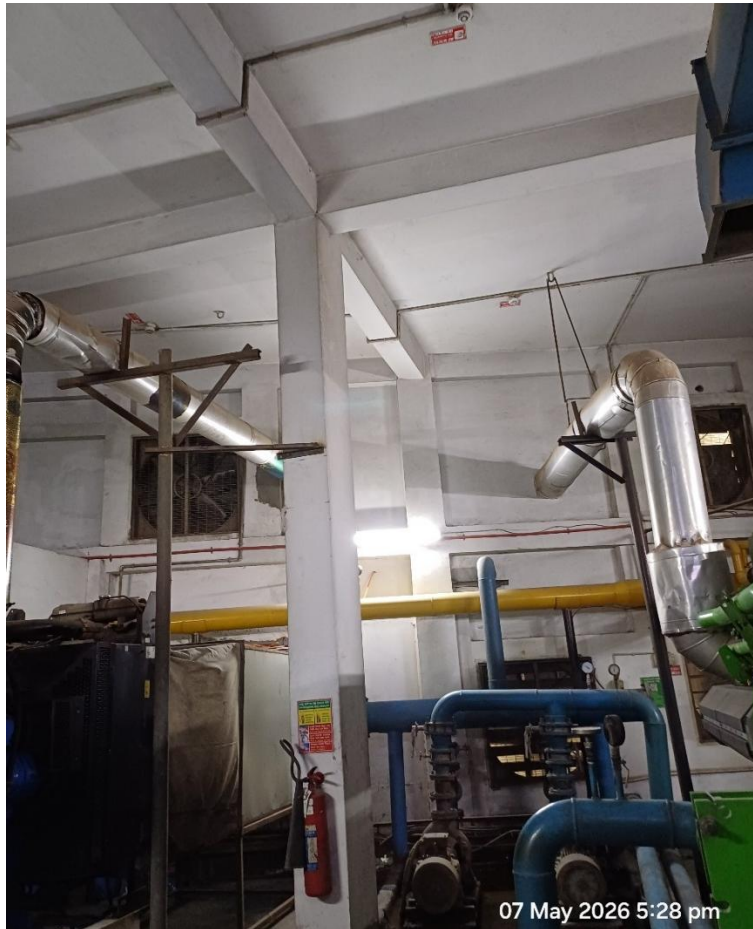
### Observation-01: Slender Column and Lack of Design Documents (Building-4).

**Description:** Column of Building-4 found to be slender on the ground floor. Also, design documents were not available for Building-4. The building engineer is required to review the design, load, seismic requirements, framing system, and incorporate necessary measures (if necessary) as per Section 1.3.4; Section 1.3.5; Section 1.5.4.2; Section 1.5.4.3 & Section 2.5.5 of BNBC 2006 and update the analysis and design report in accordance with Section 1.9.1 of BNBC 2006. Also, the building engineer is required to incorporate necessary remedial works (if required).

Moreover, the necessary documentation for the confirmation of material strength was not available. The building engineer is required to verify the concrete strength by taking cores (100 mm dia, at least 4 nos for each type of member) from the columns, beams, & slabs of Building-4.

| Item No | Observation | Action Plan | Timeline |
|---|---|---|---|
| 1. | Slender Column and Lack of Design Documents (Building-4). | The building engineer is required to review the design, load, and seismic requirements of the slender column (observed), and review all requirements of the overall framing system, and incorporate necessary measures (if necessary) as per Section 1.3.4; Section 1.3.5; Section 1.5.4.2; Section 1.5.4.3 & Section 2.5.5 of BNBC 2006 and update the analysis and design report in accordance with Section 1.9.1 of BNBC 2006 and submit to RSC for review. | within 6 weeks |
| 2. | | Verify the concrete strength by taking cores (100 mm dia at least 4 nos for each type of member) from the column, beam, and slab. | within 6 weeks |
| 3. | | Implement remediation work if required. | within 6 months |

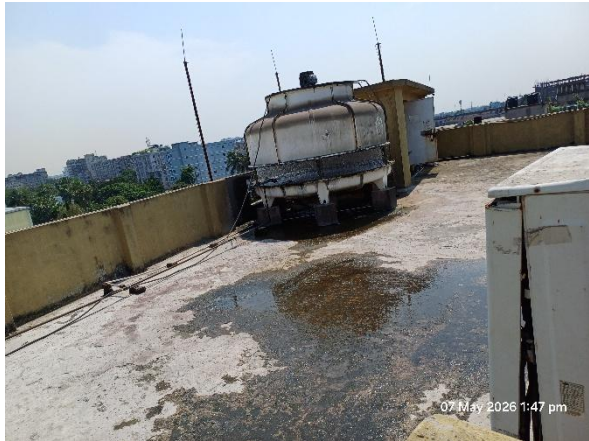
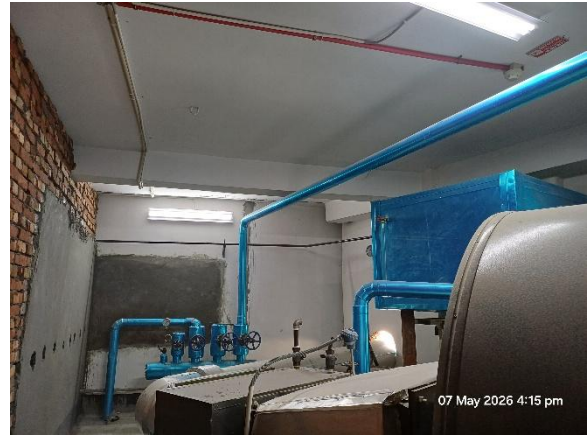
**Observation-02:** Discrepancy and lack of information in as-built drawings (Building-4).

**Description:** The thickness and height of the brick wall, built up for the machine anchorage, are not shown in the drawing. In addition, the detailed dimensions of the wall, wall thickness, cantilever extension length, and details of the stair & stair top framing are not shown clearly in the drawings. The building engineer is required to survey the as-built condition and prepare an accurate set of as-built drawings (including verification of foundation size and thickness; verification of column & beam rebar) and submit them to RSC for review.

| Item No | Observation | Action Plan | Timeline |
|---|---|---|---|
| 5. | Discrepancy and lack of information in as-built drawings (Building-4). | The building engineer is required to survey the as-built condition and prepare an accurate set of as-built drawings (including verification of foundation size and thickness; verification of column & beam rebar) and submit them to RSC for review. | within 6 weeks |

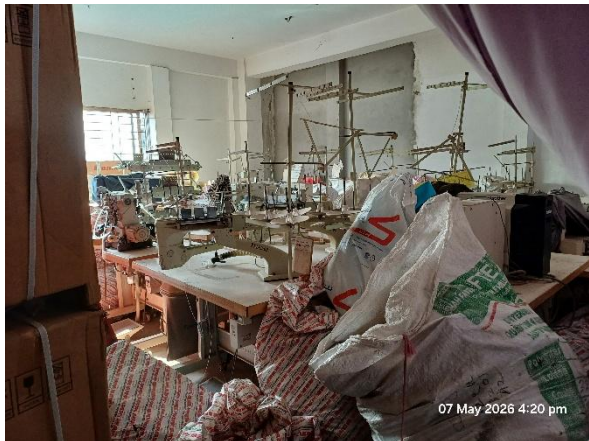
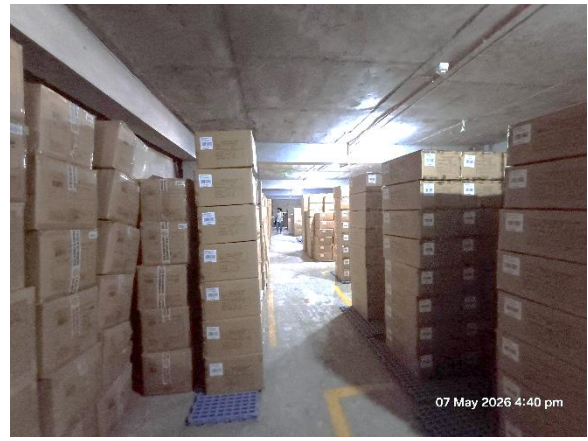
**Observation-03:** Lack of a proper load-management plan (All Structure).

**Description:** No load markings and proper load management were evident. The building engineer is required to prepare the load plan following NTPA guideline section 4.13; post the floor load plan on each floor, provide load restriction height markings, signage on the storage area, and manage the floor load plan as per the acceptable load limits of BNBC.

| Item No | Observation | Action Plan | Timeline |
|---|---|---|---|
| 4. | Lack of a proper load-management plan (Building-4) | The building engineer is required to prepare the load plan following NTPA guideline section 4.13, & post the load plan, provide load restriction height markings and signage for the storage area, and manage floor loading as per the load plan. | within 6 weeks |

| 12. | Lack of a proper load-management plan (Building-5) | The building engineer is required to prepare the load plan following NTPA guideline section 4.13, & post the load plan, provide load restriction height markings and signage for the storage area, and manage floor loading as per the load plan. | within 6 weeks |

| 28. | Lack of a proper load-management plan (Building-6) | The building engineer is required to prepare the load plan following NTPA guideline section 4.13, & post the load plan, provide load restriction height markings and signage for the storage area, and manage floor loading as per the load plan. | within 6 weeks |

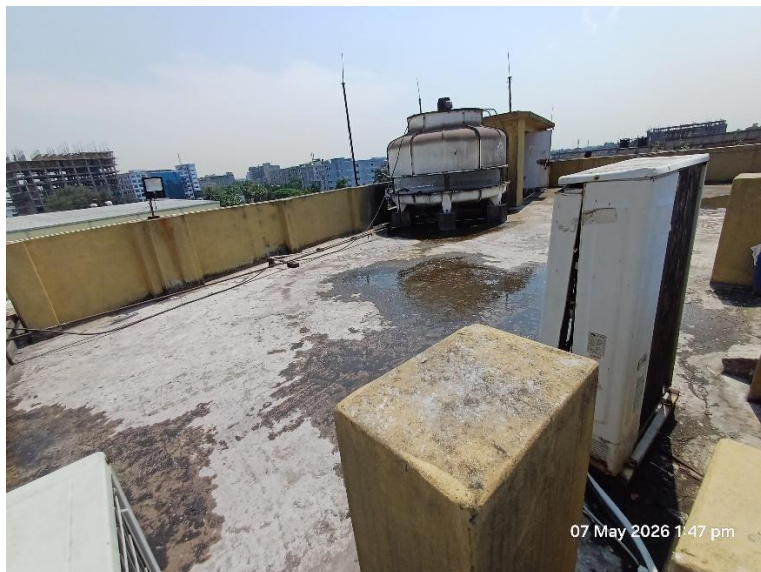
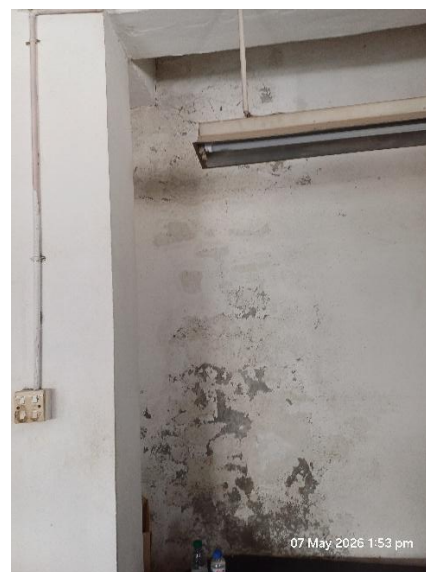
**Observation-04:** Water ponding, Dampness on Wall & lack of a proper drainage system on the roof of Building-4.

**Description:** Water ponding was evident on the roof of Building-4. Also, water-related dampness was observed on the wall. Provide a waterproofing layer on the roof and maintain the necessary slope to improve the roof drainage system. Also, seal the source of water and repair the water-related dampness with a suitable method.

| Item No | Observation | Action Plan | Timeline |
|---|---|---|---|
| 6. | Water ponding, dampness on wall & lack of a proper drainage system on the roof of Building-4. | Provide a waterproofing layer on the roof and maintain the necessary slope to improve the roof drainage system. Also, seal the source of water and repair the water-related dampness with a suitable method. | within 6 weeks |

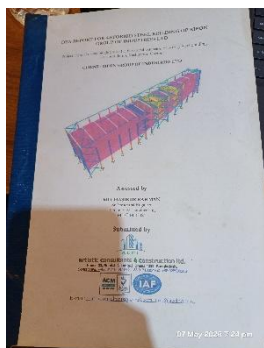
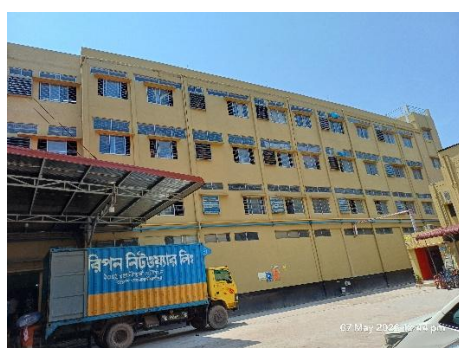
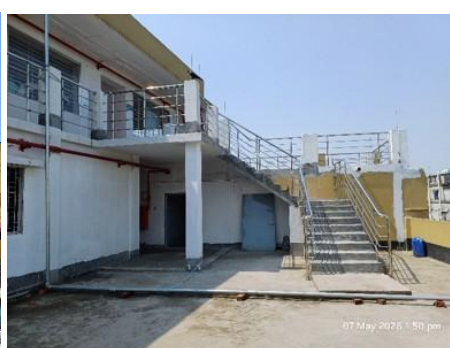
**Observation-05:** Stress in columns and lack of appropriate design documents & building separation (Building-5).

**Description:** The columns were found to be stressed above the normal design limit in cursory calculations. A Detailed Engineering Assessment (DEA) is required to commence. Moreover, a stair was observed to be connected structurally between Building-5 & Building-6. A design report was found for the Building-5 only. However, it doesn't satisfy the requirements of the BNBC 2006 provisions. Also, no material test reports were available. The building engineer is required to review the design, load, seismic requirements, framing system, and incorporate necessary measures as per Section 1.3.4; Section 1.3.5; Section 1.5.4.2; Section 1.5.4.3 & Section 2.5.5 of BNBC 2006 and update the analysis and design report in accordance with Section 1.9.1 of BNBC 2006. Moreover, the necessary documentation for the confirmation of material strength was not available. The building engineer is required to verify the steel grade by necessary testing.

In addition, the building engineer is required to ensure the necessary separation gap from the nearby structures in accordance with section 1.5.6.2 of BNBC 2006.

| Item No | Observation | Action Plan | Timeline |
|---|---|---|---|
| 8. | Stress in columns and lack of appropriate Design Documents & building | The building engineer is required to review the design, load, seismic requirements, framing system, and | within 6 weeks |

| | separation (Building-5). | incorporate necessary measures as per Section 1.3.4; Section 1.3.5; Section 1.5.4.2; Section 1.5.4.3 & Section 2.5.5 of BNBC 2006 and update the analysis and design report in accordance with Section 1.9.1 of BNBC 2006. | |
| 9. | | The building engineer is required to verify the steel grade by necessary testing. | within 6 weeks |
| 10. | | The building engineer is required to ensure the necessary separation gap from the nearby structures in accordance with section 1.5.6.2 of BNBC 2006. | within 6 weeks |
| 11. | | Implement remediation work if required. | within 6 months |

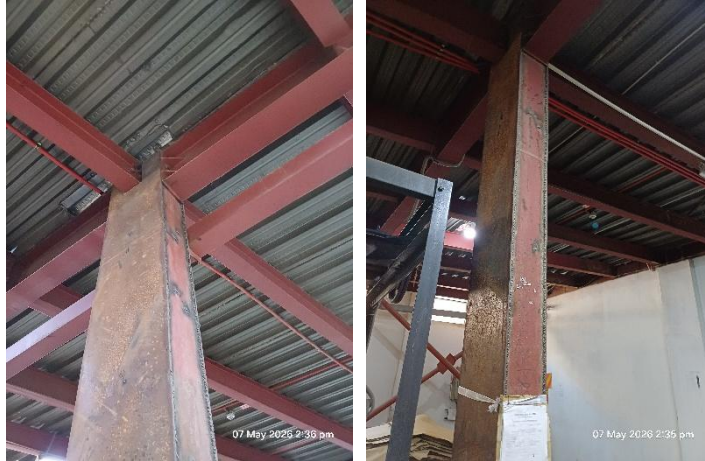
**Observation-06:** Retrofitting works incomplete & inconsistent (not indicative of available remedial drawings) and poor construction quality (Building-5).

**Description:** An engineering assessment report with remedial recommendations was available on-site. However, the remediation work has been found incomplete & inconsistent with respect to the available retrofitting outline. A building engineer is required to verify the carried out remedial works and the quality of the remedial works. The building engineer is required to complete the remediation work (if required) upon DEA acceptance from RSC.

| 13. | Retrofitting works incomplete, inconsistent (not indicative of available remedial drawings), and the poor construction quality (Building-5). | A building engineer is required to verify the carried out remedial works and the quality of the remedial works. Prepare a set of accurate as-built drawings based on actual site conditions observed. | within 6 weeks |
| 14. | | The building engineer is required to complete the remediation work (if required) upon DEA acceptance from RSC. | within 6 months |

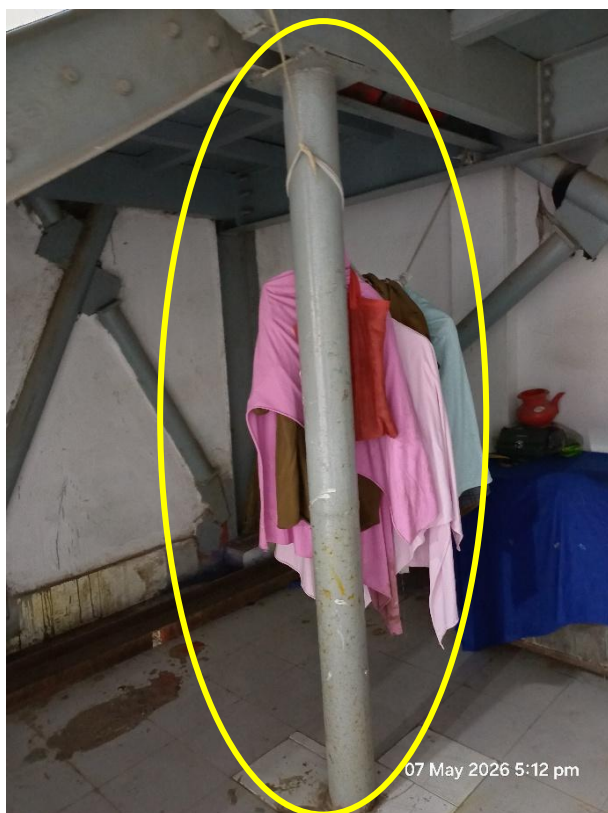
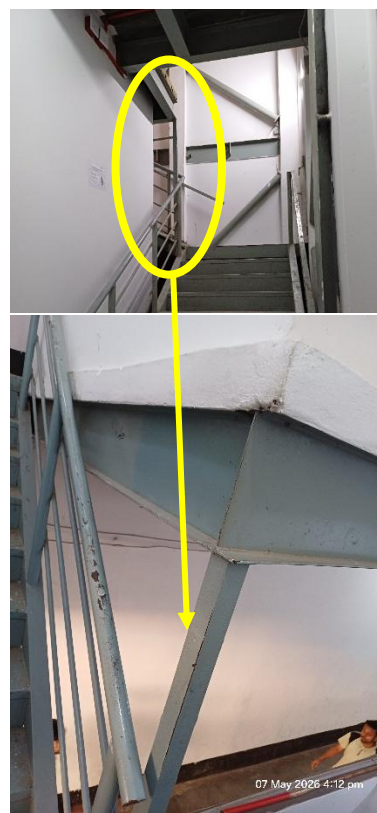
**Observation-07:** Inadequate member size & connection of vertical posts (Building-5).

**Description:** Additional vertical posts were observed with a non-engineered connection to support the cantilever floor member at the stair location and the stair landing locations. Also, the vertical posts are of an inadequate size. The building engineer is required to assess those members and connections for all types of loading (required vertical and lateral loadings) as per BNBC and incorporate remedial action (if required).

| 15. | Inadequate member size & connection of vertical posts (Building-5). | The building engineer is required to assess those members and connections for all types of loading (required vertical and lateral loadings) as per BNBC and incorporate remedial action (if required). | within 6 weeks |

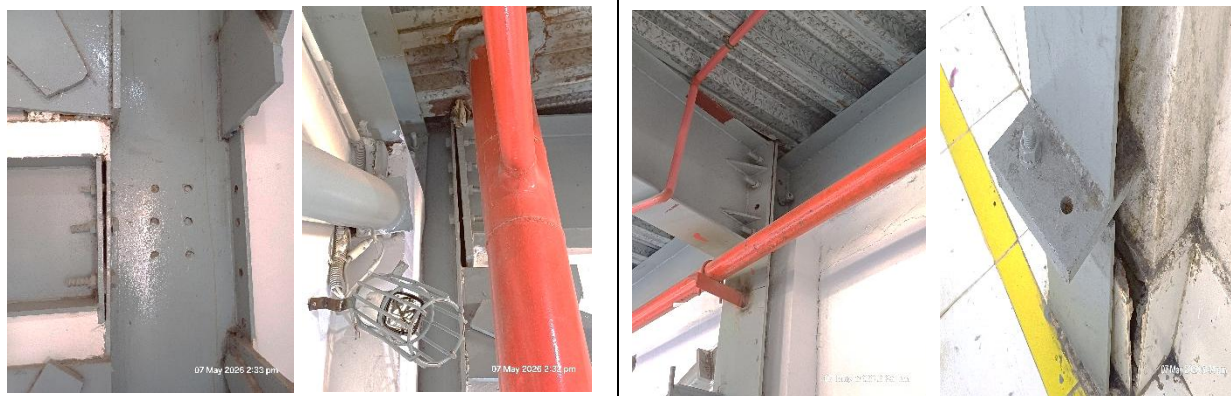
**Observation-08:** Stress in connection (missing bolts & significant connection gaps) (Building-5).

**Description:** Stresses are observed in many connections along with missing bolts and connection gaps. The building engineer is required to assess all the connections, incorporate remedial action where required, and submit to RSC for review. Also, the building engineer is required to install the missing bolt and remove the connection gap with a suitable method.

| 16. | Stress in connection (Missing bolts and significant connection gaps) (Building-5). | The building engineer is required to assess all the connections, incorporate remedial action where required, and submit to RSC for review. Also, the building engineer is required to install the missing bolt and remove the connection gap with a suitable method. | within 6 weeks |

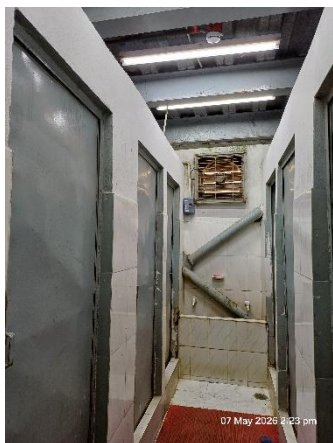
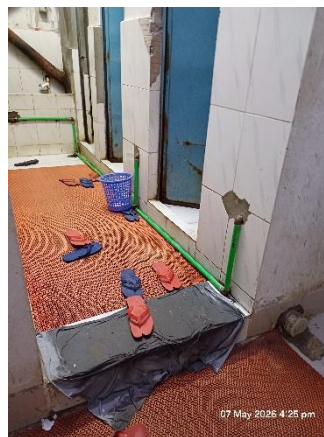
**Observation-09:** Discrepancy and lack of information in as-built drawings (Building-5).

**Description:** The thickness and height of the brick wall, built up information, are not shown in the drawing. In addition, the detailed dimensions of the wall, wall thickness, cantilever extension length, and details of the stair & stair top framing are not shown clearly in the drawings. The building engineer is required to survey the as-built condition and prepare an accurate set of as-built drawings (including verification of foundation size and thickness; verification of short column rebar & grade beam size and rebar) and submit them to RSC for review.

| 17. | Discrepancy and lack of information in as-built drawings (Building-5). | The building engineer is required to survey the as-built condition and prepare an accurate set of as-built drawings (including verification of foundation size and thickness; verification of short column rebar & grade beam size and rebar) and submit them to RSC for review. | within 6 weeks |

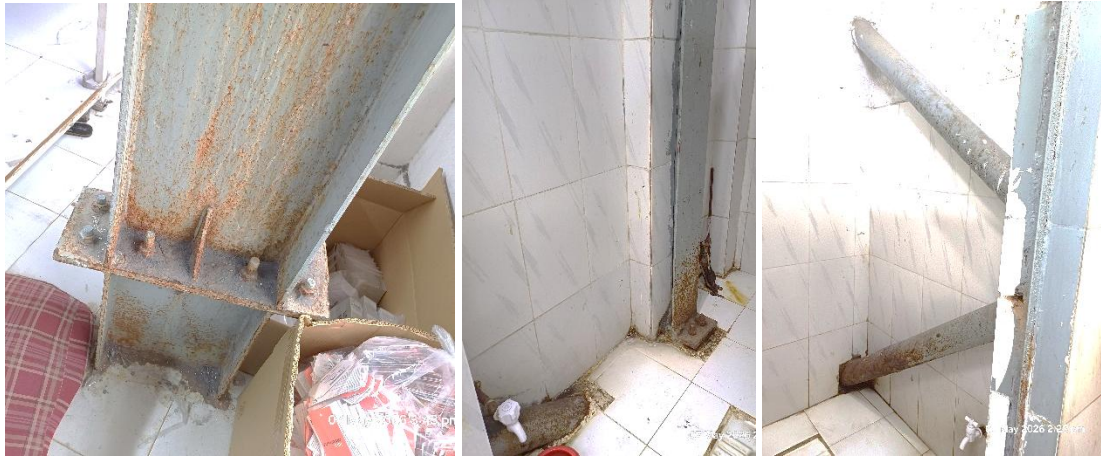
**Observation 10: Corrosion on steel columns & bracing (Building-5).**

**Description:** During inspection, severe corrosion was observed on steel columns and bracings. The building engineer is required to investigate the corrosion and the section loss from the column and the bracing member and repair it with a suitable method (if required). Also, the building engineer is required to remove rust and apply anti-corrosive coating where required.

| 18. | Severe corrosion on steel columns & bracing (Building-5). | The building engineer is required to investigate the corrosion and the section loss from the column and the bracing member and repair it with a suitable method (if required). Also, the building engineer is required to remove rust and apply anti-corrosive coating where required. | within 6 weeks |

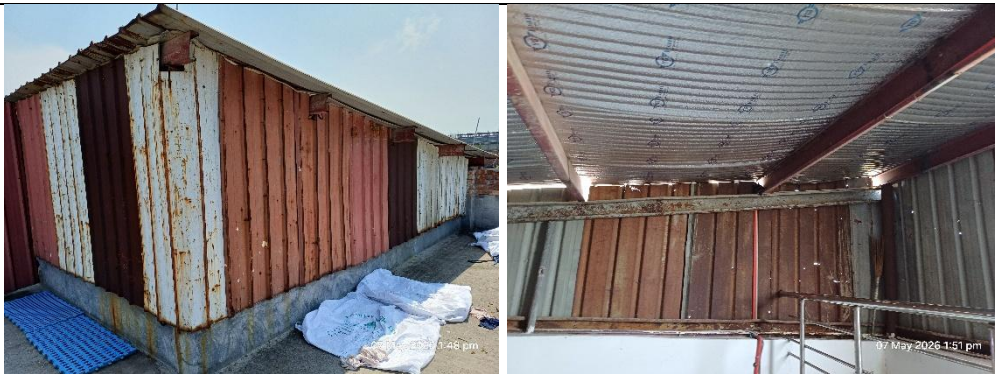
**Observation 11: Non-engineered stair top shed (Building-5).**

**Description:** A non-engineered & rusty stair top canopy was observed. The building engineer is required to assess the stair top canopy for all types of loadings and replace it with an engineered one as part of remediation (if required) and submit the required assessment along with the remedial plan to RSC for review. Upon acceptance from RSC, carry out required remedial works (if required).

| 19. | Non-engineered stair top shed (Building-5). | The building engineer is required to assess the stair top canopy for all types of loadings and replace it with an engineered one as part of remediation (if required) and submit the required assessment along with the remedial plan to RSC for review. | within 6 weeks |
| 20. | | Upon acceptance from RSC, carry out required remedial works (if required). | within 6 months |

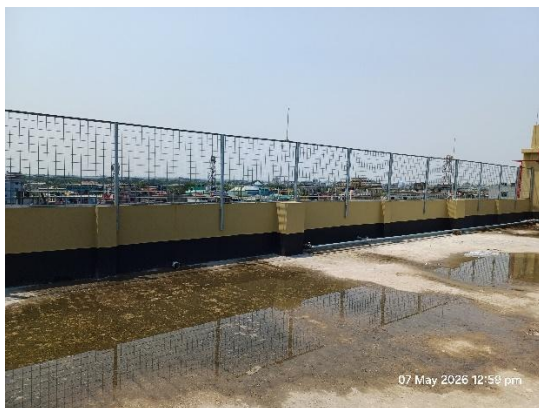
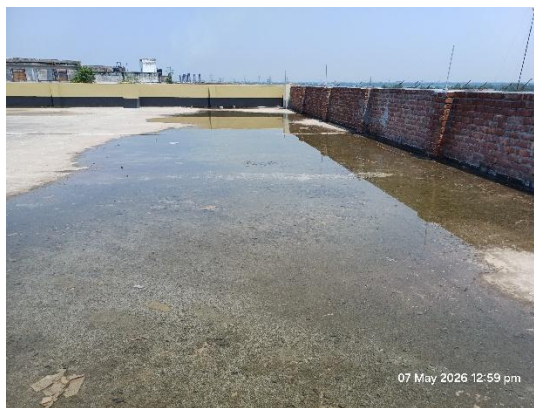
**Observation-12: Water ponding, & lack of a proper drainage system on the roof of Building-5 & Building-6.**

**Description:** Water ponding was evident on the roof of Building-5 & Building-6. Provide a waterproofing layer on the roof and maintain the necessary slope to improve the roof drainage system.

| 21. | Water ponding, & lack of a proper drainage system on the roof of Building-5. | Provide a waterproofing layer on the roof and maintain the necessary slope to improve the roof drainage system. | within 6 weeks |

| 30. | Water ponding & lack of a proper drainage system on the roof of Building-6. | Provide a waterproofing layer on the roof and maintain the necessary slope to improve the roof drainage system. | within 6 weeks |

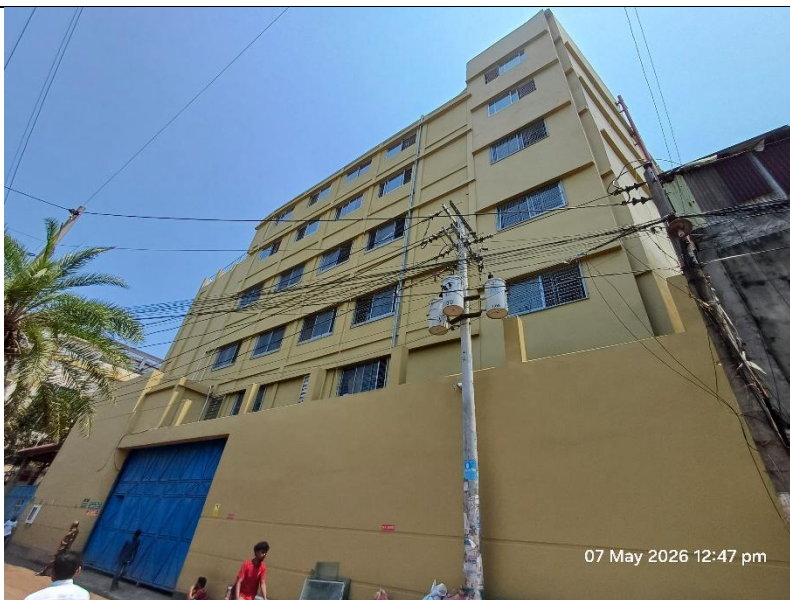
**Observation 13:** High stress in the column, and lack of design documents (Building-6).

**Description:** The columns were found to be highly stressed above the normal design limit in cursory calculations. Building engineer is required to review the design load and column stress **immediately**. A Detailed Engineering Assessment (DEA) is required to commence **immediately**.

No material test reports were available. The building engineer is required to review the design, load, seismic requirements, framing system, and incorporate necessary measures as per Section 1.3.4; Section 1.3.5; Section 1.5.4.2; Section 1.5.4.3 & Section 2.5.5 of BNBC 2006 and update the analysis and design report in accordance with Section 1.9.1 of BNBC 2006. Moreover, the necessary documentation for the confirmation of material strength was not available. Verify concrete strength by taking 100 mm diameter cores from the lower-tier column, beam-slab, **immediately** (Min 4 nos from each type of member).

Also, no as-built drawings were found on-site. The building engineer is required to produce accurate and detailed as-built drawings, including foundation size and thickness verification, rebar scan, and verification of column and beam rebar diameter **immediately**.

| 22. | High stress in the column, and lack of design documents (Building-6). | The building engineer is required to review the design load and column stress <b>immediately</b> . A Detailed Engineering Assessment (DEA) is required to commence <b>immediately</b> . | Immediate |
| 23. | | Verify concrete strength by taking 100 mm diameter cores from the lower-tier column, beam-slab <b>immediately</b> (Min 4 no's from each type of member). | Immediate |
| 24. | | The building engineer is required to produce accurate and detailed as-built drawings, including foundation size and thickness verification, rebar scan, and verification of column and beam rebar diameter <b>immediately</b> . | Immediate |

| 25. | | The building engineer is required to review the design, load, seismic requirements, framing system, and incorporate necessary measures as per Section 1.3.4; Section 1.3.5; Section 1.5.4.2; Section 1.5.4.3 & Section 2.5.5 of BNBC 2006 and update the analysis and design report in accordance with Section 1.9.1 of BNBC 2006. | within 6 weeks |
| 26. | | Implement remediation work if required. | within 6 months |

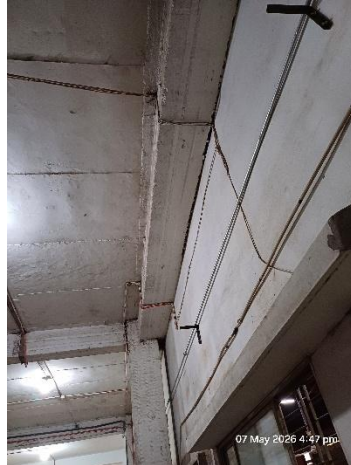
**Observation-14:** Offset beam on the ground floor roof (Building-6).

**Description:** Offset beams' adequacy and detailing need to be incorporated in the DEA report.

| 27. | Offset beam on the ground floor roof (Building-6). | Offset beams' adequacy and detailing need to be incorporated in the DEA report. | within 6 weeks |

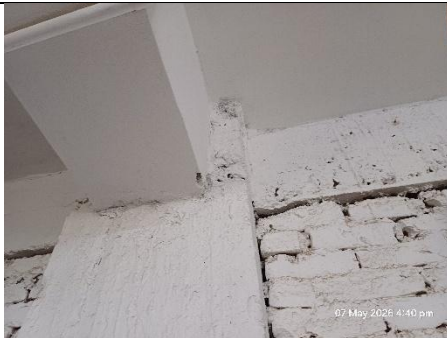
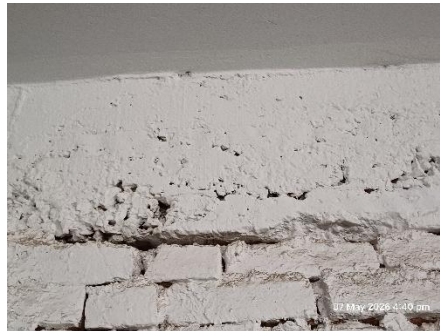
**Observation-15:** Poor Concrete Quality (honeycomb & segregation were observed) (Building-6).

**Description:** Honeycomb and segregation were found on the column and beam; construction quality is required to be verified through appropriate NDT tests.

| 29. | Poor Concrete Quality (honeycomb & segregation were observed) (Building-6) | Honeycomb and segregation were found on the column and beam; construction quality is required to be verified through appropriate NDT tests. | within 6 weeks |

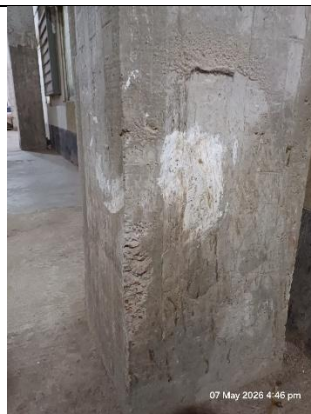
**Observation 16:** Damaged column due to trolley/vehicle impact (Building-6).

**Description:** Repair the damaged column and provide necessary safety guards and impact protection barrier to the column at all concerned locations.

| 31. | Damaged column due to trolley/vehicle impact (Building-6). | Repair the damaged column and provide necessary safety guards and an impact protection barrier to the column at all concerned locations. | within 6 weeks |

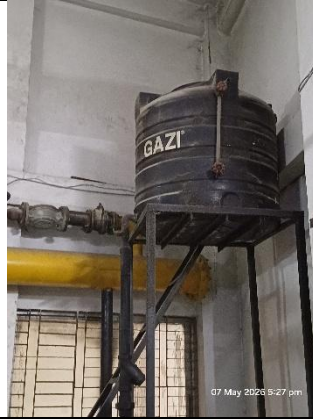
**Observation 17:** Lack of anchorage/brace of non-structural element (Water tank) (Building-4).

**Description:** Provide necessary safety guards (anchor/brace) to the water tank at the ground floor.

| Item No | Observation | Action Plan | Timeline |
|---|---|---|---|
| 7. | Lack of anchorage/brace of non-structural element (Water tank) (Building-4) | Provide necessary safety guards (anchor/brace) to the water tank at the ground floor. | within 6 weeks |

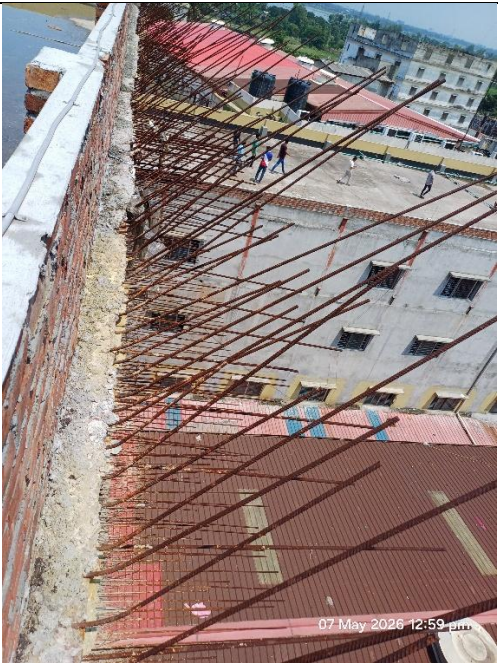
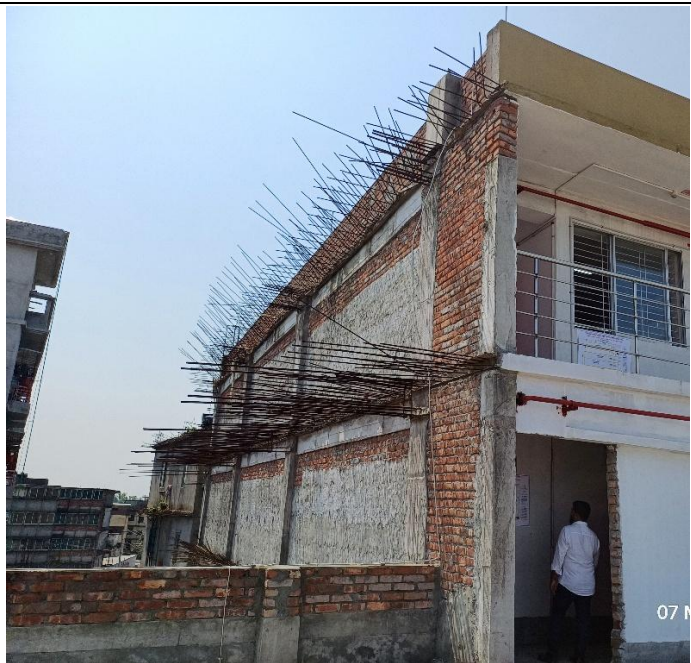
**Observation 18:** Exposed rebar (Building-6).

**Description:** During the inspection, exposed rebar was found to be corroded. The building engineer is required to remove rust and apply anti-corrosive coating to all exposed rebar.

| 32. | Exposed rebar (Building-6). | The building engineer is required to remove rust and apply anti-corrosive coating to all exposed rebar. | within 6 weeks |
