# EPYLLION STYLE LTD. (EXTENSION 2)

Bahadurpur, Bhawal, Mirzapur

7 May 2026

## Structural Inspection Report

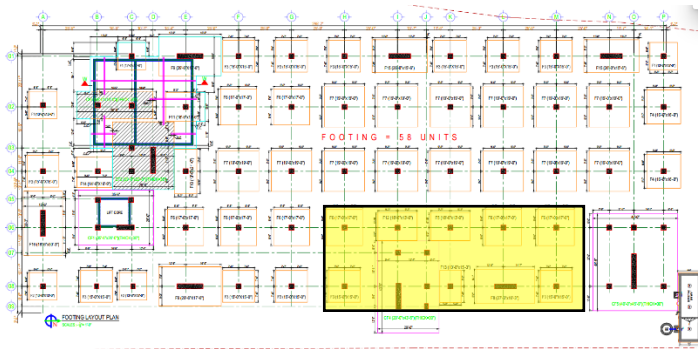
### Observation-01: Punching shear stress in foundation exceeds normal design limit (Building 1).

**Description:** cursory calculations indicate that some of the footings are experiencing punching shear stresses marginally exceeding the normal design limit, considering the prepared live load plan and the design concrete strength. The building engineer is required to review the design loads and foundation stresses in accordance with BNBC 2020 and submit the revised design documents to RSC for review.

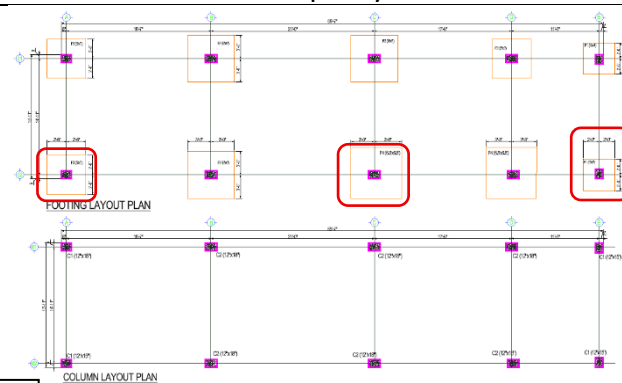
Building 1  
column

### Observation-02: Discrepancy in foundation size of mezzanine floor (Building 1)

**Description:** During inspection, the foundation of self-supported mezzanine floor was overlapped with the main building foundation as per provided drawing. The building engineer is required to survey the whole structure and update the as-built drawing and design documents as per on site condition and submit to RSC for review.

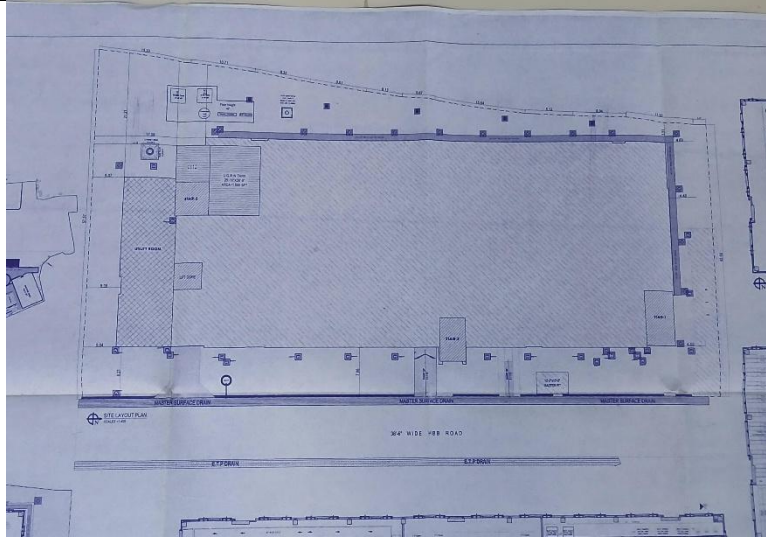
**Observation-03: Lack of building permit (Building 2)**

**Description:** During the inspection, the building permit of local authority was not found. The factory is required to obtain a building permit from the BNBC prescribed local authority.

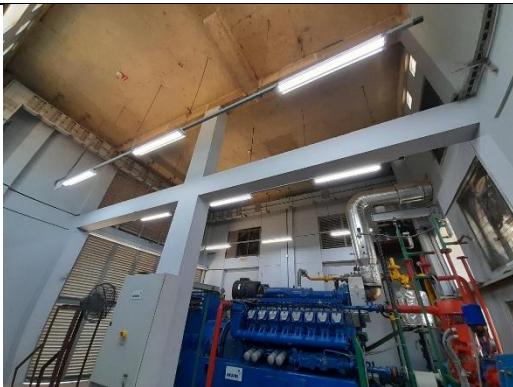
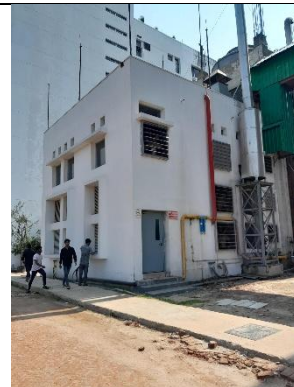
**Observation-04: Lack of Design Report (Building 2 - Generator Building)**

**Description:** As per BNBC, every building or structure designed shall have its design documents prepared in accordance with the provision of Section 1.9.1. The design document shall include a design report, and a set of structural drawings, which shall be prepared in compliance with section 1.9.1 as per BNBC. At the time of inspection, design documents (design report) were not available which are required to be prepared in compliance with section 1.9.1 (Part-6, BNBC 2020). Incorporate check of column slenderness issue in the design report.

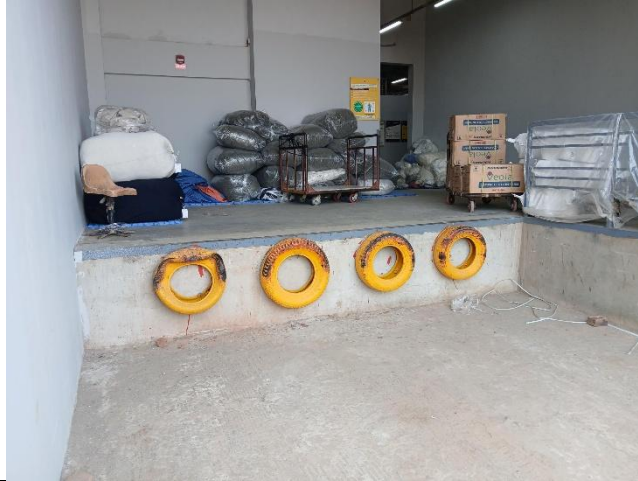
**Observation-05:** Possible falling hazard at the loading and unloading platform (Building 1)

**Description:** No barrier was found at elevated platform of loading unloading zone. The building engineer is required to provide mobile barrier/railing to the elevated platform to mitigate the falling hazard.

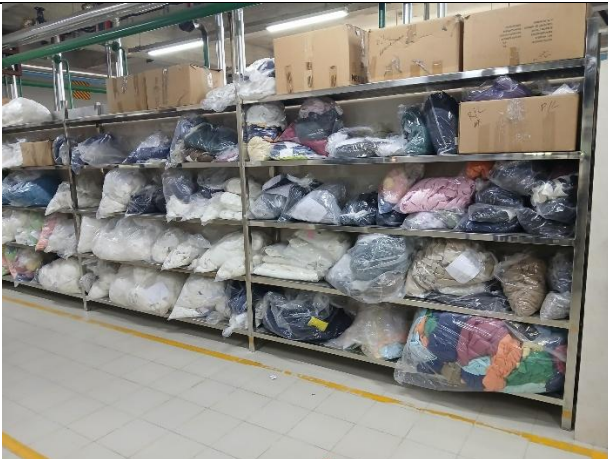
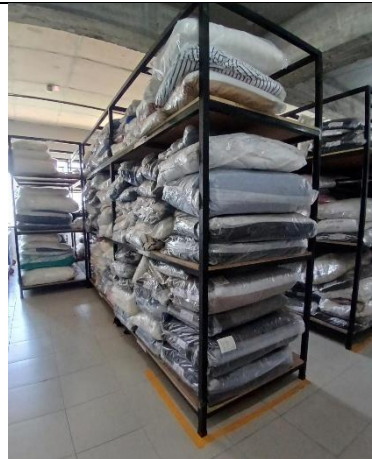
**Observation-06:** Lack of anchorage in nonstructural elements (Building 1)

**Description:** Unanchored racks observed on the production floor. The building engineer is required to provide adequate anchorage to those racks to provide stability.
