# **FIRE SAFETY INSPECTION REPORT**

**RGR SWEATER LTD.**

**ACCORD ID: 10259**

November 12, 2015

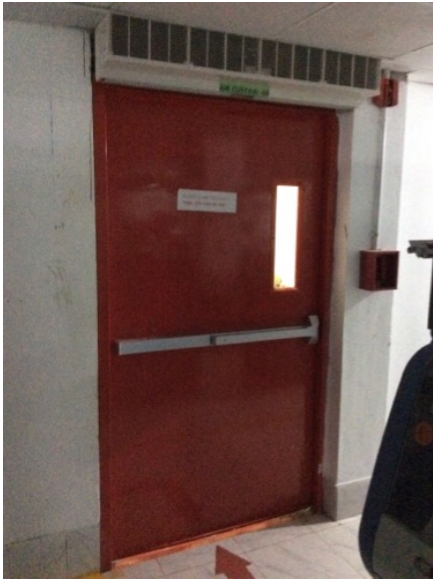
| No. | Category | Finding | Recommendation | Remediation Timeframe |
|---|---|---|---|---|
| F-1 | Fire Rated Construction | Proper certification was not available for fire rated doors installed in the factory. | Submit proper certifications for installed fire doors to the ACCORD for approval. If not available, or certification is not approved, install new, properly certified fire rated doors in accordance with ACCORD direction. | Immediately |

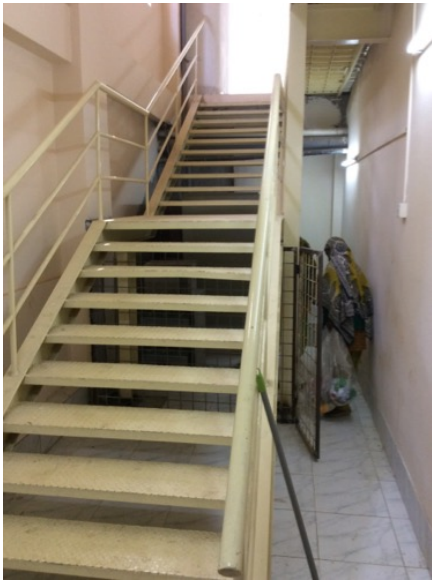
| No. | Category | Finding | Recommendation | Remediation Timeframe |
|---|---|---|---|---|
| F-2 | Fire Rated Construction | Electrical panels were located in the southeast exit stair enclosure. | Remove and re-locate all electrical panels from exit stair enclosures. | Within 3 months |

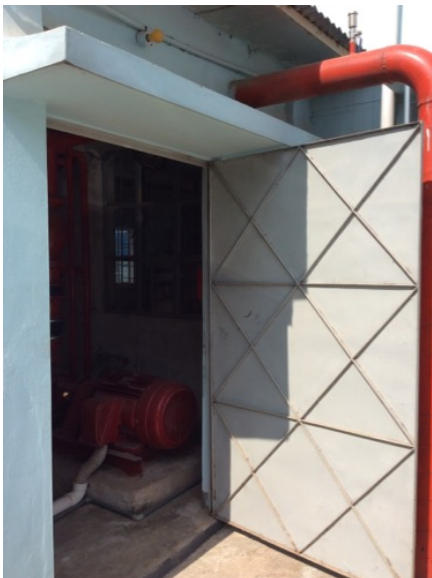
| F-3 | Fire Rated Construction | The fire pump room is not provided with adequate fire separation. | Provide fire pump room with 2 hr rated fire separation when not sprinklered and 1 hr rated fire separation when provided with automatic sprinklers, in accordance with NFPA 20. | Within 3 months |

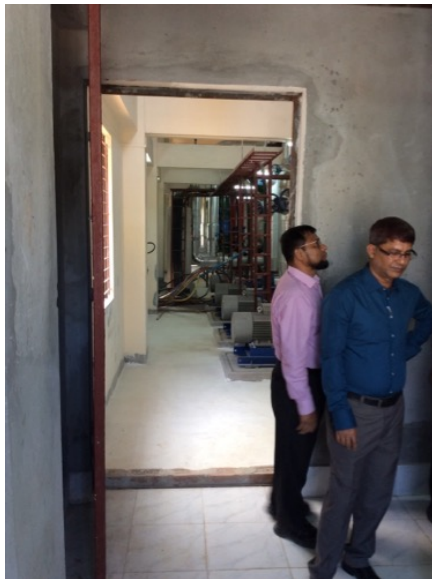
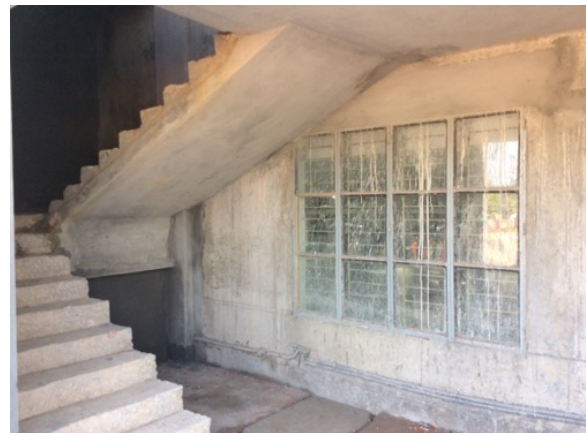
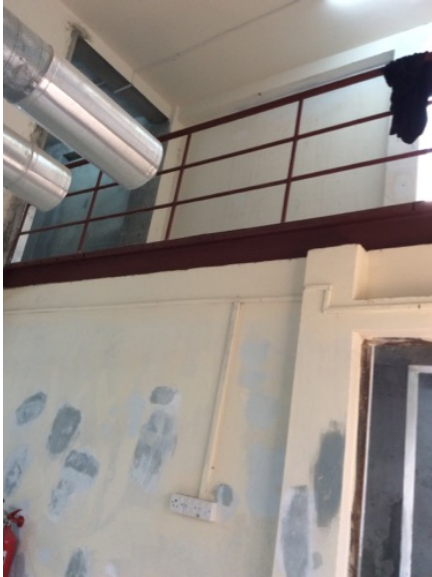
| F-4 | Fire Rated Construction | Exit stair are not separated from other spaces on each floor by fire-rated construction due to unprotected openings and penetrations. | Separate the exit stairs from from work areas and other building spaces on all floor levels by minimum 2-hr fire-rated construction. Provide minimum 1.5-hr fire rated doors and seal all unprotected openings and penetrations to maintain the fire seperation. | Within 3 months |

Ensure that all fire doors are self-closing and positive latching, and are provided with fire exit (panic) hardware where serving production floors or assembly occupancies. If fire doors are required to be held open for functional reasons, provide automatic-closing devices tied to the fire alarm system.

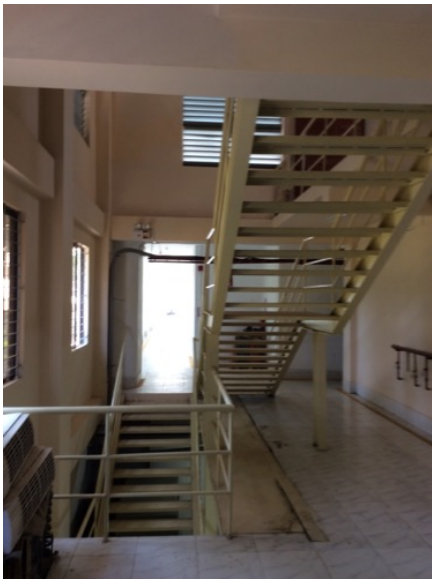
| F-5 | Fire Rated Construction | The southeast exit stair on all floors were open to factory areas due to unenclosed stairwells. | Separate the exit stairs from from work areas and other building spaces on all floor levels by minimum 2-hr fire-rated construction. | Within 3 months |

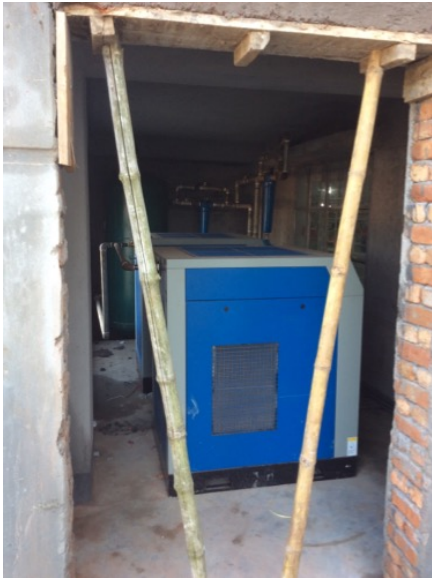
| F-6 | Fire Rated Construction | The compressor room is not separated by fire-rated construction due to openings and non-rated doors. | Separate the compressor room by a minimum 1-hr fire-rated construction for non-high rise. Seal and/or protect all openings to maintain the required fire separations. Provide proper ventilation and consult a qualified engineer. | Within 3 months |

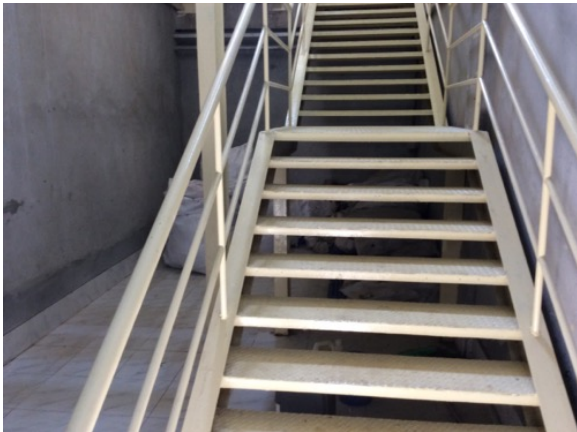
| F-8 | Egress | Storage was located in the southwest exit stair. | Remove all storage from exit stairs. | Immediately |

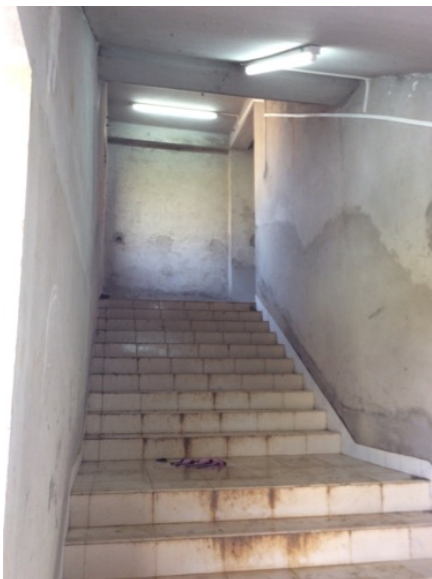
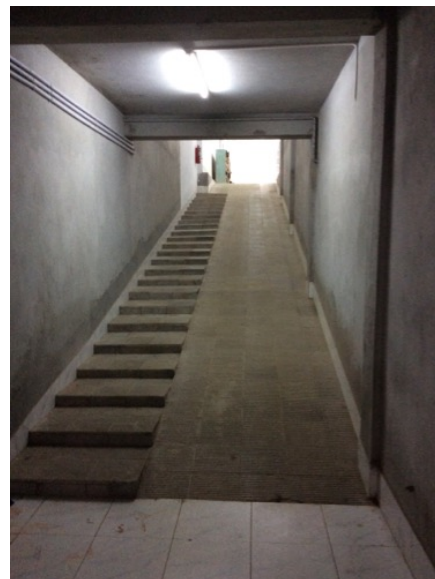
| F-9 | Egress | Handrails are not provided on both sides of the exit stair and ramp. | Provide handrails on both sides of the exit stair and ramp. New handrails shall have a minimum height of 865 mm (34 in.) and a maximum height of 965 mm (38 in.) as measured from the leading edge of the tread. Intermediate handrails shall be provided when the stair width exceeds 2.2 m (87 in.) . | Within 3 months |

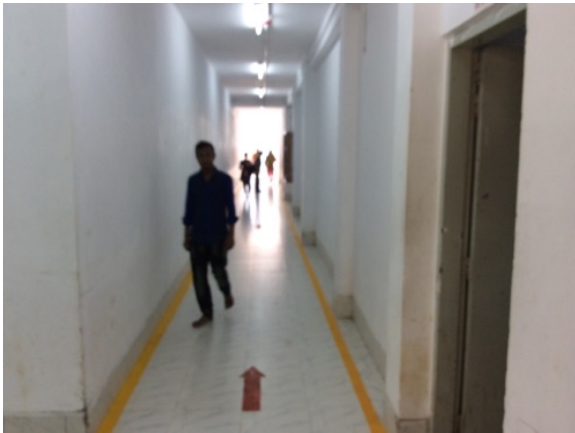
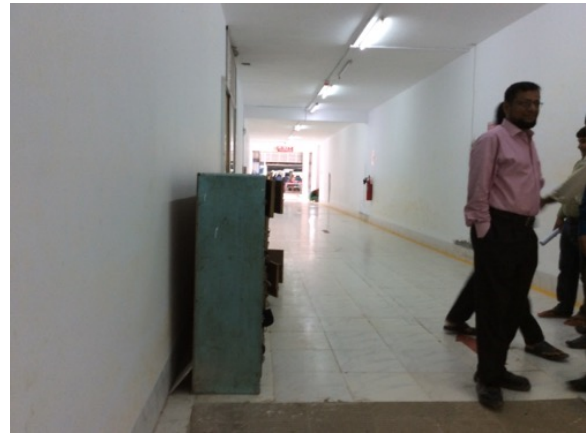
| F-10 | Egress | Exit stairs do not discharge directly to the outside. | Modify stair to discharge directly outside or provide 2-hr fire-rated exit passageway leading directly outside (vestibules to separate any storage areas). | Within 6 months |

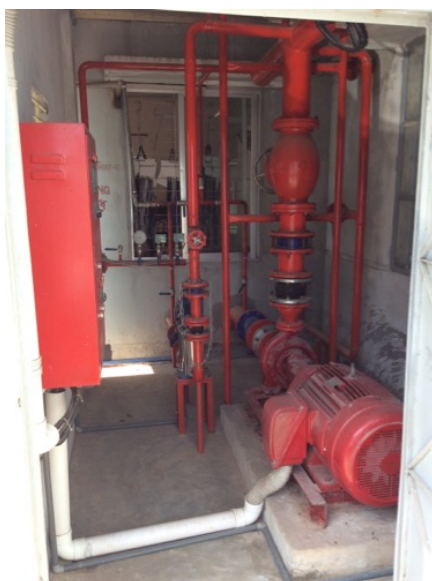
| F-11 | Fire Protection | Fire pump installation requires detailed review to confirm compliance with NFPA 20 and ACCORD standards. | Submit as-built drawings, testing records, equipment certification and other relevant documentation to the ACCORD for review and approval. | Within 1 month |

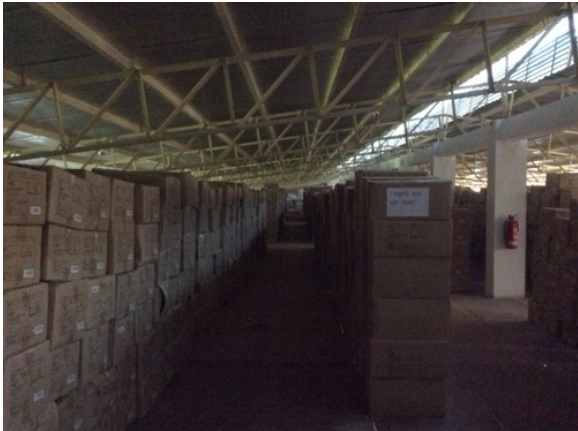
| No. | Category | Finding | Recommendation | Remediation Timeframe |
|---|---|---|---|---|
| F-1 | Fire Rated Construction | Areas used for combustible storage on mezzanine open to the factory are not properly defined and/or not within limits. | <p>Provide defined storage areas and limit the storage arrangement as follows:</p> <ul style="list-style-type: none"> <li>- Maximum height of 2.45m (8 ft) and maximum area of 23m<sup>2</sup> (250 ft<sup>2</sup>)</li> <li>- If sprinkler protected: maximum height of 3.66m (12 ft) and maximum area of 93m<sup>2</sup> (1000 ft<sup>2</sup>)</li> </ul> <p>Separate areas of unenclosed combustible storage by a minimum clear distance of 3m (10 ft).</p> | Within 3 months |
