# RGR Sweater Ltd

Madhakhala Shreepur, Gazipur  
(24.180929N, 90.435039E)

7<sup>th</sup> November 2015

# Observations

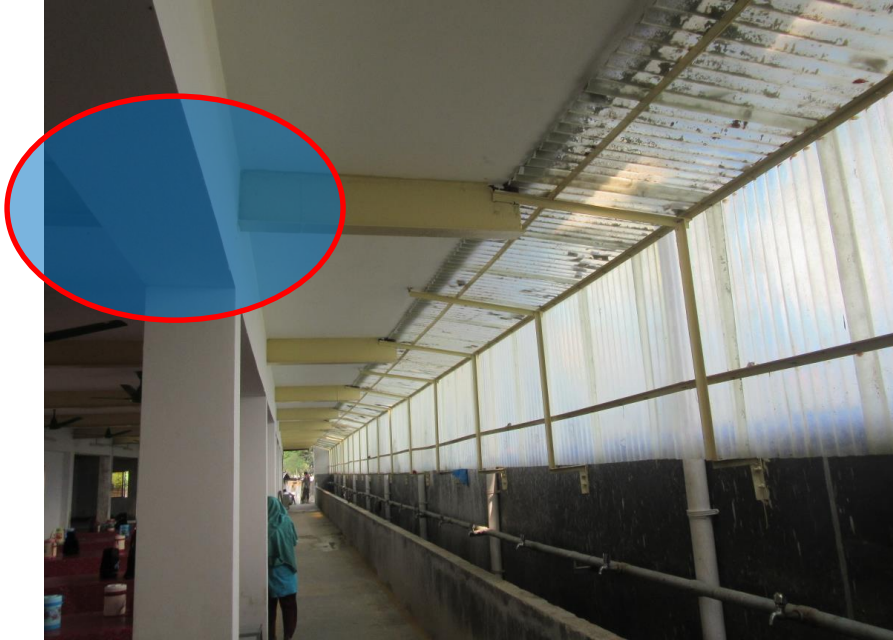
Discontinuous top reinforcement in the beam of ground floor

| Item No. | Observation | Recommended Action Plan | Recommended Timeline |
|---|---|---|---|
| 1 | Discontinuous top reinforcement on beams on the ground floor | Building Engineer to carry out a stability analysis of the Building 3. | 6-weeks |

**ITEM 1:** : Stability of the Building 3 needs to be verified by the building engineer.

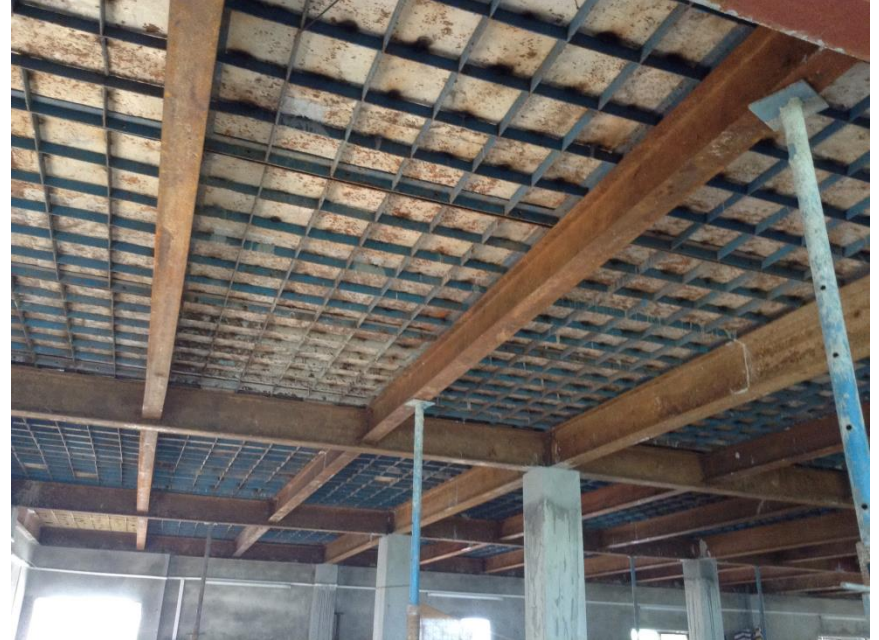
No vertical bracing observed

| Item No. | Observation | Recommended Action Plan | Recommended Timeline |
|---|---|---|---|
| 2 | Missing horizontal braces on the roof for lateral stability | Building Engineer to carry out a stability analysis and provide additional stability system. | 6-months |

**ITEM 2:** : Lateral stability of the roof for Building 2 needs to be verified by the Building engineer.
