# Cheng Yi Garments Industries Ltd

12 May 2026

## **1. Production Building**

## 4. Observation

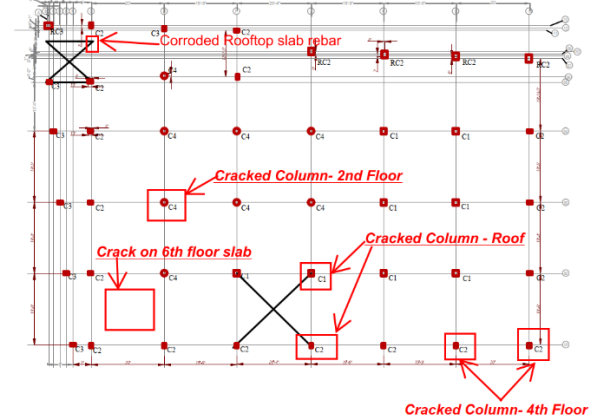
| <b>Observation-01:</b> Crack in column and slab that requires immediate action (Production Building) | |
| <p>Crack Layout</p> | <p>Spalling of Concrete due to corrosion</p> |
| <p><b>Description:</b> During the inspection, hairline cracks were found on the 2nd, 4th, and roof floors &amp; slabs (6th floor) in the 7-storied RC Production Building. Also, concrete spalling was found on the stair top slab soffit.</p> <p>The factory must immediately engage a qualified structural consultant to investigate the identified cracks. Any necessary safety measures suggested by the consultant must be implemented immediately to ensure safety.</p> <p>The building engineer is required to prepare a crack investigation report (including drawings, on-site investigation &amp; testing evidence, adequacy check, retrofitting scheme) and submit it to RSC for review.</p> <p>Upon acceptance from RSC, carry out remedial works (if any) as per the investigation report.</p> | |

| Item No | Observation | Action Plan | Timeline |
|---|---|---|---|
| 1. | Crack in column and slab that requires immediate action (Production Building) | The factory must immediately engage a consultant to investigate the cracks. Any safety measures, if required as suggested by the consultant, must be taken immediately to ensure safety. The consultant must perform a detailed concrete condition assessment to evaluate the extent of deterioration and to identify any potential impacts on the structural integrity of the concrete elements. | Immediate |
| 2. | | Building engineer is required to carry out the required NDT tests and prepare an investigation report. Submit the report to the RSC for review. | Immediate |
| 3. | | Implement remediation work if required. | within 6 weeks |

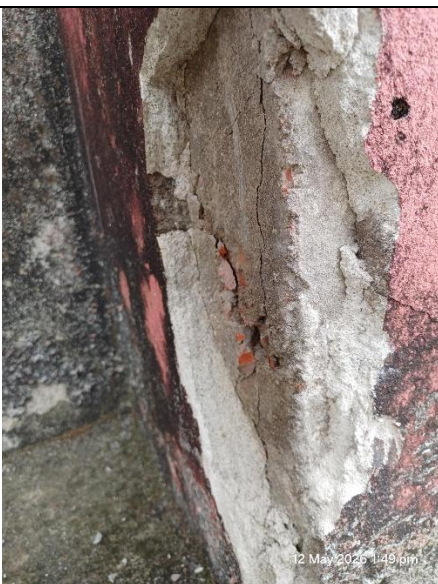
| <p>Crack on roof column 1</p> | <p>Crack on roof column 2</p> |

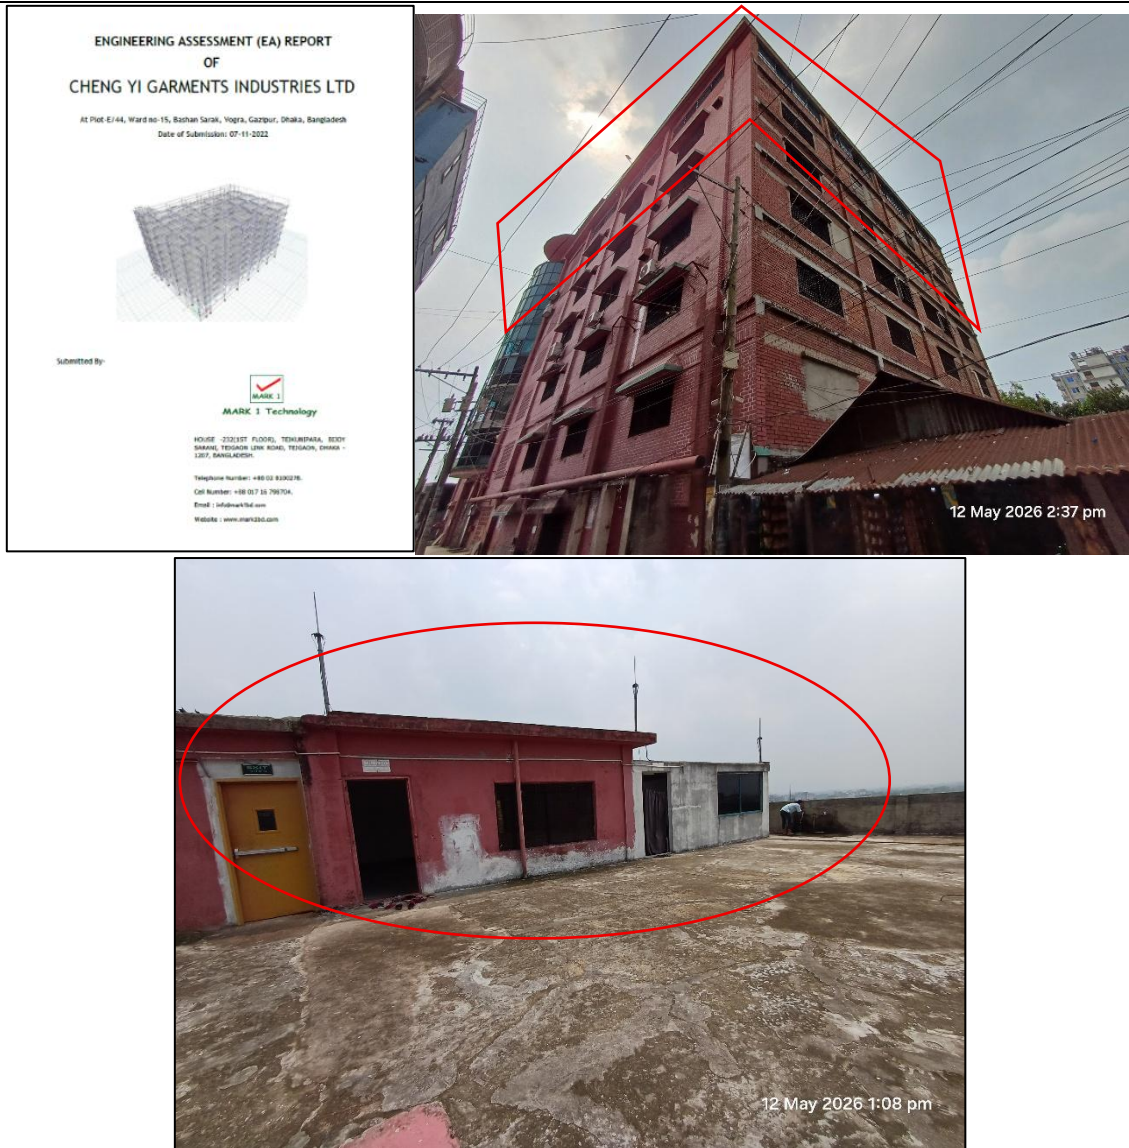
**Observation-02:** Lack of information in DEA documents (including DEA report, details of phased construction) of the Production Building.

Roof top prayer room & 6<sup>th</sup> floor phased construction marked in Red

**Description:** The building was constructed in two phases. However, no such information has been included in the DEA report. Also, a detailed review is required for lateral loadings and serviceability requirements.

- The building engineer is required to incorporate the necessary information for phased construction & review the DEA, seismic requirements, framing system, and incorporate necessary measures (if necessary) as per Section 1.3.4; Section 1.3.5; Section 1.5.4.2; Section 1.5.4.3 & Section 2.5.5 of BNBC 2006 and update the analysis and design report in accordance with Section 1.9.1 of BNBC 2006.
- Also, the building engineer is required to incorporate necessary remedial works (if required).

| Item No | Observation | Action Plan | Timeline |
|---|---|---|---|
| 4. | Lack of information in DEA documents (including DEA report, details of phased construction) of the Production Building. | The building engineer is required to incorporate the necessary information for phased construction & review the DEA as per BNBC 2006 and update the analysis and DEA report in accordance with Section 1.9.1 of BNBC 2006. | within 6 weeks |
| 5. | | Implement any required remediation work after acceptance from RSC. | within 6 months |

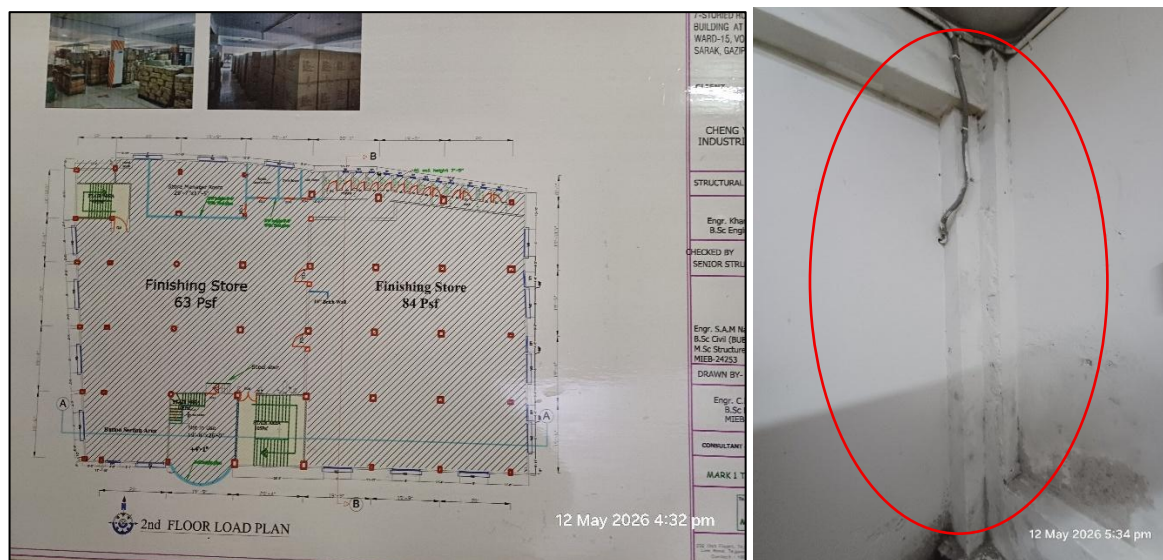
**Observation-03:** Inconsistency in DEA documents (load plan, material test reports) of the Production Building.

**Description:** A 4 kPa & 3 kPa (84 psf & 63 psf) floor live load is considered in the design for dedicated storage on different floors.

Moreover, the necessary documentation to confirm material strength was not adequate. A total of 4 cores were available from the ground-floor column.

However, the core location couldn't be verified on-site. One of the four columns was confined with a brick wall on three faces and had no access to the remaining face (perimeter column), where core sampling might not be plausible.

Another one was confined with a brick wall on two faces and had no access to one face (perimeter column), and the remaining face showed no sign of core sampling. The remaining two-column location (marked in the core layout) was found to be in a retrofitted condition.

Also, no cores were taken from the beam/slab member and upper floor level (constructed in 2<sup>nd</sup> phase)

The building was constructed in the years 2000-2005, & no rebar test report was available.

- The building engineer is required to follow the floor live load as per BNBC 2006 (i.e., 6 kPa for storage).

- The building engineer is required to validate the core location or submit evidence of core cutting.

- The building engineer is required to verify the concrete strength by taking cores (100 mm dia, at least 4 nos for each type of member and from each construction phase) from the columns, beams/slabs of the Production Building.

- The building engineer is required to verify the rebar strength (used in the building) through necessary testing by taking rebar samples from the non-retrofitted portion of the building.
- Also, the building engineer is required to incorporate necessary remedial works (if required).

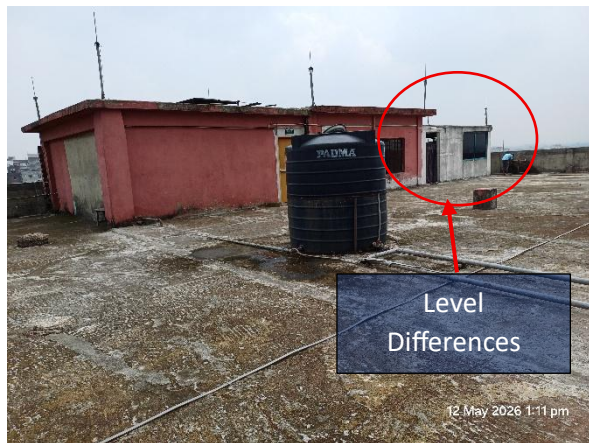
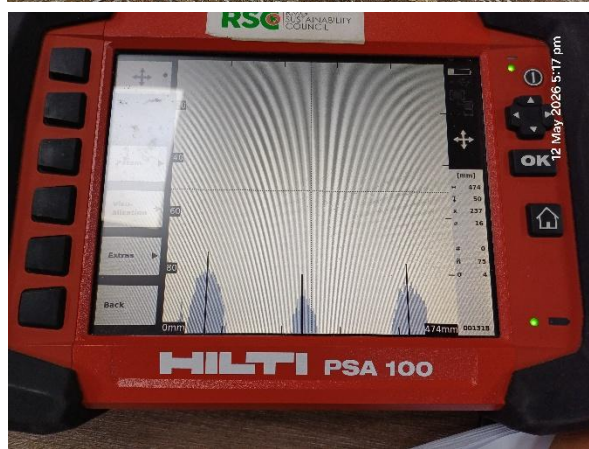
(Scan of RC2 Column short face, at Grid Point J8 of 4<sup>th</sup> floor)

**Observation-04: Mismatch in as-built drawings (Production Building).**

Also, mismatches were observed between the drawings and the scanned result in the rebar quantity of the column's main rebar as follows:

- main rebar found 8 nos instead of 12 nos in C1 column at 2<sup>nd</sup> floor level grid location 3L
- main rebar found 8 nos instead of 12 nos in C4 column at 2<sup>nd</sup> floor level grid location H4
- main rebar found 3 nos in short direction instead of 4 nos in RC2 at 4<sup>th</sup> floor level grid location J8
- main rebar found 10 nos instead of 12 nos in C4 column at 5<sup>th</sup> floor level grid location K4

The building engineer is required to survey the as-built condition of whole structure, prepare an accurate set of as-built drawings (including verification of foundation size and thickness; verification of column & beam rebar), and submit them to RSC for review.

| <b>11.</b> | Mismatch in as-built drawings (Production Building) | The building engineer is required to survey the as-built condition, prepare an accurate set of as-built drawings, and submit them to RSC for review. | within 6 weeks |

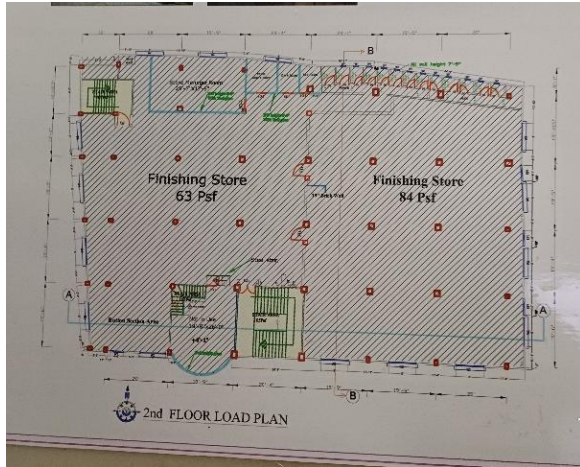
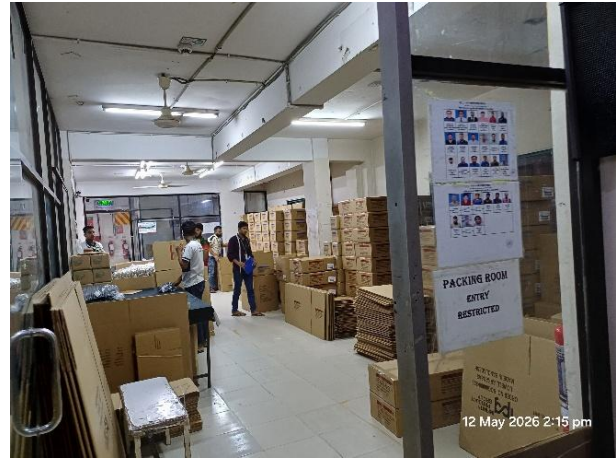
**Observation-05: Lack of load management (marking stack height) (Production Building).**

**Description:** Lack of proper load management was evident. Load height markings were found missing in some locations. Storage area loads were found to be considered as 4 kPa (84 psf) instead of 6 kPa (125 psf) as required by BNBC 2006.

The building engineer is required to prepare the load plan following NTPA guideline section 4.13; post the floor load plan on each floor, provide load restriction height markings, signage on the storage area, and manage the floor load plan as per the acceptable load limits of BNBC 2006.

| <b>12.</b> | Lack of load management (Production Building) | Produce and actively manage the load plan as per the capacity of the floor following BNBC 2006. | within 6 weeks |

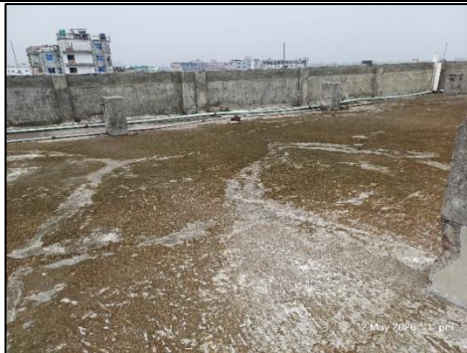
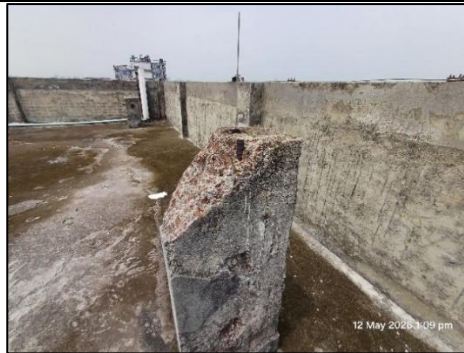
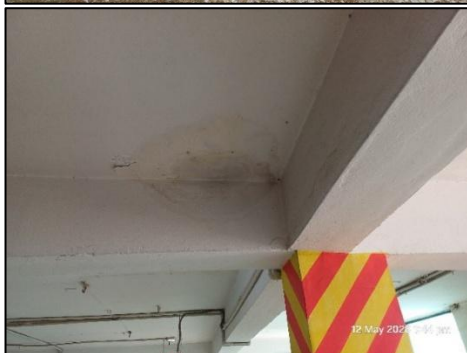
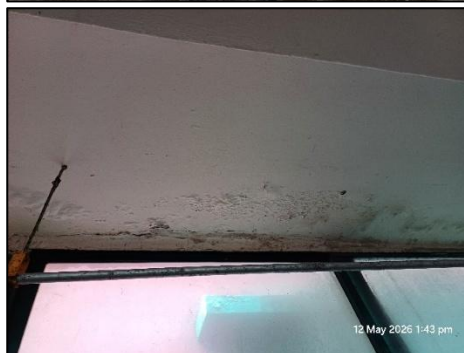
**Observation-06: Lack of a drainage system on the roof (water ponding, improper slope) and Dampness on the wall & slab/beam of the Production Building.**

**Description:** Signage of water ponding was evident on the roof of the Production Building. Also, water-related dampness was observed on the wall. Provide a waterproofing layer on the roof and maintain the necessary slope to improve the roof drainage system. Also, seal the source of water and repair the water-related dampness with a suitable method.

| <b>13.</b> | Lack of a drainage system on the roof (water ponding, improper slope) (Production Building) | Provide a waterproofing layer on the roof and maintain the necessary slope to improve the roof drainage system. | within 6 weeks |
| <b>14.</b> | Dampness on the wall & slab/beam (Production Building) | The building engineer is required to seal the source of water and repair the water-related dampness with a suitable method. | within 6 weeks |

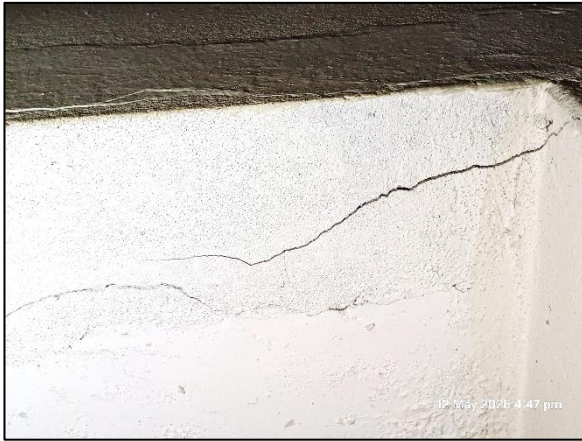
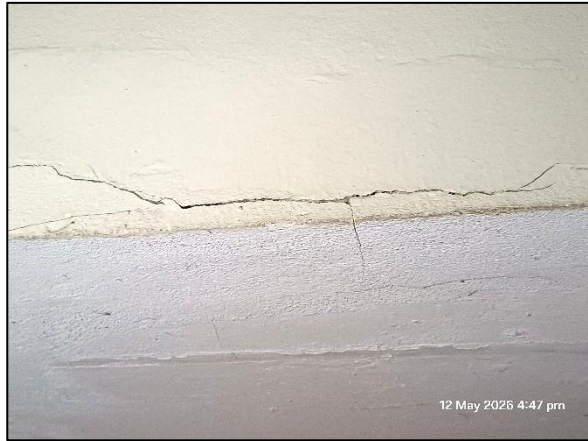
**Observation-07:** Non-structural cracks on the brick wall & RC lintel.

**Description:** Non-structural cracks were observed on the wall & RC lintel at several locations. The building engineer is required to investigate the extent of the crack and repair it with a suitable method.

| <b>15.</b> | Non-structural cracks on the brick wall & RC lintel (Production Building) | The building engineer is required to investigate the extent of the crack and repair it with a suitable method. | within 6 weeks |

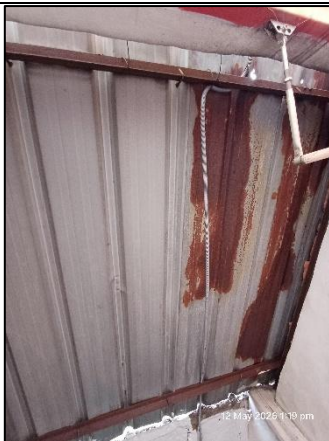
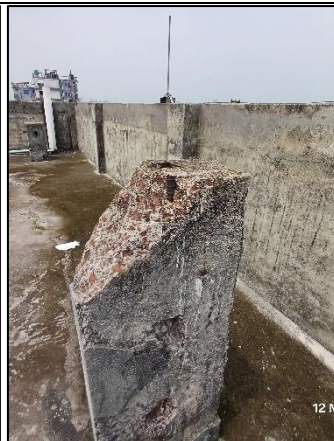
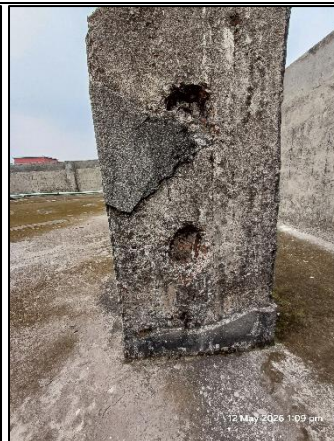
**Observation-08:** Exposed steel rebar on roof top & corroded steel canopy.

**Description:** Exposed rebars on the rooftop were observed, and rust was observed on the steel canopy. The building engineer is required to apply an anti-corrosive coating to the affected steel member.

| <b>16.</b> | Exposed steel rebar on roof top & corroded steel canopy (Production Building) | The building engineer is required to apply an anti-corrosive coating to the affected steel member. | within 6 weeks |

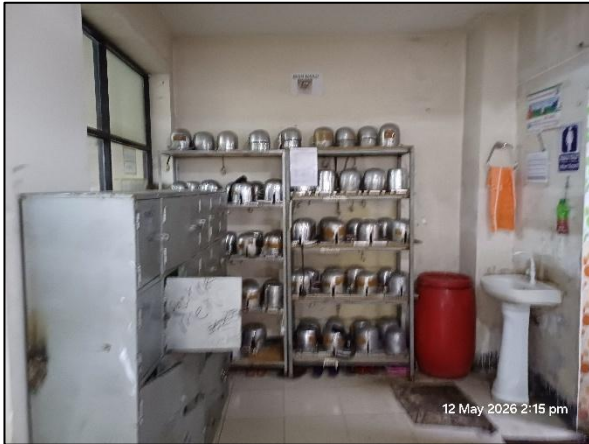
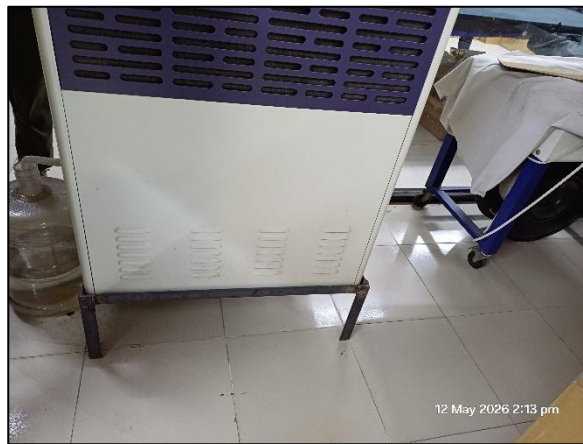
**Observation-09:** Lack of anchorage/brace at storage racks/ air cooler stand.

**Description:** Storage rack & non-structural element were found in unbraced condition/without anchorage. The building engineer is required to provide the necessary anchorage/brace for all non-structural elements.

| <b>17.</b> | Lack of anchorage/brace at storage racks/ air cooler stand (Production Building) | The building engineer is required to provide the necessary anchorage/brace for all non-structural elements. | within 6 weeks |

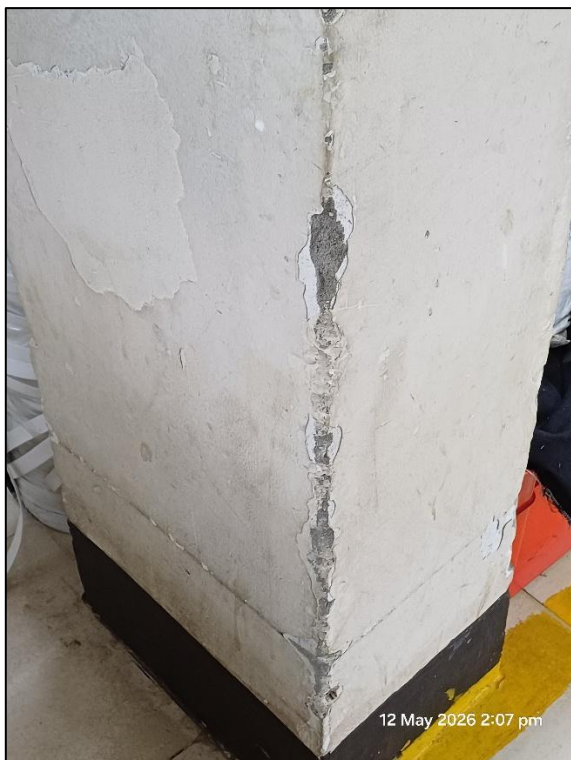
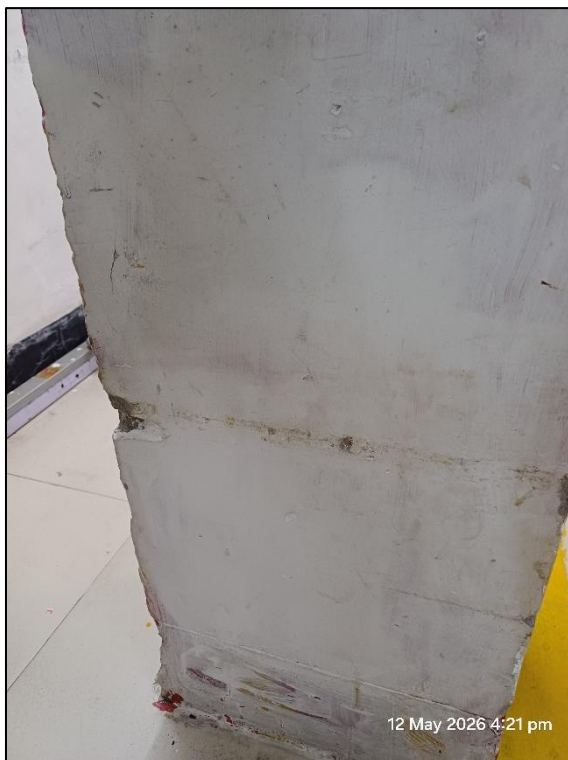
**Observation-10:** Lack of trolley impact protection on column/wall.

**Description:** Column damage due to trolley impact was observed during the inspection. The building engineer is required to provide a safety barrier at all potential trolley impact locations.

| <b>18.</b> | Lack of trolley impact protection on column/wall (Production Building) | The building engineer is required to provide a safety barrier at all potential trolley impact locations. | within 6 weeks |
