# Maxcom International Ltd

25.MARCH.2014

## Identified Priority 2 Concerns

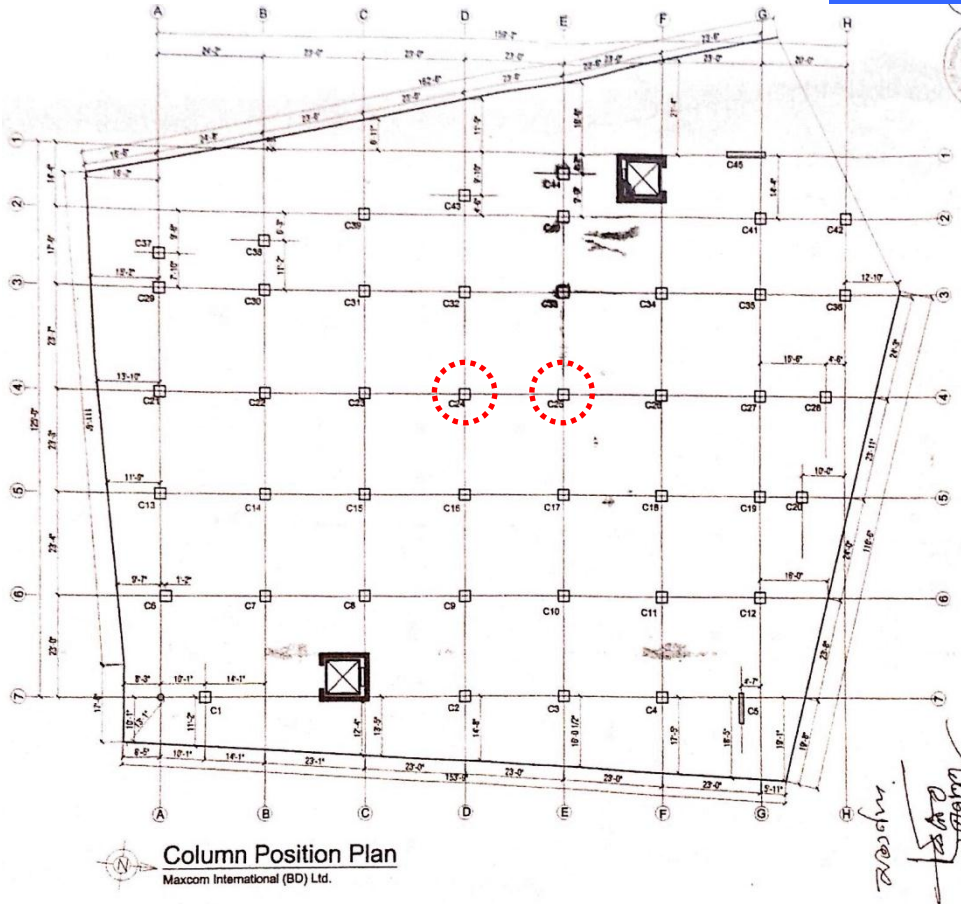
## 1<sup>st</sup> Priority 2 Concern

The main building is claimed to have an imposed load rating of 150psf per floor (7.18kPa). Having run the column run-down analysis, using 7.18kPa on all floors causes a **RED** warning. However, applying 10% live load reduction to the 1/F, and 20% live load reduction on 2/F to 8/F brings the column into an **AMBER** warning. Furthermore, reducing imposed load of 1/F to 8/F to 3.0kPa maximum live load returns the column to a **YELLOW** warning.

Fortunately, site conditions suggest an actual imposed load of much less than the design load, and so reducing the imposed load limit to 3.0kPa on all floors except G/F is considered reasonable.

Column unstable under full live load

- Ensure that all loads on all floors (except G/F) are kept within 3.0kPa, with the allowance for loading up to 7.2kPa in localised areas only
- Prepare loading plan for each floor identifying areas of the floor which can be loaded up to the original design loading capacity

- Maintain loading plan and ensure strict compliance with the loading conditions
