# INITIAL FIRE SAFETY INSPECTION REPORT

**EPYLLION STYLE LTD. (EXTENSION 2)**

**RSC ID: 26605**

**Date: 07-May-2026**

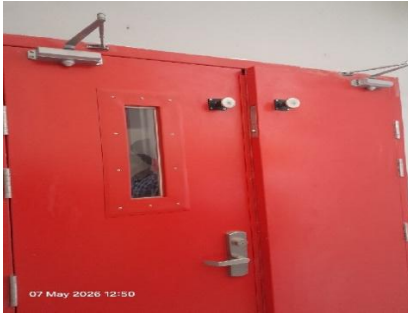
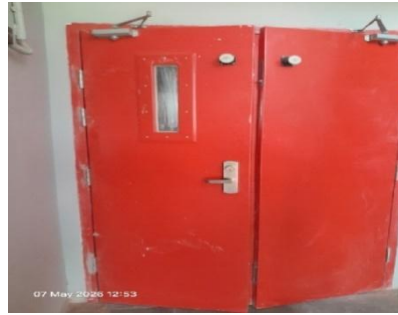
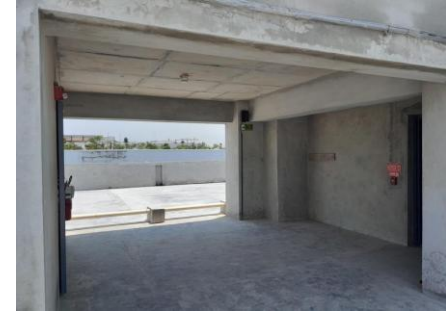
| SI No. | Category | Findings | Required Action | Remediation Time Frame |
|---|---|---|---|---|
| F-1 | Means of Egress | <p>The exit stair enclosures are not separated from work areas and other spaces on each floor by fire-rated construction.</p> <p><b>Location(s): Washing Building.</b></p> <p><b>Non-Compliance (not limited to): Fire door non-functionality, Opening from the Lift machine Room (roof).</b></p> | <p>The exit stair enclosure shall be provided with a minimum of 2-hr. fire resistance rating for buildings 4 or more stories. Provide 1.5 hr. fire rated door and seal all penetrations and openings by 2 hr. fire rated fire rated barrier construction for buildings with 4 or more stories in accordance with section 6.3.1.2 of RSC Technical Guidelines (Standard)<sup>1</sup> V1.0.</p> <p>Provide a fire-resistive rated assembly between the exterior exit stairs and the building up to 10 ft. beyond the end of the stair to achieve the required separation. The rated assembly shall be approved and/or designed by a qualified fire protection engineer.</p> <p>Ensure that the fire doors are self-closing and positive latching, and that they are provided with fire exit (panic) hardware where serving production floors. If fire doors are required to be held open for functional reasons, provide automatic closing devices tied to the fire alarm system.</p> <p>Keep proper datasheet &amp; certifications for installed fire doors &amp; accessories on-site for verification. The clearance under the bottom of a door shall be a maximum of 3/4 in. (19 mm).</p> | Within 3 Months |

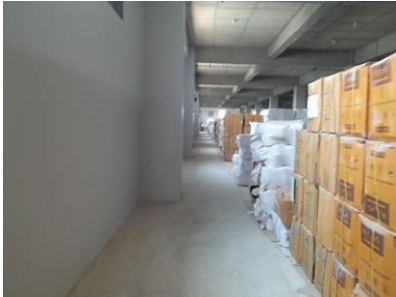
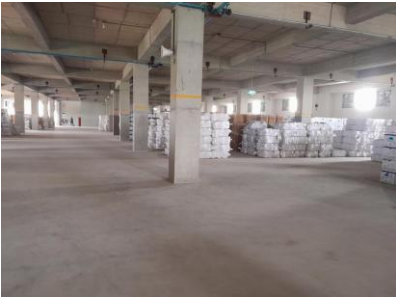
| F-3 | Means of Egress | <p>Aisles were found missing in several locations throughout the building.</p> <p><b>Location: Washing Building.</b></p> | <p>Provide minimum aisle widths of 36-in. Aisles mark shall be clearly visible.</p> | <p>Within 1 Month</p> |

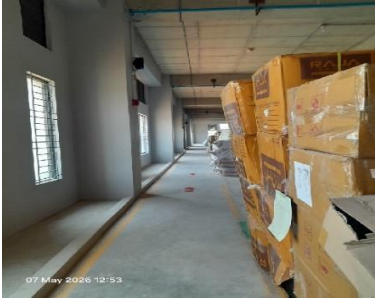
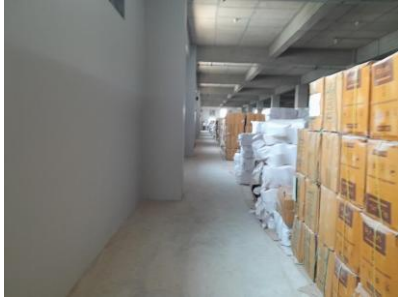
| F-4 | Means of Egress | <p>Directional signs are not provided where the direction of the path of travel to an exit has changed.</p> <p><b>Location(s): Washing Building.</b></p> | <p>Illuminated directional signs shall be provided where there is a change in the direction for the path of travel and the direction to an exit is not obvious in accordance with RSC Technical Guidelines (Standard)<sup>1</sup> V1.0 Section 6.11.3.</p> | Within 1 Month |

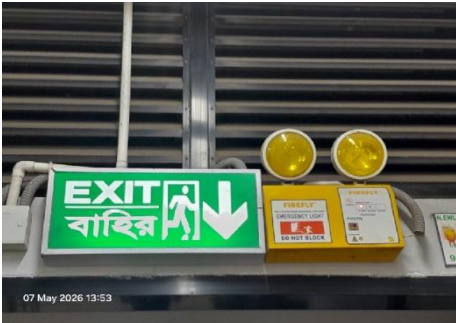
| F-5 | Means of Egress | <p>Exit signage is not illuminated during testing (burned out, broken, etc.).</p> <p><b>Location: 1st Floor, Washing Building.</b></p> | <p>Regularly inspect all exit signage/directional signage as per RSC Technical Guidelines (Standard)<sup>1</sup> V1.0. and replace/install lights as needed to illuminate signs.</p> | <p>Within 1 Month</p> |

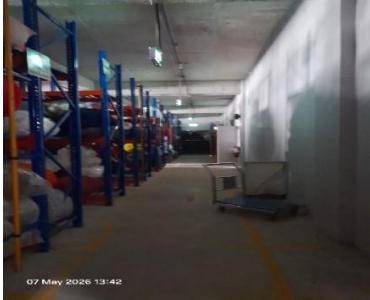
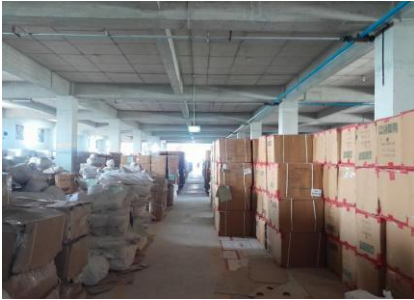
| F-6 | Means of Egress | <p>Based on the number and location of emergency lights observed, adequate illumination levels are not anticipated along egress routes.</p> <p><b>Location(s): Washing Building.</b></p> | <p>Test the emergency lighting system on each floor and provide additional emergency fixtures to provide adequate illumination along the means of egress. Provide a minimum illumination of 10 lux at the floor level within exit stairs and exit discharge paths and minimum 2.5 lux along exit access aisles. Illumination on means of egress shall meet in accordance with RSC Technical Guidelines (Standard)<sup>1</sup> V1.0 Section 10.12.2.</p> | Within 3 Months |

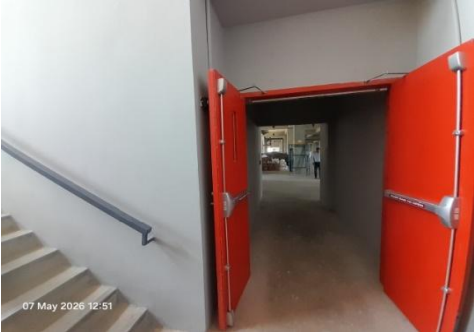
| F-7 | Means of Egress | <p>Storage areas discharge directly into the exit stair enclosures.</p> <p><b>Location(s): 4th floor, Washing Building.</b></p> | <p>Openings from exit enclosure to Storage &amp; Utility areas shall be provided with a vestibule with fire-rated construction and openings in accordance with section 6.14.3 of RSC Technical Guidelines (Standard)<sup>1</sup> V1.0. Provide a min 1-hr fire-rated door on the exit stair side and a 1.5 hr. fire-rated door on the Store, generator, sub-station room side. Ensure that the fire rating of the vestibule construction matches that of the exit stair enclosure as per RSC Technical Guidelines (Standard)<sup>1</sup> V1.0. section 6.14.3. The minimum width for vestibules shall not be less than 1.1m, and the length shall be 1.8m.</p> | Within 3 Months |

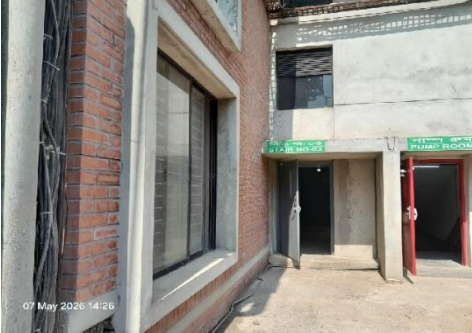
| F-8 | Means of Egress | <p>Unprotected opening within 10 ft horizontal distance from the discharge point where the elevation of the unprotected opening is less than 10 ft.</p> <p><b>Location(s): Ground Floor, South Side, Washing Building.</b></p> | <p>Provide protection of unprotected openings within 10 ft horizontal distance from the discharge point where the elevation of the unprotected opening is less than 10 ft. The fire separation rating shall not be less than that of the exit enclosure.</p> | Within 1 Month |

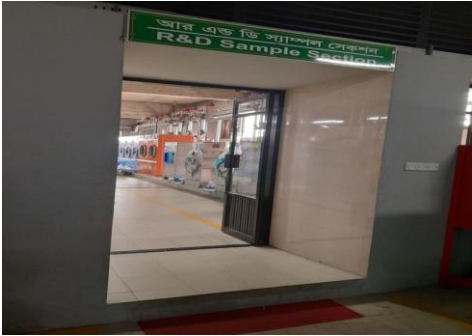
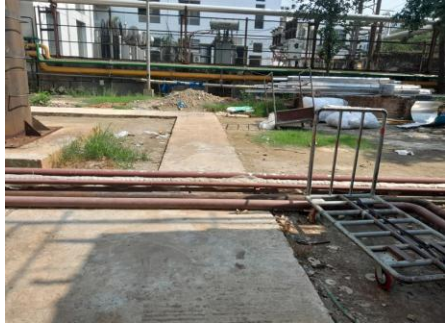
| F-9 | Means of Egress | <p>Abrupt changes in the elevation of walking surfaces were observed, not meeting the RSC Technical Guidelines (Standard)<sup>1</sup> V1.0 Section 6.3.4.</p> <p><b>Location: Ground floor, South Exit ; 1st Floor; Washing Building.</b></p> | <p>Abrupt changes in elevation of walking surfaces shall not exceed ¼ in. unless provided with a beveled slope of 1 in 2 that do not exceed ½ in. Changes greater than ½ in. shall meet the requirements for RSC Technical Guidelines (Standard)<sup>1</sup> V1.0 Section 6.3.5.</p> | Within 3 Months |

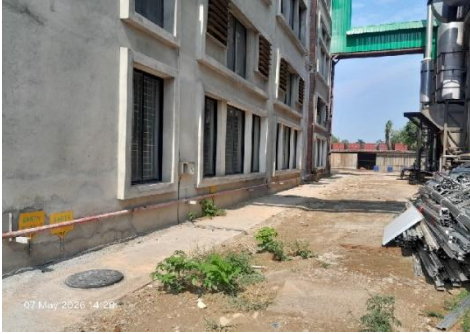
| F-10 | Means of Egress | <p>Uneven path of travel was observed in the exit discharge path due to construction purposes.</p> <p><b>Location: South Side, Washing Building.</b></p> | <p>Remove unnecessary items and level the exit path to the public way.</p> <p>Means of egress shall be maintained continuously free and clear of all obstructions.</p> | Within 3 Months |

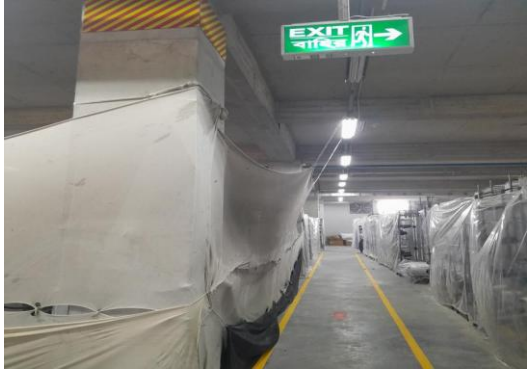
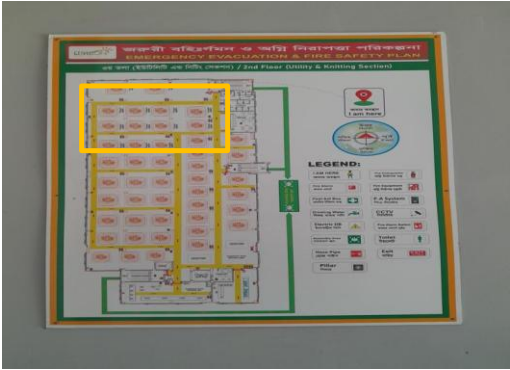
| F-11 | Means of Egress | <p>Common path of egress travel exceeds 75 ft.</p> <p><b>Location: 2nd Floor.</b><br/> <b>Occupancy/Process: Knitting.</b><br/> <b>Available Common Path: 81 ft.</b></p> | <p>Reconfigure the egress arrangement to reduce the maximum common path of travel to not more than 75 ft.</p> <p>The common path of egress travel shall not exceed 23 m (75 ft). Where the building is provided with a complete automatic sprinkler system, the common path of egress travel shall not exceed 30 m (100 ft). The common path of egress travel for Group H (storage) occupancies with not more than 30 occupants shall not exceed 30 m (100 ft). The common path of egress travel for Group J (high hazard) occupancies shall not exceed 8 m (25 ft).</p> <p>Section 6.13.2 of RSC Technical Guidelines (Standard) shall meet.</p> | Within 3 Months |

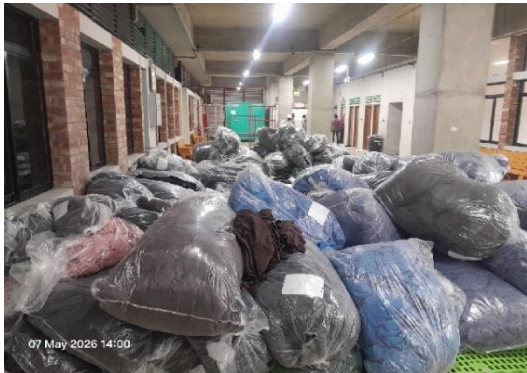
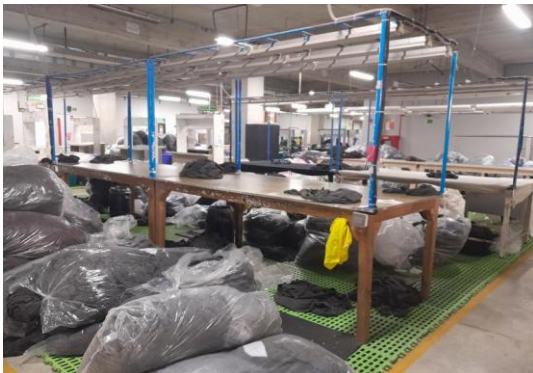
| F-12 | Fire rated construction | <p>Areas used for in-process storage of combustible materials are open to the surrounding occupancy.</p> <p><b>Location(s): 1st floor, 3rd floor.</b><br/><b>Washing Building.</b></p> | <p>Provide defined storage areas and limit the storage arrangement as follows:</p> <p>Maximum height of 2.45 m, maximum area of 23 m<sup>2</sup>, and is separated by a minimum of 3.0 m (10ft) from other storage areas, and they do not exceed 10 percent of the building area of the story in which they occur.</p> <p>or,</p> <p>If sprinkler protected, Maximum height 12 ft (3.66 m) and maximum area of 1000 ft<sup>2</sup> (93 m<sup>2</sup>), separated by at least 25 ft (7.62 m) and does not constitute more than 10 percent of the building area or 4000 ft<sup>2</sup> (372 m<sup>2</sup>) of the sprinklered area, whichever is greater.</p> <p>or,</p> <p>Enclose the storage area from the surrounding occupancy with a minimum 1-hour construction.</p> | Within 3 Months |

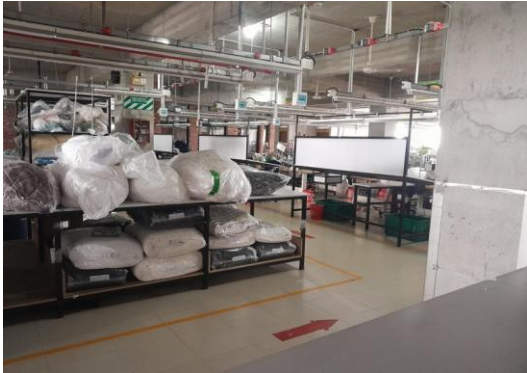
| F-13 | Fire rated construction | <p>Storages were found underneath the cutting tables.</p> <p><b>Location: 4th Floor, Washing Building.</b></p> | <p>Storage underneath the cutting tables shall be kept clear of combustibles at all time, except as provided for miscellaneous storage in accordance with 3.4.2.1.6.</p> <p>Or,</p> <p>Where an automatic sprinkler system is installed sprinklers are required to be installed beneath cutting tables greater than 4 ft in width that are used for storage of combustibles.</p> | Within 3 Months |

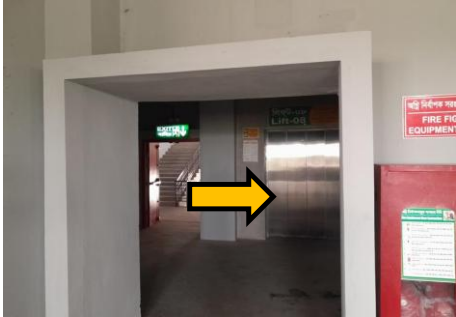
| F-17 | Fire Rated Construction | <p>Elevator shafts open directly into the production floor without proper fire separation due to unprotected openings. Reportedly, factory has installed fire-rated lift landing for elevator shaft separation. However, required documents, relevant design philosophy, etc., were not available on-site. Also, interfacing with the FACP is not completed yet.</p> <p><b>Location(s): All floors, Washing Building.</b></p> <p><b>Non-Compliance (not limited to) : No listing label was found on the installed lift landing doors.</b></p> | <p>Elevator shaft shall be separated from production area by 2 hours fire rated construction. 2-hr fire barriers shall be protected with minimum 1.5-hr fire protective opening assemblies.</p> <p>Installation shall be as per the manufacturer's published installation guidelines and the certification authority guidelines to ensure the fire rating.</p> <p>Keep proper datasheet &amp; certifications for the installed fire-curtain on-site for verification. Also, ensure the required interfacing with the Fire Alarm &amp; Detection System.</p> | Within 3 Months |

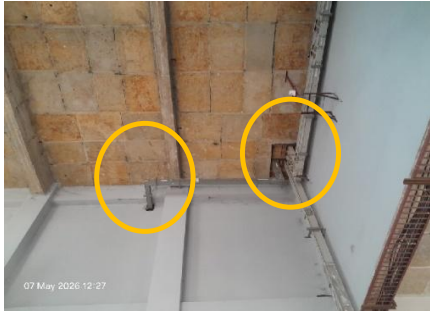
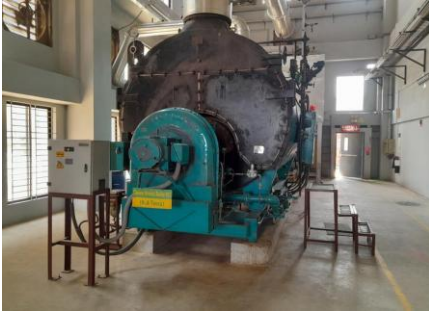
| F-18 | Fire Rated Construction | <p>The boiler or furnace room is not properly separated from the production area by fire-rated construction.</p> <p><b>Location: Ground Floor, Washing Building.</b><br/><b>Non-Compliance (not limited to): BBT penetration.</b></p> | <p>Boilers or other heat producing equipment shall be separated from other occupancies by a minimum 1-hr fire rated construction (wall, floor, slab etc.). Seal all penetrations and openings (door, window etc.) should be protected by 0.75-hr (45 min) fire rated materials to maintain the fire separation if required. All exhaust systems shall discharge to the exterior of the building in a safe location.</p> <p>Or</p> <p>Relocate it to exterior of the building and maintain a minimum 3m (10 ft.) spatial separation distance from the building. Boiler room separation shall meet section 3.4.2.1.2 of RSC Technical Guideline (Standard) .</p> | Within 3 Months |

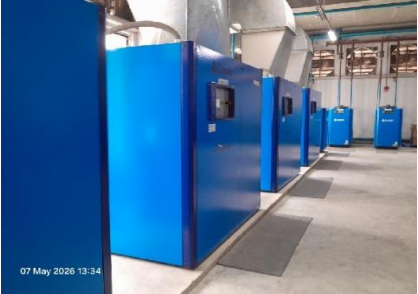
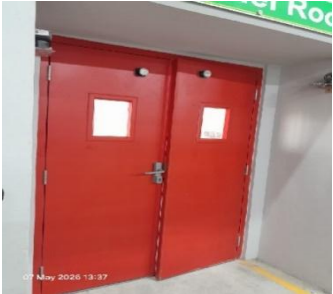
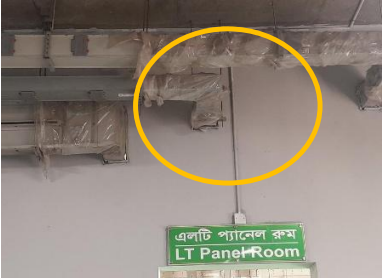
| F-19 | Fire Rated Construction | <p>Compressor room is not properly separated by fire rated construction from the production areas.</p> <p><b>Location: 1st Floor, Washing Building.</b><br/> <b>Non-Compliance (not limited to): Fire door non-functionality, BBT penetration.</b></p> | <p>Compressor or other heat producing equipment shall be separated from other occupancies by a minimum 1-hr fire rated construction (wall, floor, slab etc.). Seal all penetrations and openings (door, window etc.) should be protected by 0.75-hr (45 min) fire rated materials to maintain the fire separation if required. All exhaust systems shall discharge to the exterior of the building in a safe location.</p> <p>Or</p> <p>Relocate it to exterior of the building and maintain a minimum 3m (10 ft.) spatial separation distance from the building. Boiler room separation shall meet section 3.4.2.1.2 of RSC Technical Guideline (Standard) .</p> | Within 3 Months |

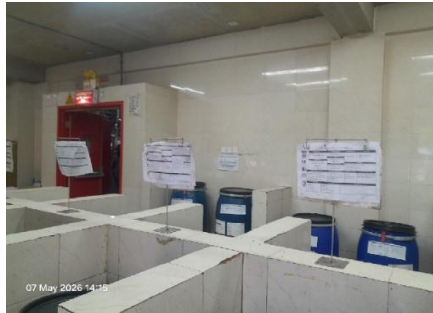
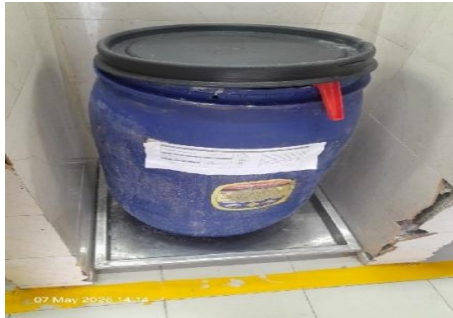
| F-20 | Fire Rated Construction | <p>Chemical storage area is not separated from production occupancy by fire-rated construction as per BNBC 2020, Table 3.2.1.</p> <p><b>Location: Ground floor, Washing Building.</b><br/><b>Non-compliance reason: A protected opening has been provided on a 4-hour rated firewall, which doesn't comply with BNBC 2020, Section 2.3.3.</b></p> | <p>Provide a 4-hour fire-rated construction barrier to separate the chemical store from the surrounding production/combustible storage areas. The 4-hour fire resistive separation wall or slab shall have no unprotected openings therein and shall provide a fire resistance for at least 4-hour.</p> <p>Chemical stores shall comply with BNBC 2020, Part 3, Section 2.14<br/>or,<br/>Ensure exempt amounts of chemicals as per Table 3.2.5 (BNBC 2020) with a nearly similar occupancy group. Provide fire separation if required.</p> | Within 3 Months |

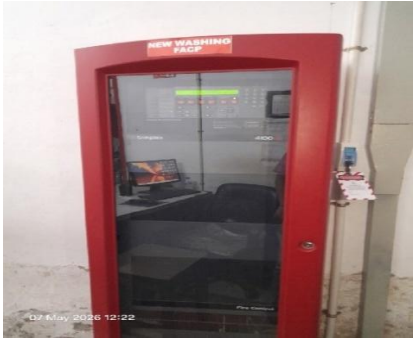
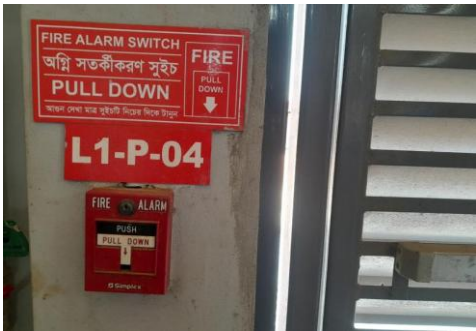
| <b>F-21</b> | Fire Alarm & Detection System (FADS) | <p>The factory has installed a fire alarm and detection system that requires a detailed review to confirm compliance with NFPA 72 and RSC Technical Guidelines (Standard).</p> <p><b>Location(s): All Buildings.</b></p> | <p>Submit the fire alarm and detection system design to RSC for review.</p> <p>Once the design is reviewed, install and modify the fire detection and alarm system throughout the building in accordance with review comment, RSC Technical Guidelines (Standard) and NFPA 72.</p> <p>After installation the owner shall conduct internal testing and commissioning and then contact the RSC for witness of final acceptance testing.</p> | Design within 2 months and modification/ installation with 4 months |

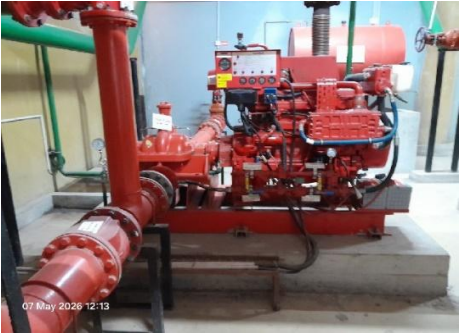
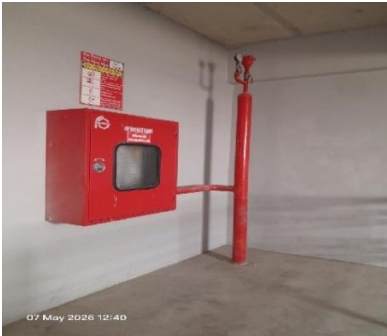
| F-23 | Fire Suppression System (SUPS) | <p>The factory has installed a standpipe &amp; Hose system that requires a detailed review to confirm compliance with NFPA 14,20, 24 and RSC Technical Guidelines (Standard).</p> <p><b>Location(s): Washing Building.</b></p> | <p>Submit the standpipe system drawing to RSC for review.</p> <p>Once reviewed, install or modify the standpipe system throughout the building in accordance with RSC Technical Guidelines (Standard)<sup>1</sup> V1.0. and NFPA 14, 20,22 and 24.</p> <p>After installation the owner shall contact the RSC for witness of conducting the final acceptance testing of the standpipe system.</p> | <p>Design within 2 months and modification/ installation with 4 months</p> |
