# M.M. Knitwear Ltd. (Extension 2)

Ambagh Road, Konabari, Nilnagar, Gazipur

18 May 2026

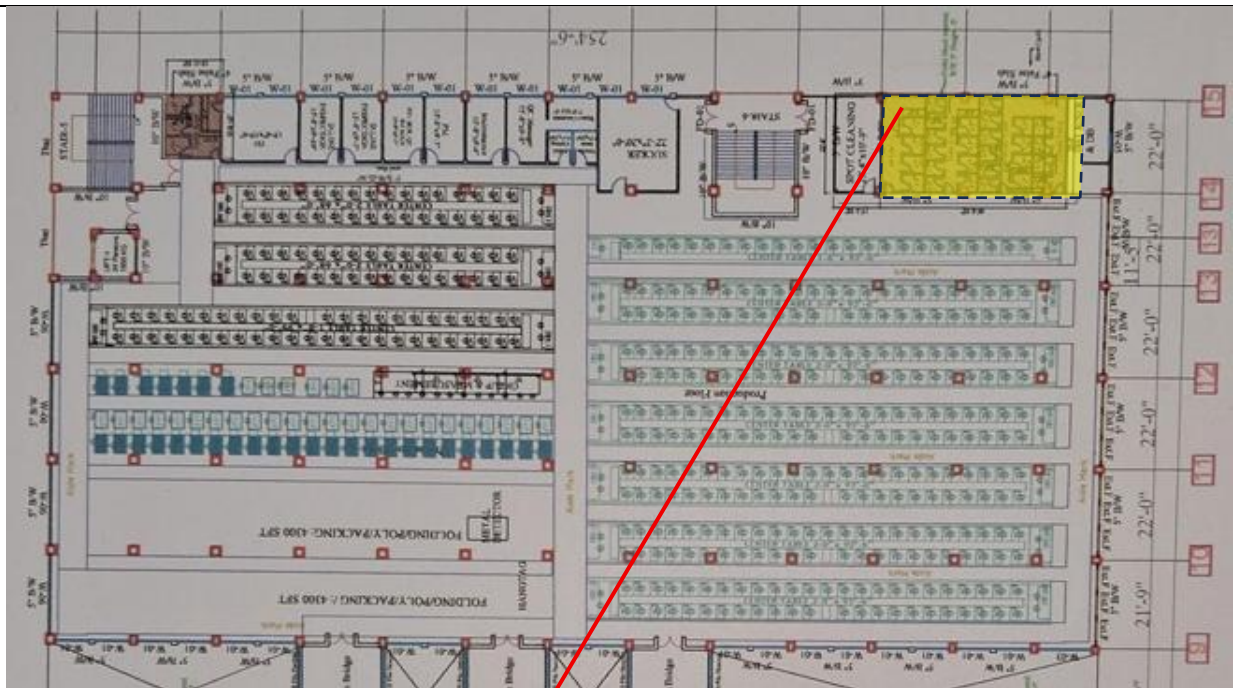
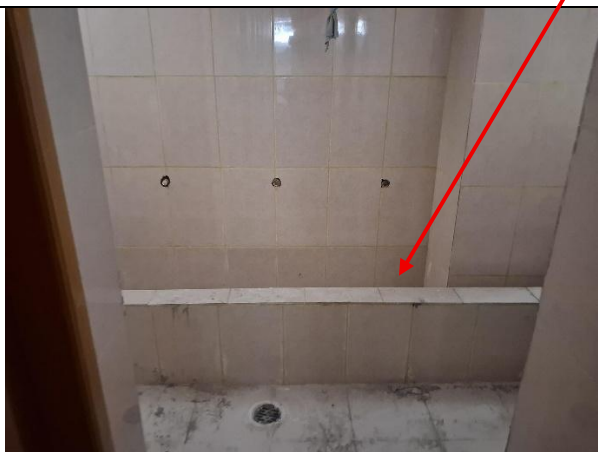
Observation-01: Mismatch and Lack of information in the as-built drawing. (Building-5B)

**Description:** Ablution area with buildup wall of 300 mm was found in the toilet section. The building engineer is required to survey the structures and prepare comprehensive as-built drawings.

| Item No | Observation | Action Plan | Timeline |
|---|---|---|---|
| 1. | Mismatch and lack of information in the as-built drawing. (Building-5B) | The building engineer is required to survey the structures and prepare comprehensive as-built drawings. | within 6 weeks |

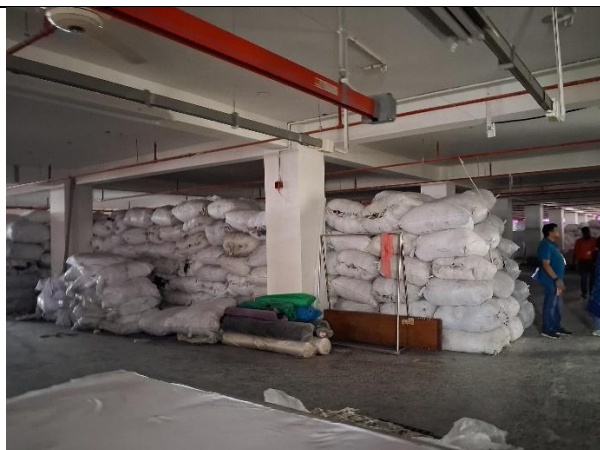
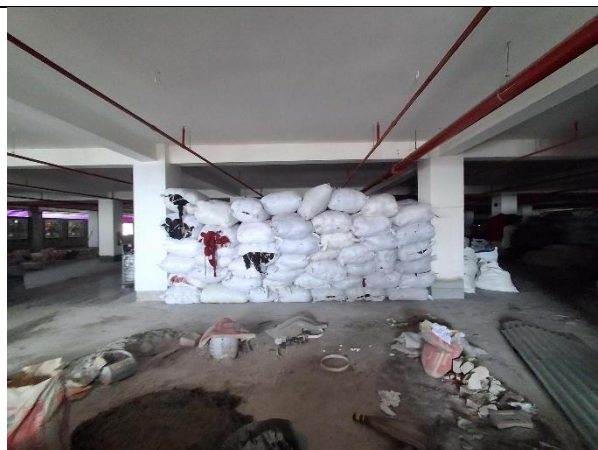
**Observation-02:** Lack of a proper load-management plan (Building-5B).

**Description:** No load markings and proper load management were evident. The building engineer is required to post the floor load plan on each floor, provide load restriction height markings, signage on the storage area, and manage the floor load plan as per the acceptable load limits of BNBC.

| Item No | Observation | Action Plan | Timeline |
|---|---|---|---|
| 2. | Lack of a proper load-management plan (Building-5B) | The building engineer is required to post the floor load plan on each floor, provide load restriction height markings, signage on the storage area, and manage the floor load plan as per the acceptable load limits of BNBC. | within 6 weeks |

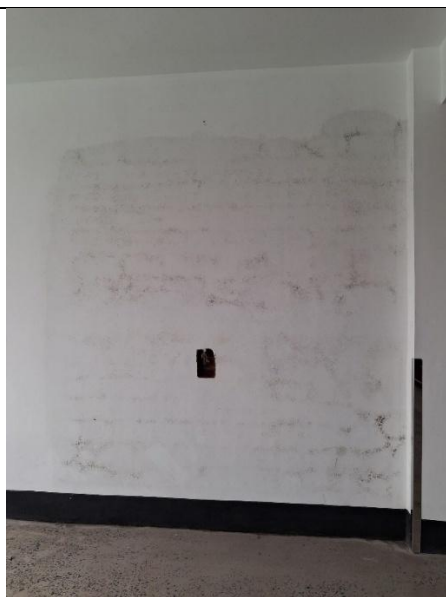
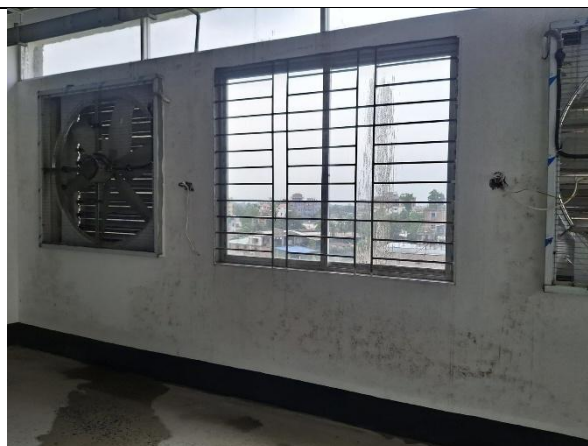
**Observation-03:** Dampness on brick walls (Building-5B)

**Description:** Dampness was observed on the lift core wall, periphery wall. The building engineer is required to investigate the causes of the dampness repair with suitable methods.

| Item No | Observation | Action Plan | Timeline |
|---|---|---|---|
| 3. | Dampness on brick walls (Building-5B) | The building engineer is required to investigate the causes of the dampness repair with suitable methods. | within 6 weeks |

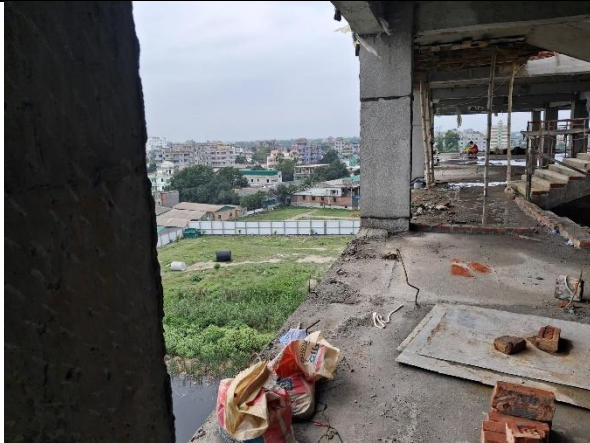
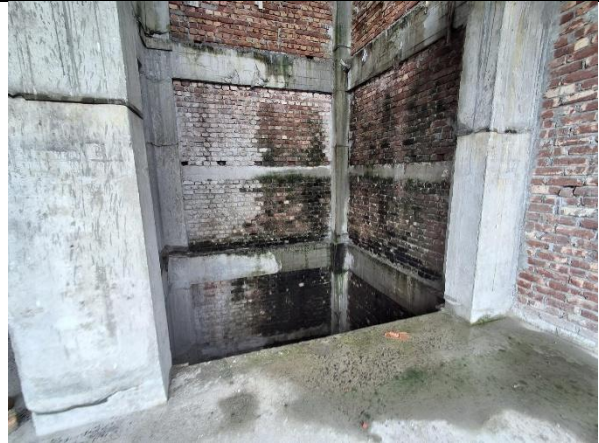
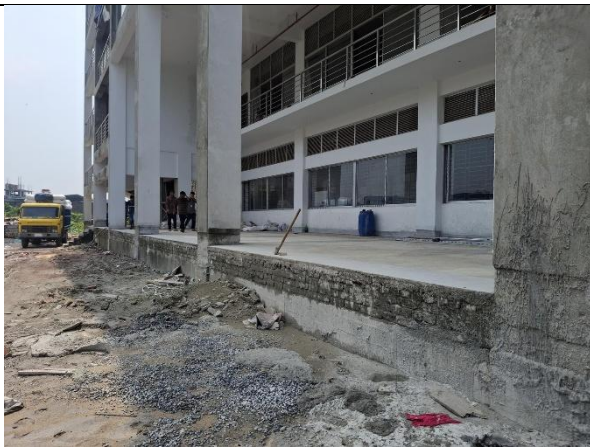
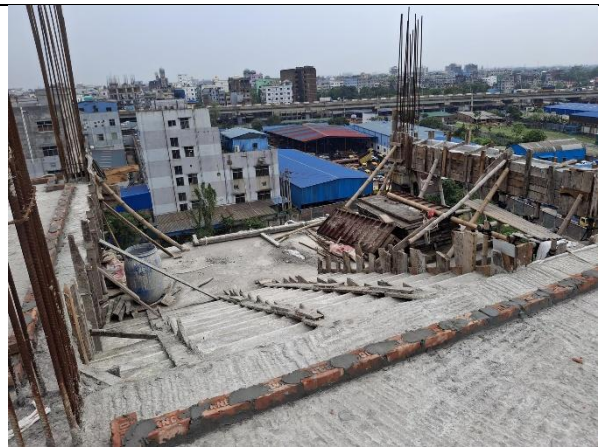
**Observation-04:** Falling hazard from Roof, slab edge, void (Building-5B)

**Description:** Potential falling hazard was found on ground floor corridor, lift lobby, roof & several floors. The building engineer is required to provide edge protection barrier, parapet or railing.

| Item No | Observation | Action Plan | Timeline |
|---|---|---|---|
| 4. | Falling hazard from Roof, slab edge, void (Building-5B) | The building engineer is required to provide edge protection barrier, parapet or railing. | within 6 weeks |

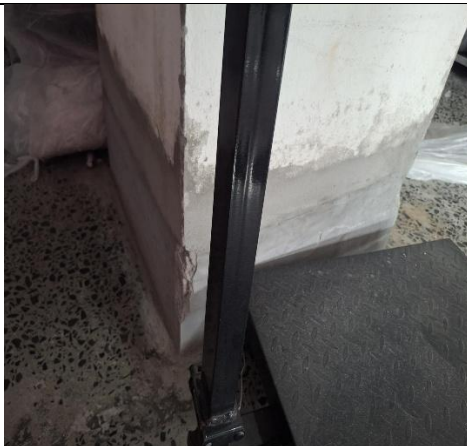
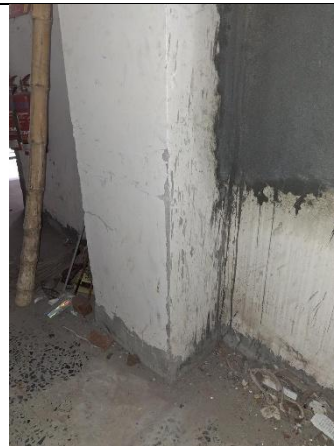
**Observation-05:** Column surface damage to trolley impact. (Building-5B)

**Description:** Columns are damaged to trolley impact. The building engineer is required to repair the damage to the columns and provide a column guard to prevent the trolley impact.

| Item No | Observation | Action Plan | Timeline |
|---|---|---|---|
| 5. | Column surface damage to trolley impact. (Building-5B) | The building engineer is required to repair the damage to the columns and provide a column guard to prevent the trolley impact. | within 6 weeks |

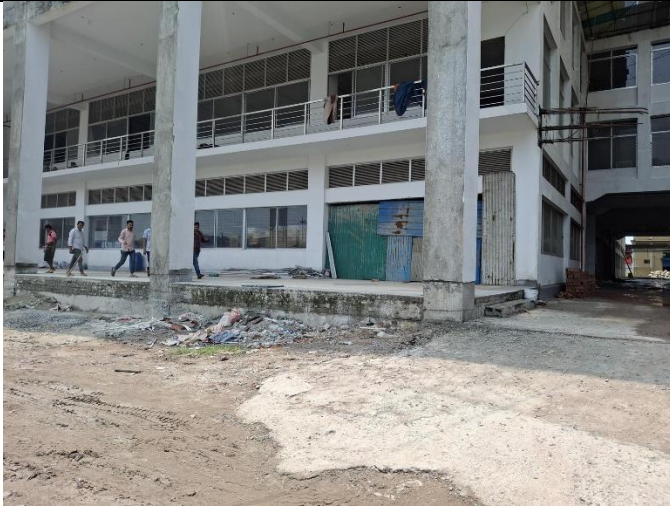
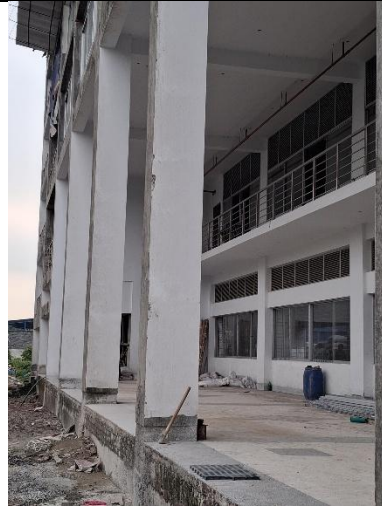
**Observation-06:** Columns susceptible to vehicle impact. (Building-5B)

**Description:** Columns potential to vehicle impact damage observed at loading unloading zone. The building engineer is required to provide separate barriers around columns in loading unloading zone.

| Item No | Observation | Action Plan | Timeline |
|---|---|---|---|
| 6. | Columns susceptible to vehicle impact. (Building-5B) | The building engineer is required to provide separate barriers around columns in loading/unloading zone. | within 6 weeks |

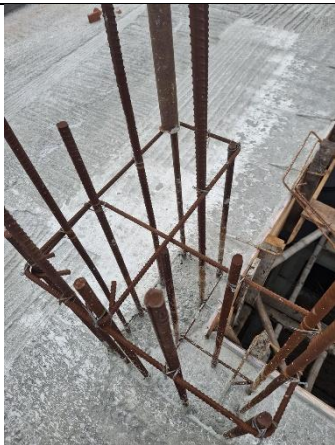
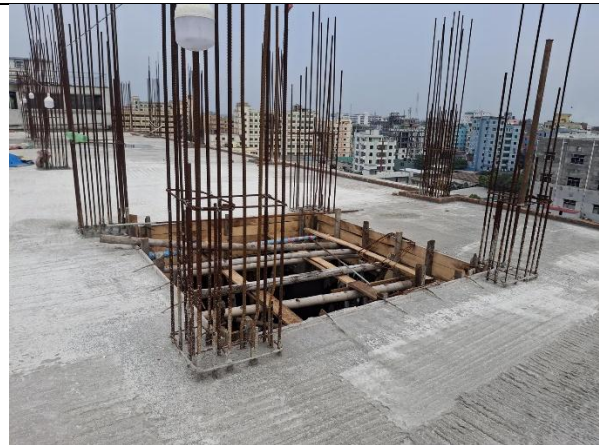
**Observation-07:** Corrosion on steel rebar. (Building-5B)

**Description:** Corrosion was observed on the steel rebars. The building engineer is required to remove the corrosion with a suitable method and provide anti-corrosive coating.

| Item No | Observation | Action Plan | Timeline |
|---|---|---|---|
| 7. | Corrosion on steel rebar. (Building-5B) | The building engineer is required to remove the corrosion with a suitable method and provide anti-corrosive coating. | within 6 weeks |

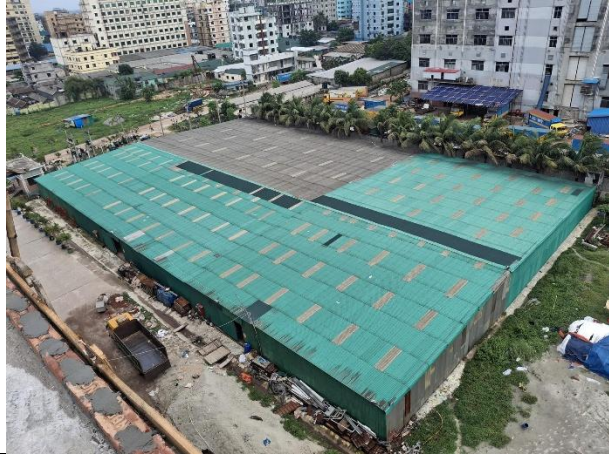
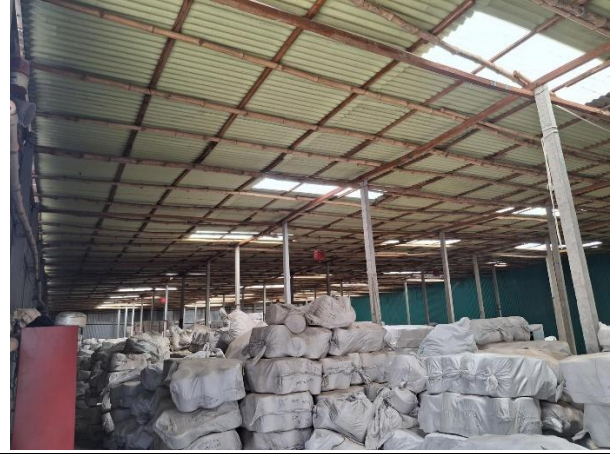
**Observation 08:** Non-engineered structure, lack of design documents and no obvious lateral stability system (Yarn Shed).

**Description:** During the inspection, no obvious lateral stability systems (bracing and compression struts) were observed. So, the lateral stability system of the structure is incomplete. Also, the shed was framed with bamboo and timber resting over 100 mm X 100 mm RC posts in an non-engineered manner (without any engineered connection). During the inspection, the design report and as-built structural drawings were unavailable on site. The building engineer is required to prepare a set of design documents (considering lateral stability), which shall be prepared in compliance with section 1.9.1, part-6 of BNBC and submit to RSC for review.

| Item No | Observation | Action Plan | Timeline |
|---|---|---|---|
| 8. | Non-engineered structure, lack of design documents and no obvious lateral stability system (Yarn Shed) | The building engineer is required to prepare a set of design documents (considering lateral stability), which shall be prepared in compliance with section 1.9.1, part-6 of BNBC and submit to RSC for review. | within 6 weeks |

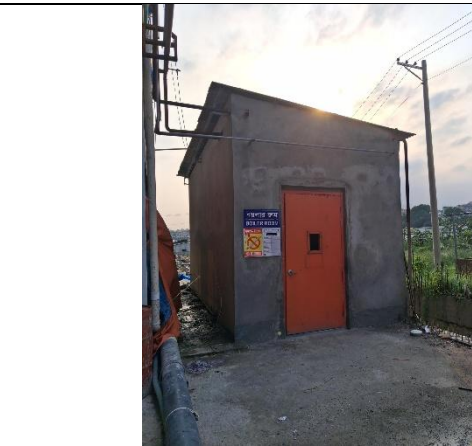
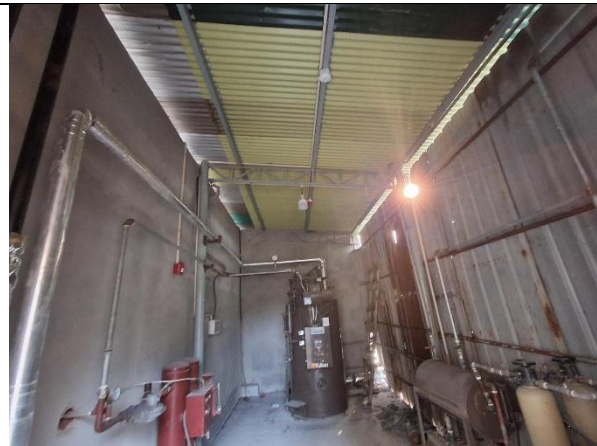
**Observation-9:** Lack of design documents and lateral stability. (Boiler Shed (B5))

**Description:** During the inspection, lack of lateral stability systems (bracing and compression struts) was observed. In addition, the design report and as-built structural drawings were unavailable on site. The design report and material test reports were also not available. The building engineer is required to prepare design documents (considering lateral stability) submit to the RSC for detailed review.

| Item No | Observation | Action Plan | Timeline |
|---|---|---|---|
| 9. | Lack of design documents and lateral stability. (Boiler Shed (B5)) | The building engineer is required to prepare design documents (considering lateral stability) submit to the RSC for detailed review. | within 6 weeks |

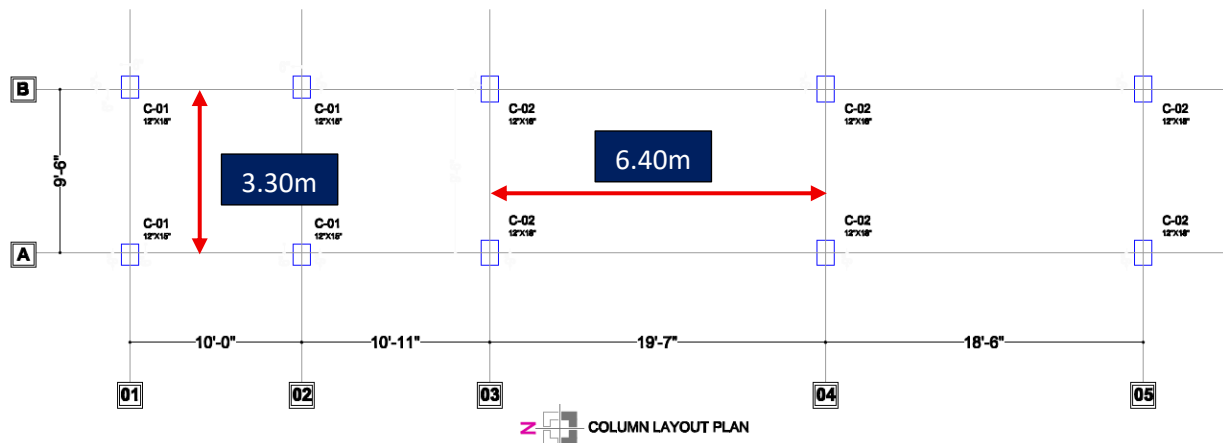
**Observation-10: Mismatch in the as-built drawing (Security building)**

**Description:** Grid dimension at y-direction was found 3.30m instead of 2.9m and at grid-03~grid-04 dimension was found 6.40m instead of 5.96m. Additionally, architectural drawings were not available.

The building engineer is required to survey the structures and prepare comprehensive as-built drawings.

| Item No | Observation | Action Plan | Timeline |
|---|---|---|---|
| 10. | Mismatch in the as-built drawing (Security building) | The building engineer is required to survey the structures and prepare comprehensive as-built drawings. | within 6 weeks |

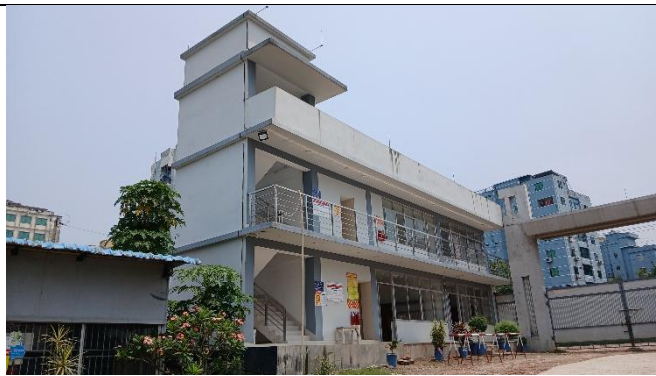
**Observation-11: Lack of design documents. (Security building)**

**Description:** During the inspection design report, load plan, material test reports were not available.

The building engineer is required to prepare design documents and submit to the RSC for detailed review.

| <b>11.</b> | Lack of design documents.<br>(Security building) | The building engineer is required to prepare design documents and submit to the RSC for detailed review. | within 6 weeks |

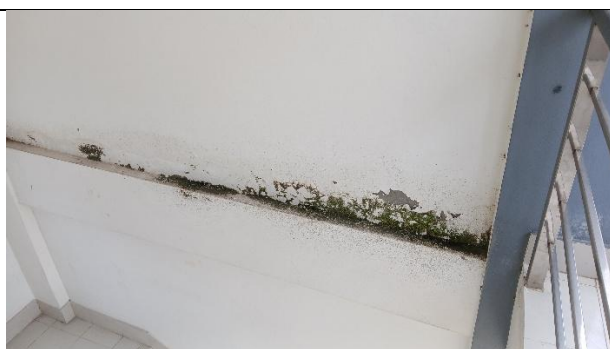
**Observation-12: Dampness on brick walls. (Security building)**

**Description:** Dampness was observed on the brick wall at stair roof portion. The Building Engineer is required to investigate the causes of the dampness repair with suitable methods.

| <b>14.</b> | Dampness on brick walls.<br>(Security building) | The Building Engineer is required to investigate the causes of the dampness repair with suitable methods. | within 6 weeks |

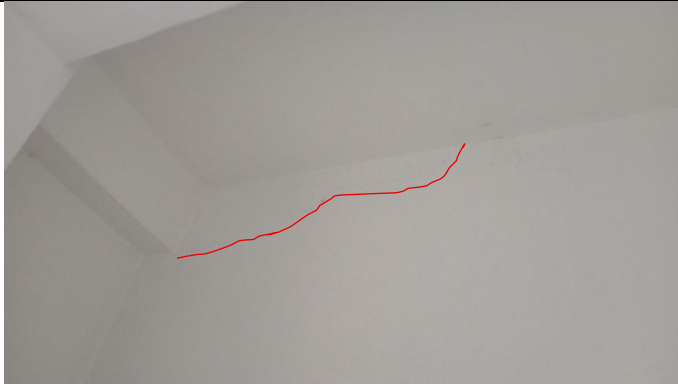
**Observation-13:** Cracks on brick walls. (Security building)

**Description:** Cracks were observed on 1<sup>st</sup> floor brick walls. The building engineer is required to investigate the reason for the crack and repair it with a suitable method.

| <b>15.</b> | Cracks on brick walls.<br>(Security building) | The building engineer is required to investigate the reason for the crack and repair it with a suitable method. | within 6 weeks |

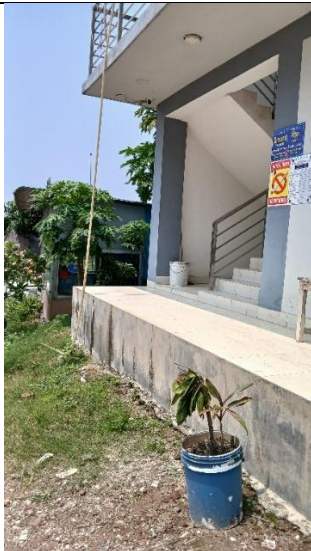
**Observation-14:** Falling hazard on the ground floor. (Security building)

**Description:** Falling hazard was observed on the ground floor. The factory engineer is required to provide edge protection barriers/railing.

| <b>16.</b> | Falling hazard on the ground floor. (Security building) | The factory engineer is required to provide edge protection barriers/railing. | within 6 weeks |

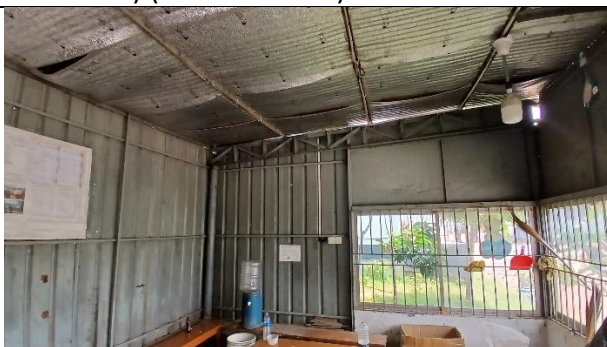
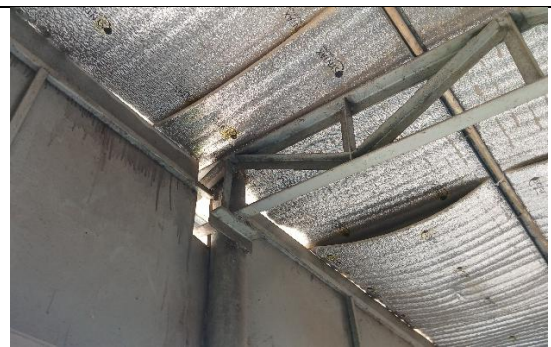
**Observation-15:** Lack of Lateral Stability (load transfer media, vertical bracing and proper connection) (Canteen shed)

**Description:** Steel truss action was observed along the short direction of the shed. Along the long direction of the shed, there were no stability system & load transfer media (strut, vertical bracing and roof bracing) observed. Building engineers are required to carry out Engineering Assessment (EA) to check the lateral stability of the shed.

| <b>17.</b> | Lack of lateral Stability (load transfer media, vertical bracing and proper connection) (Canteen shed) | Building engineers are required to carry out Engineering Assessment (EA) to check the lateral stability of the shed. | within 6 weeks |

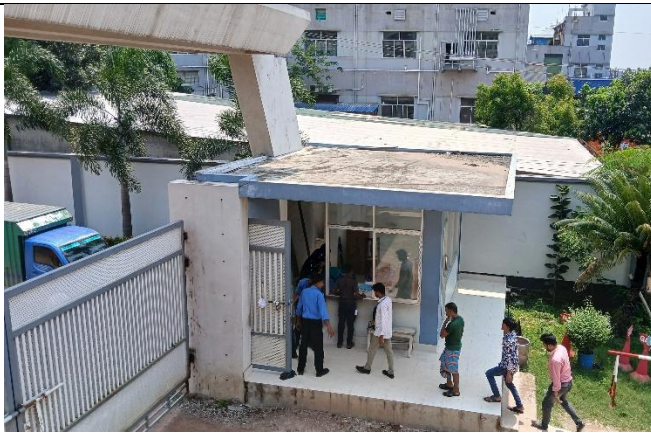
**Observation-16:** Lack of design documents. Security Post (Gate-5)

**Description:** During the inspection design report, as-built drawings were not available.

The building engineer is required to prepare design documents and submit to the RSC for detailed review.

| <b>19.</b> | Lack of design documents.<br>Security Post (Gate-5) | The building engineer is required to prepare design documents and submit to the RSC for detailed review. | within 6 weeks |

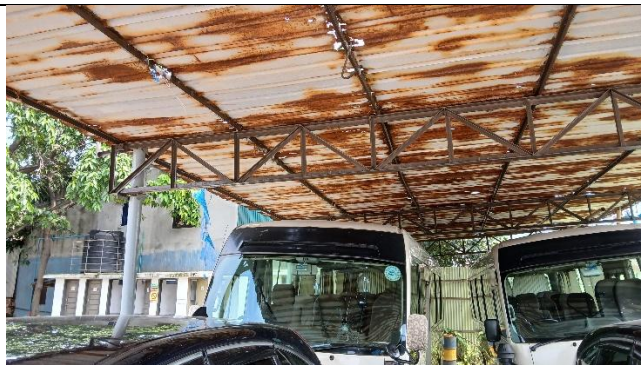
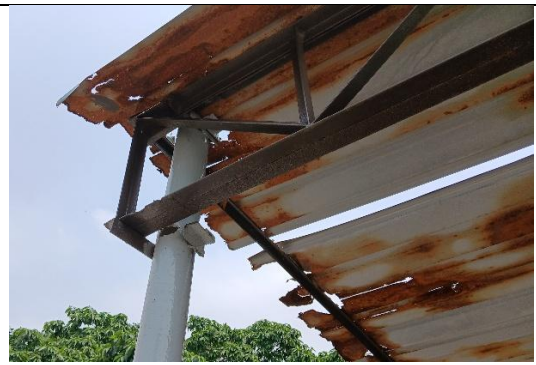
**Observation-17:** Lack of Lateral Stability (load transfer media, vertical bracing and proper connection). (Card Parking shed)

**Description:** Steel truss action was observed along the short direction of the shed. Along the long direction of the shed, there were no stability system & load transfer media (strut, vertical bracing and roof bracing) observed.

The Building Engineer is required to conduct Engineering Assessment (EA) to check the shed's lateral stability.

| <b>21.</b> | Lack of lateral Stability (load transfer media, vertical bracing and proper connection). (Card Parking shed) | The Building Engineer is required to conduct Engineering Assessment (EA) to check the shed's lateral stability. | within 6 weeks |

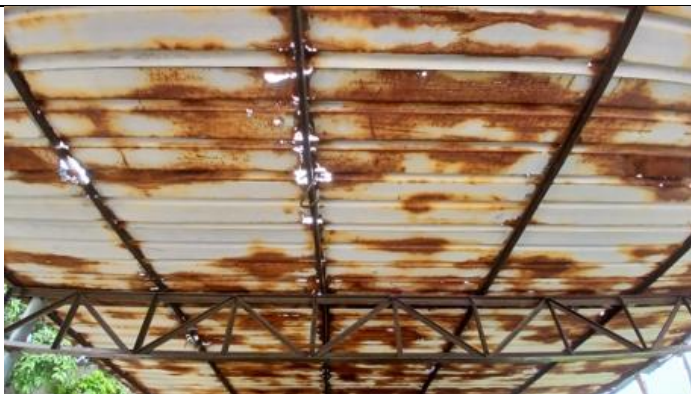
**Observation-18:** Corrosion on steel members. (Card Parking shed)

**Description:** Corrosion was observed on the roof steel members. The building engineer is required to remove the corrosion with a suitable method and provide anti-corrosive coating.

| <b>23.</b> | Corrosion on steel members. (Card Parking shed) | The building engineer is required to remove the corrosion with a suitable method and provide anti-corrosive coating. | within 6 weeks |

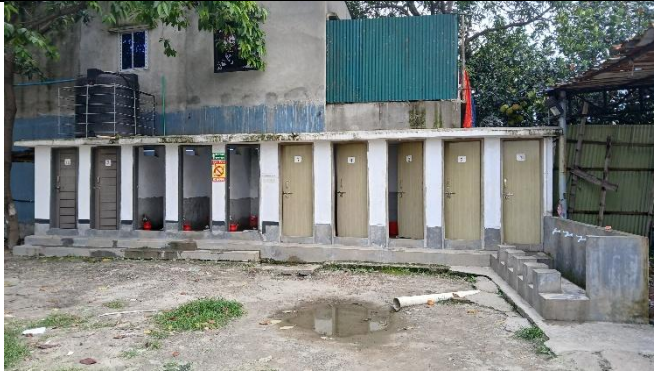
**Observation-19:** Lack of design documents. (Toilet Block)

**Description:** During the inspection design report, as-built drawings were not available.

The building engineer is required to prepare design documents including the vertical load carrying capacity check for brick wall and submit to the RSC for detailed review.

| <b>24.</b> | Lack of design documents.<br>(Toilet Block) | The building engineer is required to prepare design documents including the vertical load carrying capacity check for brick wall and submit to the RSC for detailed review. | within 6 weeks |

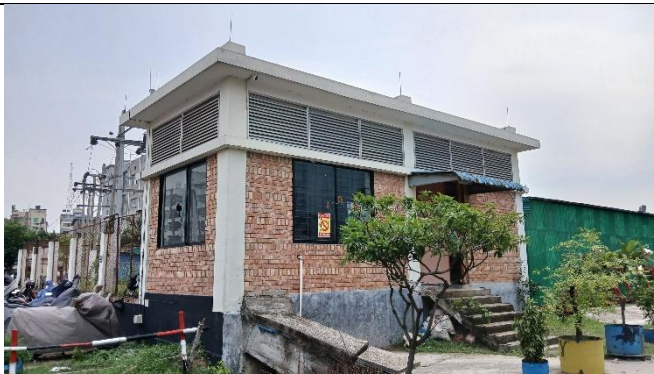
**Observation-20:** Lack of design documents. (33 KV Substation)

**Description:** During the inspection design report, as-built drawings were not available.

The building engineer is required to prepare design documents and submit to the RSC for detailed review.

| <b>26.</b> | Lack of design documents.<br>(33 KV Substation) | The building engineer is required to prepare design documents and submit to the RSC for detailed review. | within 6 weeks |
