# INITIAL FIRE ASSESSMENT REPORT (FAR)

Factory Name: **Noman Fashion Fabrics Ltd**  
Address: **Pagar, Tongi Gazipur, Dhaka Gazipur Dhaka  
Bangladesh**  
Assessor: **Bureau Veritas**  
Date: **19 May 2014**

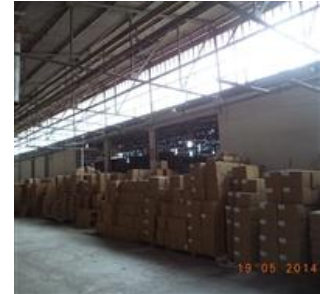
| Description: | All the existing doors, openings, penetrations and ducts along the required fire rated barriers or assemblies in the buildings were found non-rated. Some of the findings are as follows: 1) Openings of fabric store on ground floor of stitch-2 building. 2) Openings of chemical mixing area of Home Dyeing sheds and Fashion Dyeing sheds. 3) Openings of Dyeing Lab and Chemical Sub-store in Home Dyeing-1 and 2 and at Fashion Dyeing-2 were either open or non-rated. |
| Source of Findings: | Photograph: Openings and penetrations were found without required fire protection at all the assessed buildings in the factory premises. |

| Suggested Plan of Action: | Provide fire rated doors and protections at all the required non-rated doors or openings in all the assessed buildings. If possible, close all these openings with fire rated barriers. Protect all the penetrations along the fire restrictive rated assemblies with a listed through penetration fire-stop system tested in accordance with ASTM E81. Consult a qualified fire protection engineer for required solutions. |
