# Modele De Capital Ind Ltd (Unit 2) (Extension)

No 2 Hajiganj, Narayanganj, Bangladesh.

18 June 2026

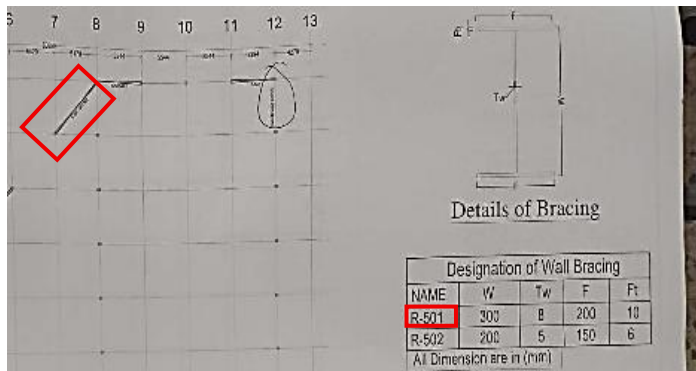
Mentioned wall bracing type R-501 not found

**Description:** During the inspection, mismatches were observed between the provided drawing and the site condition for bracing types.

The building engineer is required to update the as-built drawing as per the actual site condition and submit it to RSC for detailed review.

| Item No | Observation | Action Plan | Timeline |
|---|---|---|---|
| 1. | Mismatch in the as-built drawing with actual site condition. [Knitting Shed] | Building engineer is required to update as-built drawing as per actual site condition and submit to RSC for detailed review. | within 6 weeks |

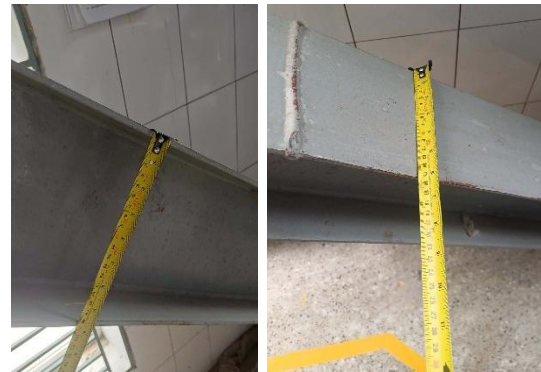
On-site condition (matched with R-502)

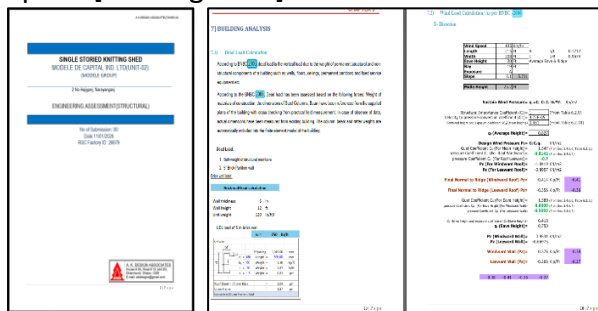
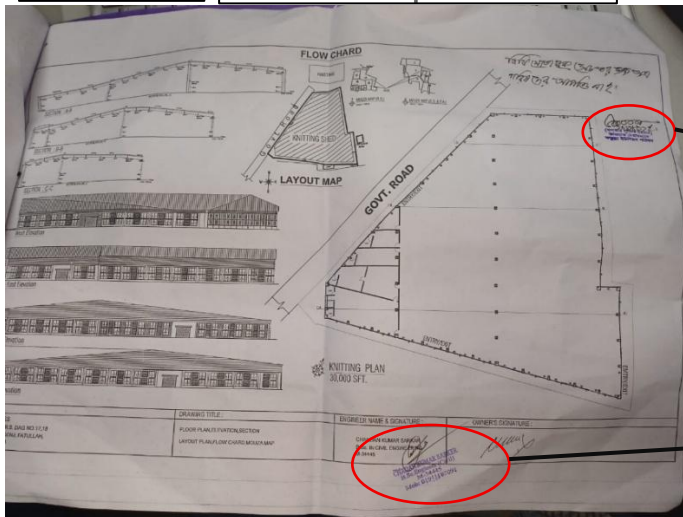
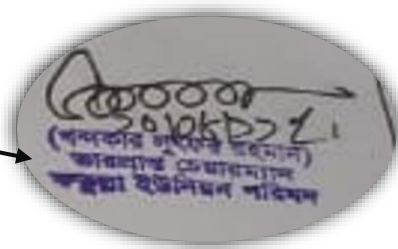
**Description:** The construction was started after 2024 for Knitting Shed. However, the building permit was taken on August-2011. So, the structure was constructed after the validity period of the building permit. Also, design report has been prepared following BNBC 2006.

The factory is required to obtain fresh permit from the local authority, the structures shall be subjected to reassessment based on the obtained Building permit in accordance with the applicable provisions of the Code. Submit the revised design report to RSC for detailed review.

| Item No | Observation | Action Plan | Timeline |
|---|---|---|---|
| 2. | Validity and duration of building permit and applicable building code in the design report. [Knitting Shed] | The factory is required to obtain fresh permit from the local authority. | within 6 weeks |
| 3. | | The building engineer is required to reassess the structure based on the obtained Building permit in accordance with the applicable provisions of the Code. Submit the revised design report to RSC for detailed review. | within 6 weeks |

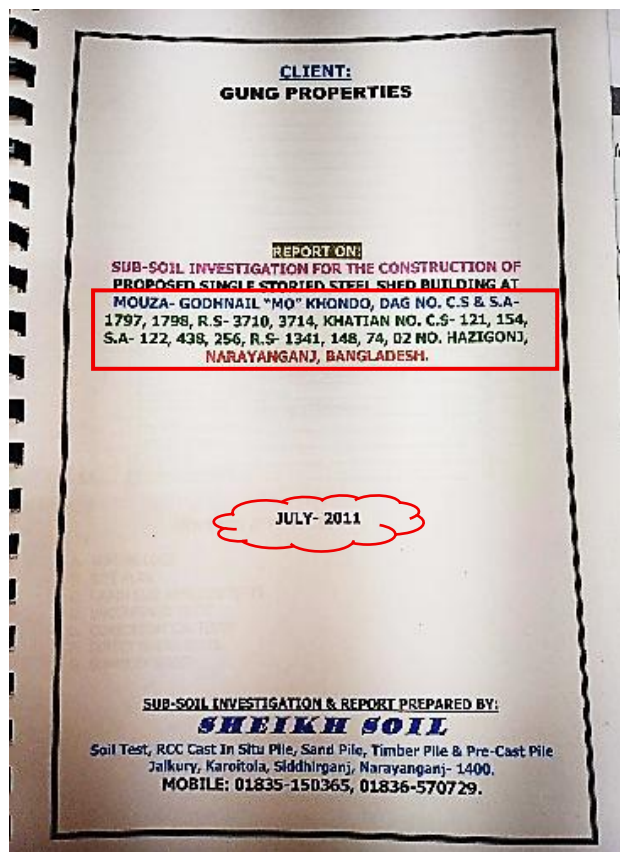
Mouza and Dag no's do not match with the project location

**Description:** Inconsistencies were identified in the geotechnical investigation report. The reported locations do not match the project location, making it difficult to verify the actual investigation site. Additionally, the report preparation date was stated as 2011; however, the seismic zoning map presented is based on BNBC 2020, raising concerns regarding the authenticity and reliability of the report.

The building engineer is required to carry out a new geotechnical investigation, incorporate the investigation results and recommendations into the design report, and submit both the geotechnical investigation report and revised design report to RSC for detailed review.

| Item No | Observation | Action Plan | Timeline |
|---|---|---|---|
| 5. | Inconsistency in the geotechnical investigation report. [Knitting Shed] | The building engineer is required to carry out a new geotechnical investigation, incorporate the investigation results and recommendations into the design report, and submit both reports to RSC for detailed review. | within 6 weeks |

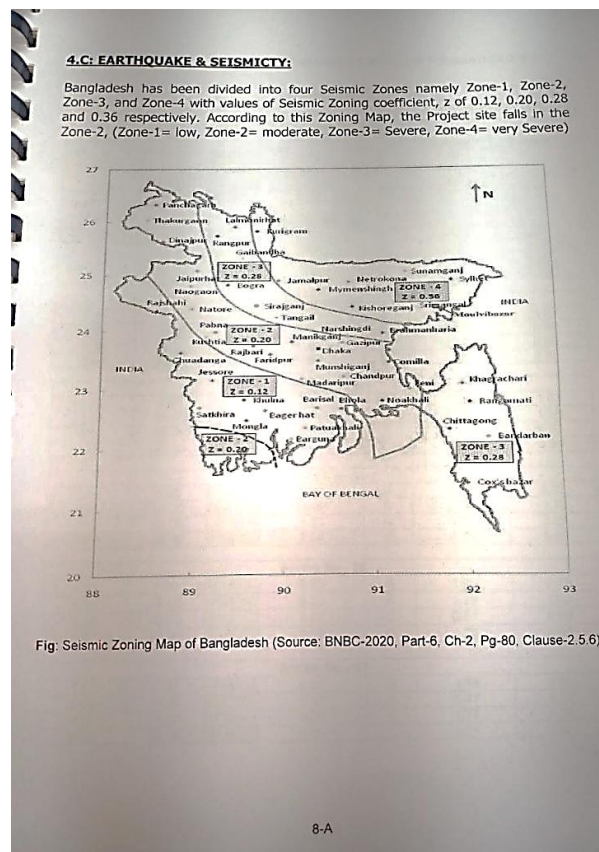
Report preparation date mentioned 2011 but seismic zoning map shown as per BNBC 2020

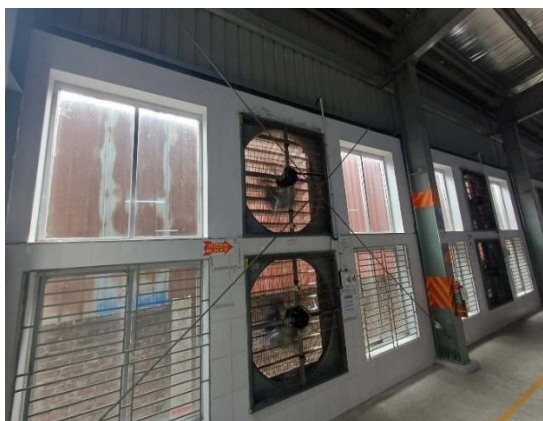
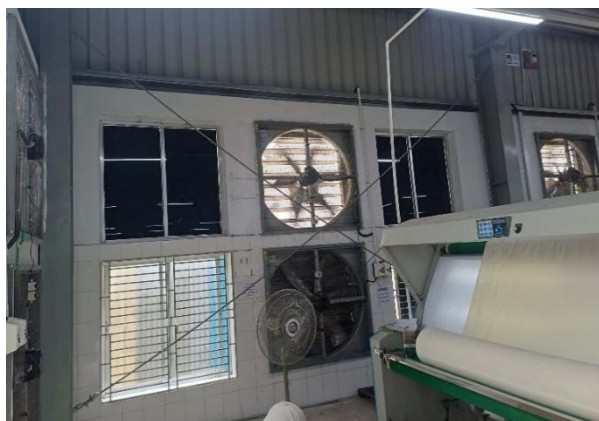
### Observation-04: Loose and inactive cable bracing. [Knitting Shed]

**Description:** During the inspection, some cable bracings were found loose. The factory is required to tighten all loose bracings.

| Item No | Observation | Action Plan | Timeline |
|---|---|---|---|
| 6. | Loose and inactive cable bracing. [Knitting Shed] | The factory is required to tighten all loose bracings. | within 6 weeks |

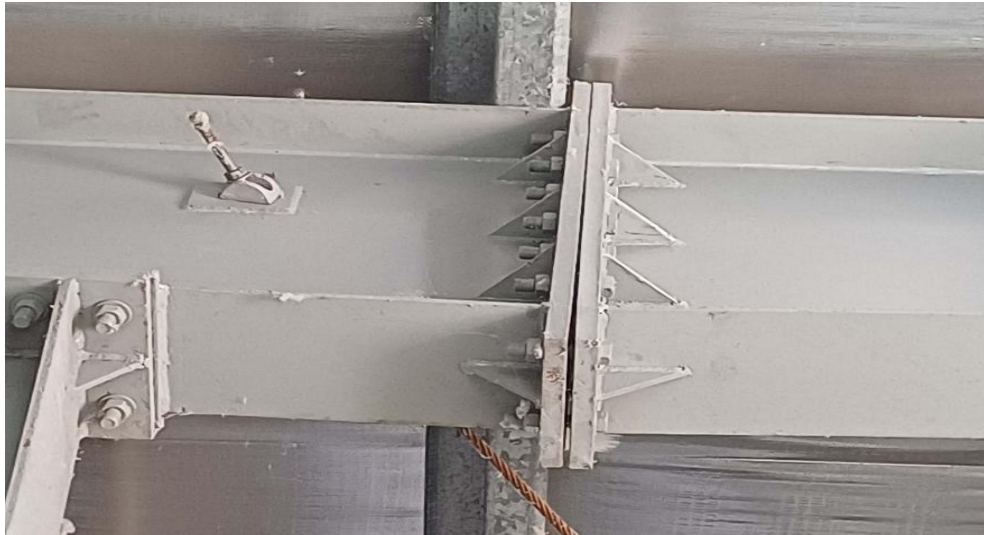
**Observation-05:** Gap in steel connection. [Knitting Shed]

**Description:** During the inspection, connection gaps were observed at some locations. The factory is required to repair/fill the gap with a suitable method.

| Item No | Observation | Action Plan | Timeline |
|---|---|---|---|
| 7. | Gap in the steel connection. [Knitting Shed] | The factory is required to repair/fill the gap with a suitable method. | within 6 weeks |

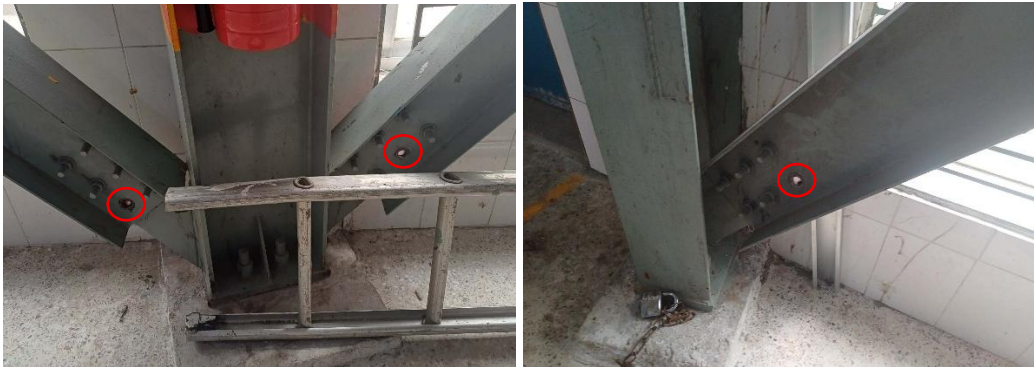
**Observation-06:** Missing nut-bolt. [Knitting Shed]

**Description:** During the inspection, missing connection bolts were observed at several locations. The factory is required to identify all locations and install missing bolts.

| Item No | Observation | Action Plan | Timeline |
|---|---|---|---|
| 8. | Missing nut-bolt. [Knitting Shed] | The factory is required to identify all locations and install missing bolts. | within 6 weeks |

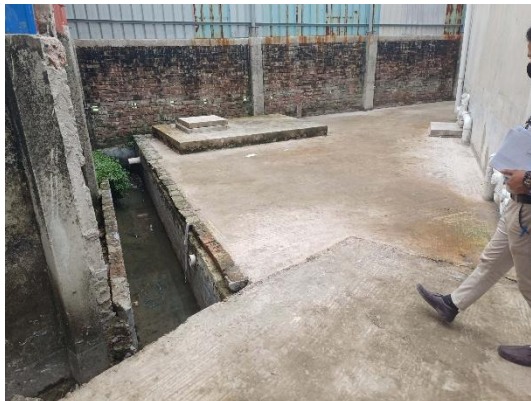
**Observation-07:** Falling hazard beside Knitting Shed.

**Description:** During the inspection, possible falling hazard observed beside the Knitting Shed. The factory is required to cover the open drain to avoid a falling hazard.

| Item No | Observation | Action Plan | Timeline |
|---|---|---|---|
| 9. | Falling hazard beside the Knitting Shed. | The factory is required to cover the open drain to avoid a falling hazard. | within 6 weeks |

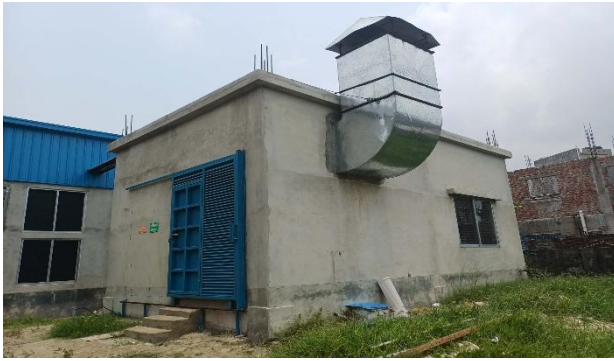
Compressor Room

At the time of inspection, design documents (design report and material test reports) were not available which are required to be prepared in compliance with section 1.9.1 (part-6, BNBC).

| Item No | Observation | Action Plan | Timeline |
|---|---|---|---|
| 10. | Lack of design report.<br>[Compressor Room] | The building engineer is required to prepare design documents in compliance with BNBC 2020 and submit them to RSC for detailed review. | within 6 weeks |

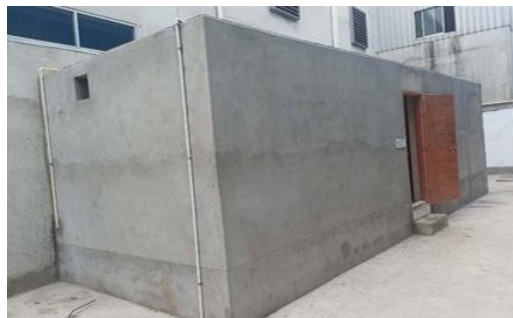
**Observation-9: Lack of Structural Drawing. [Toilet Block]**

**Description:** As-built structural drawing was not prepared for the Toilet Block. The building engineer is required to prepare accurate as-built structural drawings reflecting actual site condition.

| Item No | Observation | Action Plan | Timeline |
|---|---|---|---|
| 12. | Lack of Structural Drawing.<br>[Toilet Block] | The building engineer is required to prepare accurate as-built structural drawings reflecting the actual site condition. | within 6 weeks |

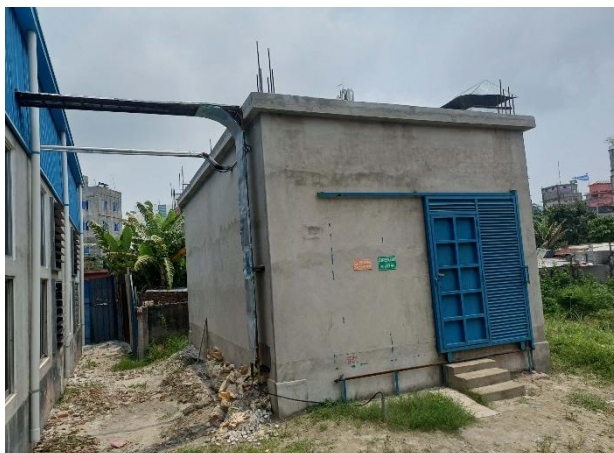
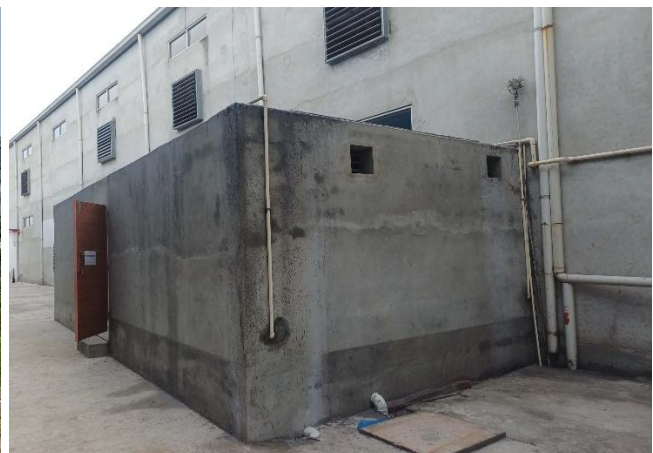
**Observation-10: Lack of building permit from the local authority. [Compressor Room, Toilet Block]**

**Description:** Local authority permit drawing was absent for both the Compressor Room and the Toilet Block. The factory is required to collect permit from the local authority along with the main shed permit.

| Item No | Observation | Action Plan | Timeline |
|---|---|---|---|
| 15. | Lack of building permit from the local authority.<br>[Compressor Room, Toilet Block] | The factory is required to collect permit from the local authority. | within 6 weeks |
