# Rhythm Fashion Ltd.

687 CDA R/A, Road No:20, Agrabad, Chattogram

14 June 2026

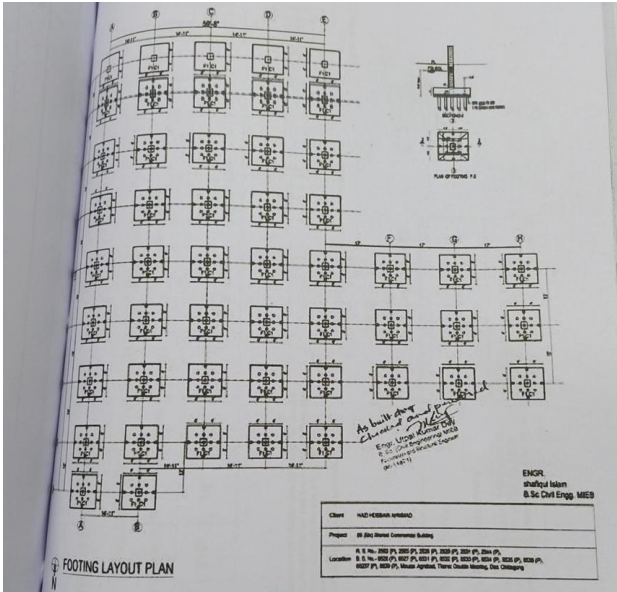
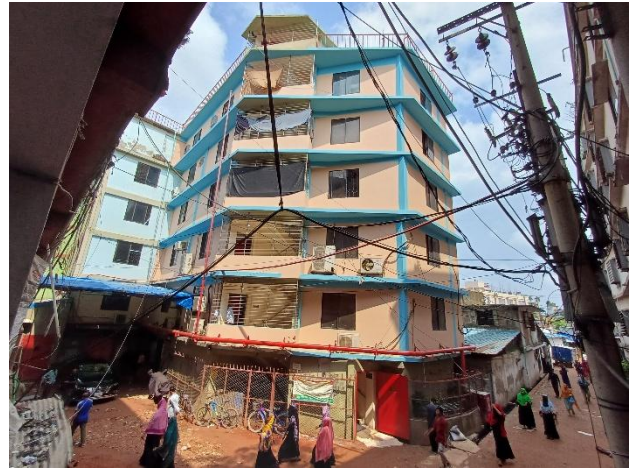
### Observation-1: High stress in foundation (Main Production Building)

**Description:** Cursory calculation indicates FoS of foundation (single footing) below the design limit considering the floor live loading 2kPa and allowable bearing capacity of soil 1.0 Tsf (FoS-2.5) at 2.9 m depth. Building engineer is required to review the design, loads, and foundation stresses.

Also, the design report of the Main Production Building was available on-site. However, only four sets of concrete core test reports from the column were available. But no material test report was available for the beam and slab (flat-plate portion). Moreover, credible drawings were not available for the foundation details. The building engineer is required to confirm the foundation system, revise the design report in accordance with BNBC 1.9.1, verify in situ concrete strength by taking 100 mm-diameter concrete cores from the structural members (Beam and Slab), and submit the design documents to RSC for detailed review.

| Item No. | Observation | Action Plan | Timeline |
|---|---|---|---|
| 1. | High stress in foundation (Main Production Building) | As part of the Detailed Engineering Assessment (DEA), the building engineer is required to review the design load, foundation stresses, and suggest proper remedial actions. | within 6 weeks |
| 2. | | Verify in-situ concrete strength by taking 100 mm diameter concrete cores from the structural members (foundation, Beam and Slab) | within 6 weeks |
| 3. | | Building engineer is required to confirm the foundation system and update the foundation check as part of the design report and submit it to RSC for review. | within 6 weeks |
| 4. | | Carry out suggested remedial works (if required) | within 6 months |

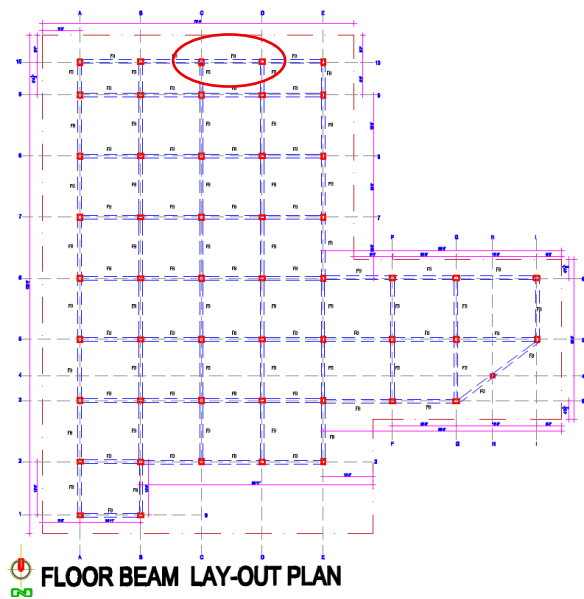
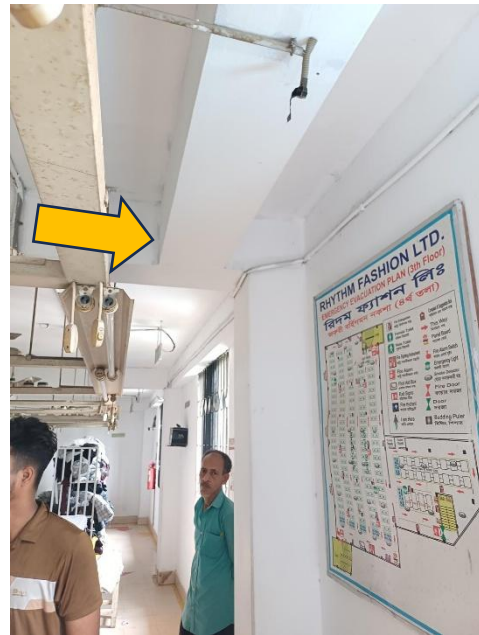
Floor beam layout

Misalignment of the beam from the column joint

**Description:** In the provided drawing, one beam is found to be misaligned, and one column is found rotated.

Building engineer is required to survey the structure and update the as-built drawing.

| Item No. | Observation | Action Plan | Timeline |
|---|---|---|---|
| 5. | Mismatch in the prepared drawings. (Main Production Building) | Building engineer is required to survey the structure and update the as-built drawing. | within 6 weeks |

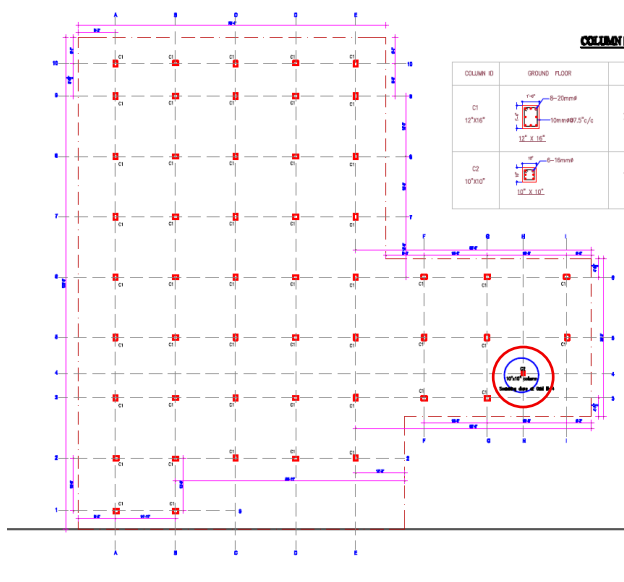
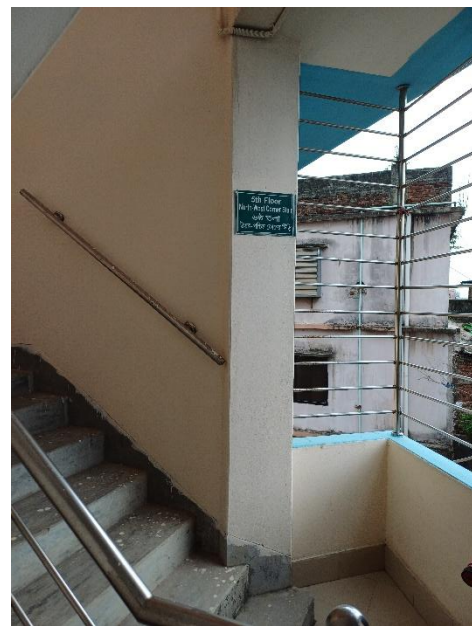
Column layout

Rotated column

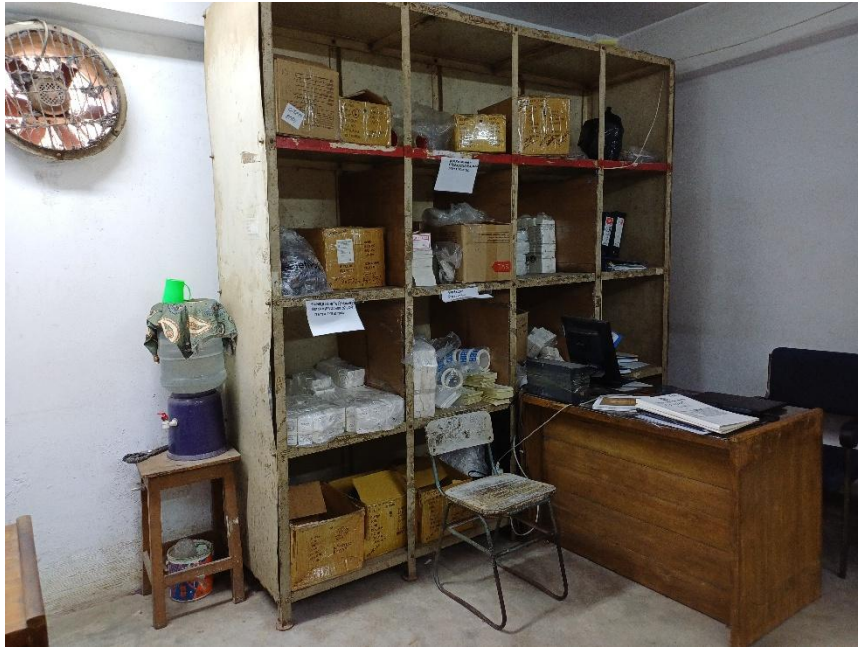
**Observation-3:** Non-structural elements found unbraced/not anchored. (Main Production Building)

**Description:** Non-structural elements suspended from, attached to, or resting atop the structure shall be adequately anchored and braced to resist earthquake forces. Factory is required to brace/anchor all non-structural elements (storage racks).

| Item No. | Observation | Action Plan | Timeline |
|---|---|---|---|
| 6. | Non-structural elements found unbraced/not anchored. (Main Production Building) | Building engineer is required to brace/anchor all non-structural elements. | within 6 weeks |

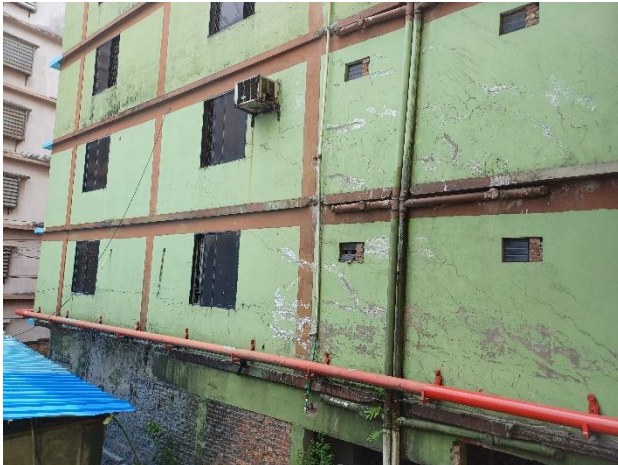
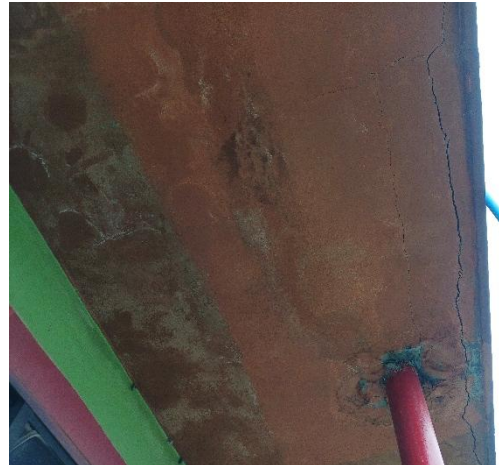
**Observation-4:** Cracks found on the brick wall and cantilever slab. (Main Production Building)

**Description:** During the inspection, cracks were observed on the brick wall and cantilever slab. The factory is required to repair the cracks as per the recommendation of the building engineer.

| Item No. | Observation | Action Plan | Timeline |
|---|---|---|---|
| 7. | Cracks were found on the brick wall and cantilever slab. (Main Production Building) | Building engineer is required to investigate the crack and repair it with a suitable method. | within 6 weeks |

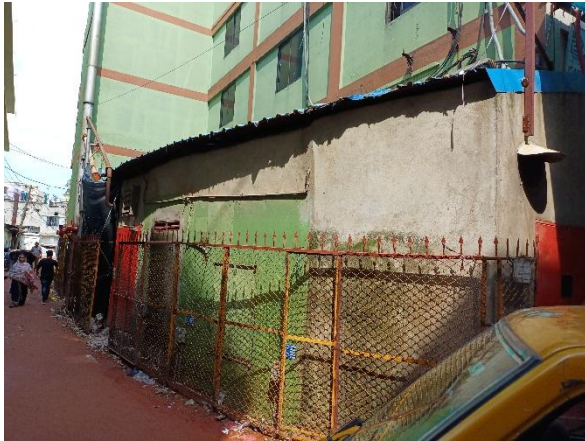
**Observation-5:** Inadequate members and connections. (Shed 1 & 2)

**Description:** Inadequate members and non-engineered connections were observed in Shed 1 and Shed 2. The building engineer is required to check the structural member, connection & stability systems and recommend appropriate remediation in the safety check report.

| Item No. | Observation | Action Plan | Timeline |
|---|---|---|---|
| 8. | Inadequate members and connections. (Shed 1) | The building engineer is required to check the structural member, connection & stability systems and recommend appropriate remediation in the safety check report. | within 6 weeks |
| 9. | | Carry out suggested remedial works (if required) | within 6 months |

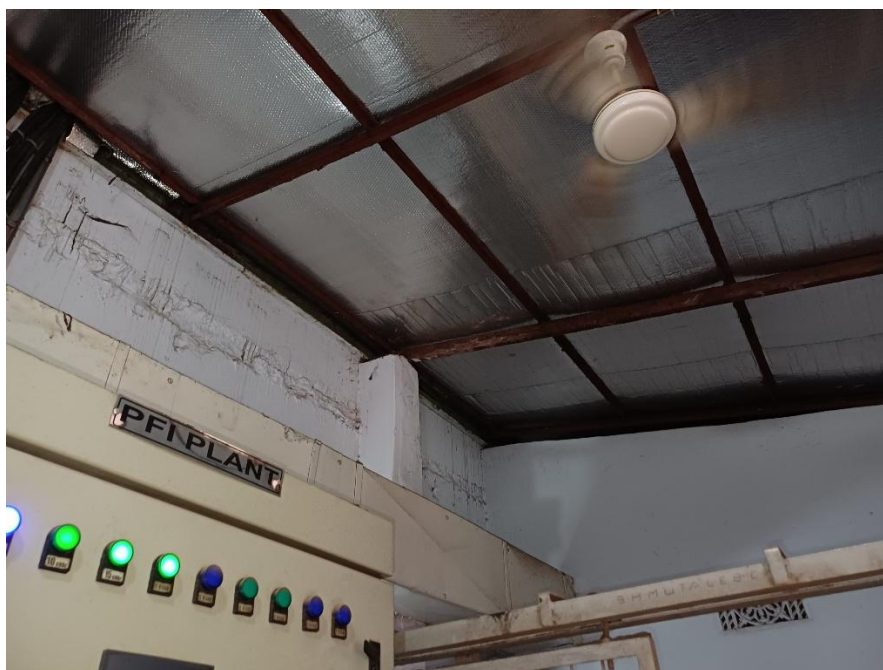
**Observation 6:** Corrosion on steel members. (Shed 1)

**Description:** Corrosion was observed on the steel members of Shed 1. The building engineer is required to remove the corrosion with a suitable method and provide an anti-corrosive coating.

| 12. | Corrosion on steel members. (Shed 1) | The building engineer is required to remove the corrosion with a suitable method and provide an anti-corrosive coating. | within 6 weeks |

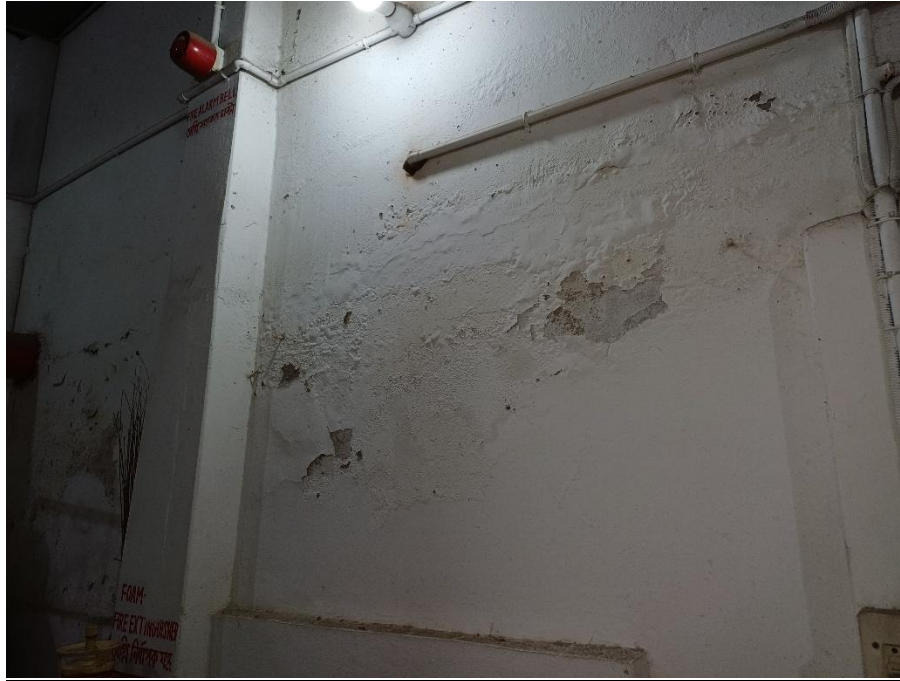
**Observation 7:** Dampness on the brick wall. (Shed 2)

**Description:** Dampness was observed on the brick wall. The building engineer is required to identify the locations and reasons, seal the source of the dampness, and repair the affected areas using an appropriate method.

| 13. | Dampness on the brick wall. (Shed 2) | The building engineer is required to identify the locations and reasons, seal the source of the dampness, and repair the affected areas using an appropriate method. | within 6 weeks |
