# AKH OUTWEAR LTD.

Holding No-19, Tannery Road, Horindhara, Hemayetpur, Savar, Dhaka-1340, Bangladesh.  
(23.788274422281194, 90.24631768585719)

8 July 2026

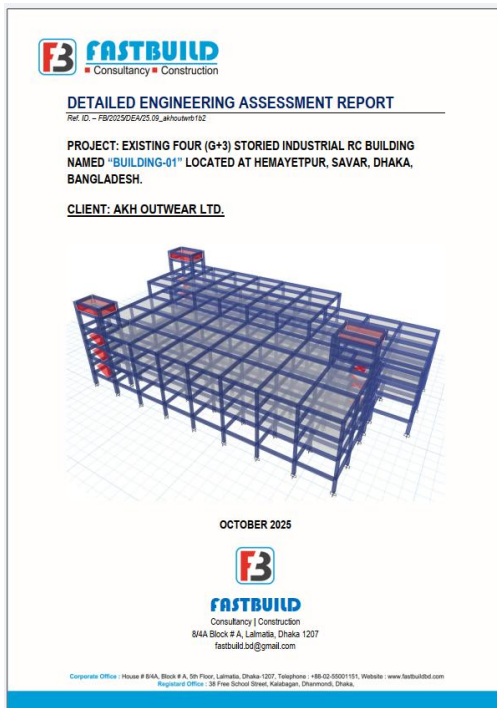
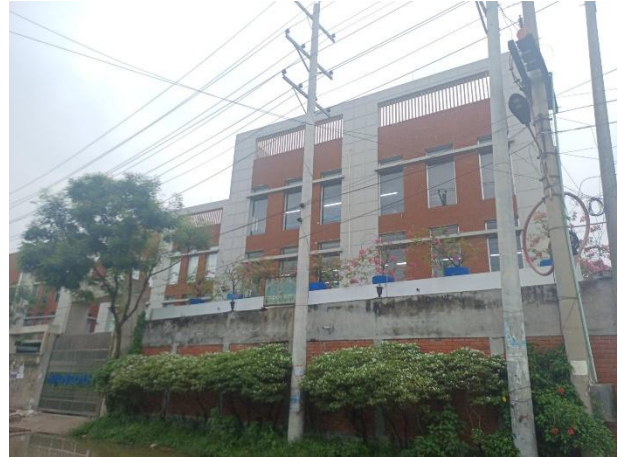
**Observation-01:** Design report required to be reviewed by RSC against lateral loading. (Production Building-1)

**Description:** A set of design reports was available for the Production Building-1. Design report needs to be reviewed against lateral loading.

| No | Observation | Action Plan | Timeline |
|---|---|---|---|
| 1. | Design report required to be reviewed by RSC against lateral loading. (Production Building-1) | Design report needs to be reviewed against lateral loading by RSC. | within 6 weeks |
| 2. | Design report required to be reviewed by RSC against lateral loading. (Production Building-1) | Implement remediation work if required. | within 6 months |
| 3. | Design report required to be reviewed by RSC against lateral loading. (Production Building-1) | Implement floor loading plan. | within 6 weeks |

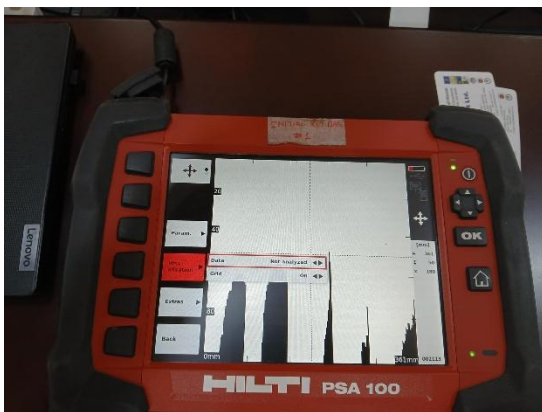
**Observation-02:** Mismatch in as-built drawing. (Production Building-1)

**Description:** Amount of rebar in C3 column does not match with onsite condition. 5 nos of rebar were found instead of 7 nos on each face. Building engineer is required to confirm the amount of rebar of each column and prepare accurate as-built drawing.

| No | Observation | Action Plan | Timeline |
|---|---|---|---|
| 4. | Mismatch in as-built drawing. (Production Building-1) | Building engineer is required to confirm the amount of rebar of each column and prepare accurate as-built drawing. | within 6 weeks |

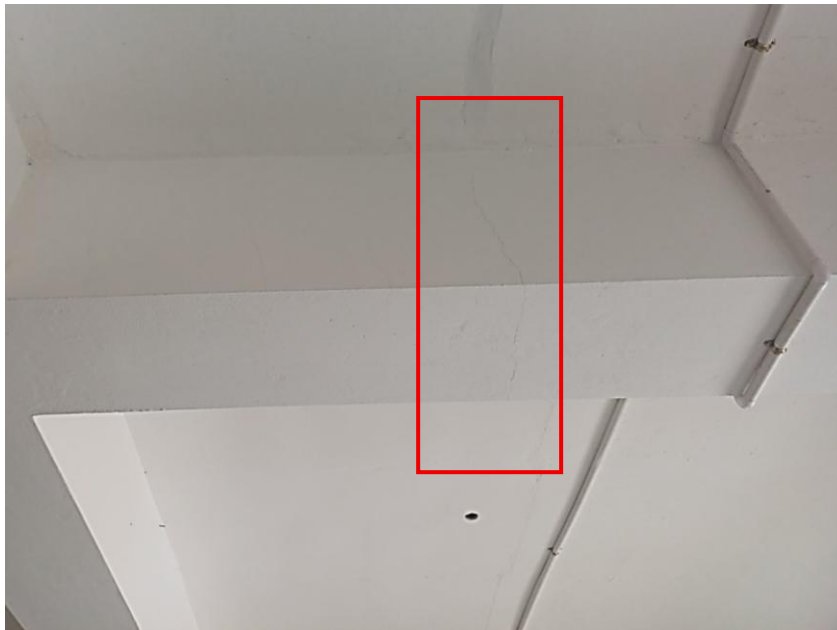
**Observation-03:** Hairline cracks on beam (Production Building-1)

**Description:** Hairline cracks observed in Roof Beam of Main Production Building-1. Repair the crack with suitable method.

| No | Observation | Action Plan | Timeline |
|---|---|---|---|
| 7. | Hairline cracks on beam (Production Building-1) | Repair the crack with suitable method. | within 6 weeks |

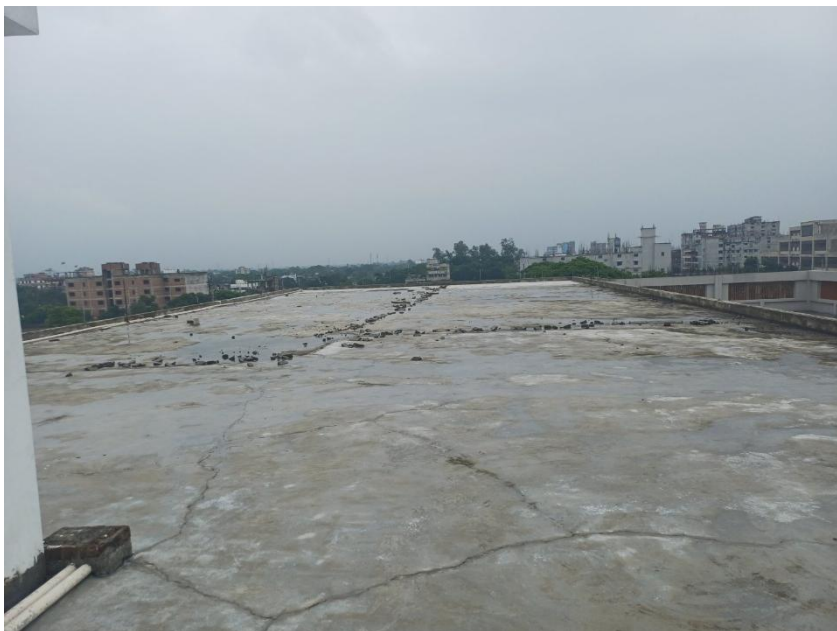
**Observation-04:** Faling hazard (Production Building-1)

**Description:** A falling hazard was observed at the roof of Production Building-1 due to the absence of adequate edge protection. The factory is required to provide a parapet wall around the roof perimeter to eliminate the falling hazard.

| No | Observation | Action Plan | Timeline |
|---|---|---|---|
| 5. | Faling hazard (Production Building-1) | The factory is required to provide a parapet wall around the roof perimeter to eliminate the falling hazard. | within 6 weeks |

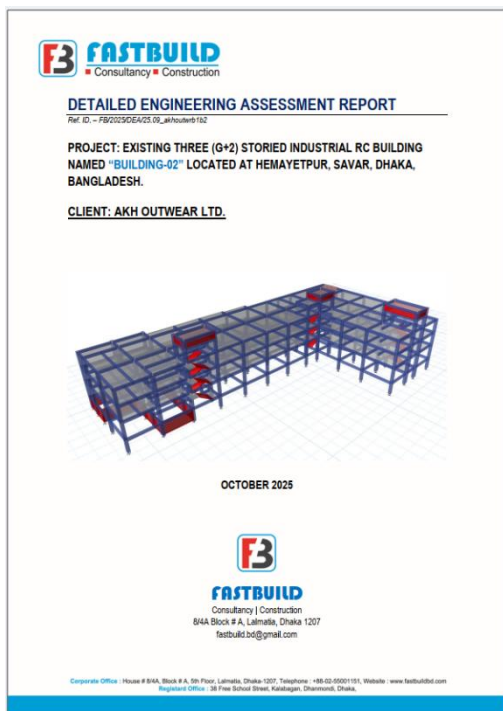
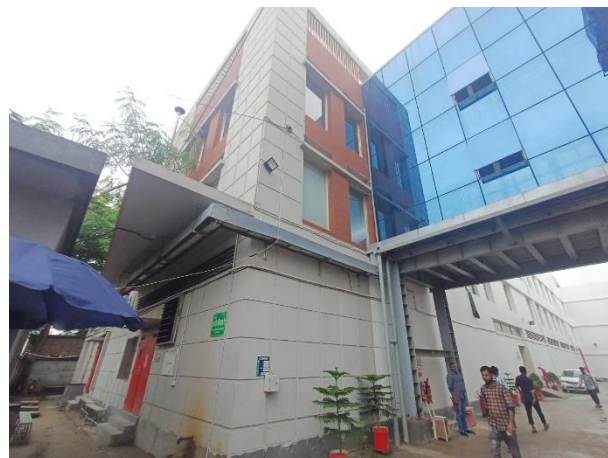
**Observation-05:** Design report required to be reviewed by RSC against lateral loading. (Production Building-2)

**Description:** A set of design reports was available for Production Building-2. Design report needs to be reviewed against lateral loading.

| No | Observation | Action Plan | Timeline |
|---|---|---|---|
| 8. | Design report required to be reviewed by RSC against lateral loading. (Production Building-2) | Design report needs to be reviewed against lateral loading by RSC. | within 6 weeks |
| 9. | Design report required to be reviewed by RSC against lateral loading. (Production Building-2) | Implement remediation work if required. | within 6 months |
| 10. | Design report required to be reviewed by RSC against lateral loading. (Production Building-2) | Implement floor loading plan. | within 6 weeks |

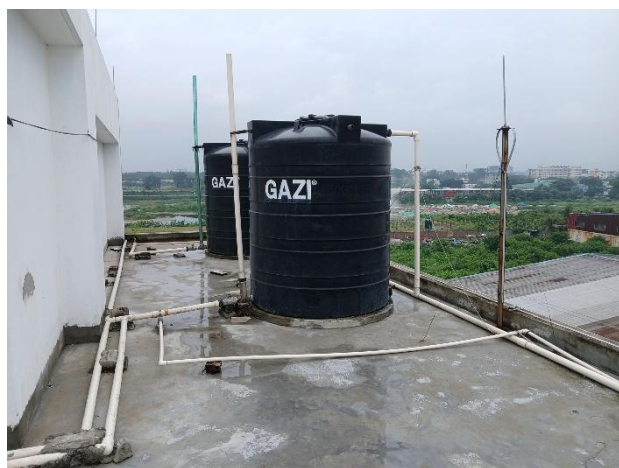
**Description:** Non-structural member (PVC tank, Rack) found not anchored/braced in both Production Building-1 and Production Building-2. Factory is required to anchor/brace the non-structural members to prevent overturning.

| No | Observation | Action Plan | Timeline |
|---|---|---|---|
| 6. | Non-structural elements found not anchored/braced (Production Building-1) | Factory is required to anchor/brace the non-structural members to prevent overturning. | within 6 weeks |

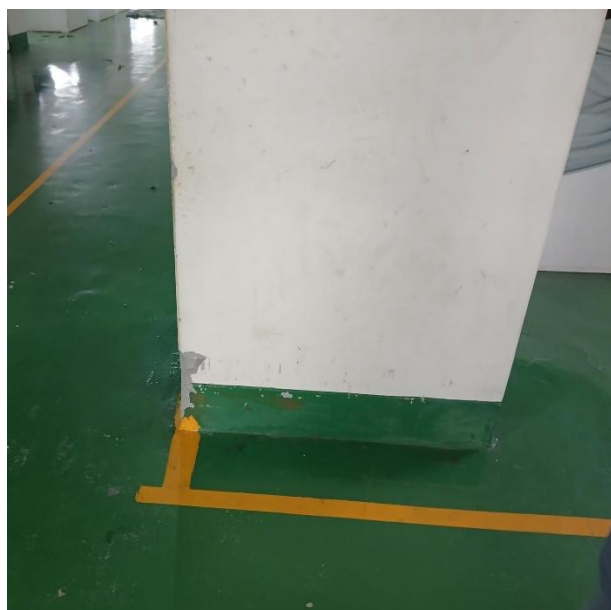
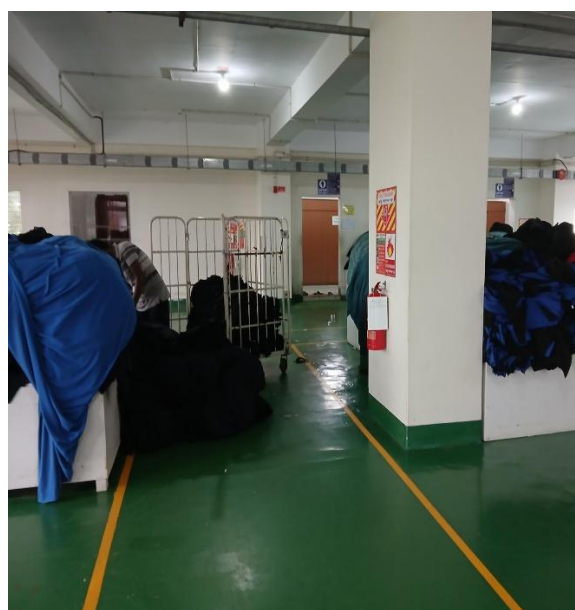
**Observation-07:** Trolley impact of column. (Production Building-2)

**Description:** Trolley impact was observed in column surface on 2<sup>nd</sup> floor. The factory is required to repair the column surface and provide column guard to the affected columns.

| 12. | Trolley impact of column.<br>(Production Building-2) | The factory is required to repair the column surface and provide column guard to the affected columns. | within 6 weeks |

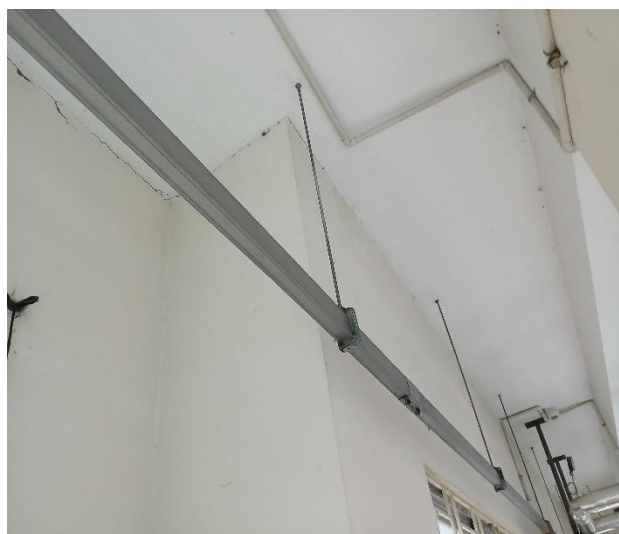
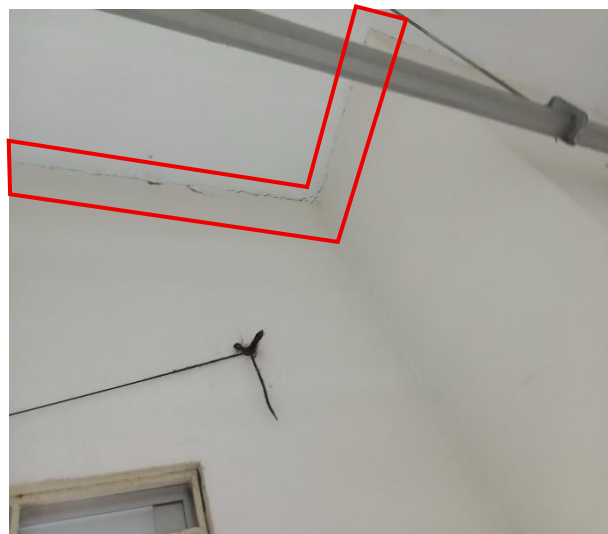
**Observation-08:** Wall cracks on several locations. (Production Building-2)

**Description:** Brick wall cracks were found in several locations of this building. The building engineer is required to investigate the reason for cracks and repair with suitable method.

| 13. | Wall cracks on several locations. (Production Building-2) | The building engineer is required to investigate the reason for cracks and repair with suitable method. | within 6 weeks |

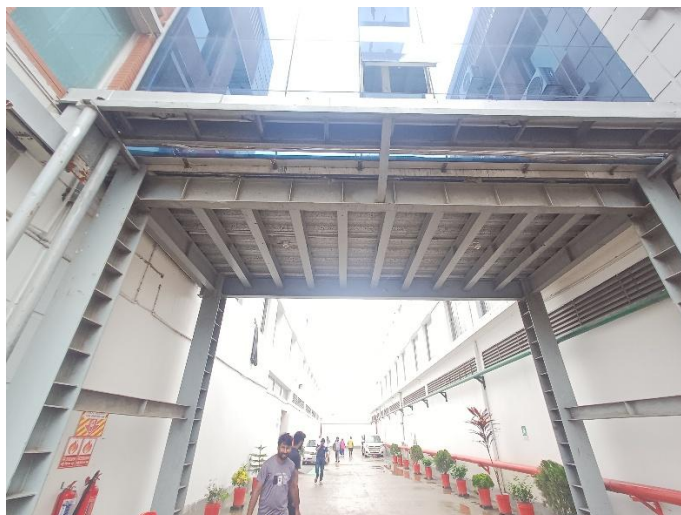
**Observation-09: Lack as-built drawing (Connecting Bridge)**

**Description:** No as-built drawing was found on site for Connecting Bridge. The building engineer is required to survey the structure and prepare accurate as-built drawing and submit to RSC.

| 14. | Lack as-built drawing<br>(Connecting Bridge) | The building engineer is required to prepare accurate as-built drawing and submit to RSC. | within 6 weeks |

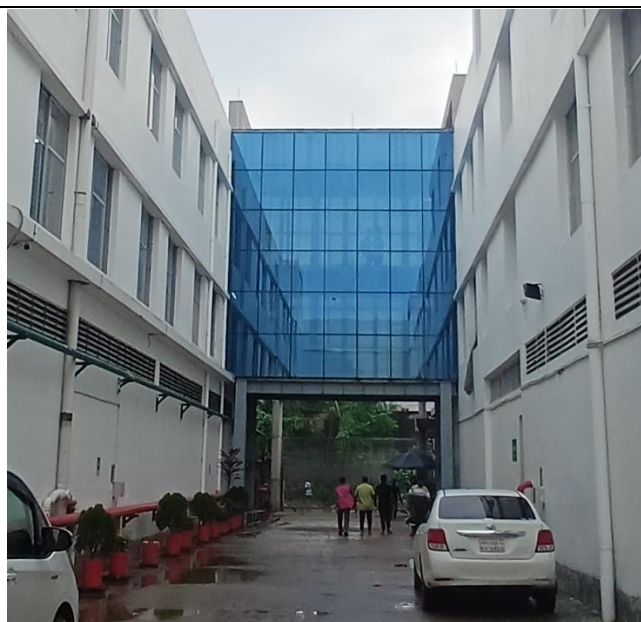
**Observation 10: Lack of Design Report (Connecting Bridge)**

**Description:** At the time of inspection, the design report for connecting bridge was not available on site. As per BNBC, every building or structure designed shall have its design documents prepared following the provisions of Section 1.9.1. The design document shall include a design report and a set of structural drawings, which shall be prepared in compliance with section 1.9.1.1 and section 1.9.1.2 as per BNBC.

The building engineer is required to prepare the Engineering Assessment (EA) in compliance with section 1.9.1.1 and section 1.9.1.2, part-6 of BNBC.

| 15. | Lack of Design Report<br>(Connecting Bridge) | The building engineer is required to prepare the Engineering Assessment (EA) in compliance with section 1.9.1.1 and section 1.9.1.2, part-6 of BNBC. | within 6 months |
| 16. | Lack of Design Report<br>(Connecting Bridge) | Implement remediation work if required. | within 6 months |
