# Uttara Knitwears Ltd Uttara Knitting and Dyeing Ltd

07 June 2014

## Structural Inspection Report

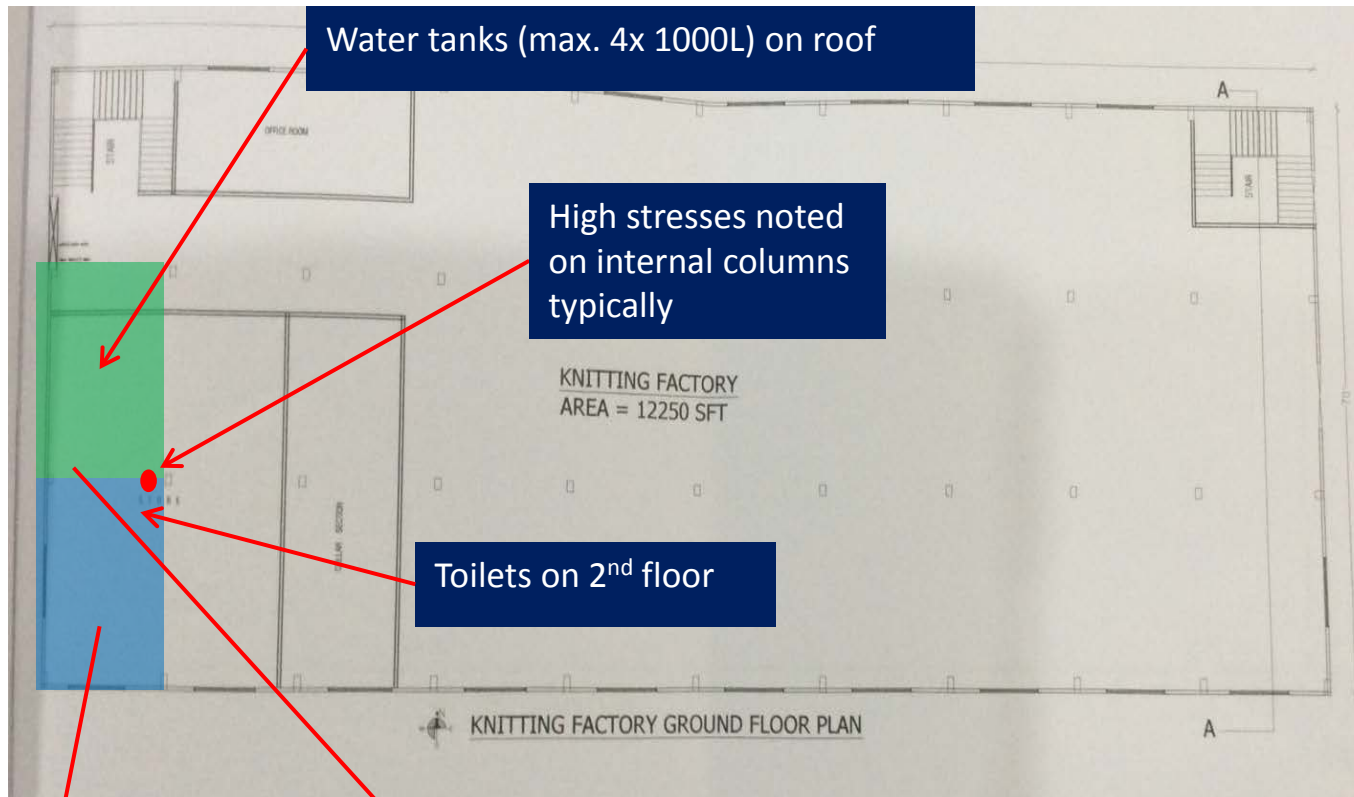
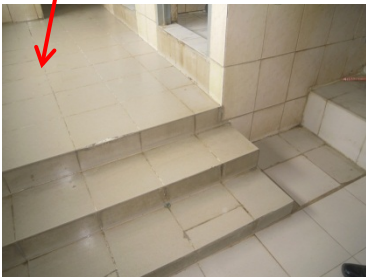
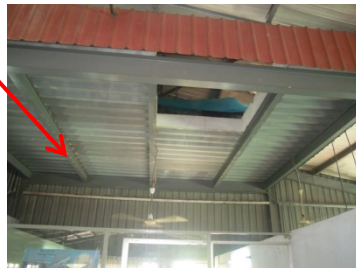
## Item 1 – High column stresses in the columns to Building 2

High Column stresses in **all columns in Building 2**.

- Maintain the current use of the floors and don't change use or increase occupation, either of which could increase loading.
- The Building Engineer is to review design, loads and column stresses in all columns in the Building 2.
- Verify insitu concrete strength either by taking 100mm diameter cores from 4 columns (minimum) or by using existing cylinder strength data for cores. Reinforcement quantities also to be confirmed.
- A Detailed Engineering Assessment of Building 2 is to be carried out to the scope attached.

- Complete the Detailed Engineering Assessment for Building 2.
- Produce and actively manage a loading plan for all floor plates within the factory giving consideration to floor capacity and column capacity.

- Continue to implement floor loading plan

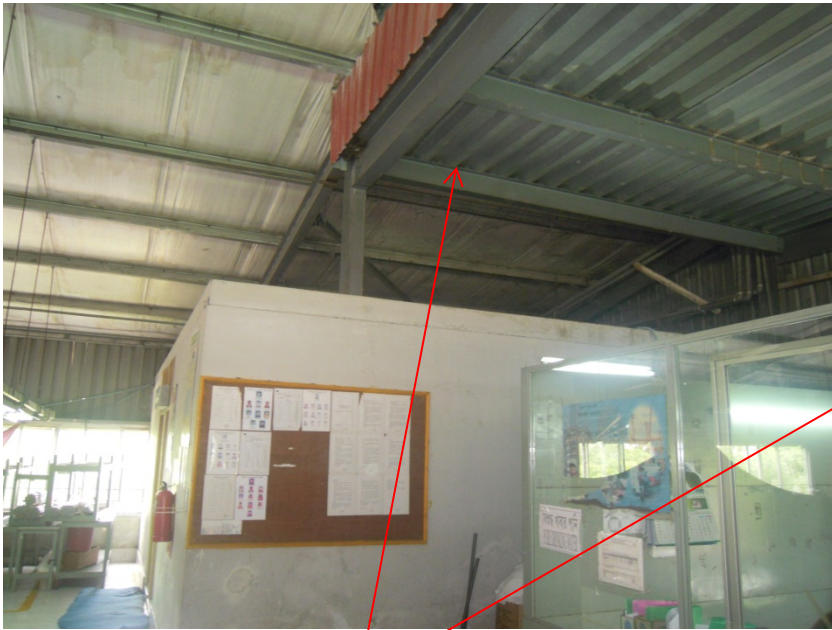
## Item 2 – Design check required for the structure supporting the water tanks in Building 2

**Structure supporting 4x 1000L water tanks**

Design Check required for the structure supporting the water tanks in Building 2.

- The Building Engineer is to carry out a Design check to confirm the structural adequacy of the supporting structure as part of the Detailed Engineering Assessment.
- Produce and actively manage a loading plan for all floor plates within the factory giving consideration to floor capacity and column capacity.

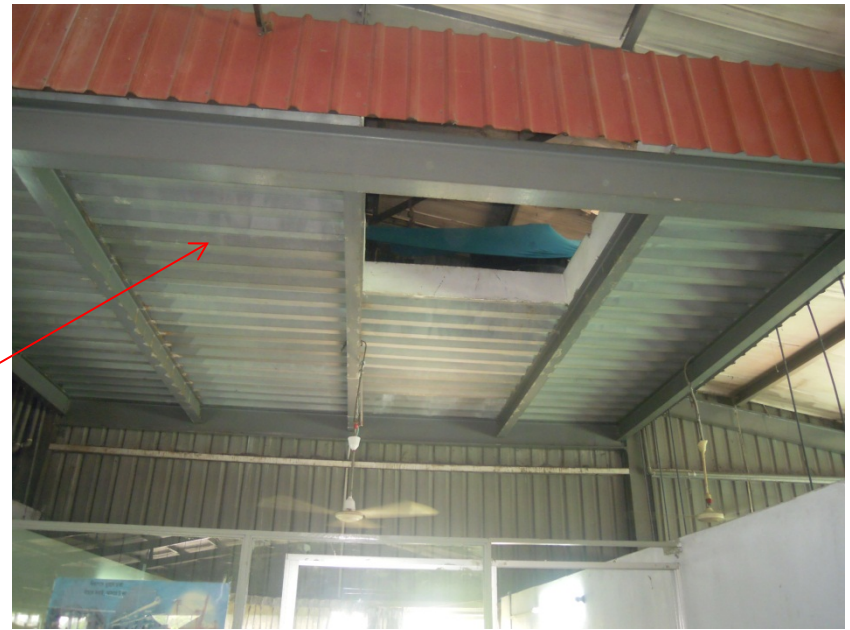
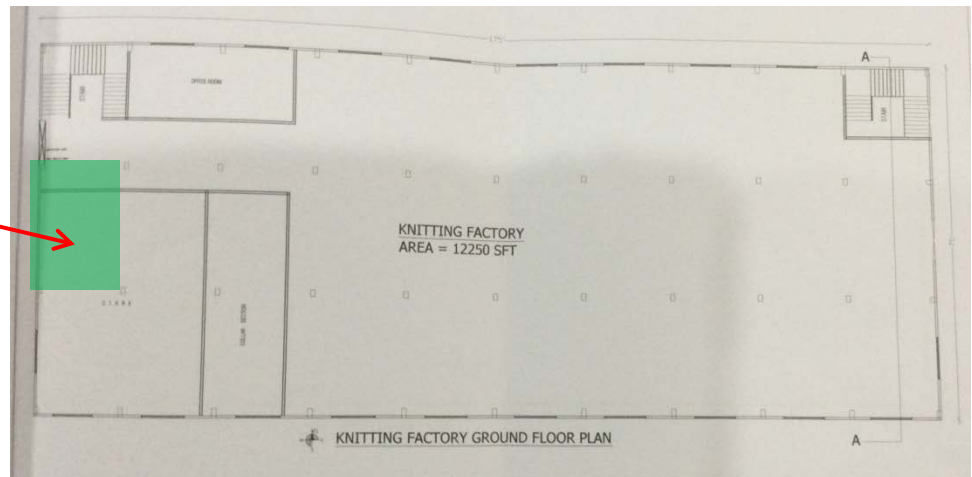
**Water tanks (max. 4x 1000L) on mezzanine at underside of roof**

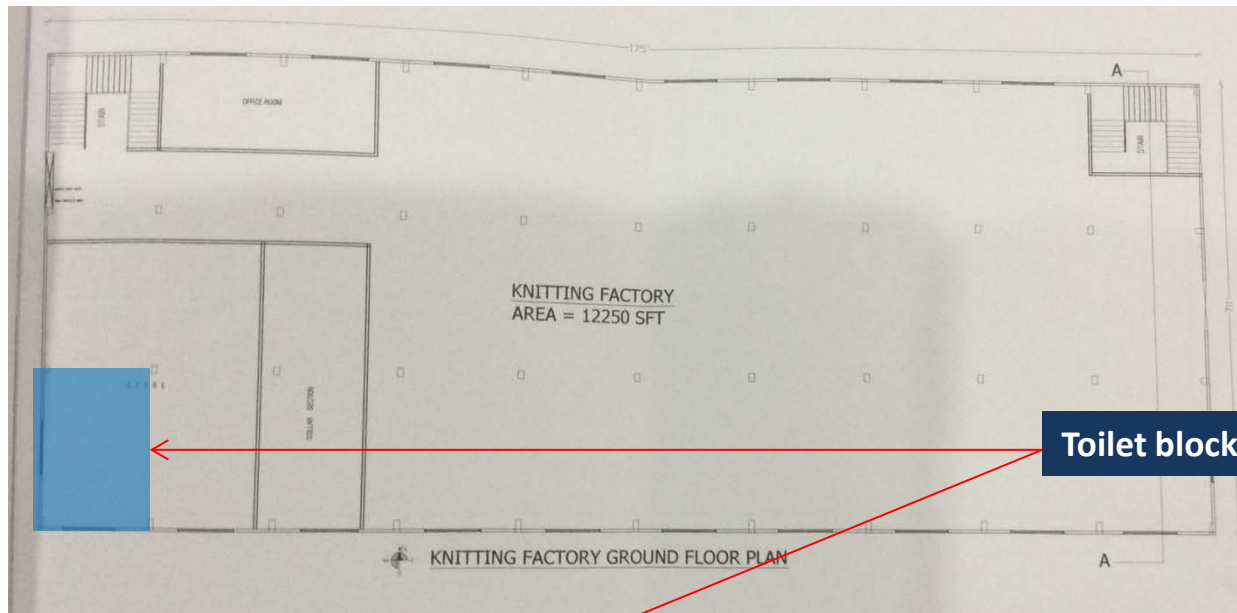
### Item 3 – Design check required for the loading from the toilet plinths in Building 2

Toilet block on 2<sup>nd</sup> floor

Design check required for the loading from the toilet plinths in Building 2.

- The Building Engineer is to carry out a Design check to confirm the structural adequacy of the supporting floor structure as part of the Detailed Engineering Assessment.
- Produce and actively manage a loading plan for all floor plates within the factory giving consideration to floor capacity and column capacity.

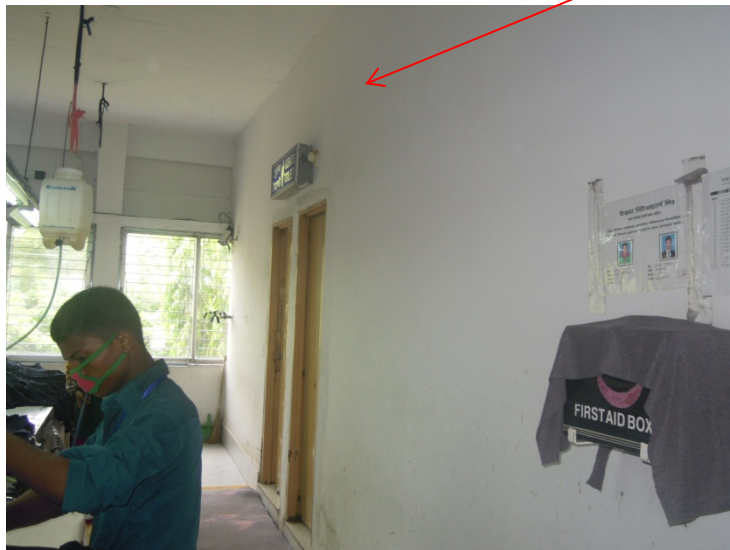
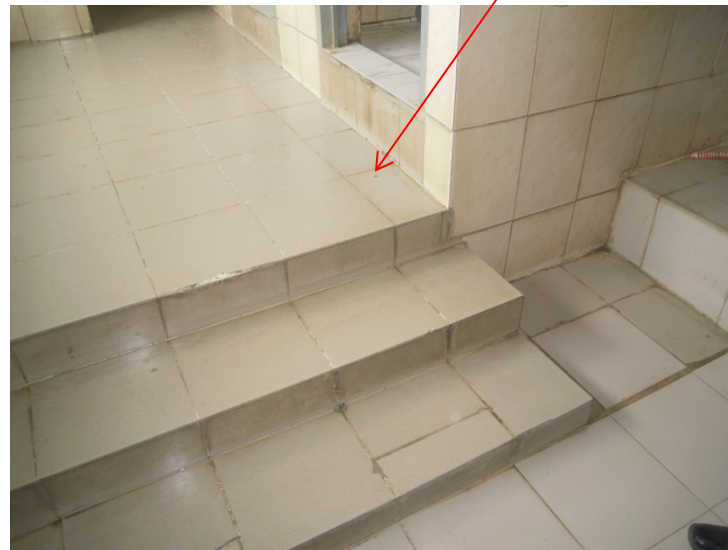
Plinth in toilet block

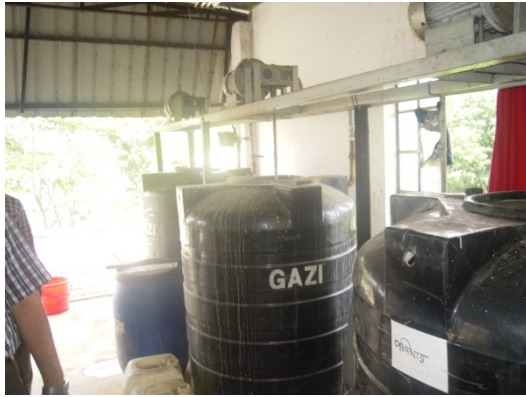
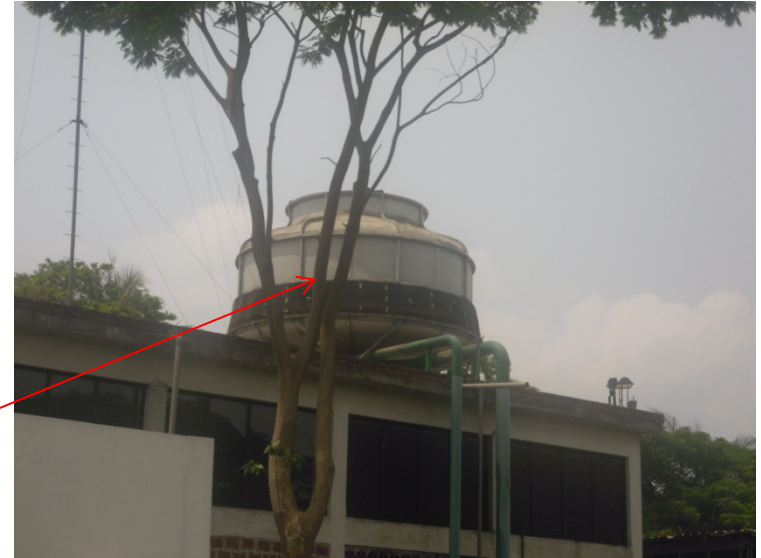
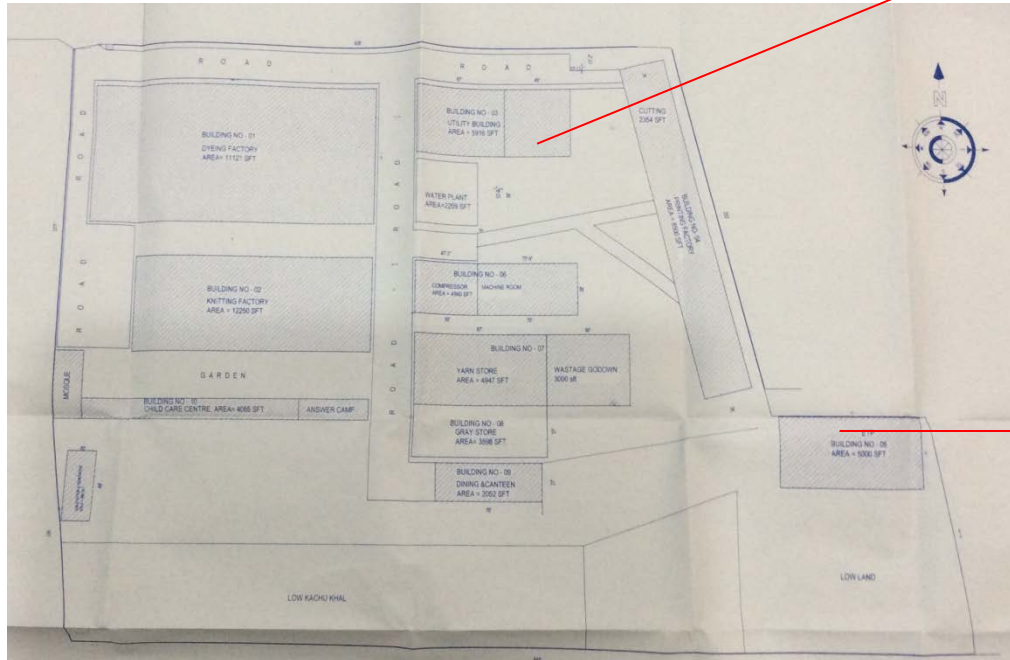
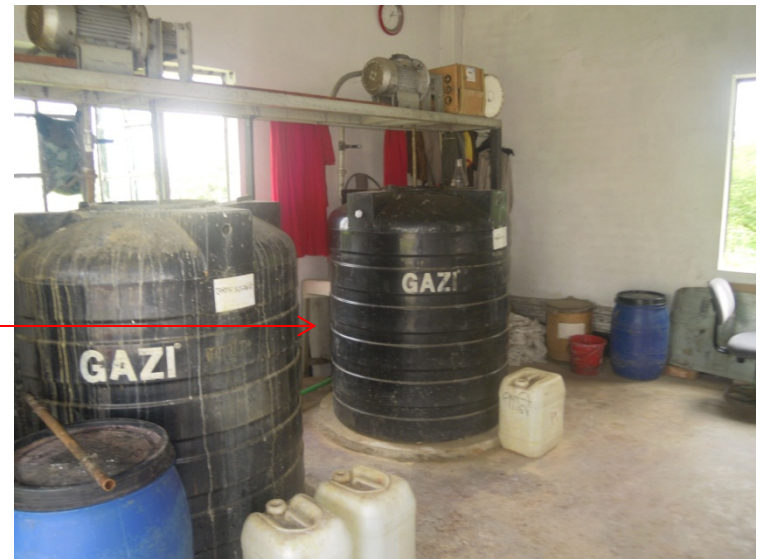
## Item 4 – Design check required for the structures supporting the water chiller and water tanks as noted

Design check required for the structures supporting the water chiller and water tanks as noted.

- The Building Engineer is to check the structural capacity of the floor and roof structures supporting the chiller and water tanks to transfer the loading to the columns.
- Produce and actively manage a loading plan for all floor plates within the building giving consideration to floor capacity and column capacity.

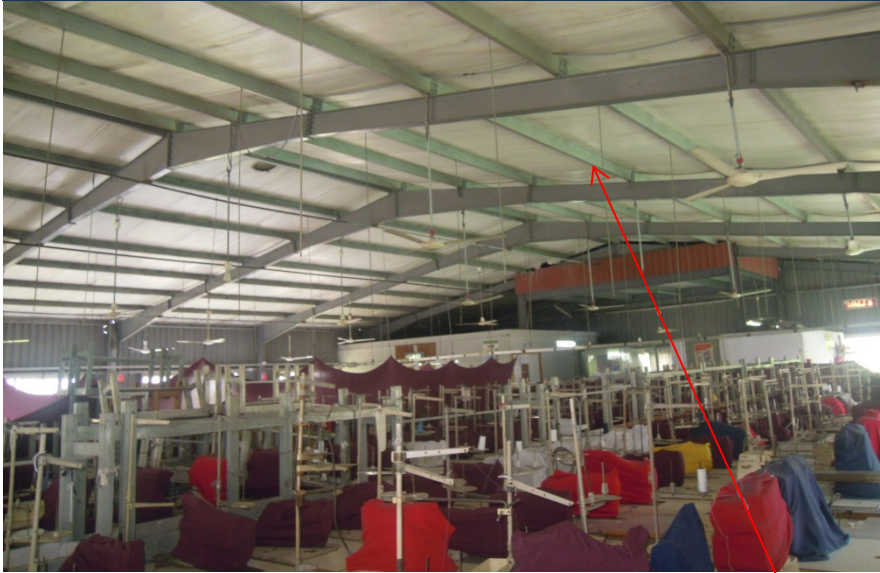
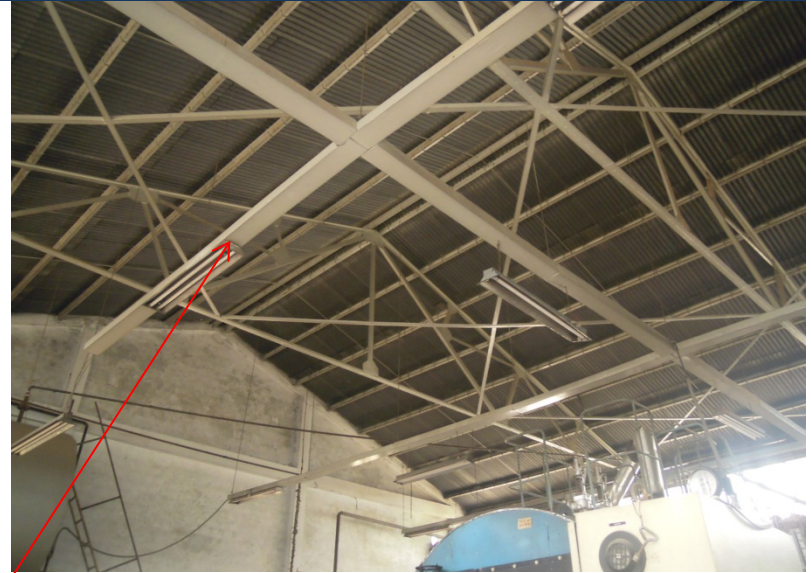
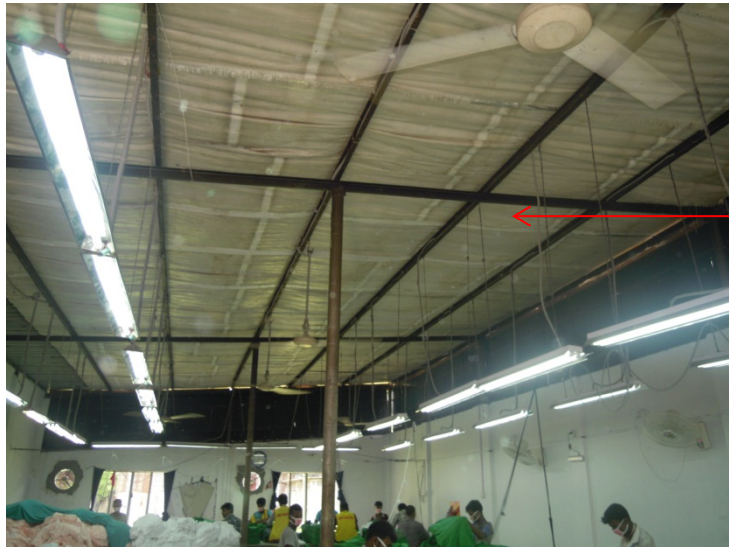
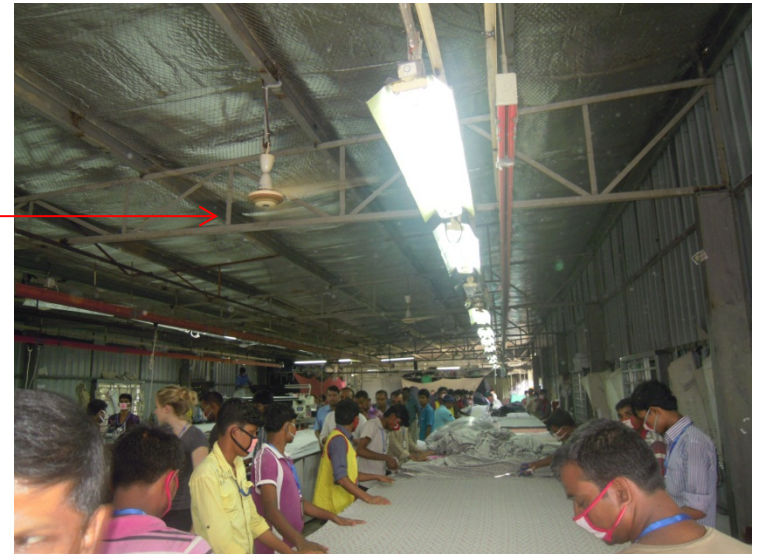
**Item 5 – Design check required for the light steel roofs as noted – generally observed to have little bracing**

**Steel roof  
structures**

Design check required for the light steel roofs as noted.

- No bracing noted in most of the light weight steel roofs and structures viewed on site.
- The Building Engineer is to assess the adequacy of the structures to resist wind loading (pressure, suction & uplift). The installation of bracing and any other remedial measures to be carried out as directed by the Building Engineer.
