# T-DESIGN KNITWEAR LIMITED

Boherarchala, Sreepur, Gazipur, Bangladesh.

13<sup>th</sup> August 2017

# Observations

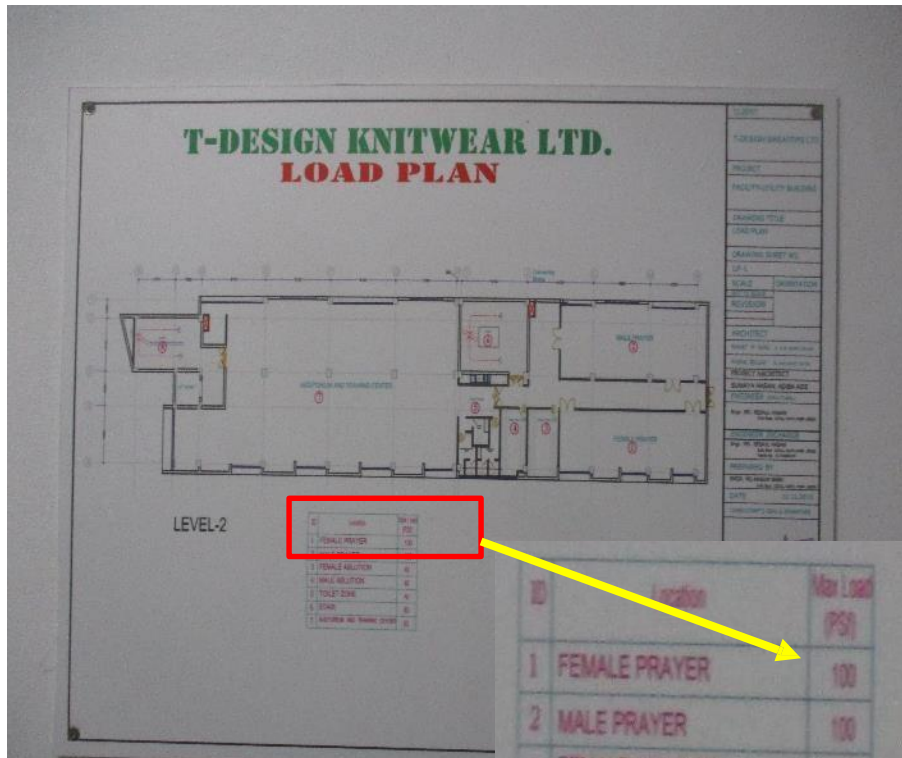
**Observation: Utility Building**

**Prepared Load Plan required to be verified**

Factory Engineer prepared a load plan considering 5 Kpa (100 psf) allowable floor loading for Utility building. Design review required if the factory management wants to implement that load plan.

Factory is required to maintain floor live load 3Kpa until further verification by design engineer. During inspection, no overloading was observed and FOS calculation for internal column was found satisfactory considering 3Kpa allowable live loading.

- Maintain 3 Kpa loads on all floors.
- Produce and actively manage a load plan for all floor plates within the factory giving consideration to floor capacity and column capacity if loading above 3Kpa is considered.

- Continue to implement load plan

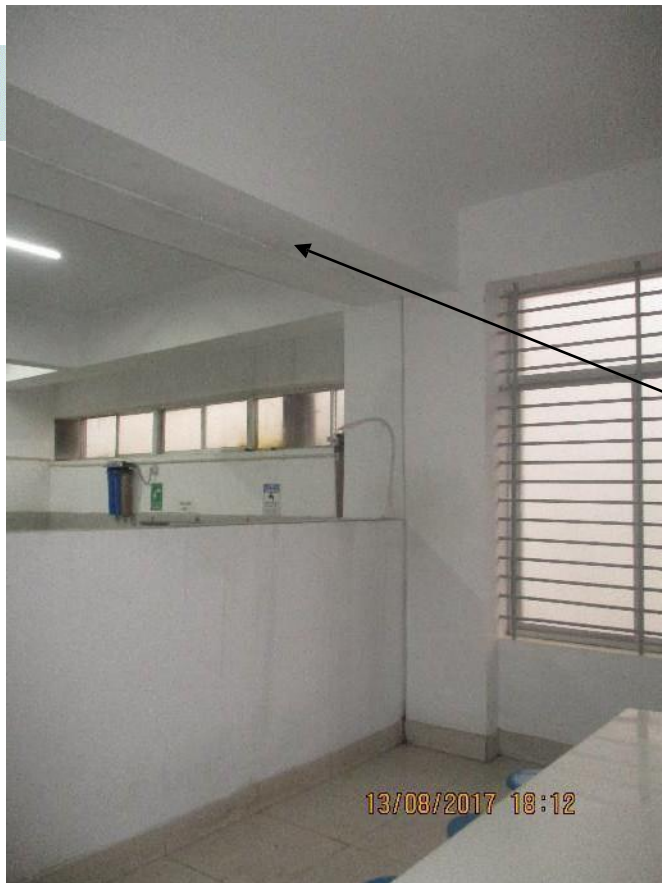
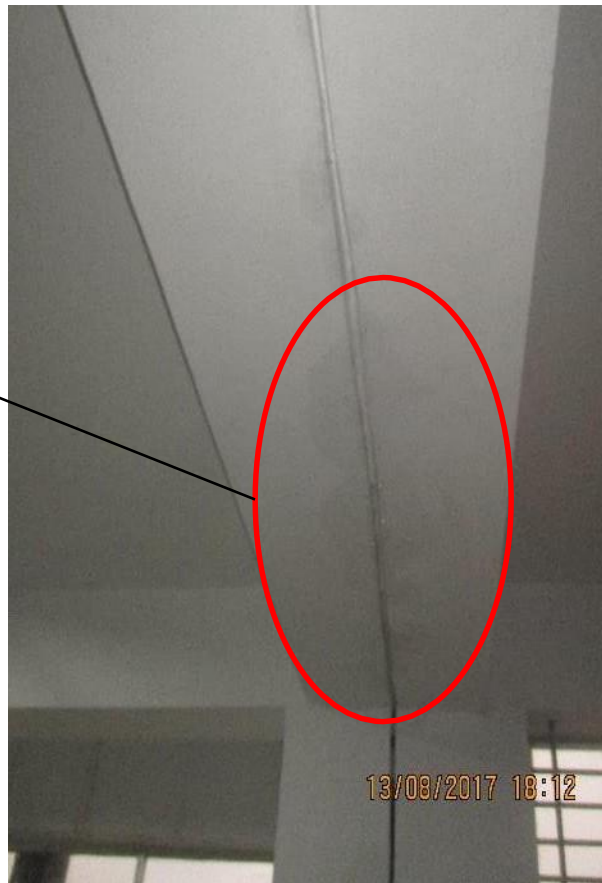
**Observation: Utility Building**

# Dampness due to water ingress on movement joint

Water ingress was found on 2<sup>nd</sup> floor at movement joint zone.

Dampness was found in several locations along with the movement joint. Factory engineer is required to check the affected beam and take proper remediation for preventing further dampness.

- Factory engineer is required to investigation the intensity of concrete damage of beams.
- Factory engineer is required to provide proper remedial method.

- Implement the repair works suggested by the factory engineer

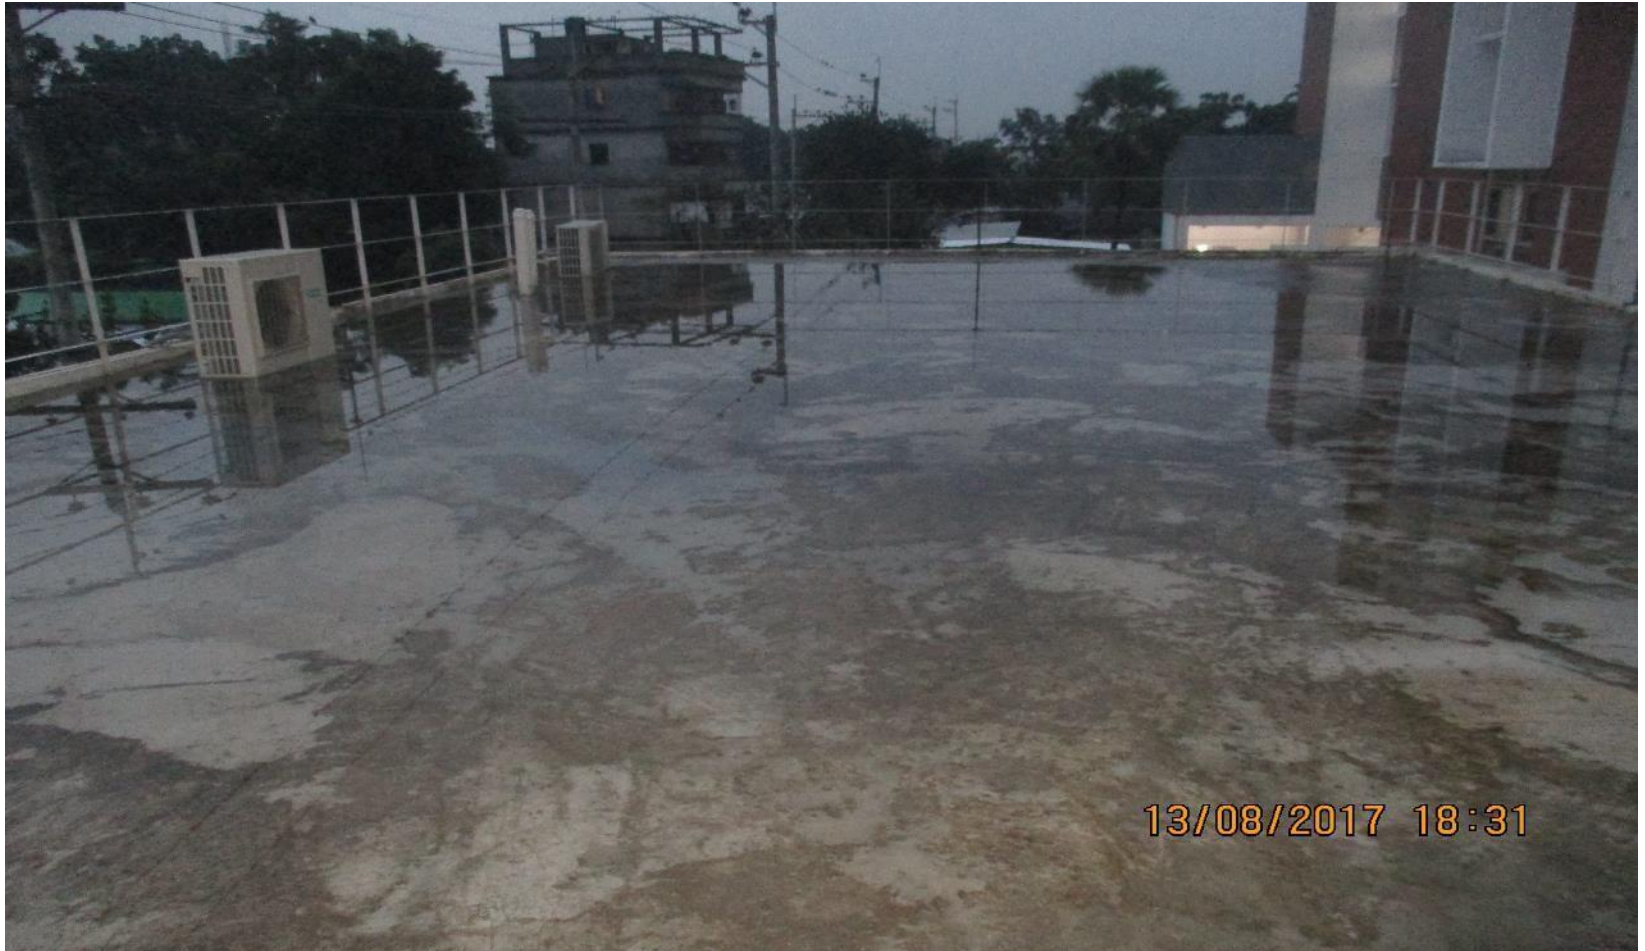
**Observation: HR & Day care Building**

# Water clogging on roof

Water clogging was observed on roof. Factory is required to install the proper drainage system for preventing water clogging.

- Factory is required to install the proper drainage system for preventing water clogging.

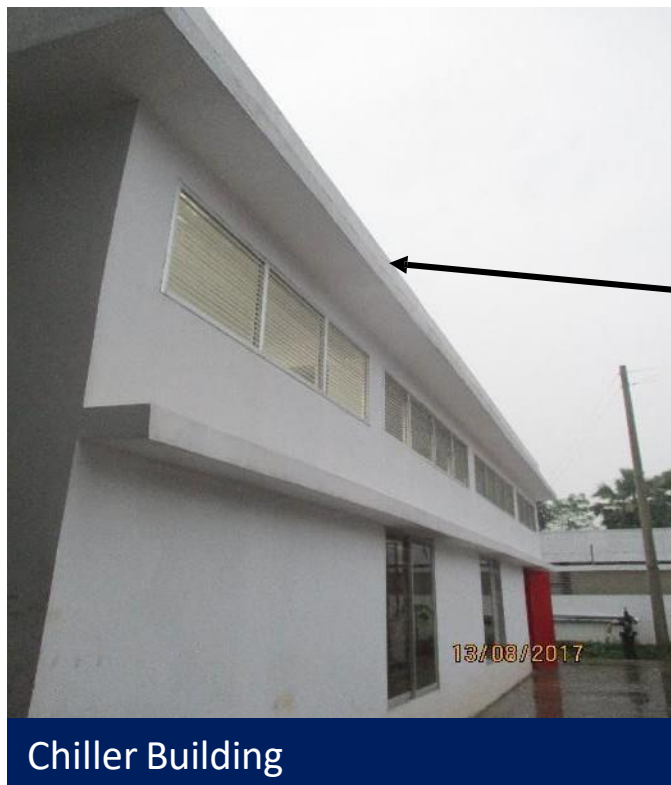
Chiller Building

# Heavy Loading observed on roof of the chiller building

- Factory is required to check the capacity of the slab to carry the additional imposed load.

- Implement necessary recommendations as per assessment where necessary.

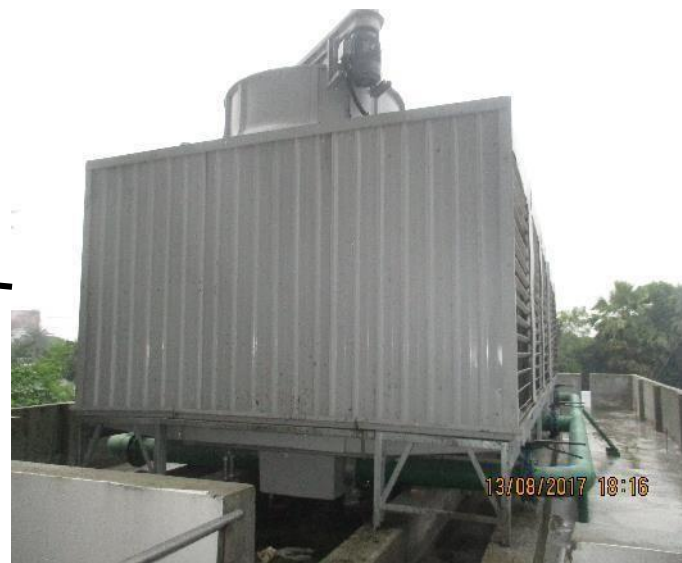
5000 Kg and 3500 Kg Cooling tower  
on roof top

During inspection, two 5000 Kg and 3500 Kg Cooling tower were observed on roof of chiller building . Factory is required to check the capacity of the slab to carry the imposed load of cooling tower.

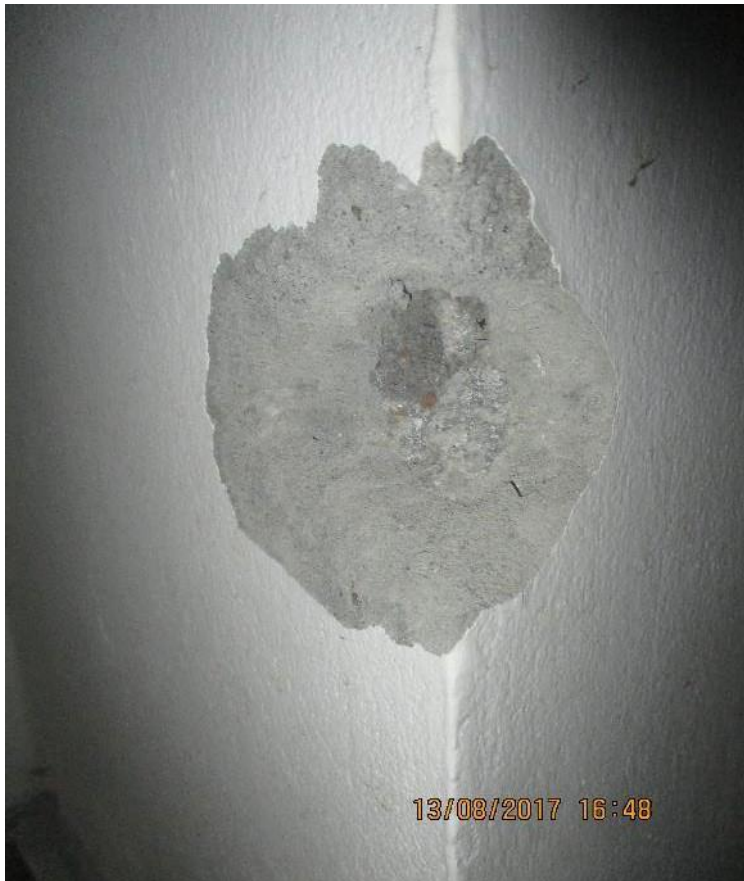
Checking aggregate of column (Stone Chips)

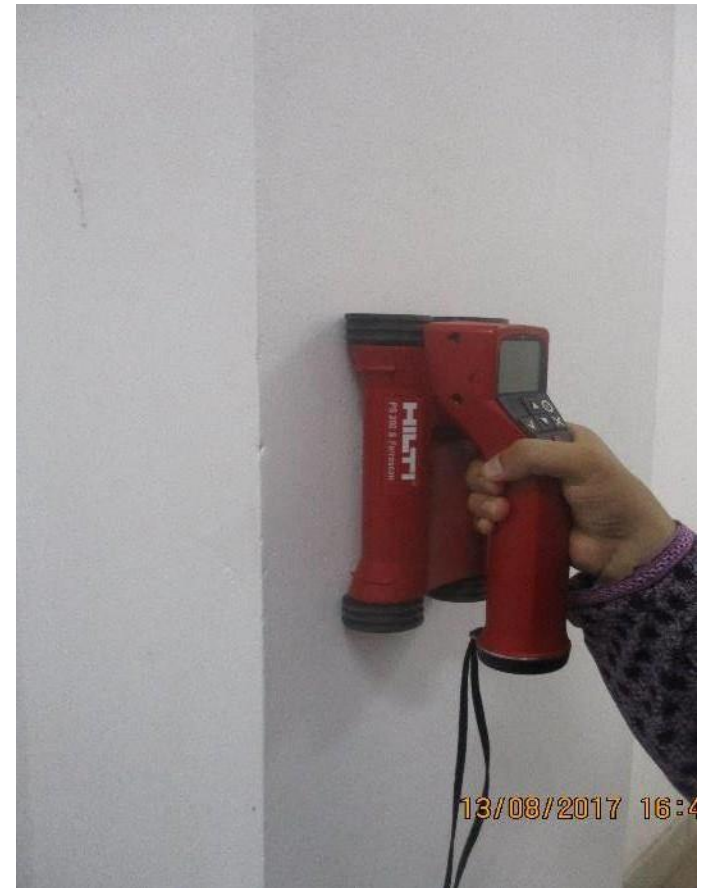
Rebar Scanning of column
