# CONFIDENCE KNITWEAR LTD.

Dhanuya, Nayanpur, Sreepur, Gazipur  
(24.2547672N, 90.3885037E)

3<sup>rd</sup> November 2015

## Problem Observed in the New Production Building:

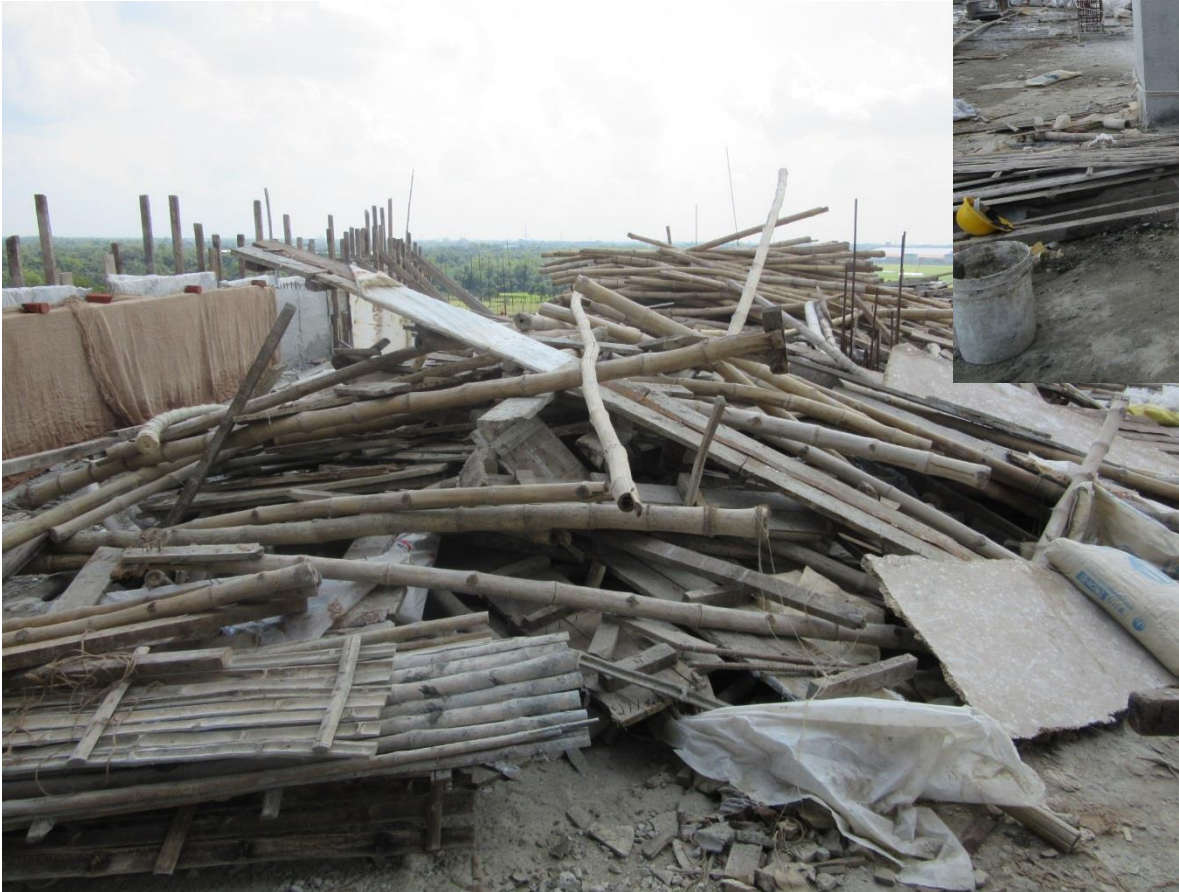
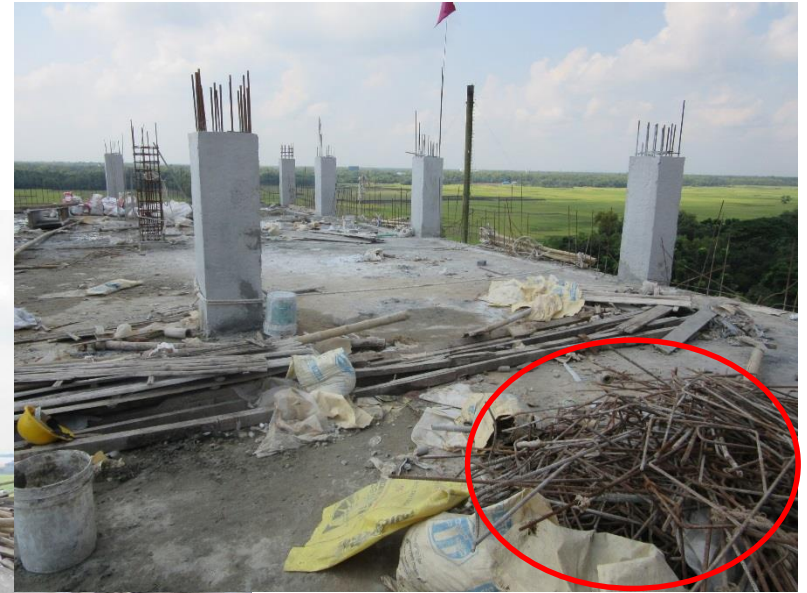
# Uncontrolled construction material storage on the roof

Uncontrolled construction material storage

| Item No. | Observation | Recommended Action Plan | Recommended Timeline |
|---|---|---|---|
| 1 | Uncontrolled construction material storage on the roof | Remove construction materials from the roof | 6-weeks |

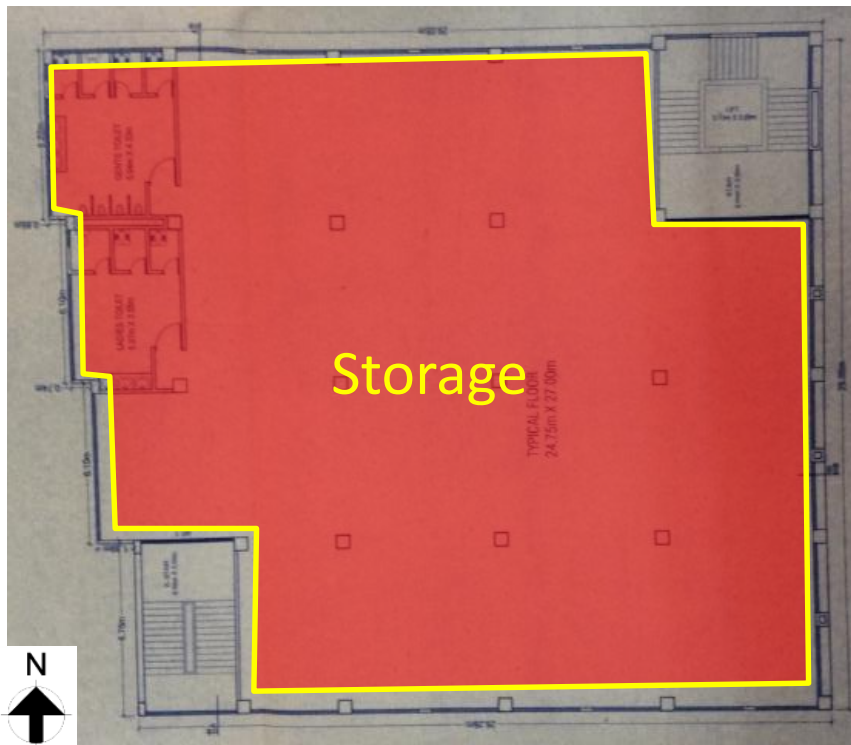
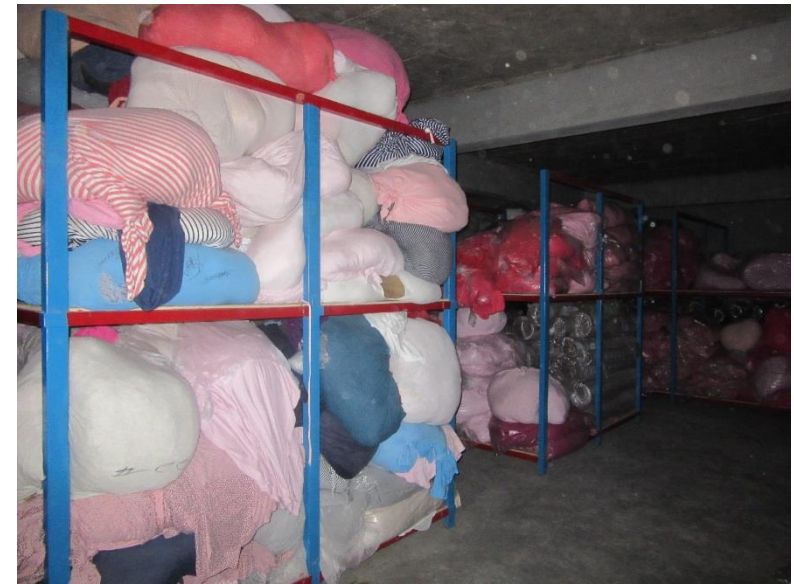
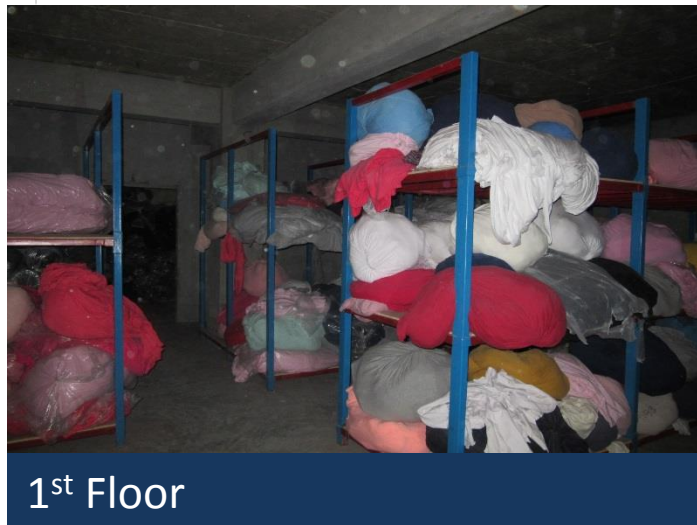
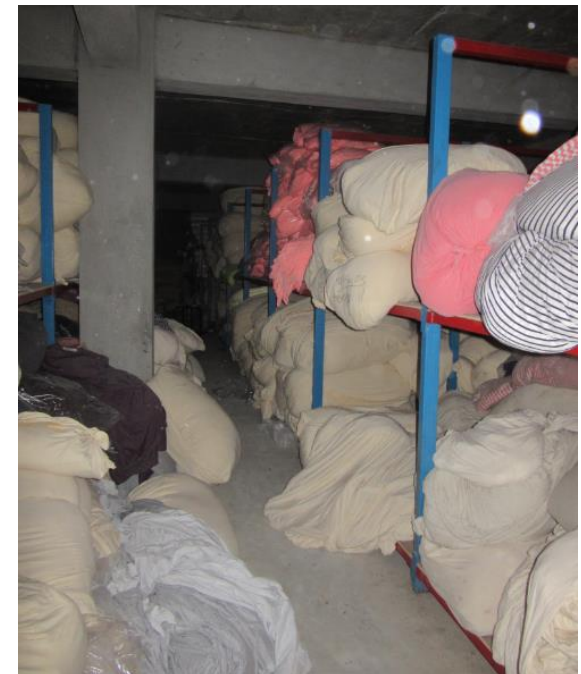
# Overloaded storage areas

| Item No. | Observation | Recommended Action Plan | Recommended Timeline |
|---|---|---|---|
| 2 | Overloaded storage areas | The quantity of the stored materials must be reduced to the level specified by the original designer | 6-weeks |
| 3 | Overloaded storage areas | Building Engineer to provide a Load Plan for each level | 6-weeks |
| 4 | Overloaded storage areas | Reduce loading to the recommendations of the loading plans | 6-months |

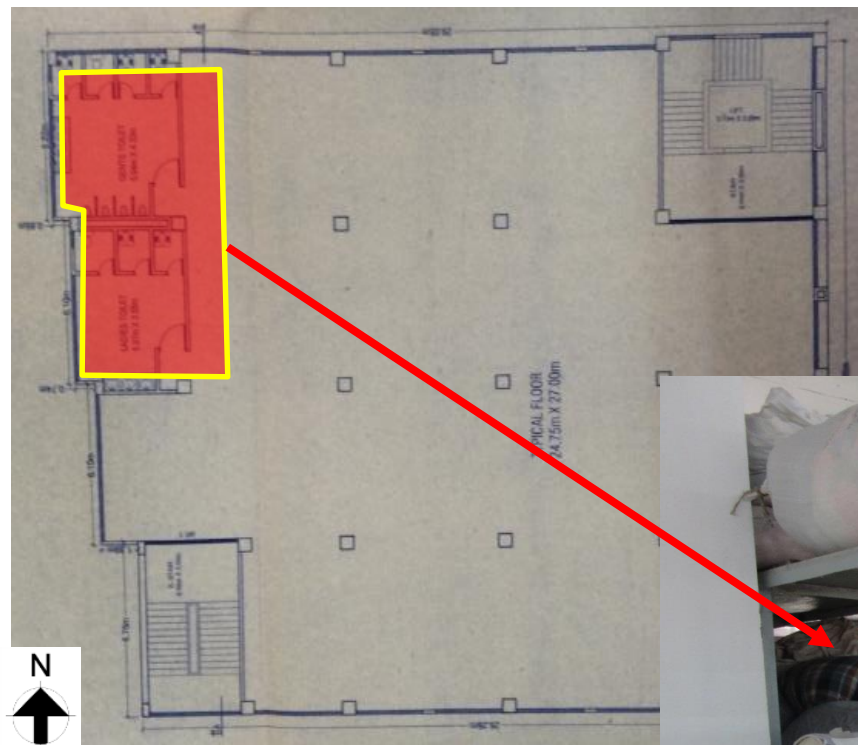
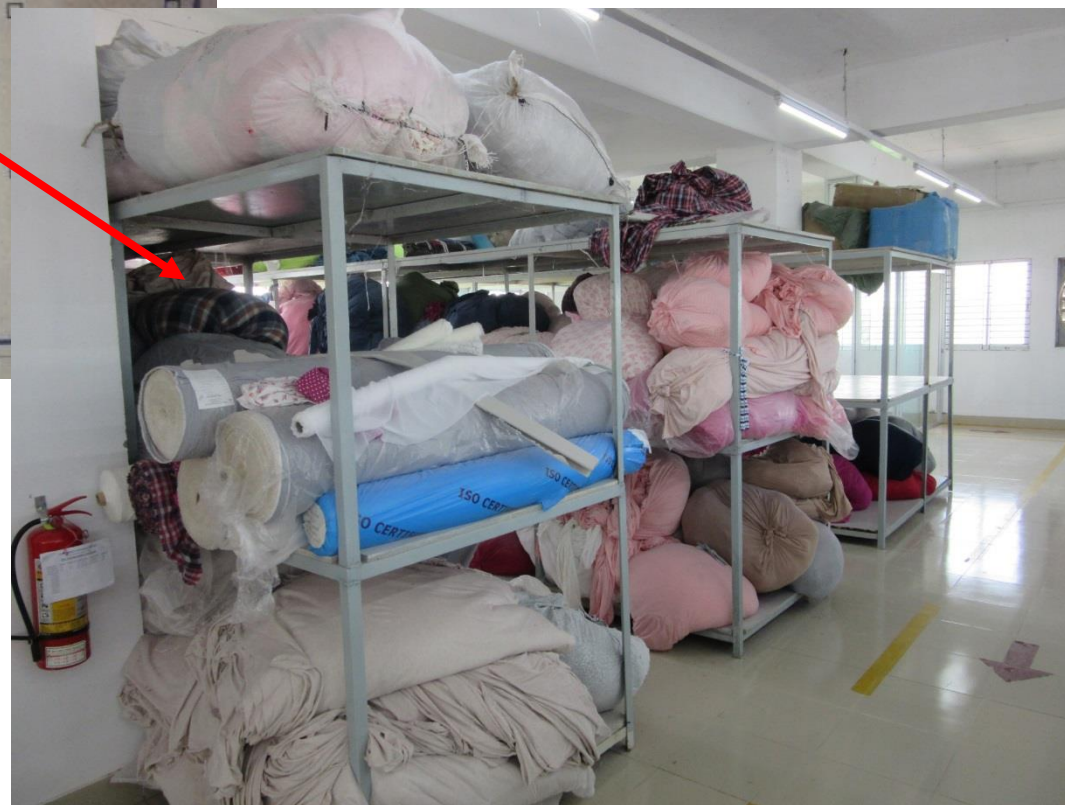
3<sup>rd</sup> Floor

## Observations – New Production Building
