# ELECTRICAL SAFETY INSPECTION REPORT

**L Usine Fashion Ltd (Unit-2)**

**Inspected on March15, 2014**

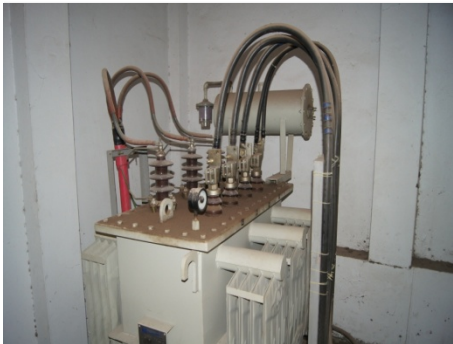
| <b>Finding #:</b> E- 1 | |

| <b>Finding:</b><br>Excessive lint and dust deposit on transformer body. | |
| <b>Remediation Timeframe:</b> Within 1 month | Transformer. |

| <b>Recommendation:</b><br>Establish a routine cleaning program to keep neat and clean the transformer room. Shut down the power of the transformer and clean the exterior of the transformer at scheduled period. | |

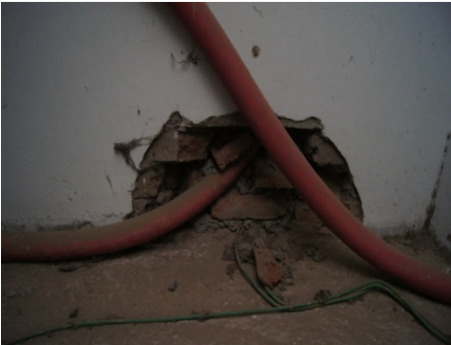
| <b>Finding #:</b> E- 2 | |

| <b>Finding:</b><br>HT cable passing through the wall is not protected. | |
| <b>Remediation Timeframe:</b> Within 1 month | HT cable |

| <b>Recommendation:</b><br>Provide steel pipe through the wall to protect the HT cable from any kind of damage. Seal all the penetrations using appropriate fire rated material and ensure the cable insulation does not get damaged during sealing work. | |

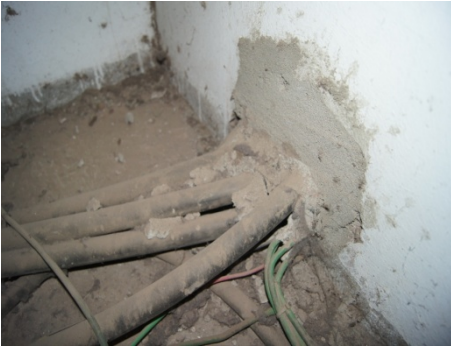
| <b>Finding #:</b> E- 3 | |

| <b>Finding:</b><br>Transformer LT cables passing through the wall where the hole is sealed by concrete. | |
| <b>Remediation Timeframe:</b> Within 1 month | LT cables passing through permanent wall |

| <b>Recommendation:</b><br>Cables passing underground or through permanent walls must be protected in steel/PVC pipes and remaining holes around the pipe must be sealed with appropriate fire rated material. | |

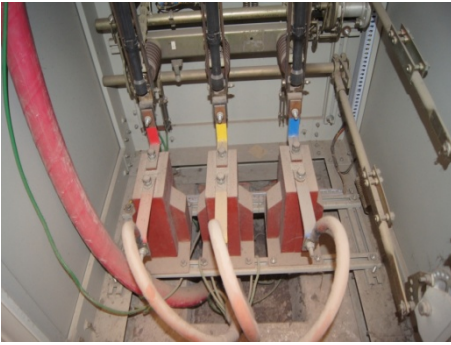
| <b>Finding #:</b> E- 4 | |

| <b>Finding:</b><br>Dust fund inside the HT panel. | |
| <b>Remediation Timeframe:</b> Within 1 month | HT panel |

| <b>Recommendation:</b><br>Disconnect the panel from power source and clean the interior of the HT panel regularly and seal the opening to protect ingress of lint and dusts. Provide covers if any additional gap remains after installing cable glands. | |

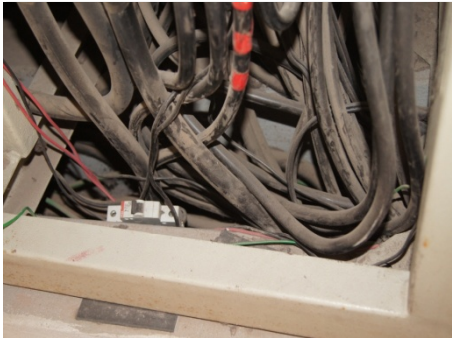
| <b>Finding #:</b> E- 5 | |

| <b>Finding:</b><br>MCB is not supported inside the panel. | |
| <b>Remediation Timeframe:</b> Within 1 month | Inside scenario of a panel |

| <b>Recommendation:</b><br><br>Protective devices inside panel must be fixed rigidly with proper nut-bolt/screw (may be provided by manufacturer) inside panel. | |

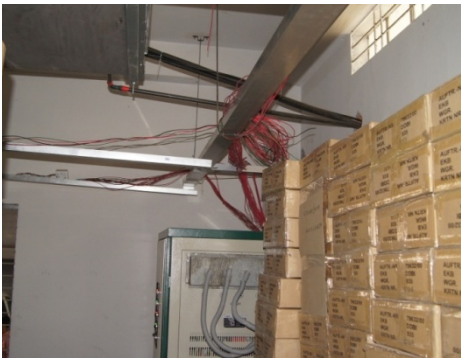
| <b>Finding #:</b> E- 6 | |

| <b>Finding:</b><br>Storage near the cable duct. | |
| <b>Remediation Timeframe:</b> Within 1 month | Goods storage |

| <b>Recommendation:</b><br>Storage goods must be stored, keeping safe clearance from any electrical installation to reduce the risk of spreading fire due to short circuit. | |

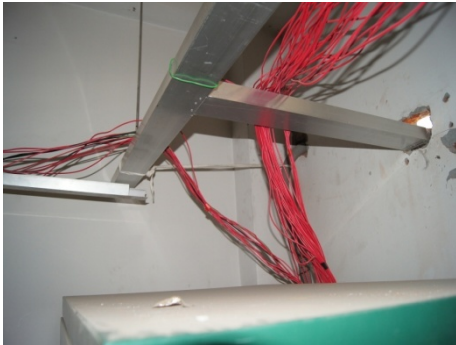
| <b>Finding #:</b> E- 7 | |

| <b>Finding:</b><br>No cable duct/trays are used for support and protection of the cables. | |
| <b>Remediation Timeframe:</b> Within 1 month | Wires are hanging on the floor. |

| <b>Recommendation:</b><br>Install metallic (non-combustible) cable duct over the floor and provide metallic cover on it to keep it dust and vermin free. Establish a periodic cleaning program to keep all the duct/trays/channel dust-free. | |

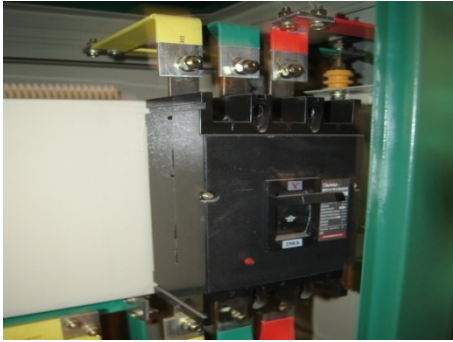
| <b>Finding #:</b> E- 8 | |

| <b>Finding:</b><br>No phase barrier is installed in MCCB. | |
| <b>Remediation Timeframe:</b> Within 1 month | MCCB inside the panel |

| <b>Recommendation:</b><br>Provide phase separators between poles of MCCB made of noncombustible materials preferably use rubber having enough dielectric strength to insulate phases from each other. | |

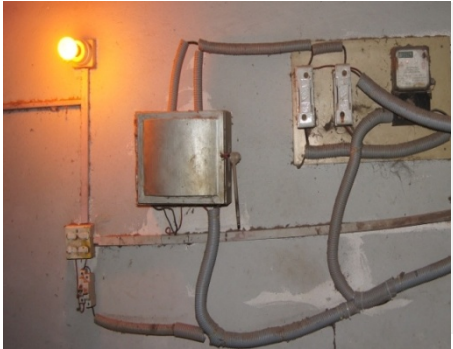
| <b>Finding #:</b> E- 09 | |

| <b>Finding:</b><br>Protective devices are mounted on the wall without enclosure. | |
| <b>Remediation Timeframe:</b> Within 1 month | Control devices are mounted on the wall |

| <b>Recommendation:</b><br>Protective devices should be encased in metal casing made of 20 SWG thickness metal sheets. Replace the semi enclosed rewire-able fuse with miniature circuit breaker (MCB). | |

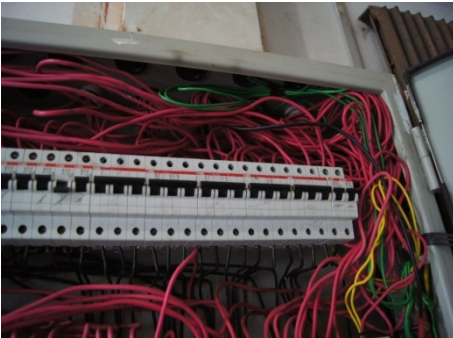
| <b>Finding:</b><br>Excessive wires are crowding inside the panel. | |
| <b>Remediation Timeframe:</b> 3 months | Distribution panel. |

| <b>Recommendation:</b><br>Assign an electrical engineer to determine the capacity of the installation and redesign the wirings of the panel. If the wirings and loads exceed the capacity of the panel, install additional panel. Establish a load management program for avoiding any installation exceeding its capacity in future. Install slotted wiring-duct inside the panel to arrange and latch the haphazard cables. | |

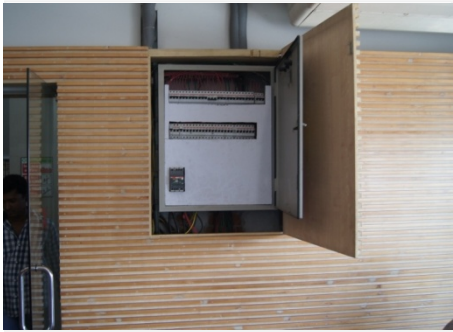
| <b>Finding #:</b> E- 11 | |

| <b>Finding:</b><br>Panel is covered by flammable material (used for interior design). | |
| <b>Remediation Timeframe:</b> Within 1 month | Distribution panel |

| <b>Recommendation:</b><br>Panel must be removed from this location and installed at safe location, away from the combustible material | |

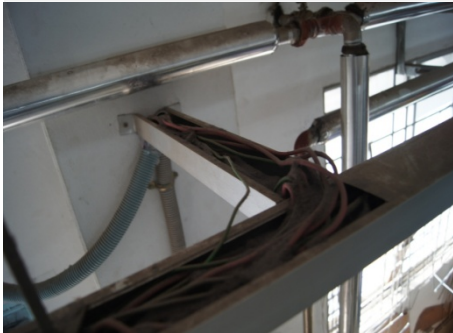
| <b>Finding:</b><br>Excessive lint and dust deposit inside the wiring duct. | |
| <b>Remediation Timeframe:</b> Within 1 month | Wiring duct |

| <b>Recommendation:</b><br>Disconnect the power source of the cable laid into channel and clean dust and debris of all interior components. Establish a periodic cleaning program and maintain records of the activities. Provide cover made of noncombustible material on the channel for preventing ingress of dust and debris in future. | |

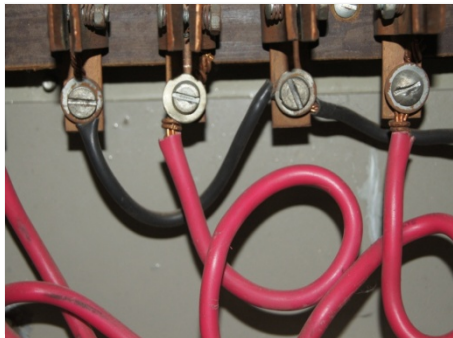
| <b>Finding #:</b> E- 13 | |

| <b>Finding:</b><br>Wires are connected without lug. | |
| <b>Remediation Timeframe:</b> Within 1 month | Wires are connected without lug |

| <b>Recommendation:</b><br>Cables shall be connected to terminals only by soldered/welded lugs according to the size of the respective cables. Proper crimping tools must be used to punch the socket. | |
