FIRE SAFETY INSPECTION REPORT

VISION COMPOSITE KNIT LTD.

ACCORD
on Fire and Building Safety in Bangladesh

June 1, 2014

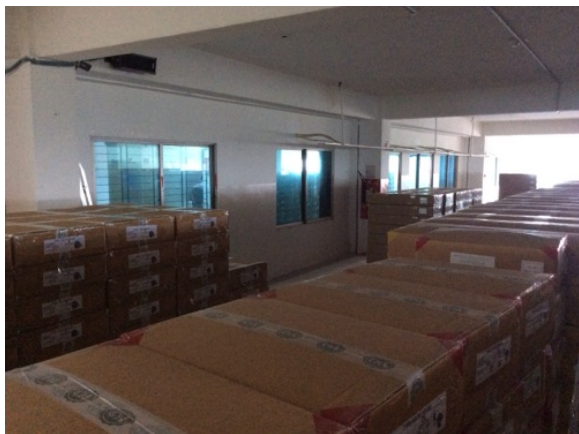
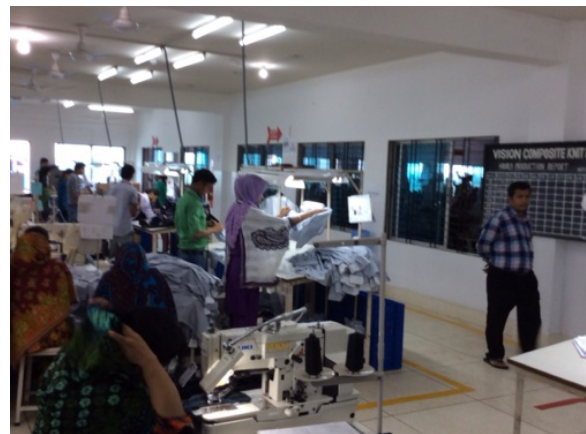
No.	Category	Finding	Recommendation	Remediation Timeframe
F-1	Fire Rated Construction	Dedicated storage areas of the adjacent ninth storied building (5th and ground floor) were not separated from the working areas by means of fire rated construction (non-rated door and unprotected openings)	Provide dedicated storage rooms separated by minimum 1-hr fire-rated construction.	Within 3 months

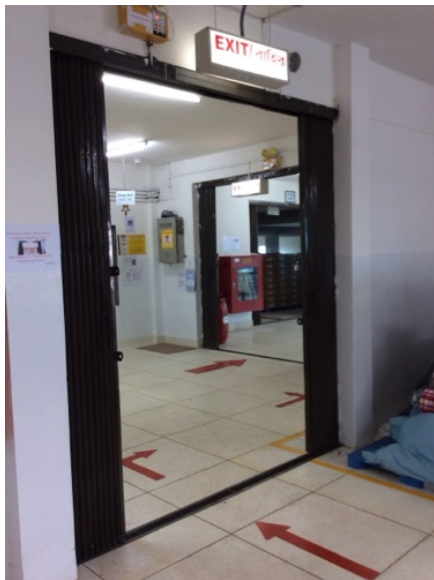
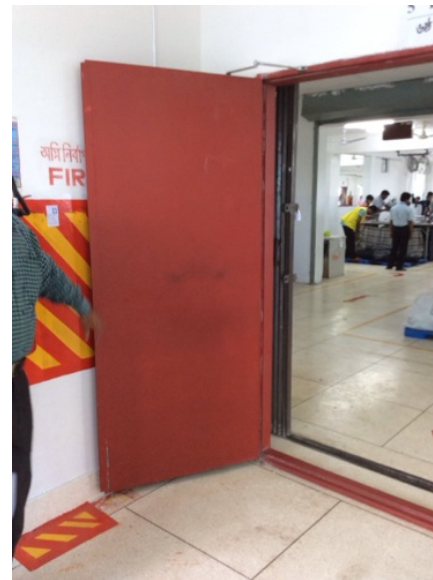
F-2	Fire Rated Construction	The western exit stair was not separated from work areas on each floor by fire-rated construction. The eastern stair was provided with non-listed doors.	Provide minimum 1.5-hr fire rated doors and seal all unprotected openings to separate the exit stairs from work areas and other building spaces on all floor levels. Ensure that the fire doors are self-closing and positive latching and that they are provided with fire exit (panic) hardware where serving production floors.	Within 3 months
-----	-------------------------	--	--	-----------------

If fire doors are required to be held open for functional reasons, provide automatic-closing devices tied to the fire alarm system.

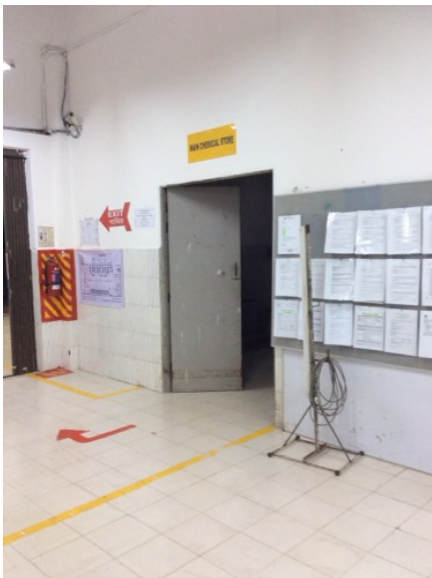
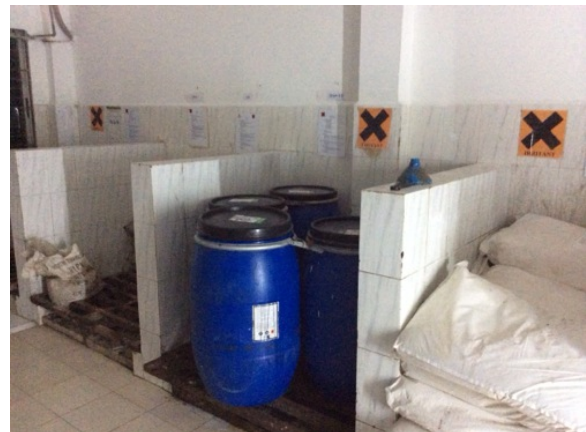
F-4	Fire Rated Construction	The chemical storage room is not separated from the working areas by fire-rated construction (non-rated doors).	Separate the hazardous materials / flammable liquid storage room by a minimum 2-hr fire-rated construction. Seal and/or protected all openings to maintain the required fire separations.	Within 3 months
-----	-------------------------	---	---	-----------------

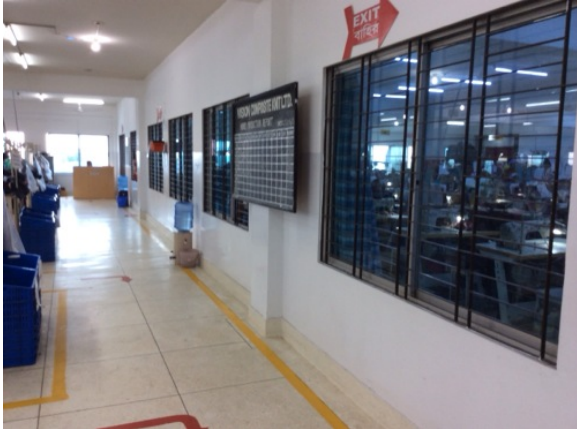
F-5	Fire Rated Construction	Adequate fire rated separation was not present between the two main buildings throughout all floors (unprotected openings between walls).	Separate the buildings by minimum 1-hr fire-rated construction.	Within 3 months
-----	-------------------------	---	---	-----------------

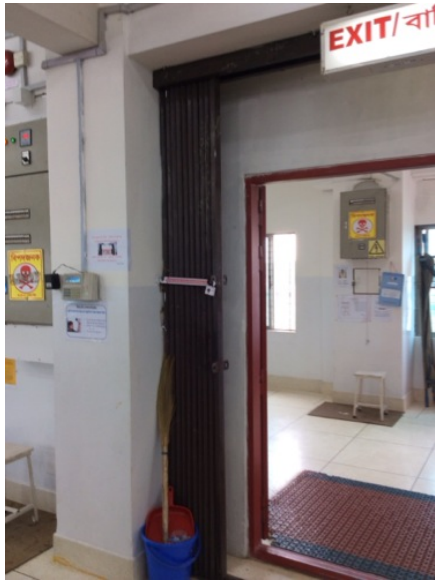
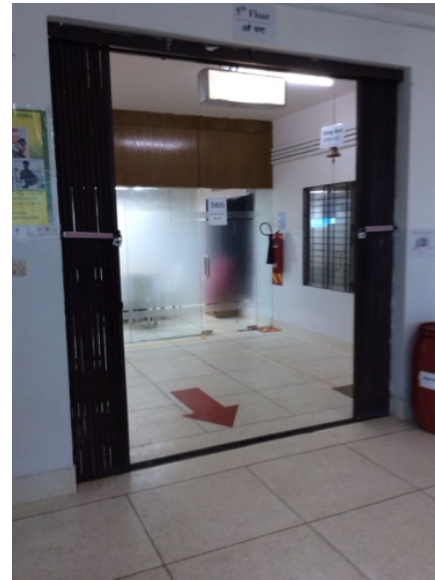
F-6	Egress	Egress doors and gates with locking features are provided at all building exits, exit stairs and exit discharges.	Remove locking features from all egress doors / gates. If locks are required for security reasons, utilize special door locking features complying with NFPA 101.	Immediate
-----	--------	---	--	-----------
