# **FIRE SAFETY INSPECTION REPORT**

## **CRYSTAL INDUSTRIAL BANGLADESH LTD.**

**SA PLOT 2013 KEWA SREEPUR, GAZIPUR**

February 21, 2014

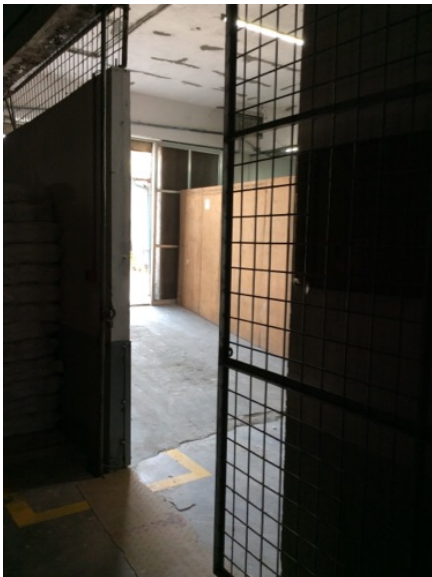
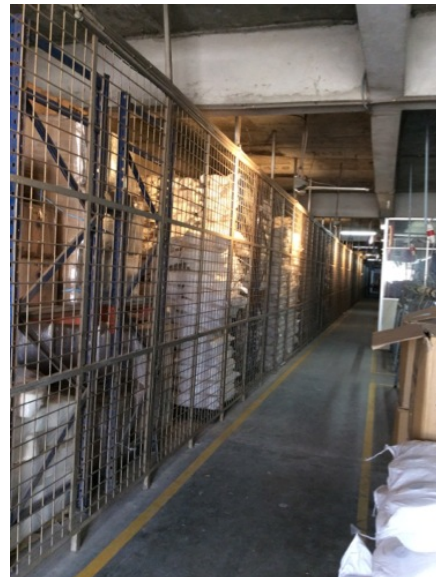
| No. | Category | Finding | Recommendation | Remediation Timeframe |
|---|---|---|---|---|
| F-1 | Fire Rated Construction | Areas used for combustible storage, specifically the storage warehouse areas to the northwest corner of the factory, are not separated by fire-rated construction. | <p>Provide dedicated storage rooms separated by minimum 1-hr fire-rated construction.</p> <p>Where separate storage rooms are not feasible, provide defined storage areas and limit the storage arrangement as follows:</p> <ul style="list-style-type: none"> <li>- Maximum height of 2.4m and maximum area of 23m<sup>2</sup></li> <li>- If sprinkler protected: maximum height of 3.66m and maximum area of 93m<sup>2</sup></li> </ul> <p>Separate areas of unenclosed combustible storage by a minimum clear distance of 3m.</p> | Within 3 months |

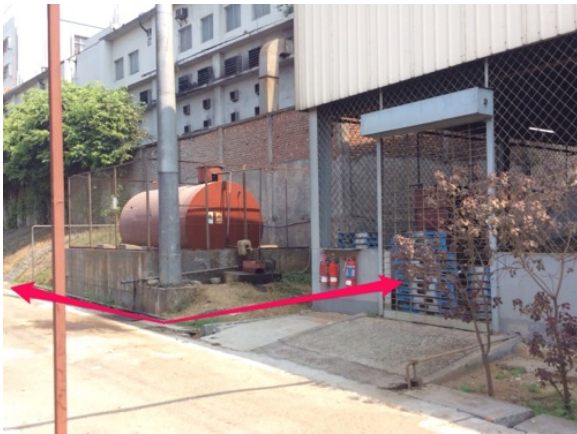
| F-2 | Fire Rated Construction | The southeast boiler/generator/transformer structure and the factory building are not separated from the diesel fuel storage tank by fire-rated construction. | <p>Separate the boiler/generator/transformer structure and factory building from the diesel storage tank by a minimum 2-hr fire-rated construction.</p> <p>Ideally, a wall separation at a height equal to or greater than that of the tank to maintain the required fire separation. Design accordingly with an access hatch so that refilling of the tank is possible.</p> | Within 3 months |

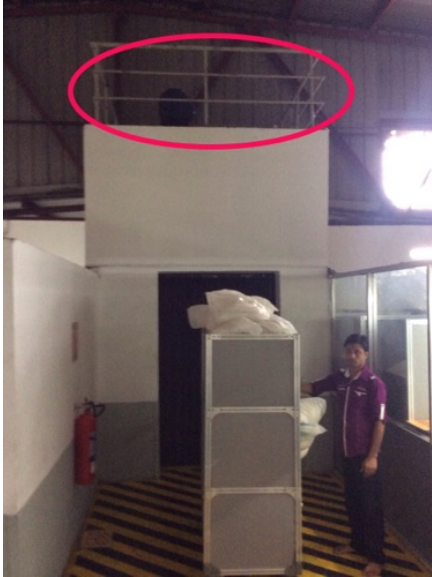
| F-3 | Fire Rated Construction | The elevator machine area in the second floor mezzanine is not separated by fire-rated construction. | Separate the elevator machine area by a minimum 2-hr fire-rated construction. Seal and/or protected all openings to maintain the required fire separations | Within 3 months |

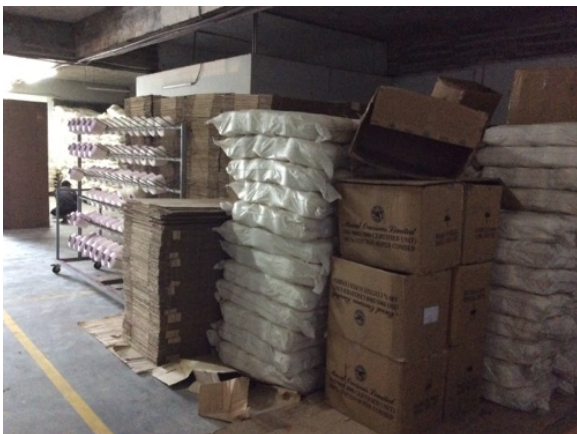
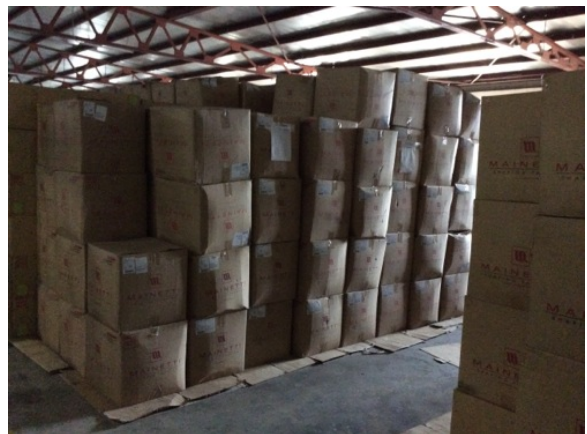
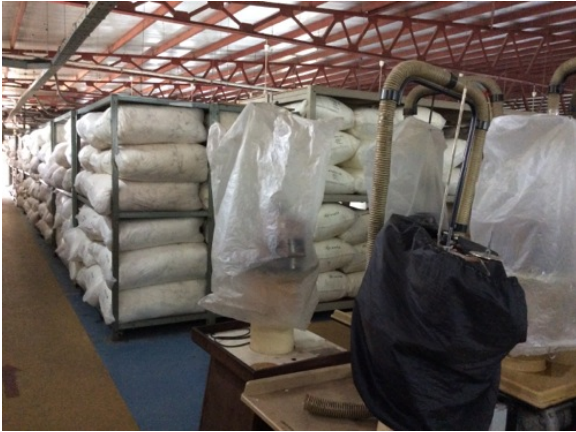
| F-4 | Fire Rated Construction | Areas used for combustible storage throughout the factory floor are not separated by fire-rated construction. | Provide defined storage areas and limit the storage arrangement as follows: <ul style="list-style-type: none"><li>- Maximum height of 2.4m and maximum area of 23m<sup>2</sup></li><li>- If sprinkler protected: maximum height of 3.66m and maximum area of 93m<sup>2</sup></li></ul> | Within 3 months |

| | | | Separate areas of unenclosed combustible storage by a minimum clear distance of 3m. | |

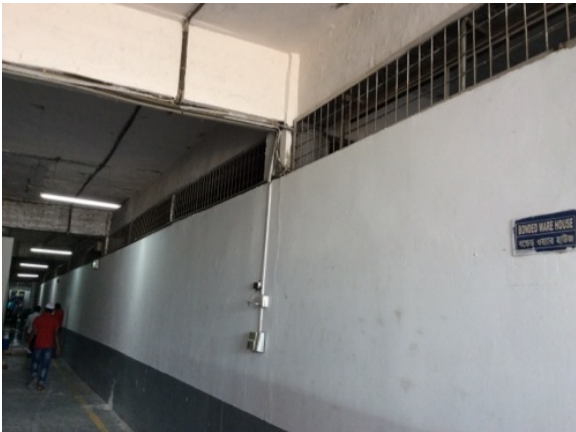
| F-5 | Fire Rated Construction | Unsealed penetrations and openings are located in the fire-resistant wall assemblies in the storage warehouse. | Seal all penetrations and openings in wall assemblies to maintain the fire separation. | Within 3 months |

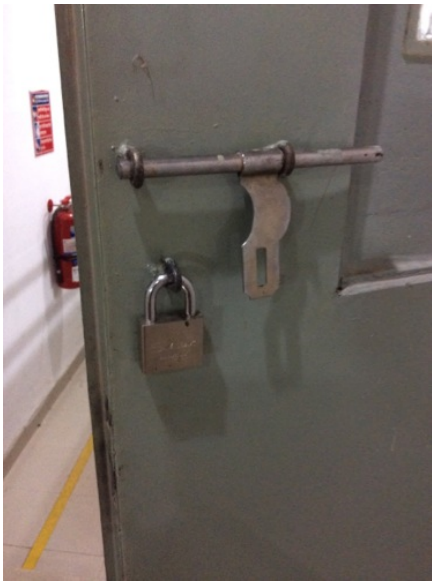
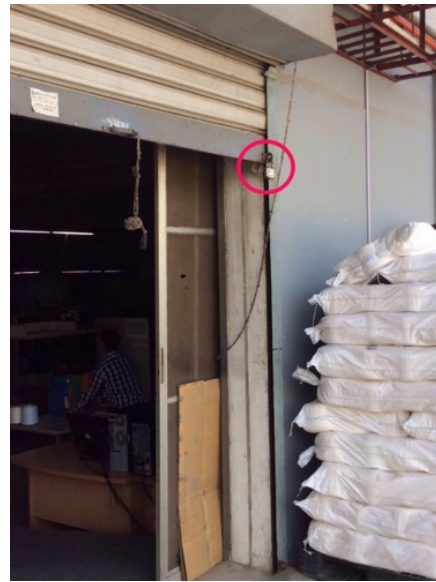
| F-6 | Egress | Egress doors with locking features are provided at building exits, exit stairs, along egress routes, and at exit discharge. During the inspection all gates/doors were open and unlocked during the inspection. | Remove locking features from all egress doors / gates.<br><br>If locks are required for security reasons, utilize special door locking features complying with NFPA 101. | Immediate |

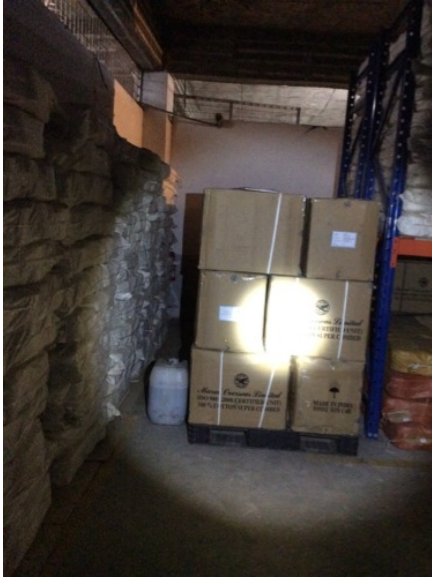
| F-7 | Egress | Storage was located in the egress path in the storage warehouse. | Keep egress paths and stairs clear of storage. | Immediate |

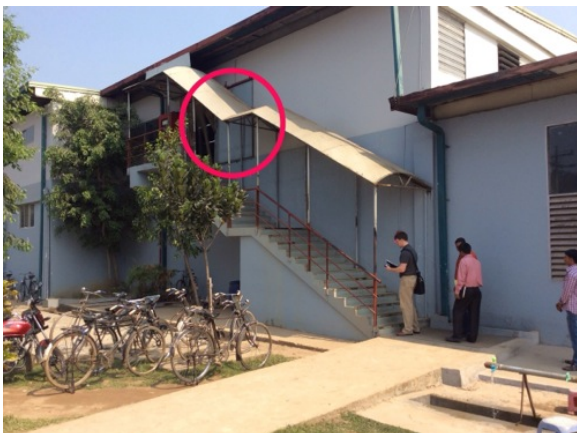
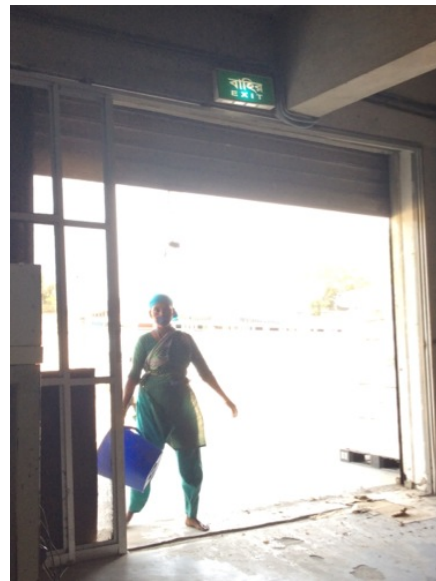
| F-8 | Egress | Sliding doors are provided at building exits in various locations throughout the factory. | Replace all sliding doors along the means of egress with side-hinged, swinging egress doors. | Within 1 month |

If locks are required for security reasons, utilize special door locking features complying with NFPA 101.

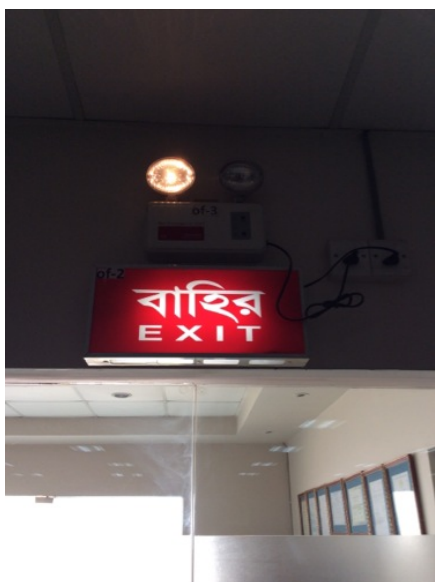
| F-12 | Egress Lighting | Emergency lighting did not function in test mode in the main office area because some bulbs were burned out. | Regularly test the emergency lighting system on each floor and replace/repair lights as needed. | Within 1 month |

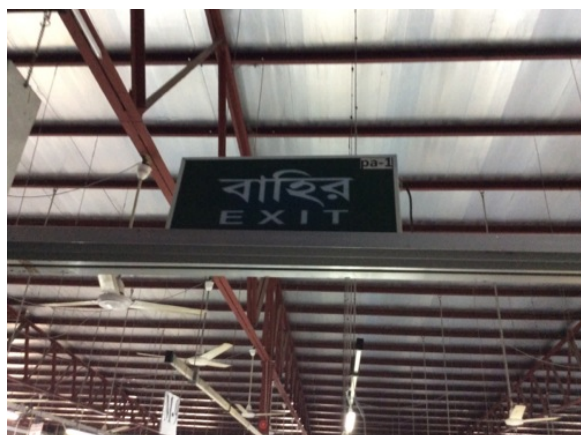
| F-13 | Egress Lighting | Exit signage on the factory floor was not illuminated, the signage was either broken or the bulb was burned out. | Regularly inspect all exit signage and replace/install lights as needed to illuminate signs. | Within 1 month |

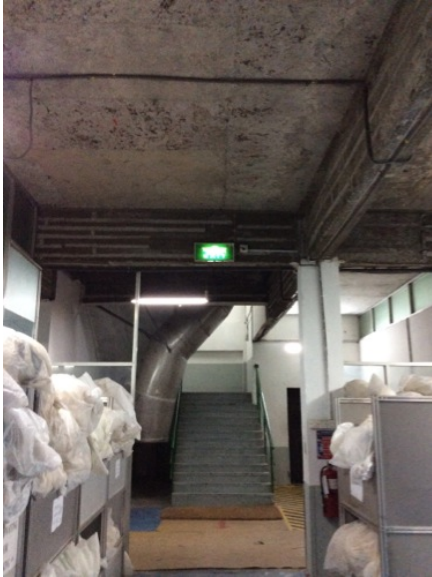
| F-14 | Egress Lighting | The exit sign at the bottom of the stairs to the mezzanine was in a position such that the most immediate exit access from the factory floor was not evident. | Replace all intermediate exit signs with directional signage such that the most immediate exit egress path is known. | Within 3 months |
