# Iris Design Ltd.

Dhaka Bypass Road, Zajhor, National University, Gazipur  
(23.964424 N ,90.397965 E)

22<sup>nd</sup> November 2015

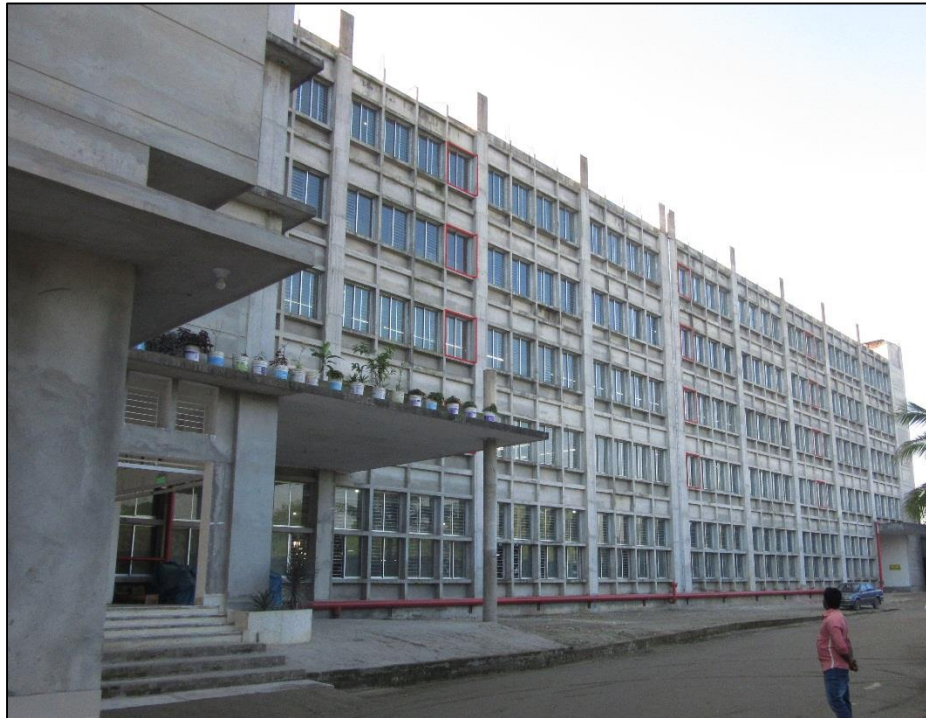
**Reinforcement in columns on site appears  
to be different to column layout drawings  
in Building 2**

## Observed by Ferro Scanning

24 rebars (8 bars each face)

18 rebars

Reinforcement detected by Ferro Scanning internal and edge columns in Building 2 (Garment Building) appears to be different than shown in the structural drawings. Building engineer to verify number and diameter of rebars at least at two sides by removing plaster and concrete cover at typical columns before commencing construction

| Item No. | Observation | Recommended Action Plan | Recommended Timeline |
|---|---|---|---|
| 1 | Reinforcement in columns onsite appears to be different to column layout drawings in Building 2 | Building engineer to verify number and diameter of rebar on at least two sides by removing plaster and concrete cover at typical columns before commencing construction. | 6-months |
