# FGS Denim Wear Ltd.

Kathgora, Zirabo, Ashulia, Dhaka-1340 , Bangladesh

30 April 2014

# Observations

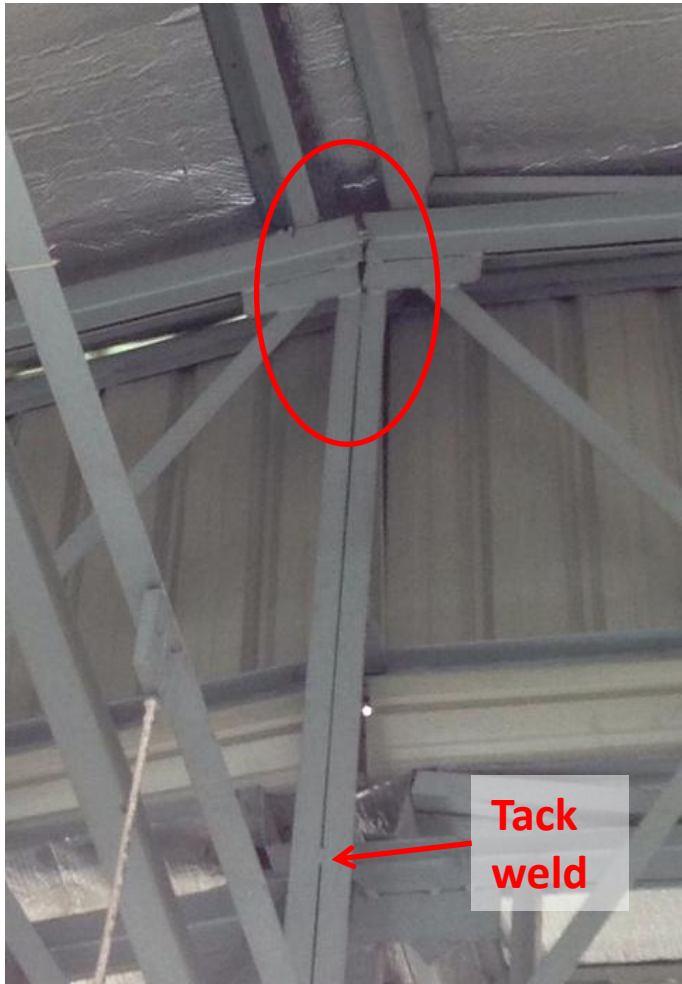
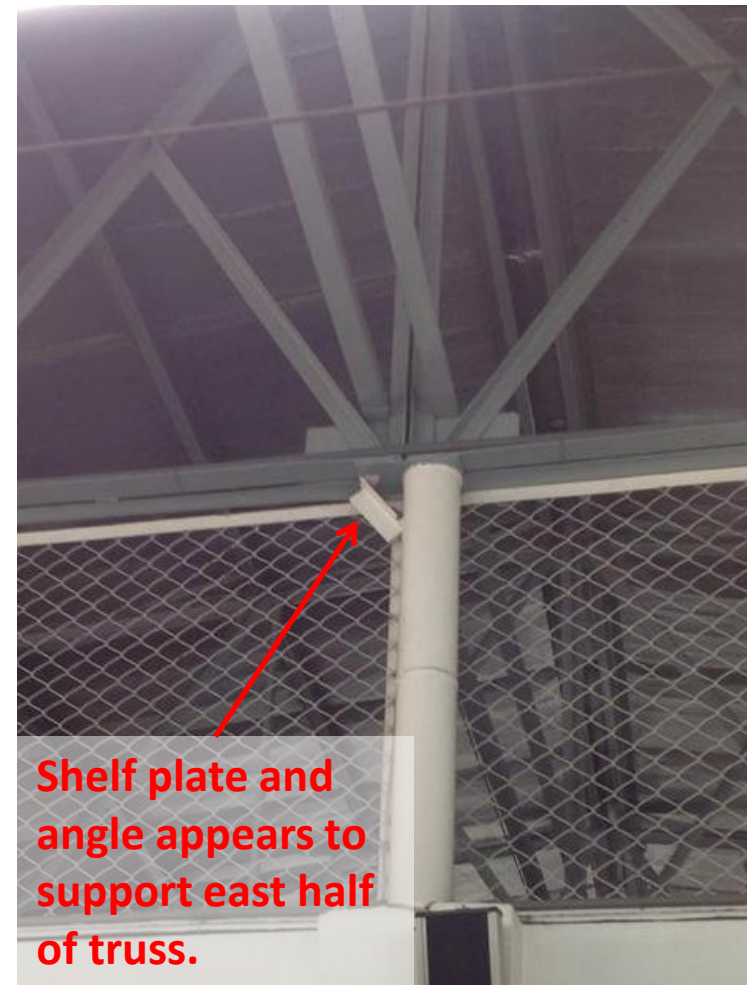
- Members in top boom of truss are not connected at apex of roof.
- Vertical members appear to be tack welded.
- Truss does not appear to be continuous over central support.

| Item No. | Observation | Recommended Action Plan | Recommended Timeline |
|---|---|---|---|
| 1 | Structural design of Building 2 | Building Engineer to review the structural design of Building 2. Particular attention to be paid to i) steelwork connections and design assumptions, ii) lateral stability of the structure in north-south and east-west directions. | 6-months |

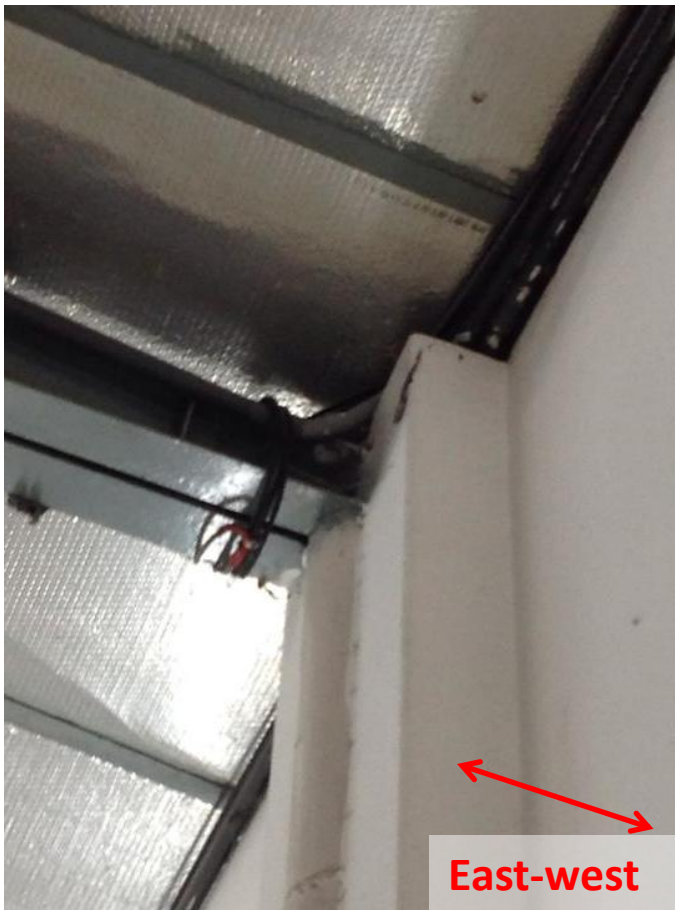
- Unclear lateral stability system in Building 2 in east-west direction.
- Unclear connection details between circular steel columns and trusses.

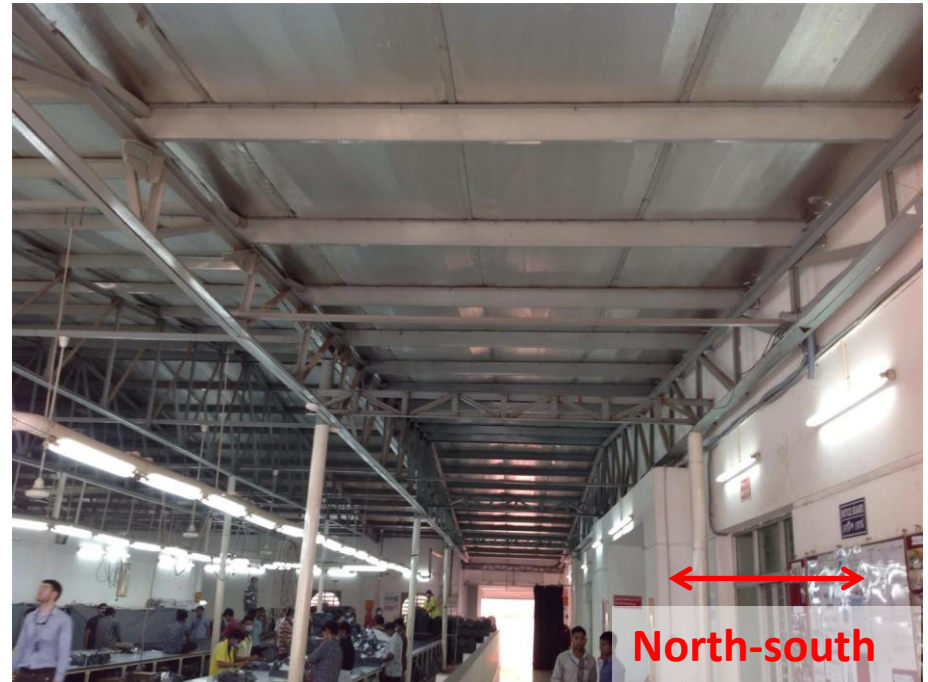
- Unclear lateral stability system in Building 2 in north-south direction.
- No plan bracing apparent in roof.

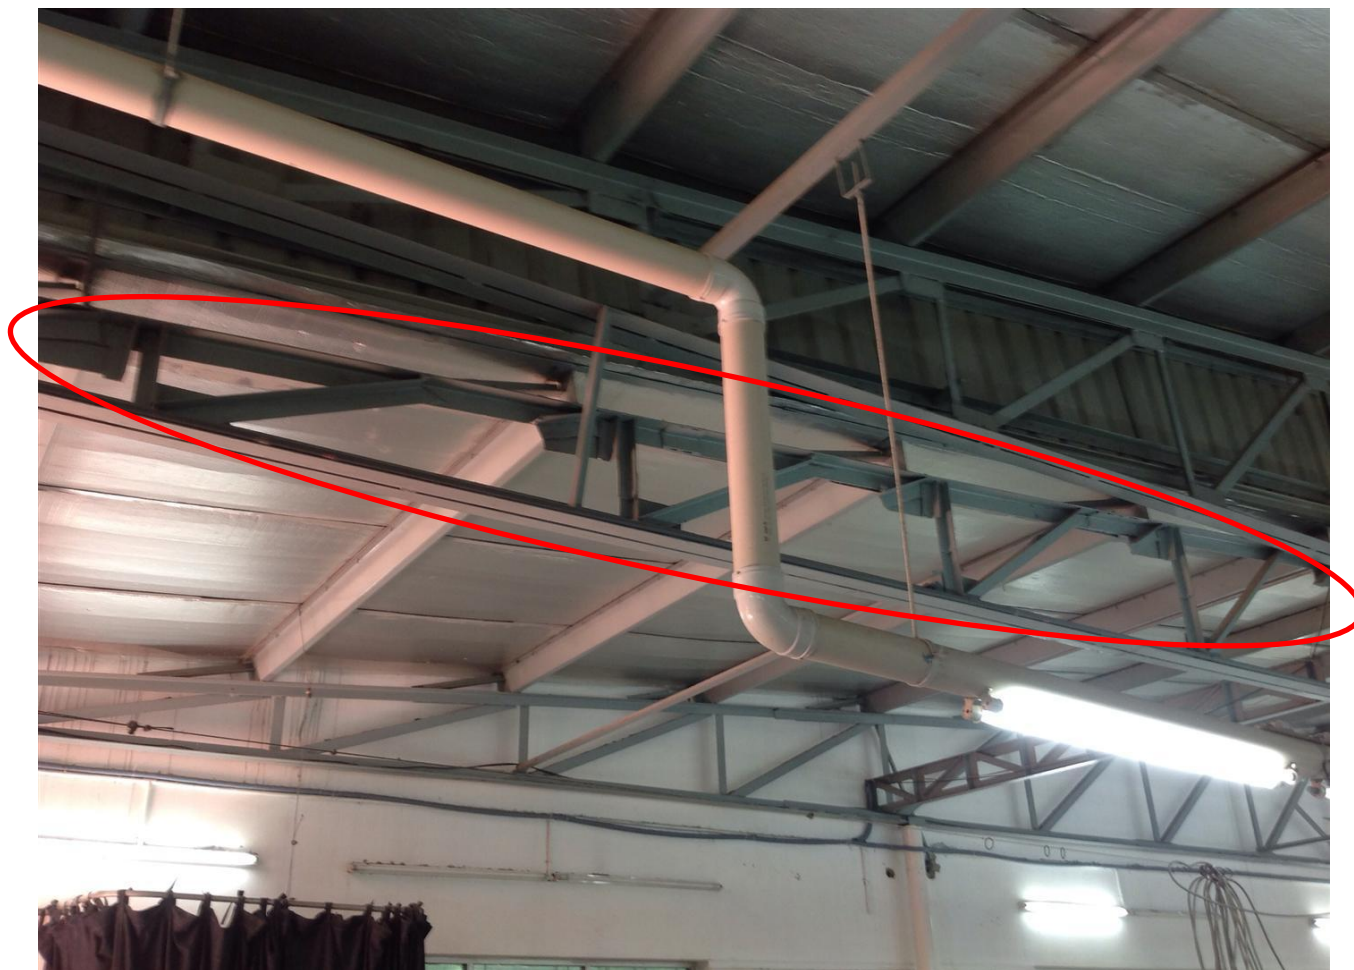
- Non-engineered trusses at north end of Building 2.
- Diagonal members do not 'node out' with vertical members of truss.

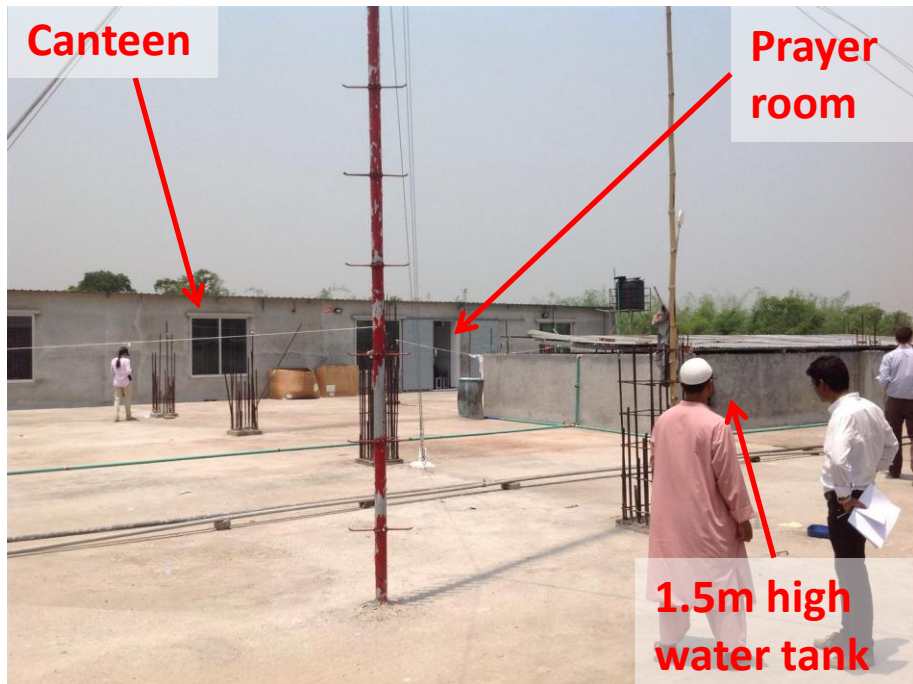
- Canteen and prayer room structures at roof level are not included on permit drawings.
- No structural information was available for these buildings.

| Item No. | Observation | Recommended Action Plan | Recommended Timeline |
|---|---|---|---|
| 4 | Undocumented extension to Building 1 | As-built structural drawings to be updated to include undocumented extensions at roof level. | 6-months |

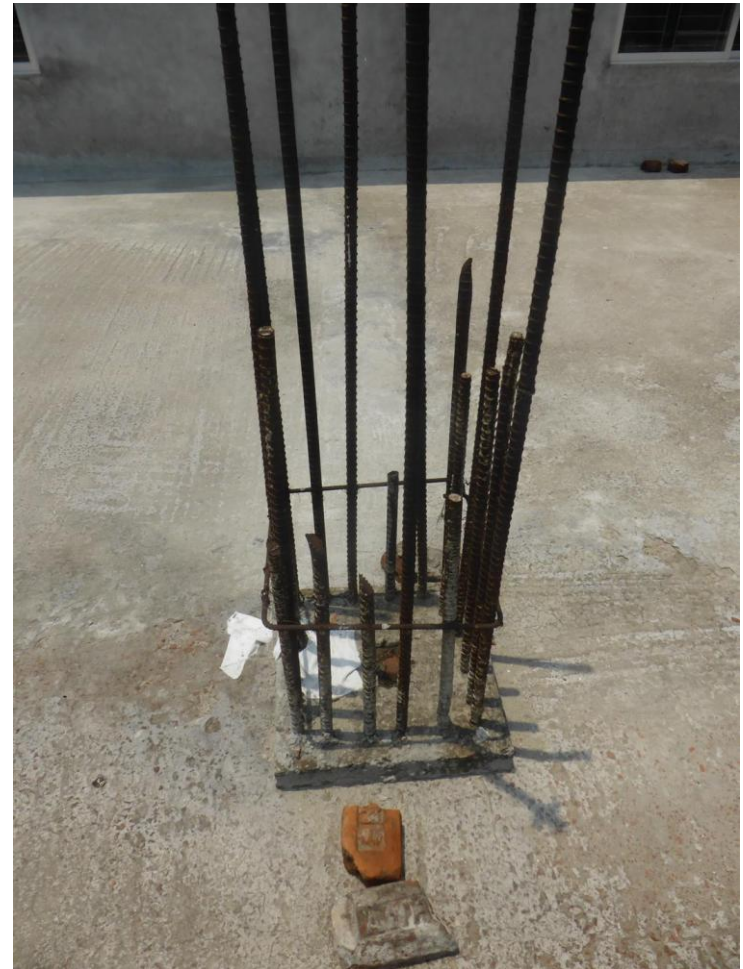
Factory management indicate that they intend to add three additional storeys to the building.

| Item No. | Observation | Recommended Action Plan | Recommended Timeline |
|---|---|---|---|
| 2 | Undocumented extension to Building 1 | Supporting RC flat slabs, beams and columns to be checked for loads applied, including structures at roof level. | 6-months |

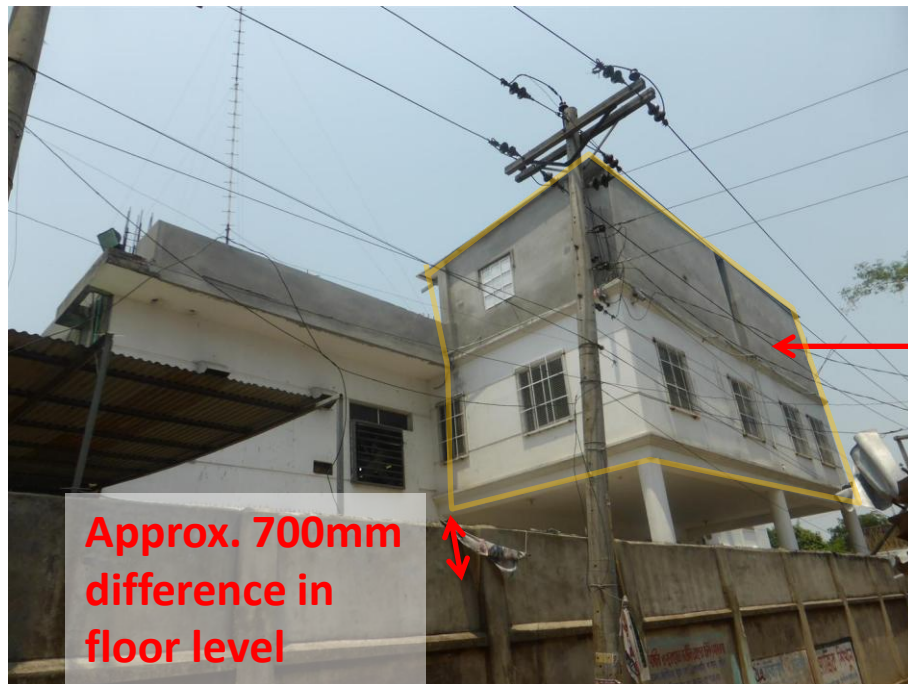
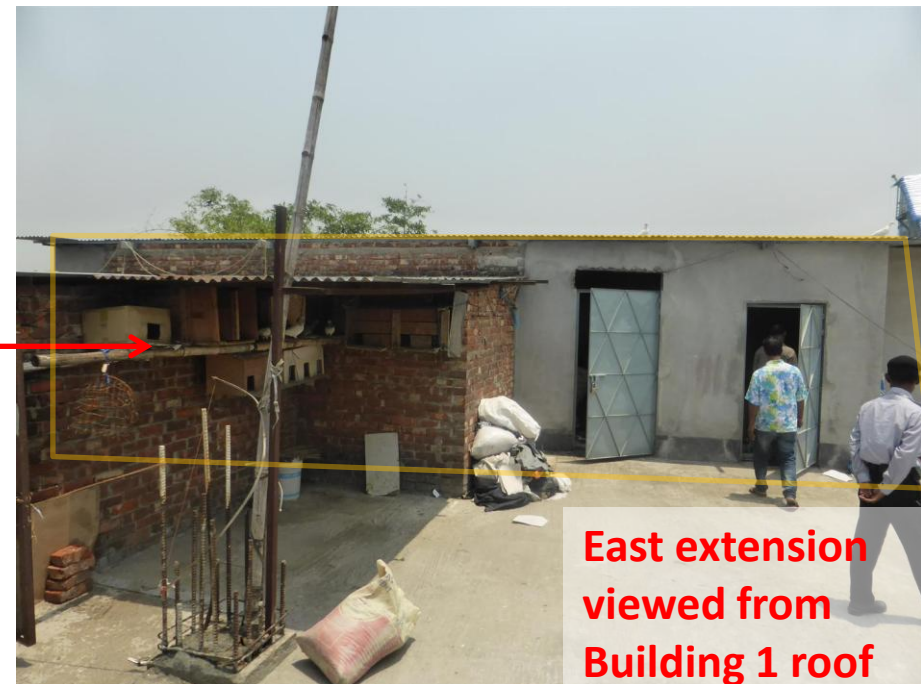
- Extension to the East of Building 1 is not included on structural drawings. Factory management indicate that this was built at the same time as Building 1.
- Different floor level observed between Building 1 and extension at 1<sup>st</sup> floor level.

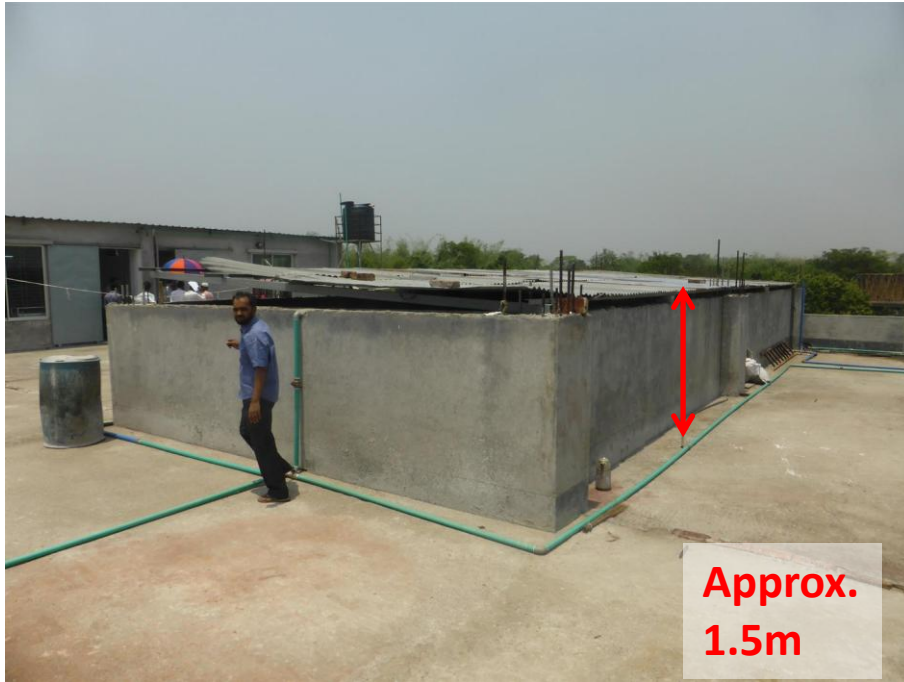
- 1.5m high masonry water tank at roof level. Concrete walls 280mm thick.
- Flat slab construction below, although beam and slab construction indicated on drawings.

| Item No. | Observation | Recommended Action Plan | Recommended Timeline |
|---|---|---|---|
| 6 | Concentrated areas of high loading | Building Engineer to verify capacity of existing roof structure (flat slab, beams and columns) to support full water tanks. | 6-months |

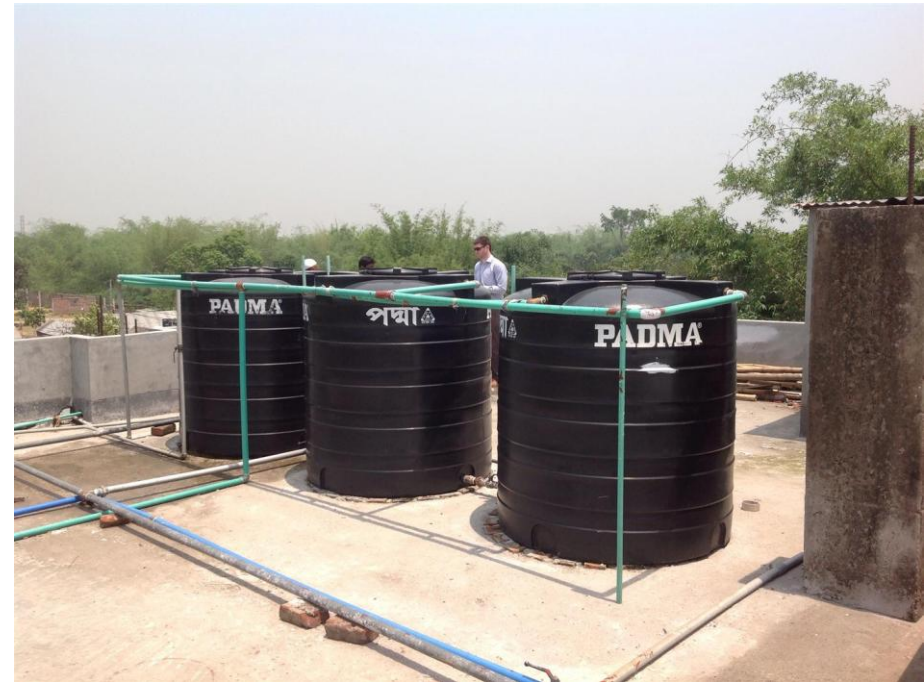
- 3no. 2000 litre water tanks provided at roof level.
- Flat slab construction below, although beam and slab construction indicated on drawings.

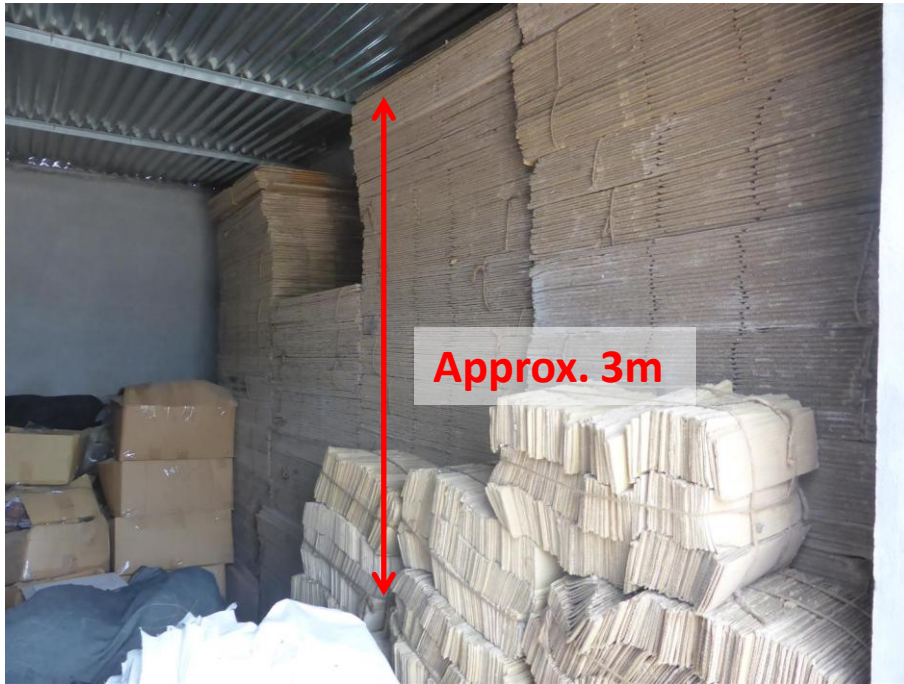
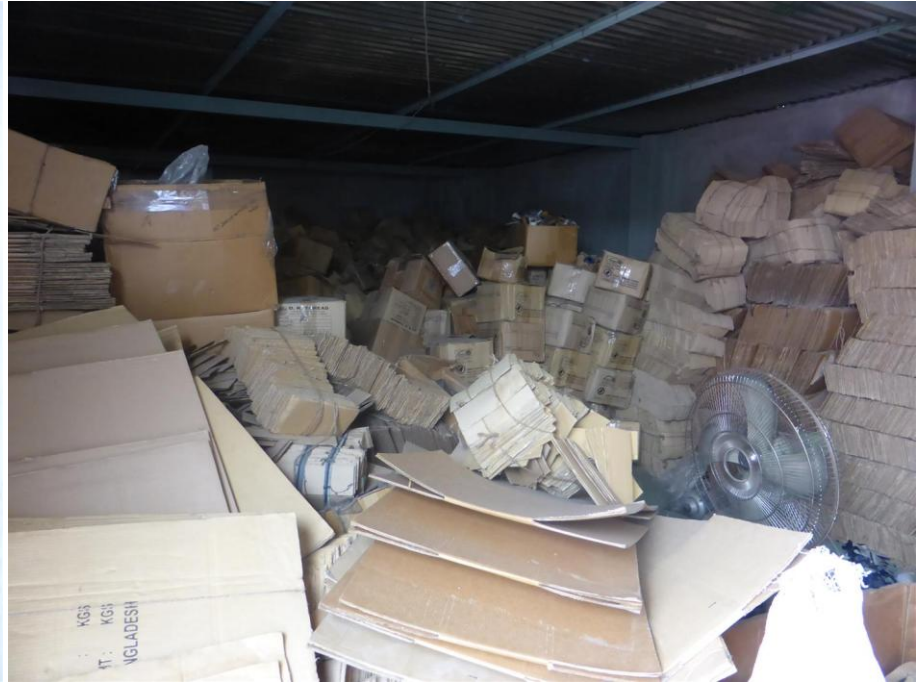
- Storage area at roof level contains stacked cardboard and boxes.
- No loading management system in place.

| Item No. | Observation | Recommended Action Plan | Recommended Timeline |
|---|---|---|---|
| 5 | Concentrated areas of high loading | Building Engineer to develop loads plans for all buildings, accounting for usage, floor build-ups, solid partition walls and areas of concentrated loading. | 6-months |
| 7 | Concentrated areas of high loading | Factory management to implement load plans. | 6-months |

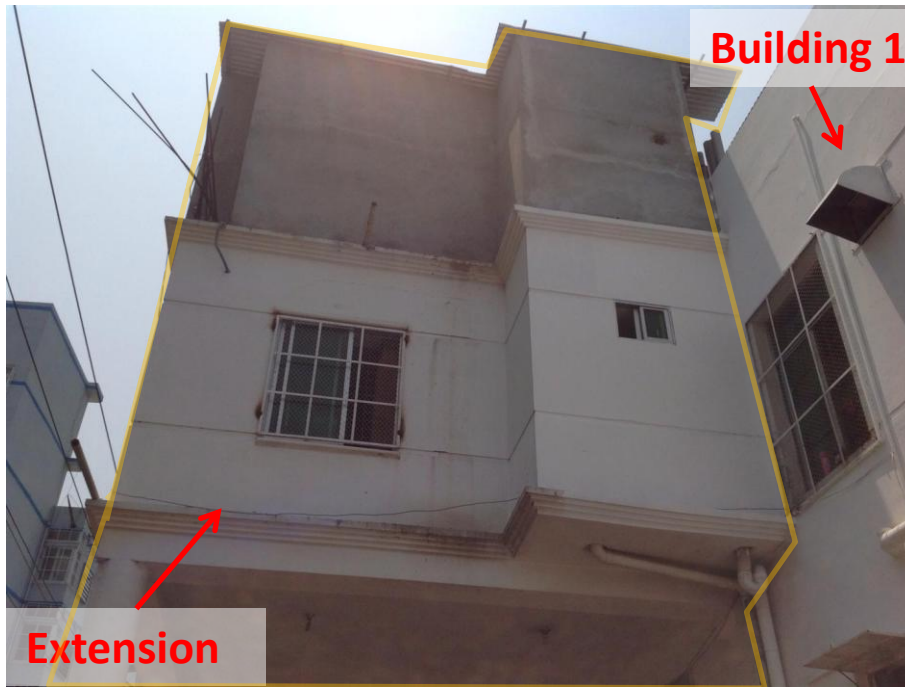
**Extension to east of building. View looking south.**

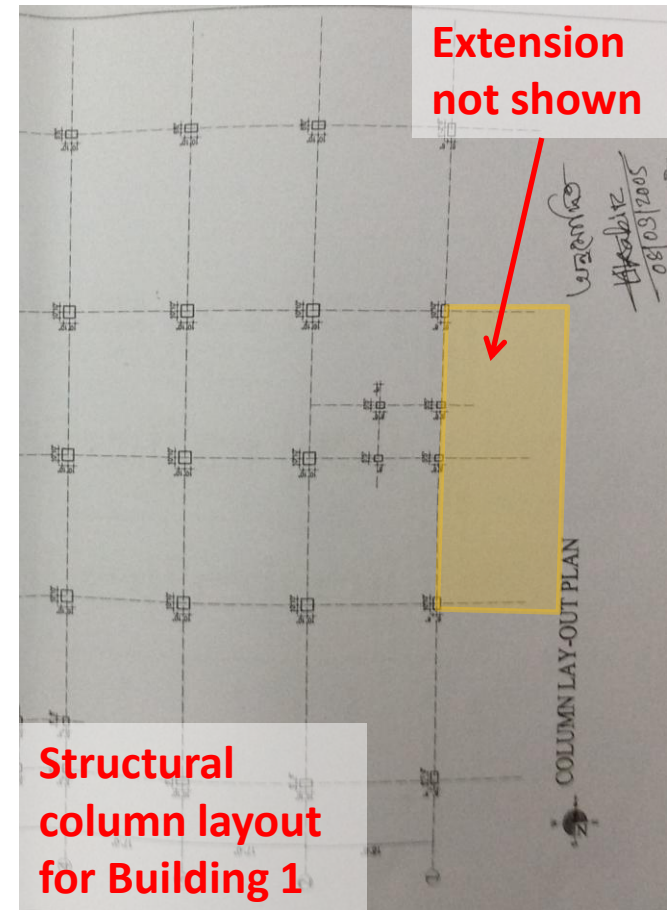
- Two storey extension to Building 1 not indicated on structural drawings.
- Extension is supported by edge columns of Building 1.
- Factory management indicate extension and Building 1 constructed at same time.

| Item No. | Observation | Recommended Action Plan | Recommended Timeline |
|---|---|---|---|
| 8 | Inconsistencies between structural drawings and buildings on site | As-built structural drawings to be generated for all buildings on factory complex, including horizontal and vertical extensions. | 6-months |

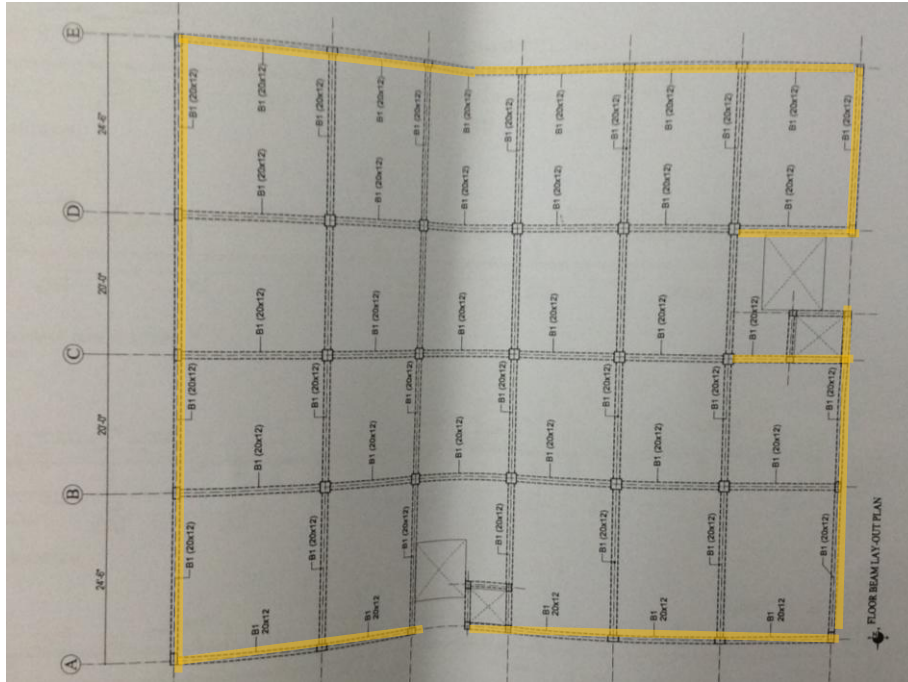
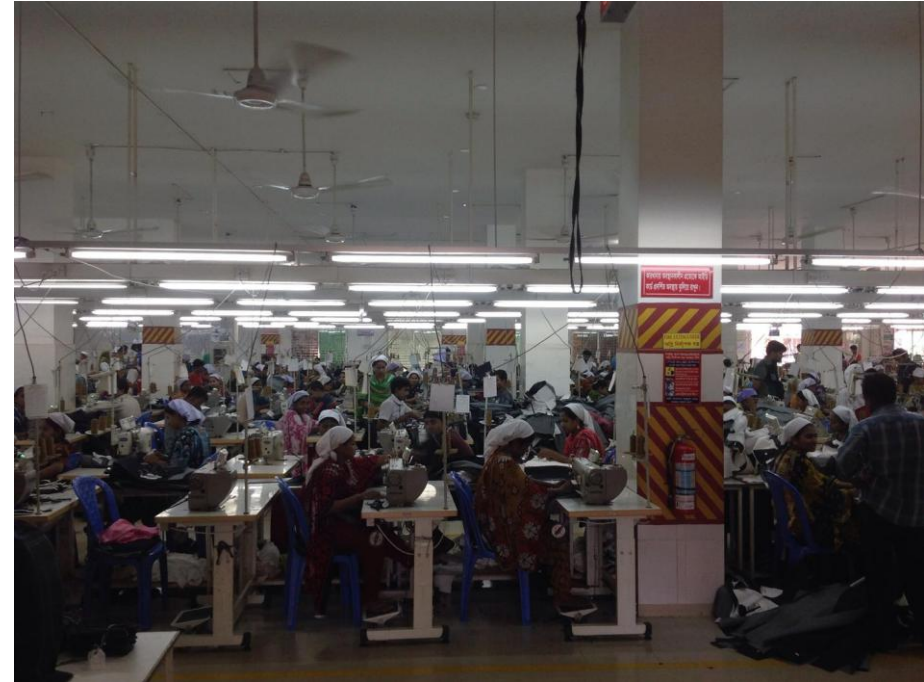
- Structural beam drawing for Building 1 indicates beam & slab construction throughout.
- Flat slab construction observed generally at 1<sup>st</sup> and 2<sup>nd</sup> (roof) floors of Building 1.

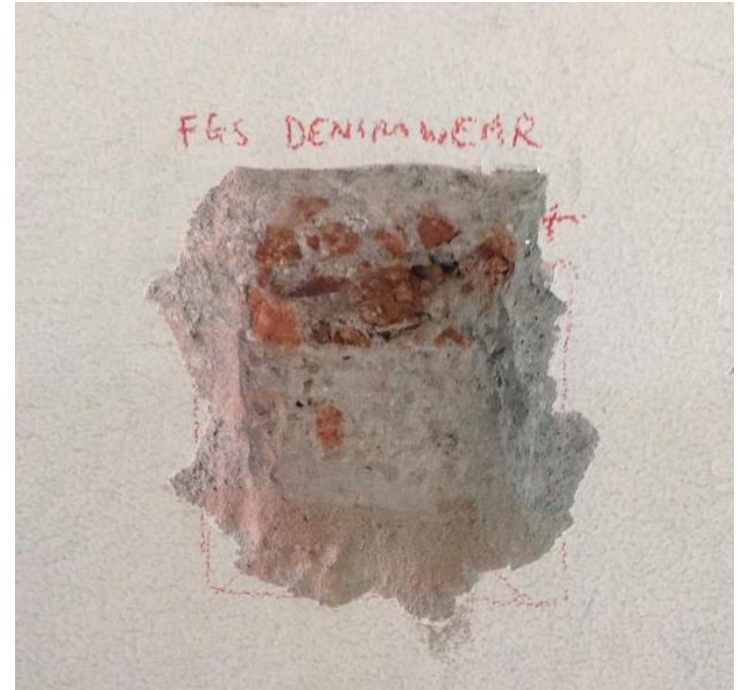
**Structural drawings indicate crushed stone chips to be used for all concrete works.**

**Brick chip aggregate observed in ground floor column on site.**

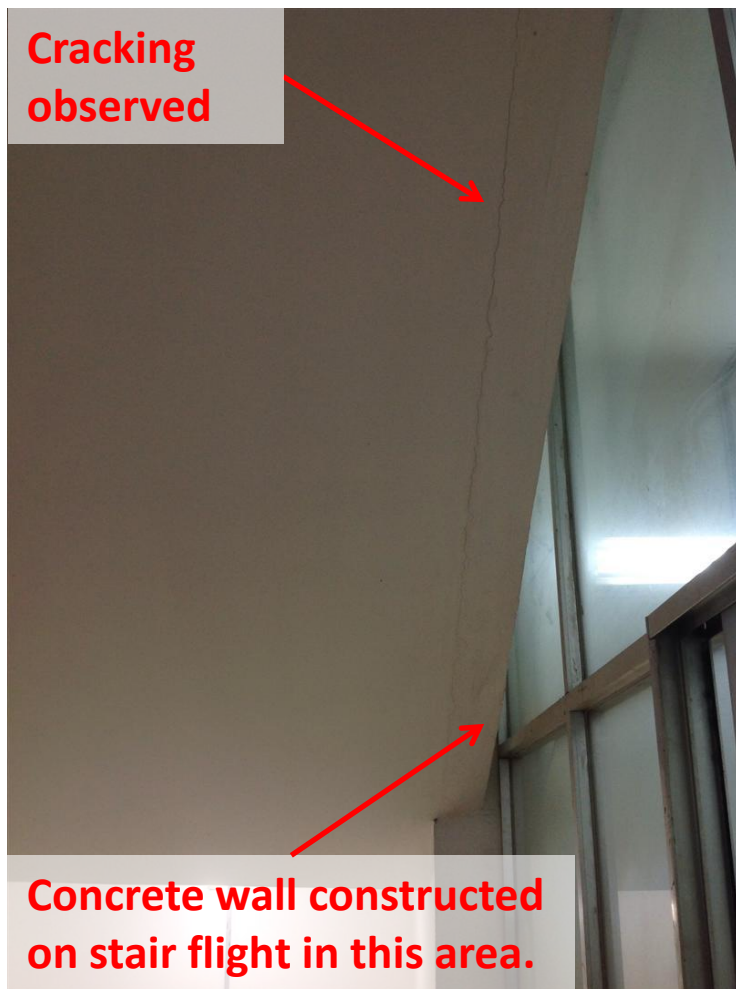
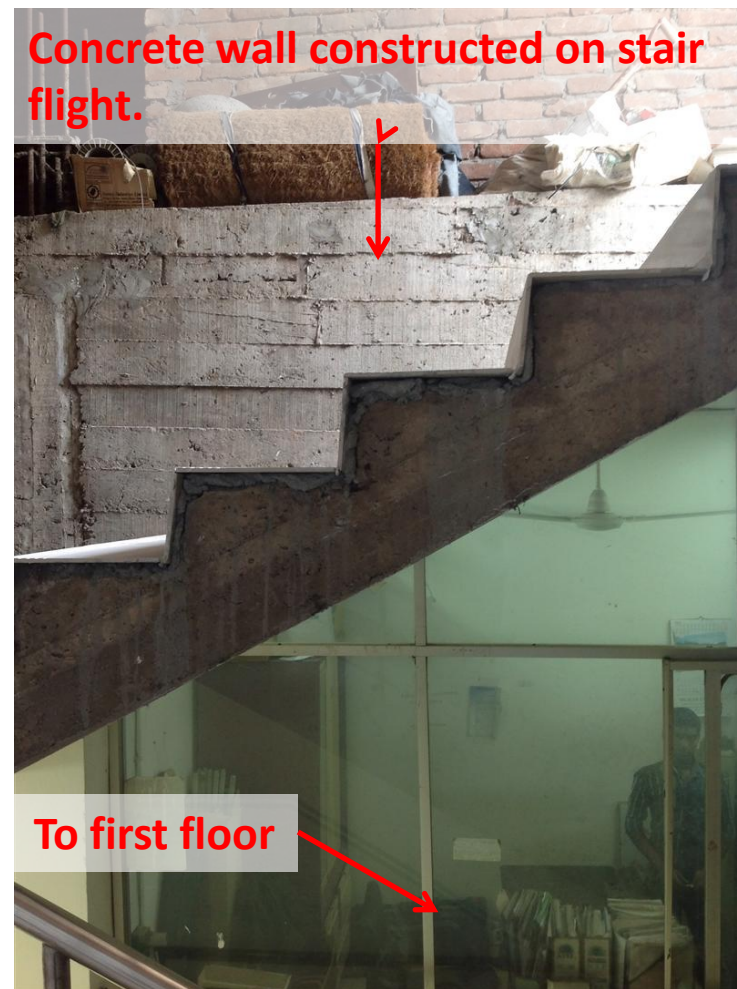
- Cracking observed in stair flight between first floor and roof in Building 1.
- No handrails provided to stair flight up to roof level.

| Item No. | Observation | Recommended Action Plan | Recommended Timeline |
|---|---|---|---|
| 10 | Evidence of cracking and damage to structural elements (Building 1) | Building Engineer to identify areas of structural cracking throughout Building 1. | 6-months |
| 11 | Evidence of cracking and damage to structural elements (Building 1) | Building Engineer to continue to monitor size, length and location of structural cracking throughout Building 1. | 6-months |

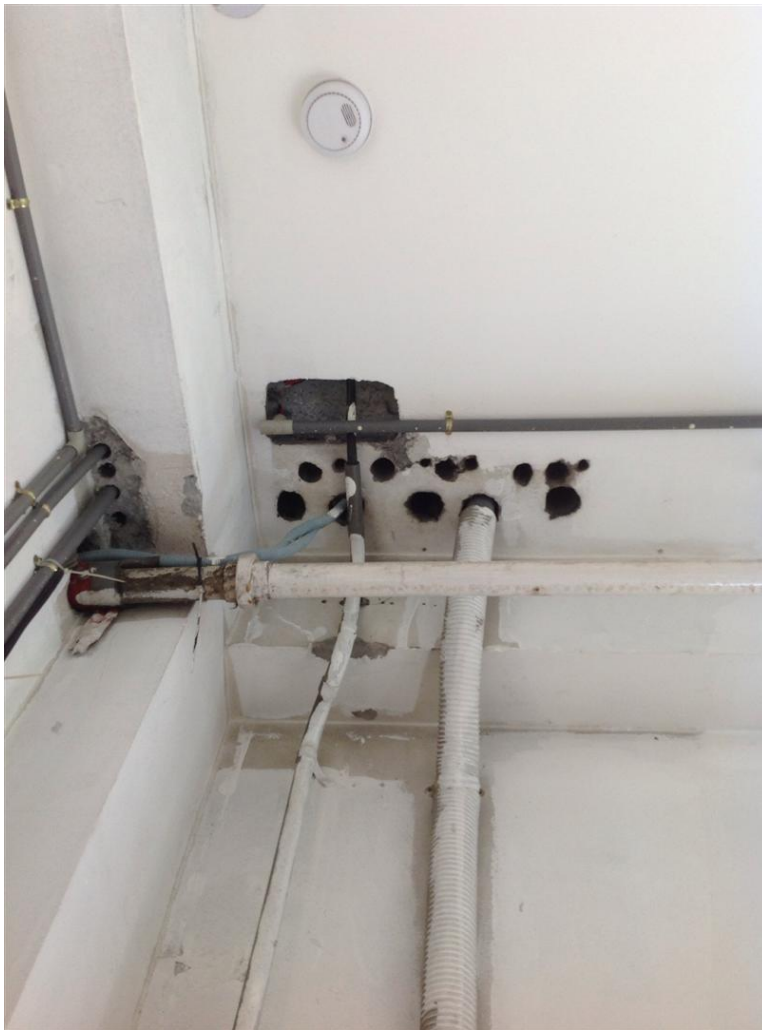
- Numerous openings observed in slab and beams at corner column in Building 1.

| Item No. | Observation | Recommended Action Plan | Recommended Timeline |
|---|---|---|---|
| 12 | Evidence of cracking and damage to structural elements (Building 1) | All future penetrations through slabs and beams to be agreed with Building Engineer. | 6-months |

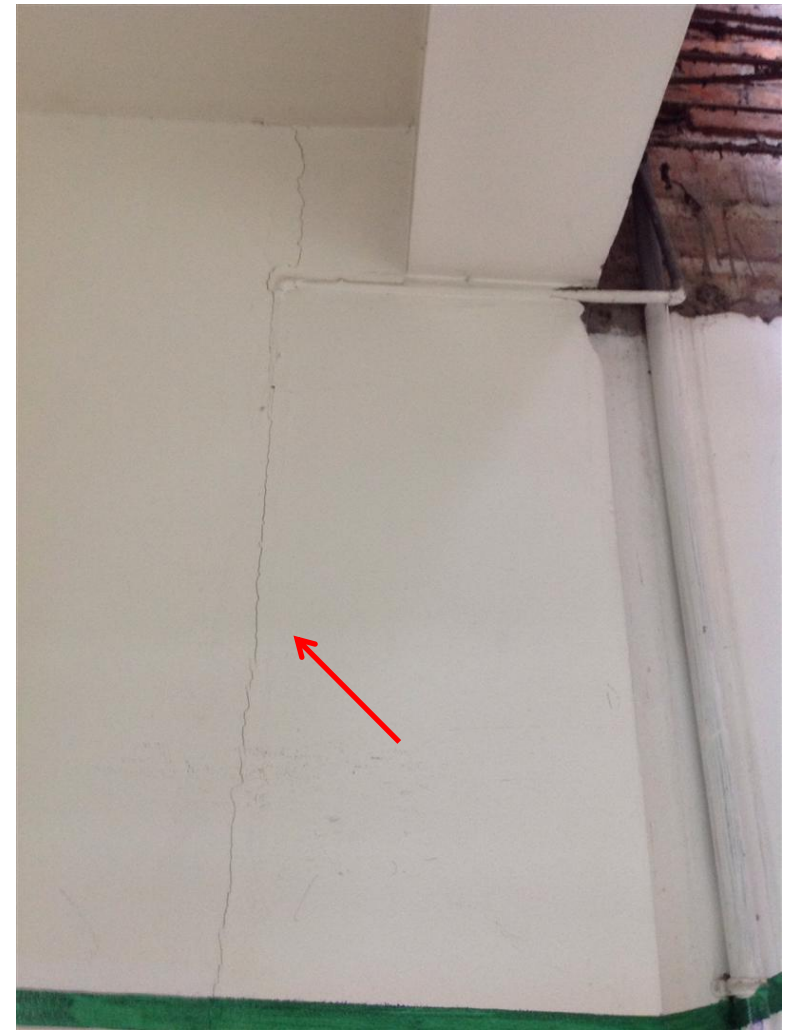
- Cracks observed between masonry walls and concrete columns.
- A small number of cracks observed in slab soffits in Building 1.

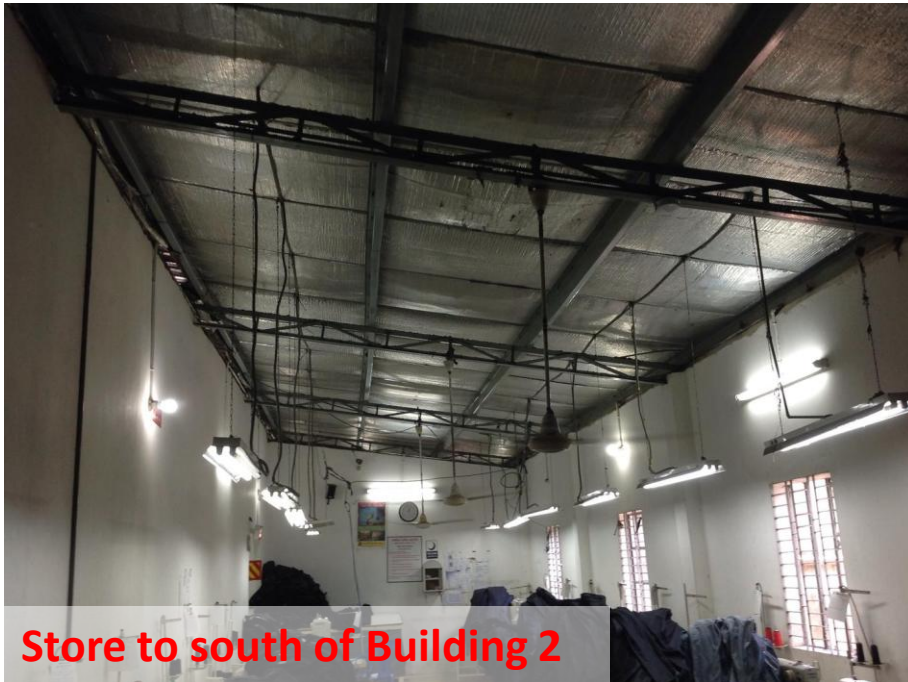
Store to south of Building 2

- Structures have lightweight roofs with no plan bracing system.
- Roofs susceptible to wind uplift due to inadequate holding down details.

| Item No. | Observation | Recommended Action Plan | Recommended Timeline |
|---|---|---|---|
| 13 | Non-engineered structures | Building Engineer to review the adequacy of non-engineered structures throughout complex. Particular attention should be paid to the lateral stability of these structures. | 6-months |

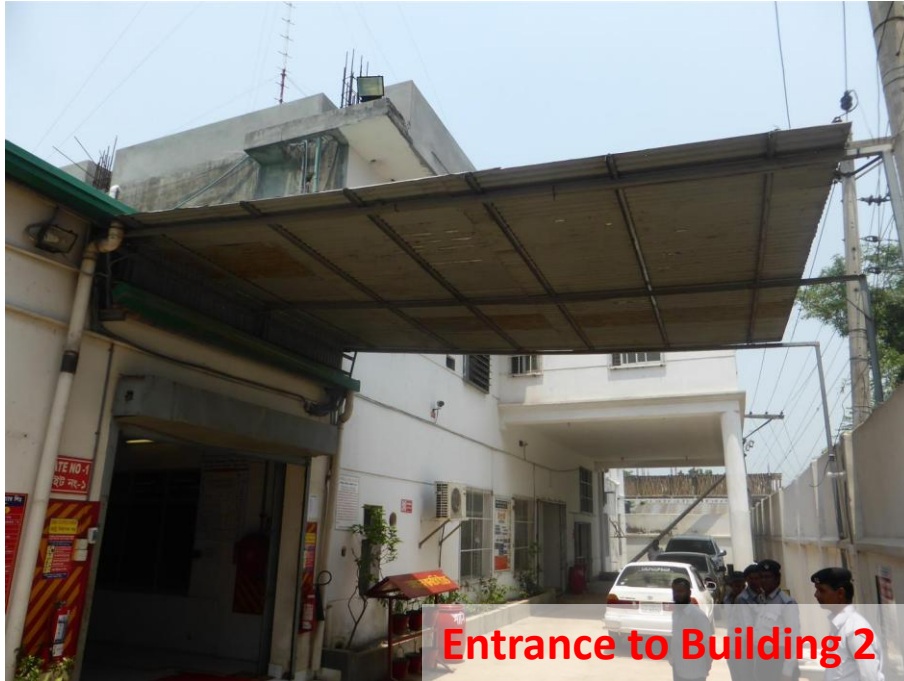
**Entrance to Building 2**

- Non-engineered canopies observed throughout complex, generally outside building entrances.
- Lightweight steel structures have inadequate independent lateral stability systems and are susceptible to wind uplift.

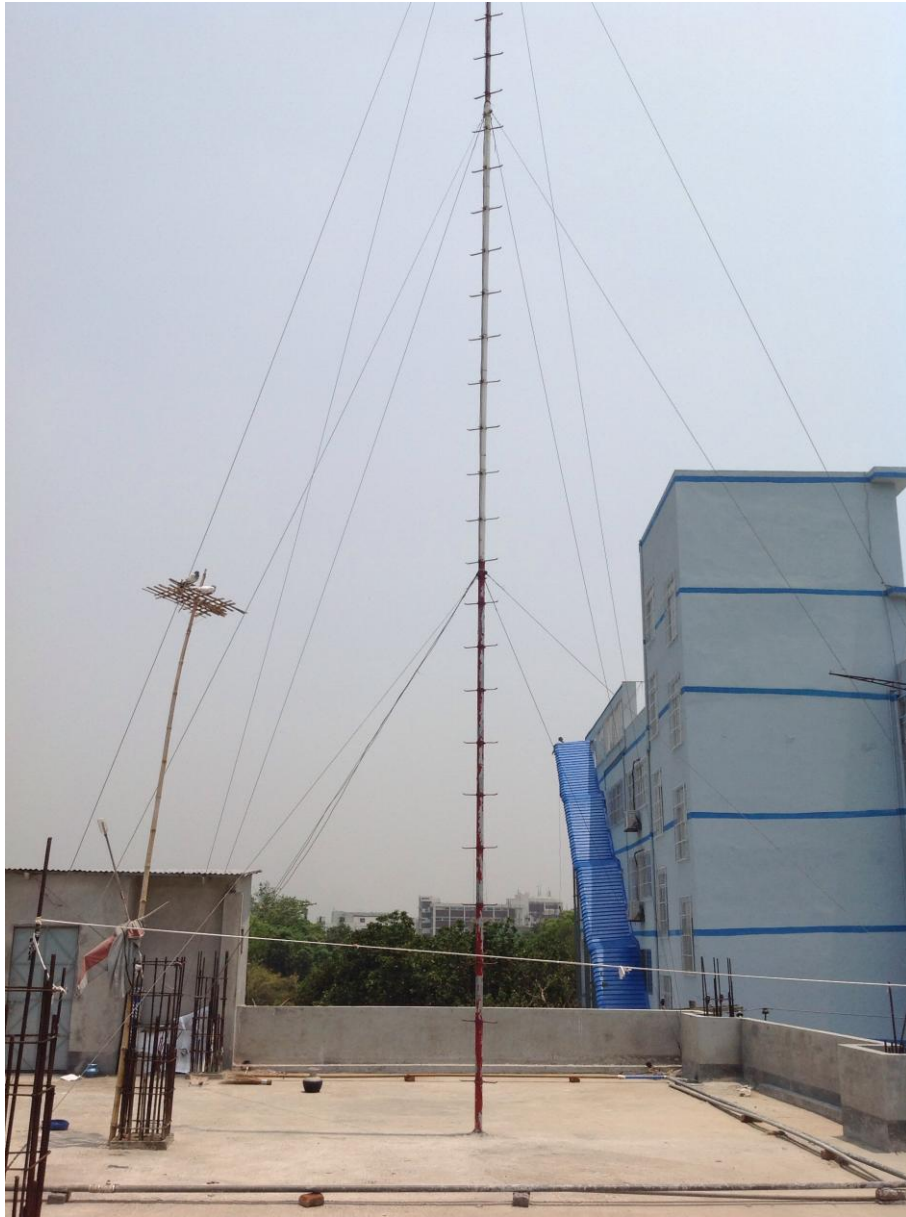
- Rooftop mast does not occur over column.
- Building Engineer to assess slab in terms of vertical and lateral loadings transmitted by mast.

| Item No. | Observation | Recommended Action Plan | Recommended Timeline |
|---|---|---|---|
| 14 | Non-engineered structures | Building Engineer to assess the effect of the rooftop mast on the roof slab. | 6-months |

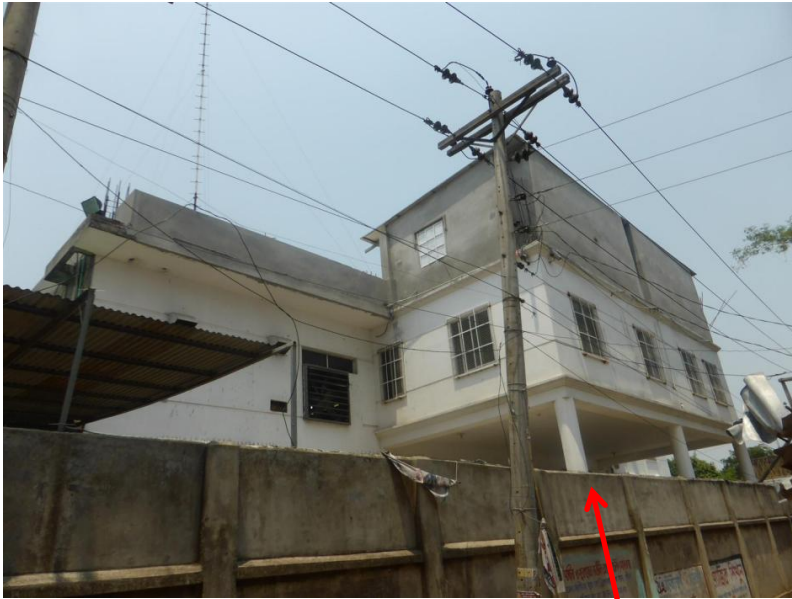
- Edge columns in Building 1 extension may be vulnerable to vehicle impact.
- Building Engineer to assess columns to see if independent protection barriers are required.

| Item No. | Observation | Recommended Action Plan | Recommended Timeline |
|---|---|---|---|
| 15 | Columns vulnerable to vehicle impact | Building Engineer to assess the edge columns to the Building 1 extension for their capacity to withstand vehicle impact loading. | 6-months |
| 16 | Columns vulnerable to vehicle impact | Implement any action arising from assessment (e.g. independent protection barriers). | 6-months |
