# **FIRE SAFETY INSPECTION REPORT**

**DYNASTY SWEATERS BANGLADESH LTD.**

**AUKPARA, ASHULIA, SAVAR**

March 24, 2014

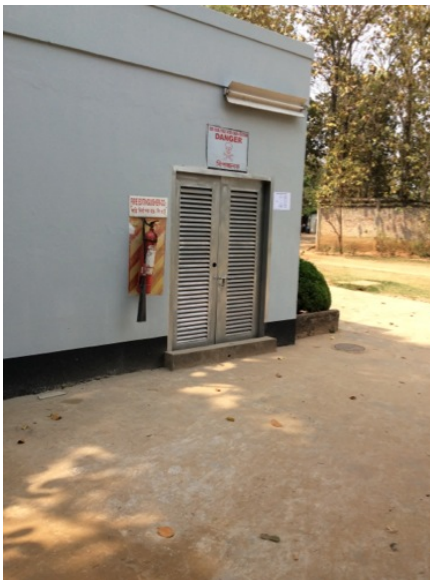
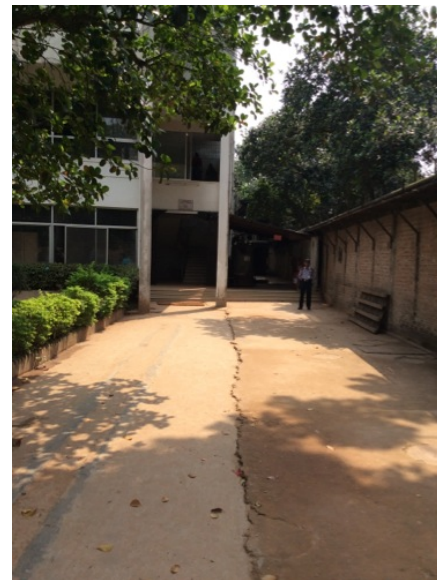
| No. | Category | Finding | Recommendation | Remediation Timeframe |
|---|---|---|---|---|
| F-1 | Fire Rated Construction | The transformer room is not separated by fire-rated construction due to openings and a non-rated door. The transformer room is adequately spaced from the building however it is adjacent to the egress path to an assembly point from the northwest stairwell discharge. | Separate the transformer room by a minimum 2-hr fire-rated construction. Seal and/or protected all openings to maintain the required fire separations | Within 3 months |

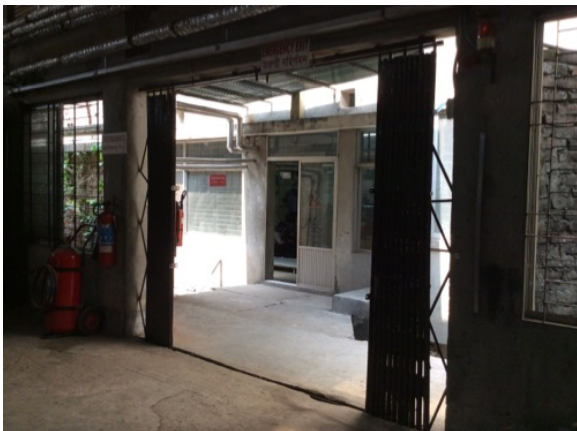
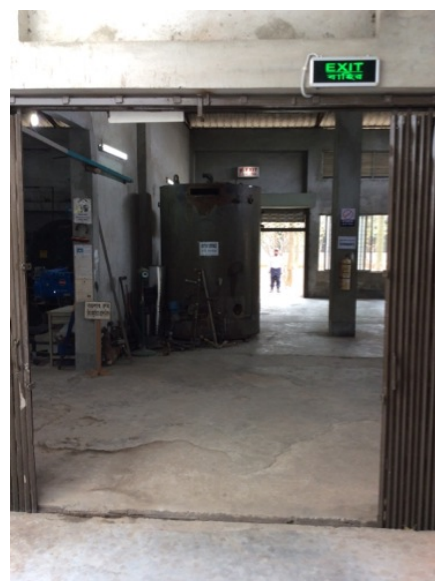
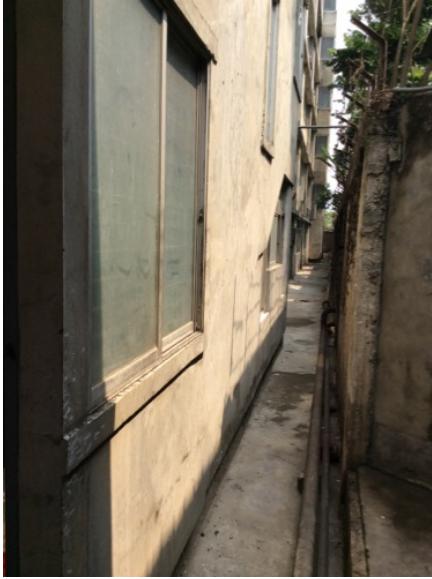
| F-2 | Fire Rated Construction | <p>The boiler/generator room is not separated by fire-rated construction due to openings, non-rated doors, penetrations, and a non fire-resistive ceiling.</p> <p>The southwest stair discharge path to an assembly point currently passes through the boiler/generator room.</p> | <p>Separate the boiler/generator room by a minimum 2-hr fire-rated construction. Seal and/or protected all openings to maintain the required fire separations.</p> <p>Alter the discharge path of the southwest stairs to join with the southeast stair discharge. Ensure that the path to join the two egress routes is unobstructed, free and clear of debris, and that all penetrations from the building below a height of 15 ft. are sealed and/or provided with fire-rated separations.</p> <p>Alternately, provide a 2-hr fire-rated passageway through the boiler/generator room with 2-hr vestibules from mechanical areas on either side. The doors discharging to the mechanical rooms should be rated for 2-hr fire resistance and the doors discharging to the exit passageway should</p> | Within 3 months |

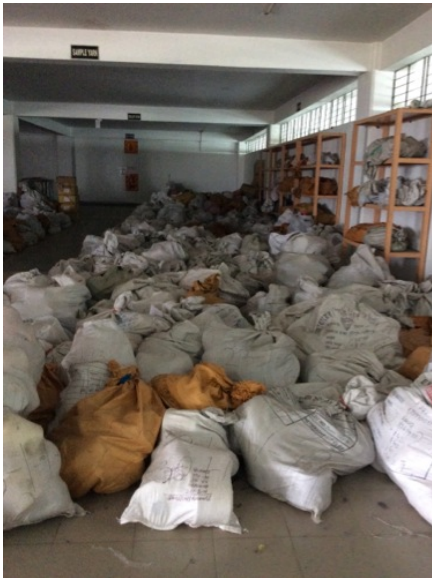
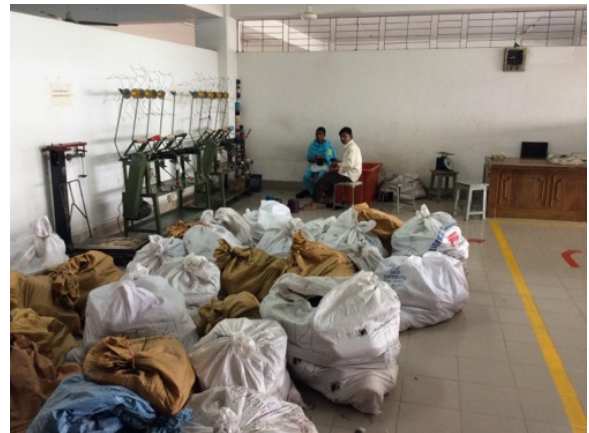
| F-3 | Fire Rated Construction | The storage room on the sixth floor (Sample Yarn Store) is not separated by fire-rated construction. Factory operations (winding) were observed within the storage room. | Provide the dedicated storage room separated by minimum 1-hr fire-rated construction.<br><br>Relocate factor operations to the exterior of the dedicated storage room. | Within 3 months |

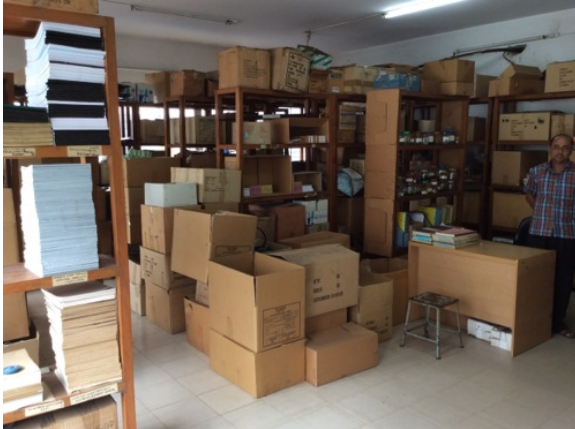
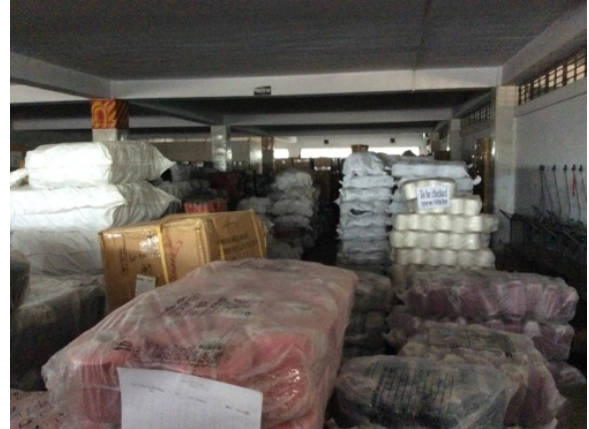
| F-4 | Fire Rated Construction | Areas used for combustible storage (Warehouse, General Store, Distribution Rooms) are not separated by fire-rated construction. | Provide dedicated storage rooms separated by minimum 1-hr fire-rated construction. | Within 3 months |

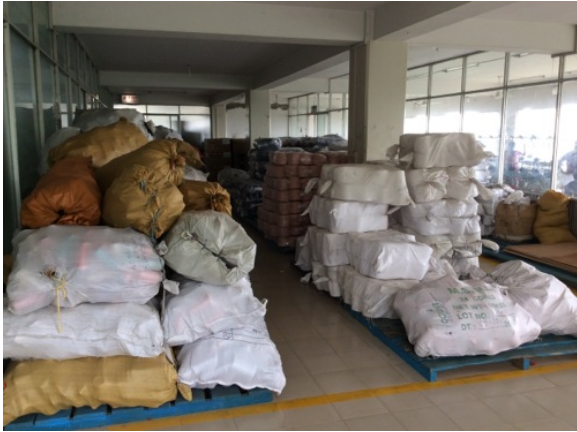
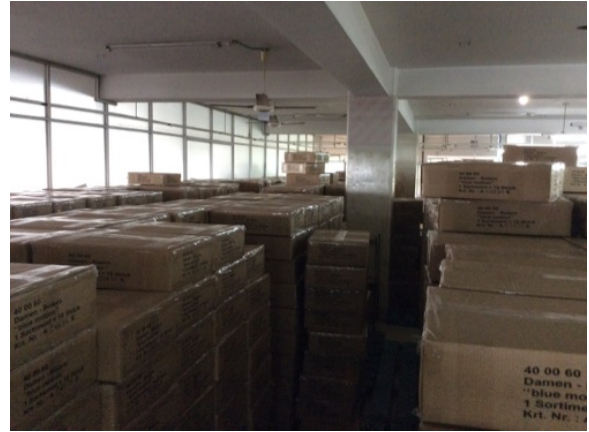
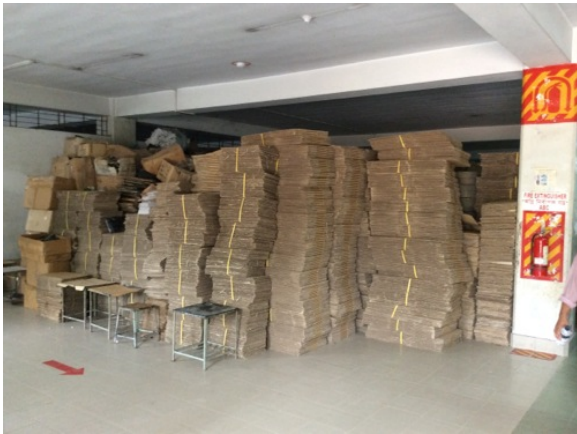
| F-5 | Fire Rated Construction | Areas used for combustible storage on factory floors are not separated by fire-rated construction. | <p>Provide defined storage areas and limit the storage arrangement as follows:</p> <ul style="list-style-type: none"> <li>- Maximum height of 2.4m and maximum area of 23m<sup>2</sup></li> <li>- If sprinkler protected: maximum height of 3.66m and maximum area of 93m<sup>2</sup></li> </ul> <p>Separate areas of unenclosed combustible storage by a minimum clear distance of 3m.</p> | Within 3 months |

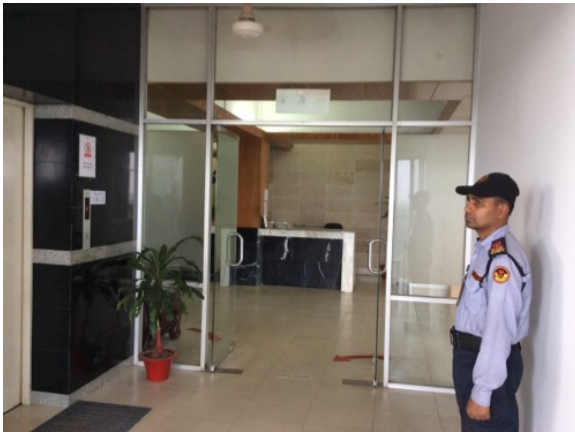
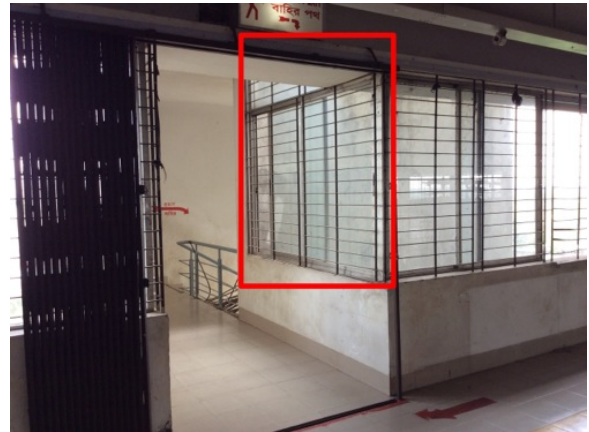
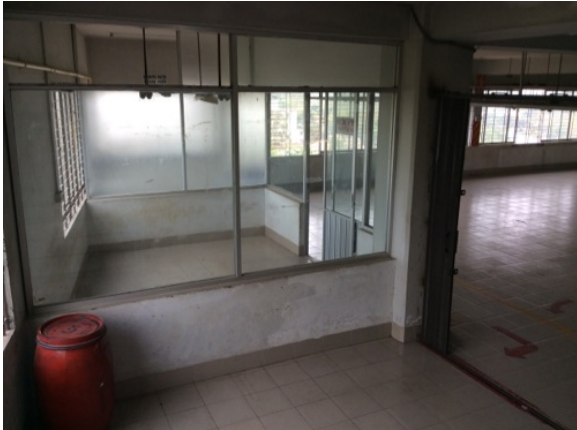
| F-6 | Fire Rated Construction | The exit stairs are not separated from work areas and other spaces on each floor by fire-rated construction. | Provide minimum 1.5-hr fire rated doors and seal all unprotected openings to separate the exit stairs from work areas and other building spaces on all floor levels. Ensure that the fire doors are self-closing and positive latching and that they are provided with fire exit (panic) hardware where serving production floors.<br><br>If fire doors are required to be held open for functional reasons, provide automatic-closing devices tied to the fire alarm system. | Within 3 months |

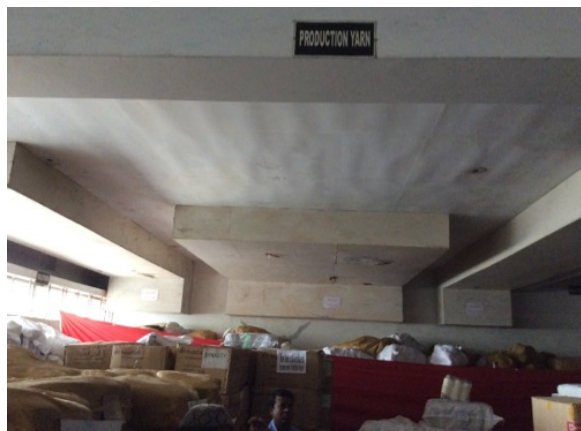
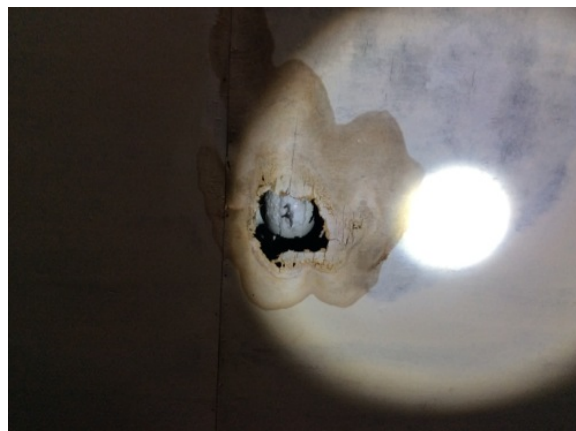
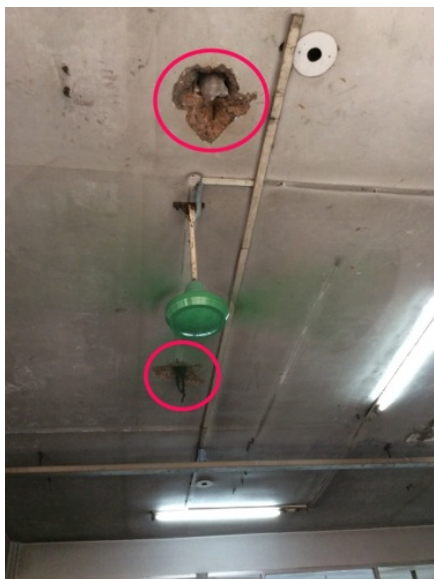
| F-8 | Fire Rated Construction | Unsealed penetrations and openings are located in the fire-rated floor/ceiling assembly on the ground floor in the Bonded Warehouse and in the Ironing Section. | <p>Provide a minimum 2-hr fire-rated shaft to separate the utility risers from each floor level.</p> <p>Seal all penetrations and openings in floor/ceiling assemblies to maintain the fire separation.</p> | Within 3 months |

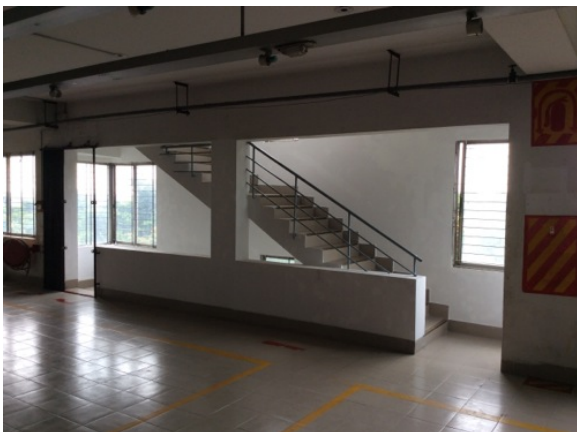
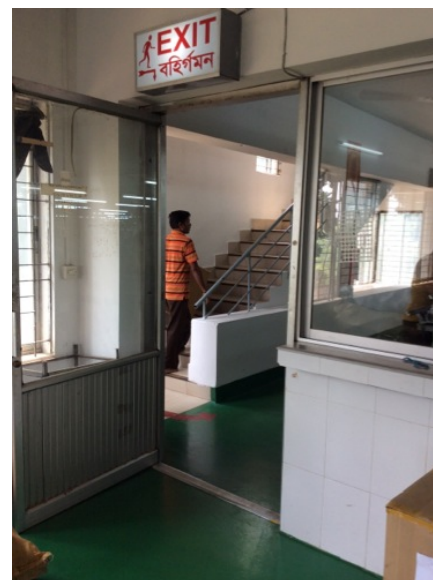
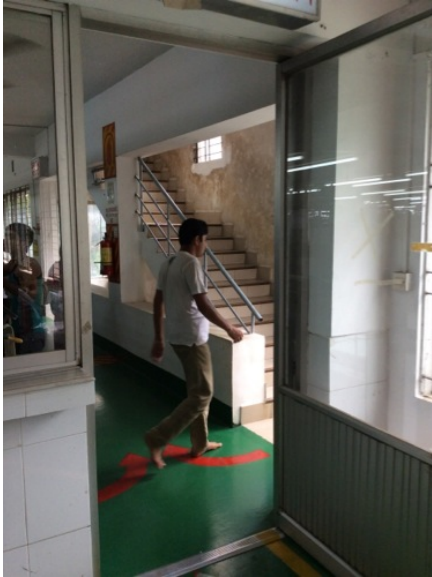
| F-9 | Fire Rated Construction | <p>The southeast and southwest exit stairs are not separated from work areas and other spaces on each floor by fire-rated construction. No fire-rated stairwell enclosure is provided for either stairs.</p> <p>Storage areas (General Store, Bonded Warehouse, Distribution Room) discharge directly to the exit stairs on several floors.</p> | <p>Provide minimum 1.5-hr fire rated doors and enclose both stairs with 2-hr fire-rated construction to separate the exit stairs from work areas and other building spaces on all floor levels. Ensure that the fire doors are self-closing and positive latching and that they are provided with fire exit (panic) hardware where serving production floors.</p> <p>If fire doors are required to be held open for functional reasons, provide automatic-closing devices tied to the fire alarm system.</p> <p>On any floor where a storage room discharges directly to the stairwell, provide a 2-hr fire-rated vestibule within the room with a 1-hr fire-rated door discharging to the storage room and a 1.5-hr fire-rated door discharging to the stairwell.</p> | Within 3 months |

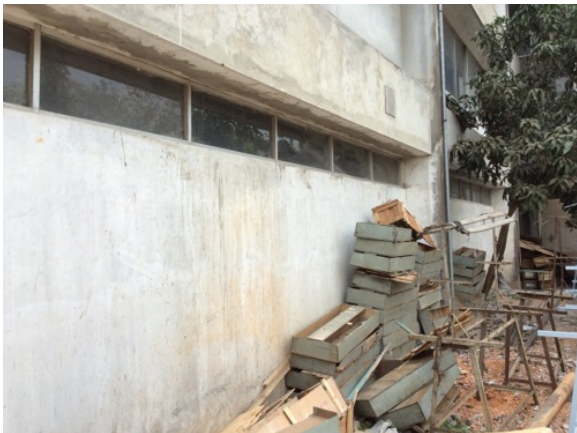
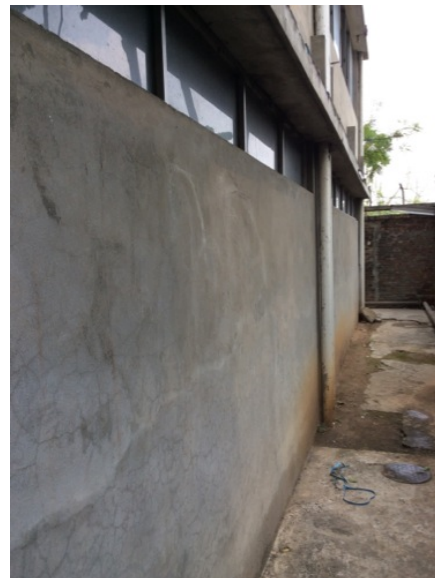
| F-10 | Fire Rated Construction | Discharge path of the southeast stairs to assembly point, with less than 30 ft. building separation, has unprotected openings at a height of less than 15 ft. | Seal all penetrations and openings to the interior of the building, up to a height of 15 ft., to maintain the fire separation. | Within 3 months |

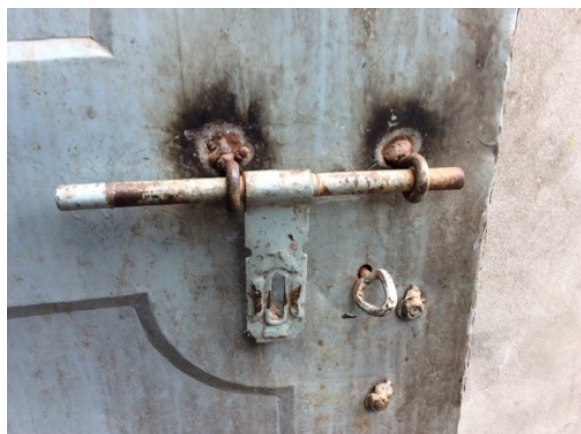
| F-11 | Egress | Egress doors and gates with locking features are provided at building exits, exit stairs, along egress routes, and at exit discharge. All gates and doors were open and unlocked during the inspection. | Remove locking features from all egress doors and gates.<br><br>If locks are required for security reasons, utilize special door locking features complying with NFPA 101. | Immediate |

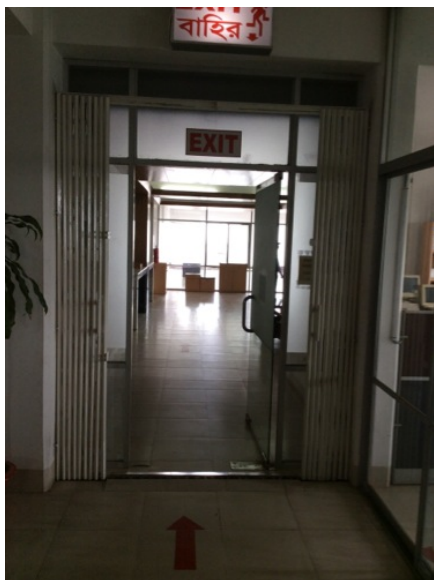
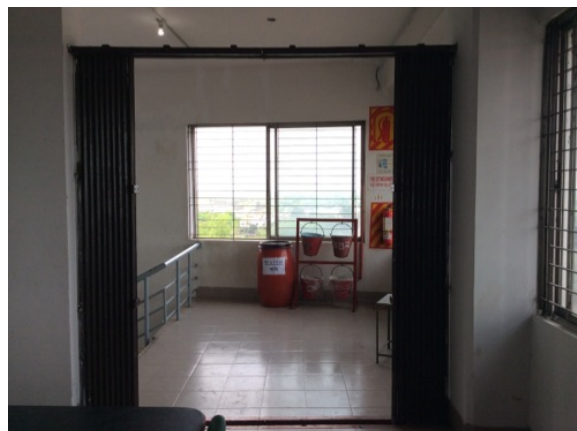
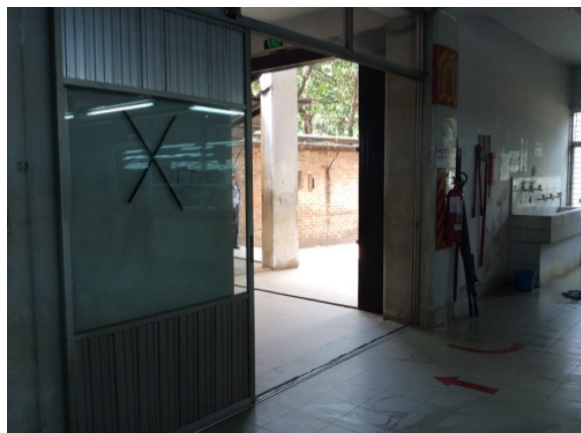
| F-12 | Egress | Collapsible gates and sliding doors are provided at building exits, exit stairs, along egress routes, and at exit discharge. | Replace all gates and sliding doors along the means of egress with side-hinged, swinging egress doors.<br><br>If locks are required for security reasons, utilize special door locking features complying with NFPA 101. | Within 1 month |

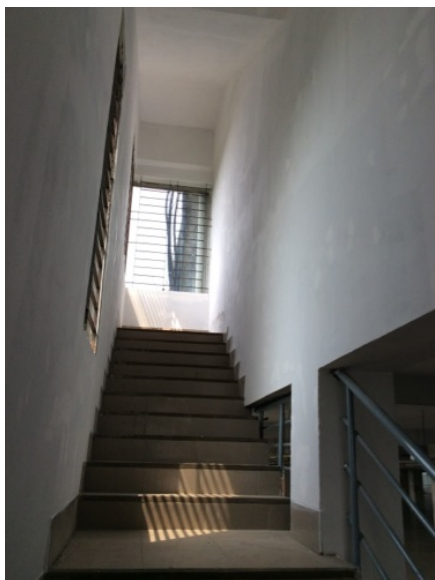
| F-13 | Egress | Common path of egress travel exceeds 30 m. on the sixth floor from the office area. | Reconfigure the egress arrangement to reduce the maximum common path of travel to not more than 30 m.<br><br>Ideally, provide the southeast exit stair as an exit from the office area. | Within 3 months |

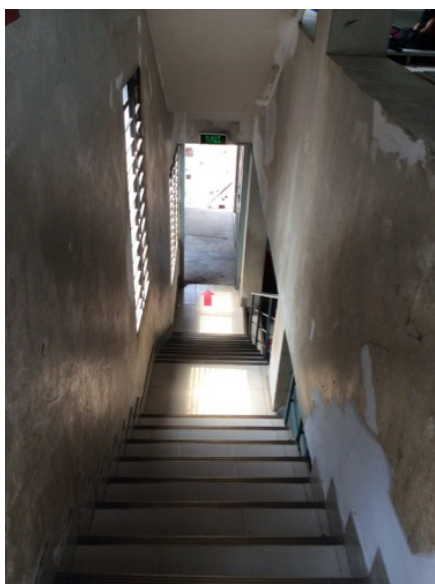
| F-14 | Egress | Handrails are not provided in the southeast and southwest exit stairs. | Provide handrails on at least one side of exit stair. | Within 3 months |

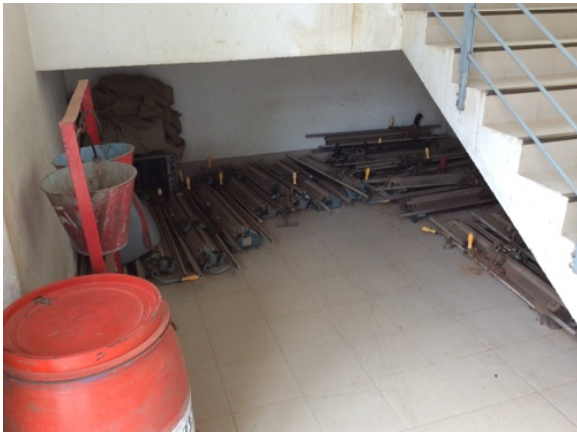
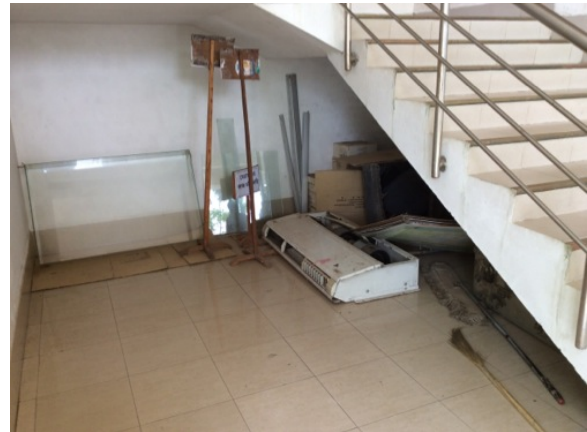
| F-15 | Egress | Storage was located in both northeast exit stairs. | Remove all storage from exit stairs and egress paths. | Within 3 months |

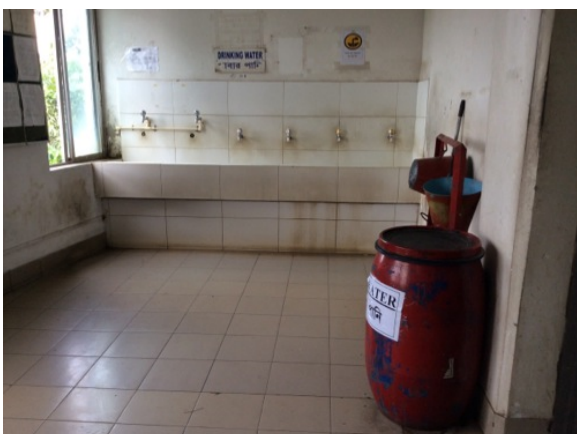
| F-16 | Egress | Non serving equipment (drinking water station) is located in the northwest stairwell. | Relocate the drinking water station to the exterior of the stairwell.<br><br>Alternately, provide access to the drinking water station directly from the factory floor and not through means of accessing the stairwell. | Within 3 months |

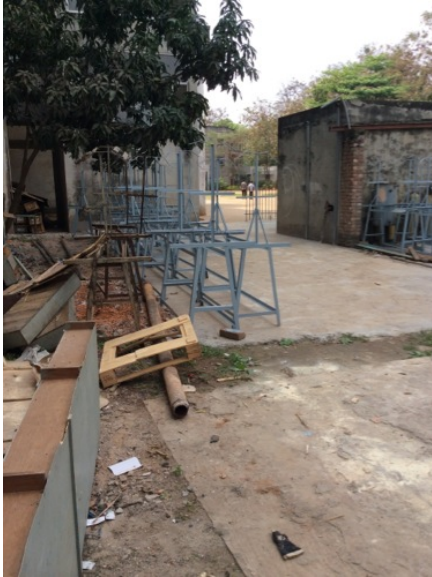
| F-17 | Egress | Storage was located along the discharge path to an assembly point from the southeast stairs. | Remove storage from the discharge path. | Within 3 months |

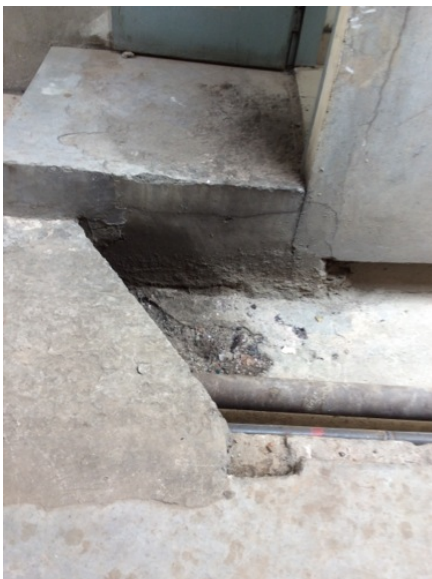
| F-18 | Egress | The exit discharge path of the southwest stairwell poses an immediate tripping/drop off hazard. | Provide an unobstructed even walking surface for all egress routes. | Within 3 months |

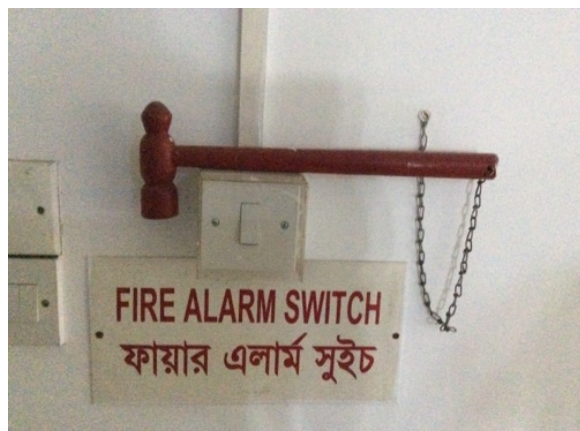
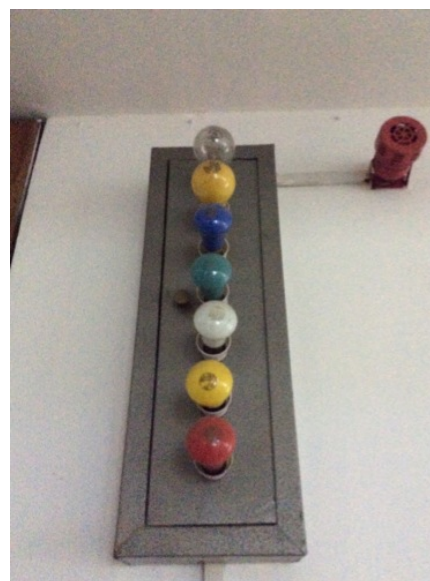
| F-19 | Fire Protection | The fire alarm system is antiquated, not a listed system, and does not provide alarm and notification features consistent with acceptable standards. | Replace the fire alarm system with a new, listed addressable fire alarm system in accordance with NFPA 72. | Design within 4 months, install within 9 months |

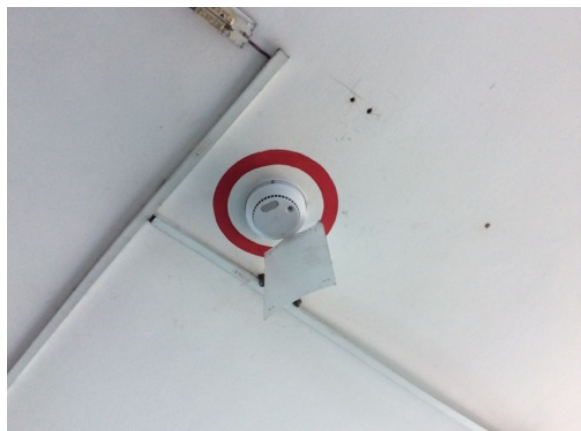
| F-21 | Fire Protection | The building is equipped with single-station smoke alarms. Smoke alarm activation sounds only a local alarm and does not provide automatic fire alarm notification of occupants. | Replace the single-station smoke alarms with automatic smoke detectors tied into the fire alarm system. Configure the fire alarm system to initiate occupant notification upon activation of any two smoke detectors in addition to the manual fire alarm stations. | Within 6 months |

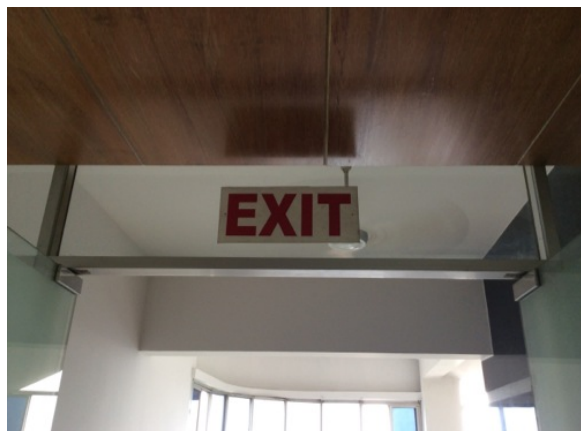
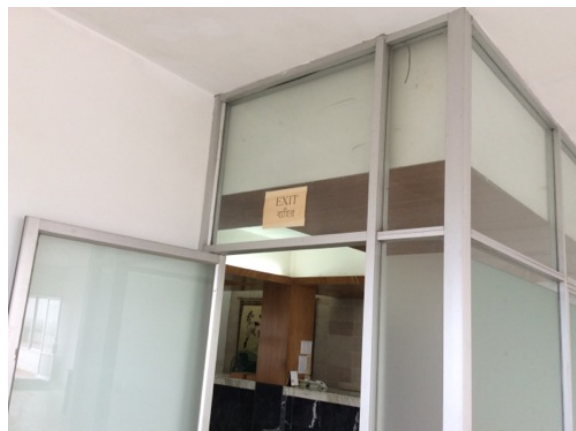
| F-23 | Egress Lighting | Lighted exit signs are not provided at and along the path of egress to the northeast stairwell on the sixth floor. | Provide exit signs above all exits to the exterior and all doors to the exit stairs. | Within 3 months |
