# INITIAL STRUCTURAL INTEGRITY ASSESSMENT REPORT (SIAR)

Factory Name: **Karnaphuli Shoes Industries Ltd. (Garments)**  
Address: **Anowara, Plot # G1 and G2, Korean EPZ, Chittagong  
Chittagong Chittagong Bangladesh**  
Assessor: **Bureau Veritas**  
Date: **21 May 2015**

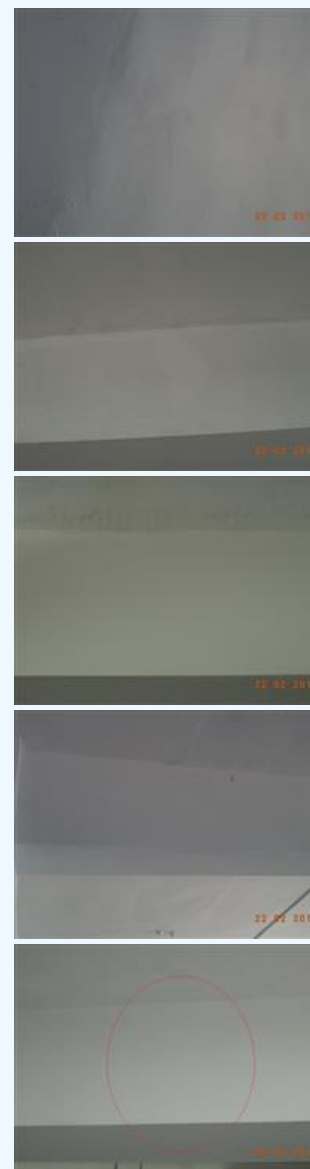
| Description: | There are some shrinkage crack which are not structural but requires proper monitoring. Building-12: North RCC part: -Shrinkage Crack on ceiling at 1st floor. South RCC part: -Shrinkage crack on beam at 1st and 2nd floor. Building-13: North RCC part: -Shrinkage crack on beam at 2nd floor. South RCC part- -Shrinkage crack on beam at 2nd floor. |

| Suggested Plan of Action: | Engage a qualified structural engineer to provide additional investigation into the areas of cracking and provide a remediation plan if required. |

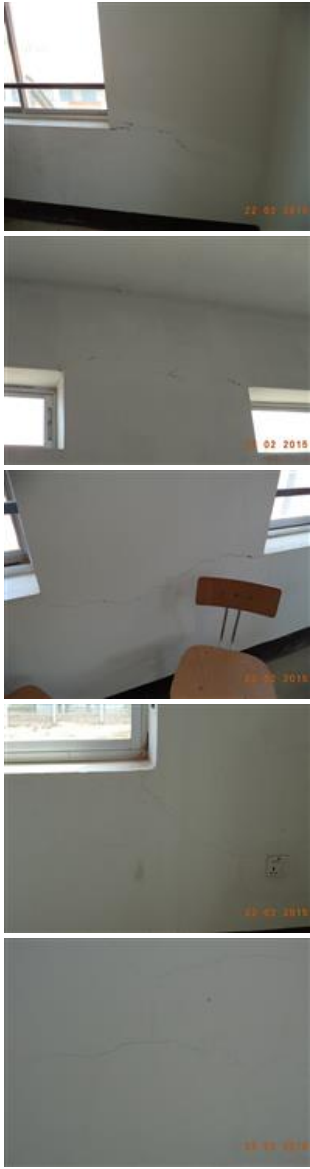
| Description: | Building-12: North side RCC part: -Column and masonry wall joint crack at 2nd floor. -Masonry crack on wall at 1st floor. South side RCC part: -Masonry crack on wall was found at 2nd floor. Building-13: North side RCC part: -Masonry crack on wall at 1st floor and roof staircase. South side RCC part: -Masonry crack on wall at 1st floor. | |

| Suggested Plan of Action: | Have a qualified structural engineer provide further testing and analysis of cracking in walls and provide a remediation plan to correct noted issues. | |
