INITIAL ELECTRICAL ASSESSMENT REPORT (EAR)

Factory Name: **Kenpark Bangladesh Apparel (Pvt) limited (K-4)**
Address: **SFB # 03, Sector #2, Karnaphuli Export Processing
Zone KEPZ, Chittagong Chittagong Chittagong
Bangladesh**
Assessor: **Emkay Enterprises LTD**
Date: **15 Jul 2014**

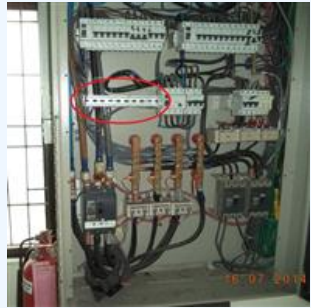
Question:	Are switchboards and/or distribution boards provided with physical means to prevent the installation of more over current devices than that number for which the panel board was designed, rated, and listed.

Priority Level:	Medium	
Non-Compliance Level:	2	
Description:	Capacity information labels have not been found in order to determine how many circuit breakers, the panels were designed for. Some of the distribution boards have space in DIN-rail channel to install additional over-current devices.	
Source of Findings:	Photograph: Space on DIN rail channel in DB-20 on 3rd Floor of Main Building.	
Suggested Plan of Action:	Calculate and display the information of the capacity & panel-schedule of the distribution boards and then provide a physical means to prevent the installation of additional circuit breakers.	
Suggested Deadline Date:	09 Dec 2014
