4A Yarn Dyeing Ltd.

Kaichabari, Savar, Dhaka-1340, Bangladesh
(23.945831, 90.261923)

25 March 2014

Observations

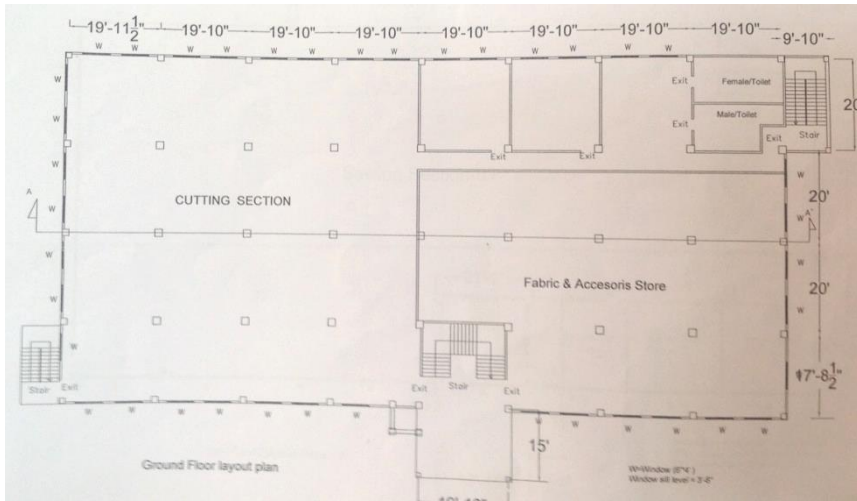
Typical Column Layout

Highly stressed columns

Outline calculations indicate that the working stresses of columns are at a high level.

Building Engineer to check that columns have been designed to accommodate applied loads including roof extension and heavy finishes.

Item No.	Observation	Recommended Action Plan	Recommended Timeline
1	Highly stressed columns	Factory Engineer to review design, loads and columns stresses including any additional loading as documented in the observations chapter.	6-weeks
2	Highly stressed columns	Verify insitu concrete stresses either by 100mm diameter cores or existing cylinder strength data for cores from minimum 4 columns.	6-weeks
3	Highly stressed columns	Produce and actively manage a loading plan for all floor plates within the factory giving consideration to floor capacity and column capacity.	6-months
4	Undocumented vertical extensions	The Building Engineer should check the load plans and confirm that the main building structure is capable of safely supporting the additional loading on the structure from the roof extension.	6-weeks
5	Undocumented vertical extensions	Building Engineer to provide detailed calculations for the temporary rooftop structures and the associated light steel roofs. These should confirm their ability to withstand all wind loading pressure, suctions and uplift forces.	6-months

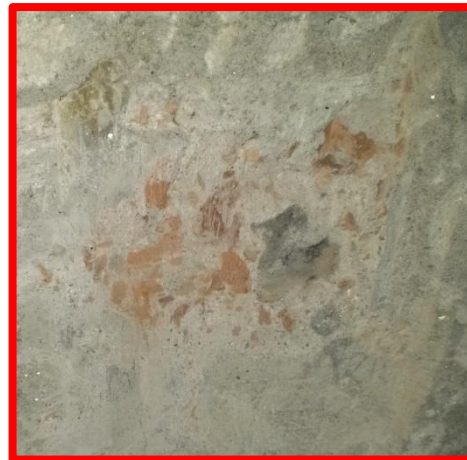
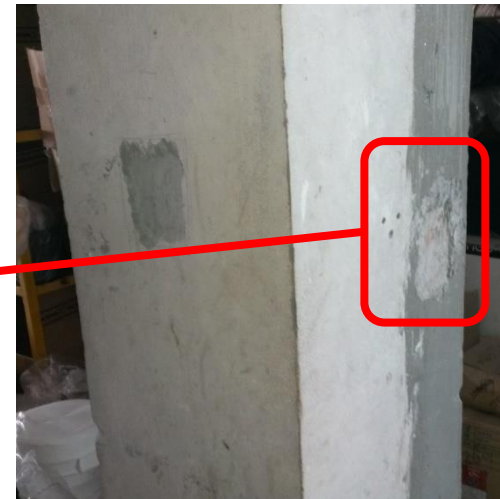
Brick aggregate observed.

Tested column at lower floors - Brick aggregate observed.

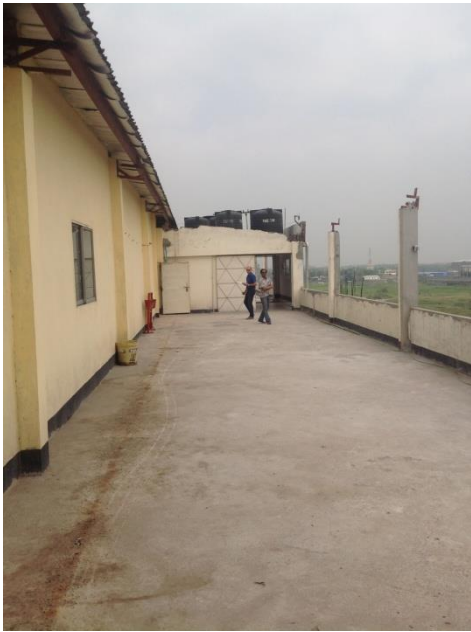
Vertical Extension

Vertical extension on roof, comprising brick masonry walls with a lightweight steel trussed roof on Building 1. No evidence of horizontal bracing.

No structural or design documentation provided for extension. Subject to uplifting forces.

6	Undocumented vertical extensions	Building engineer to check, collect information and produce accurate and complete as-built documentation.	6-months

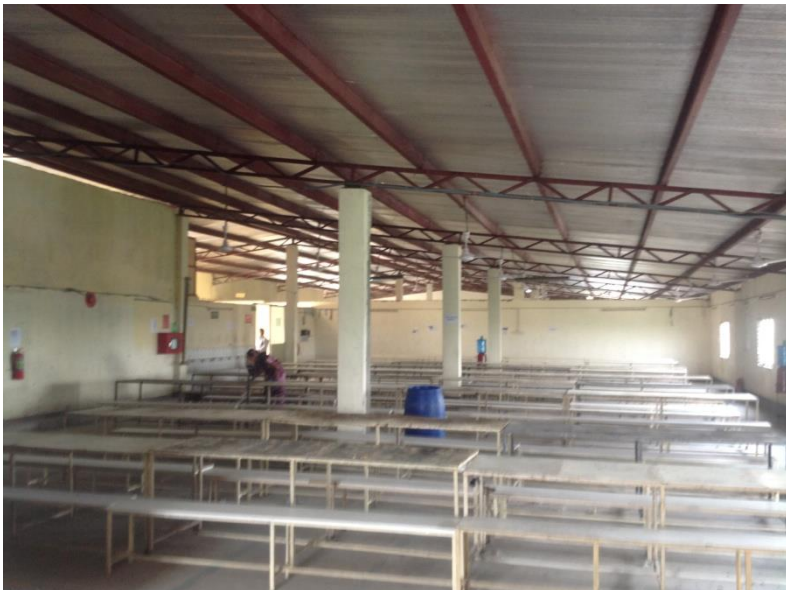
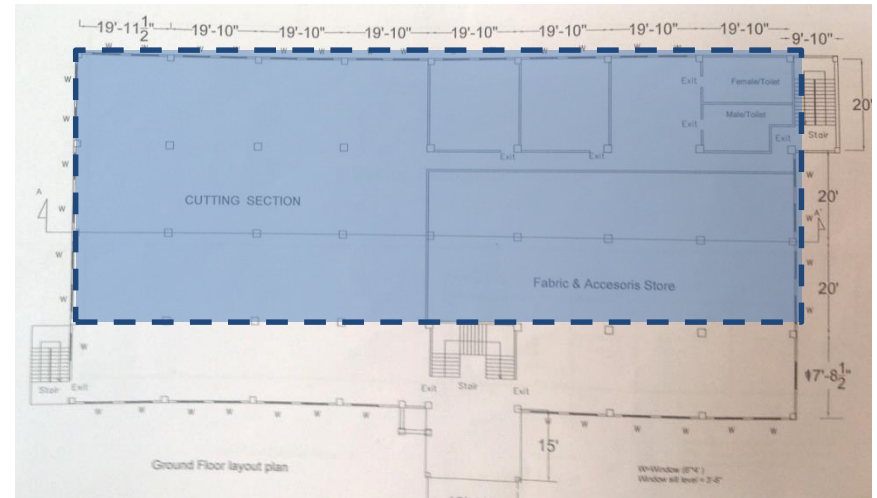
Evidence of previous storage at roof level.

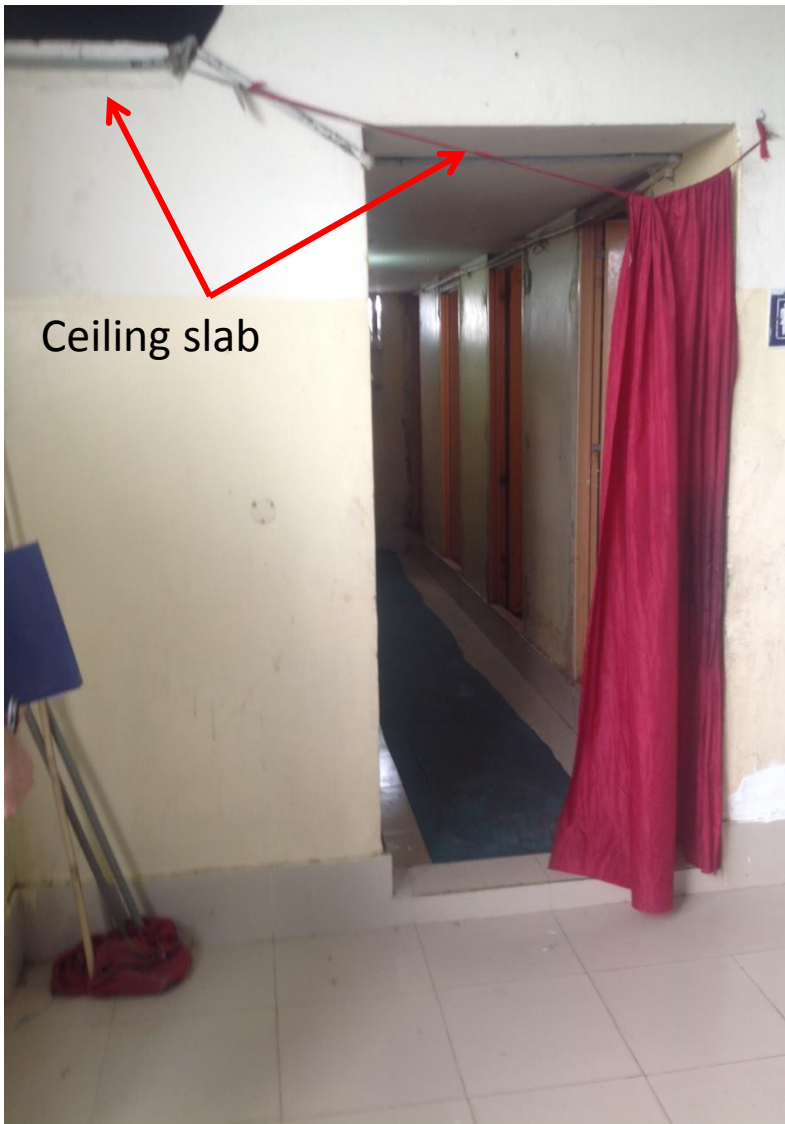
Localised areas of high loading

Ceiling slab

Typical toilet block.

Increased floor build-up in toilet block areas (~150-200mm in cubicles).

Partition walls around block and between additional cubicles

Additional approx. 100mm thick concrete ceiling above toilet blocks.

12	Localised areas of high loading in all buildings	Produce and actively manage a loading plan for all floor plates within the factory giving consideration to floor capacity and column capacity. Loading plans to be put on each factory floor.	6-months

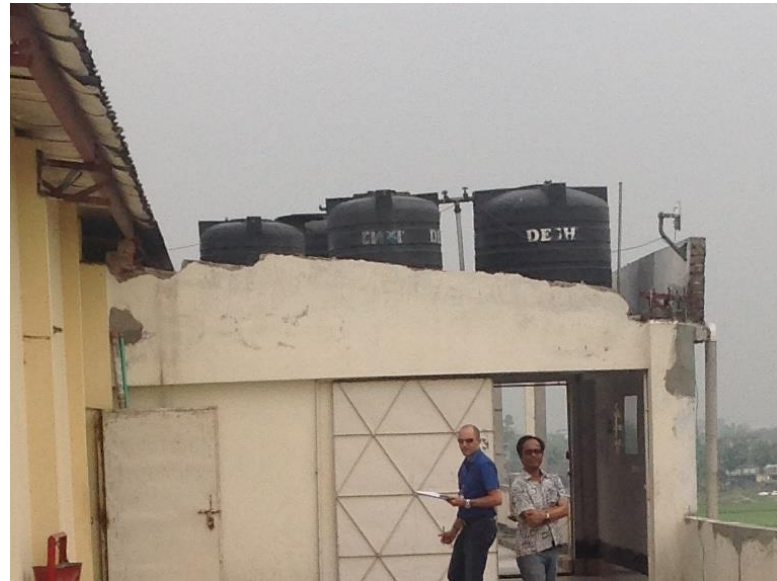
Tank storage

Water tank storage at roof level

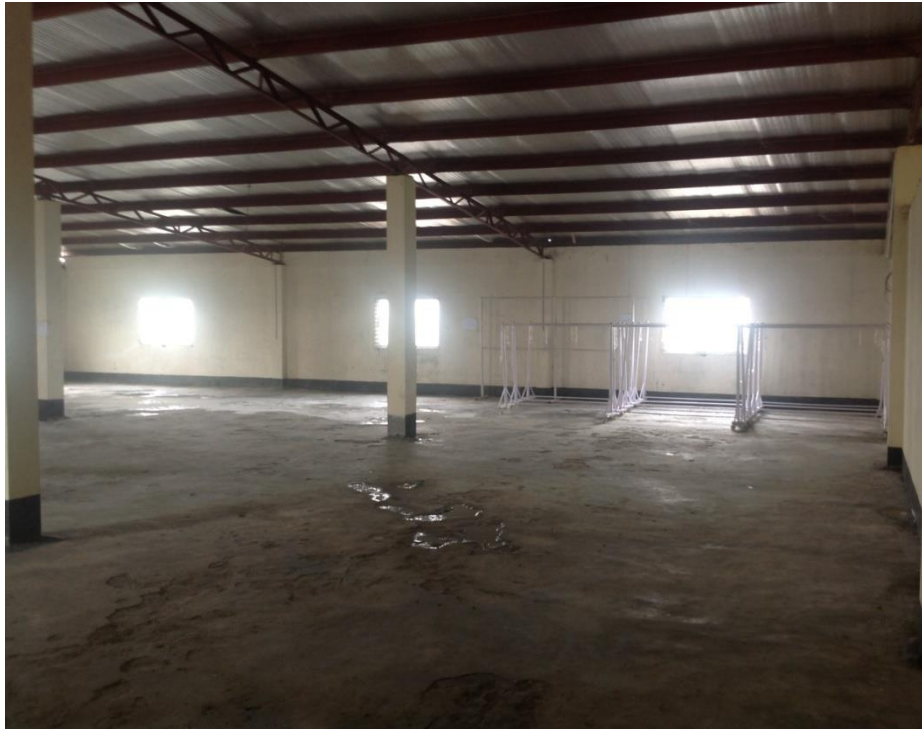
Empty storage at roof level

Empty storage area observed at roof level.

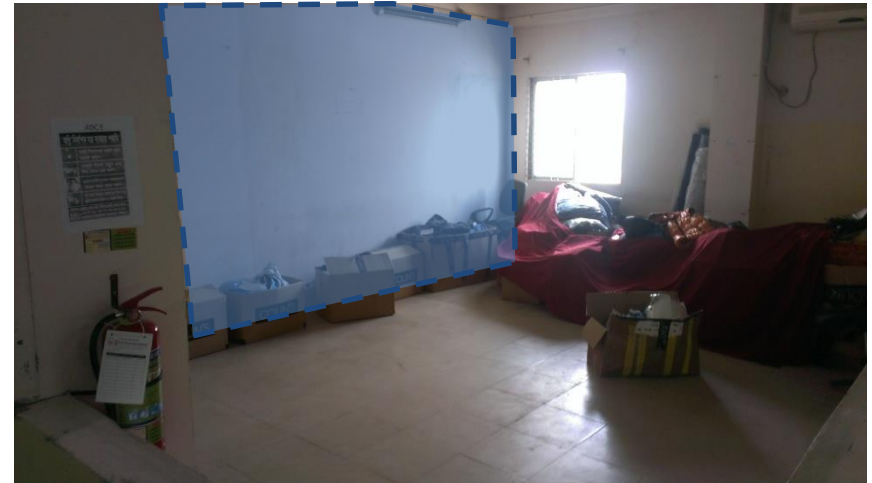
Full height brick partitions supported directly on flat slab structure in a number of locations.

Full height partition supported from regular flat slab structure.

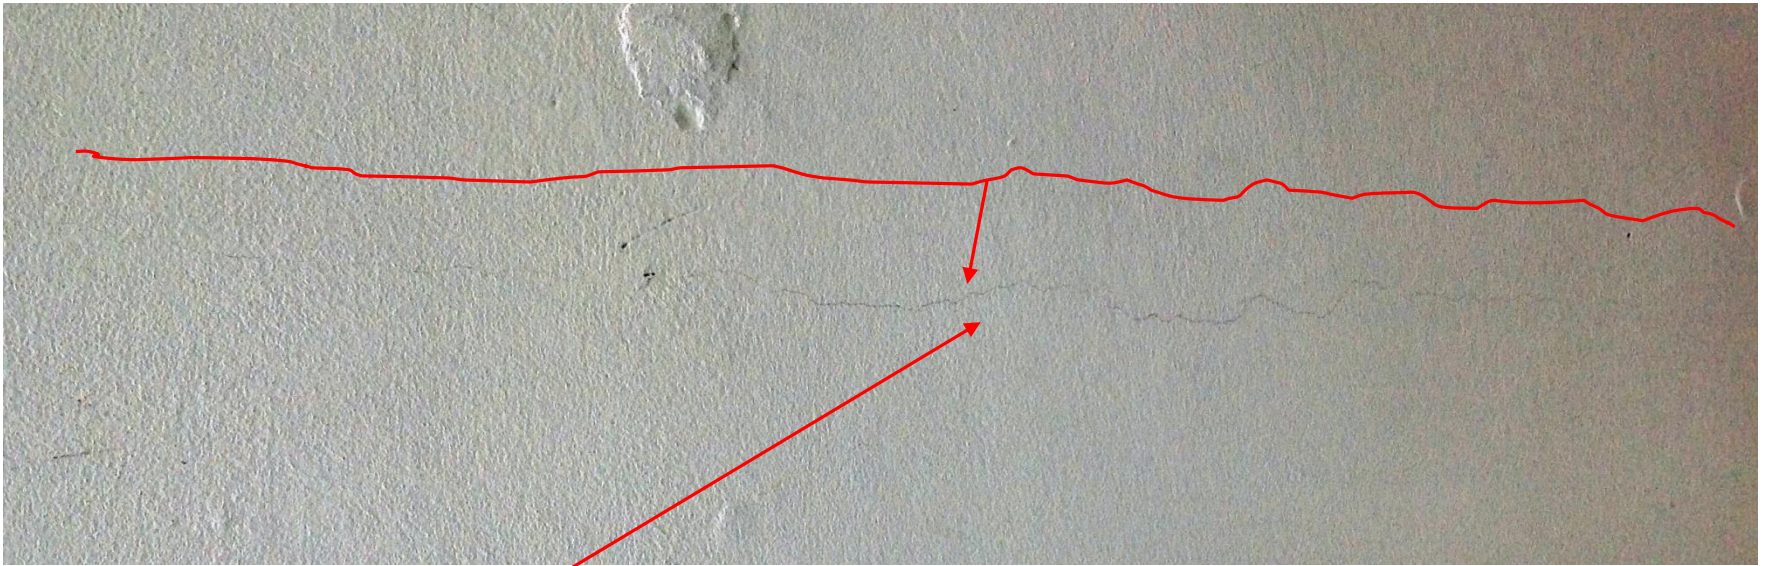
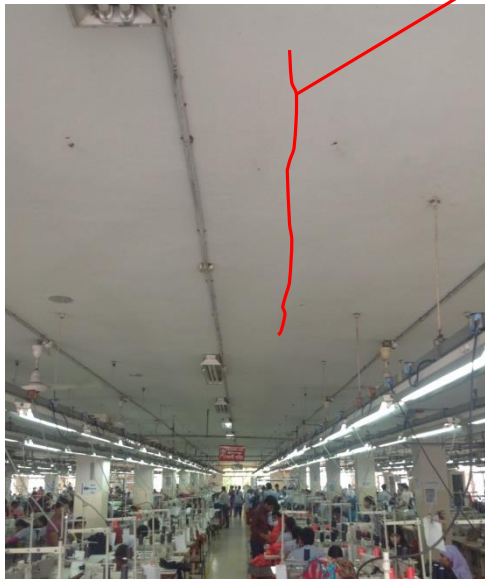
Cracking in slab below full-height partition

Crack on surface of slab soffit observed at level 1 directly below line of full height brick partition in level 2.

Factory engineer to check adequacy of flat slab structure for as-built brick partitions.

Item No.	Observation	Recommended Action Plan	Recommended Timeline
7	Cracking in slab below full-height partition	Flat slab capacity to be assessed for additional loading due to brick partitions, and extent of cracking within slab depth to be investigated.	6-weeks
8	Cracking in slab below full-height partition	Remove partitions if required by design check	6-months
9	Cracking in slab below full-height partition	Repair slab if required following investigation of crack	6-months
10	Cracking in slab below full-height partition	Design check of building required prior to installing any new brick partition walls.	6-months
11	Localised areas of high loading in all buildings	Extent of build-up loading in toilet and wash areas to be surveyed and weight of water tanks on roof to be assessed. The capacity of floor & roof slabs to be assessed to confirm that the structure is designed to carry these loads.	6-weeks

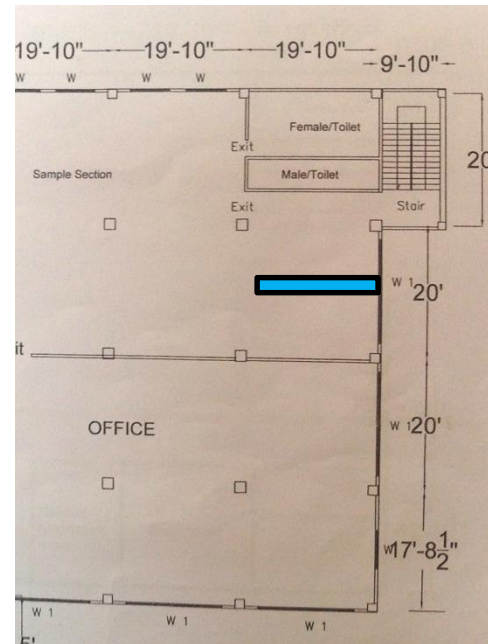
Location of partition wall at level 2 and crack in slab below

Crack in soffit of slab below full-height partition

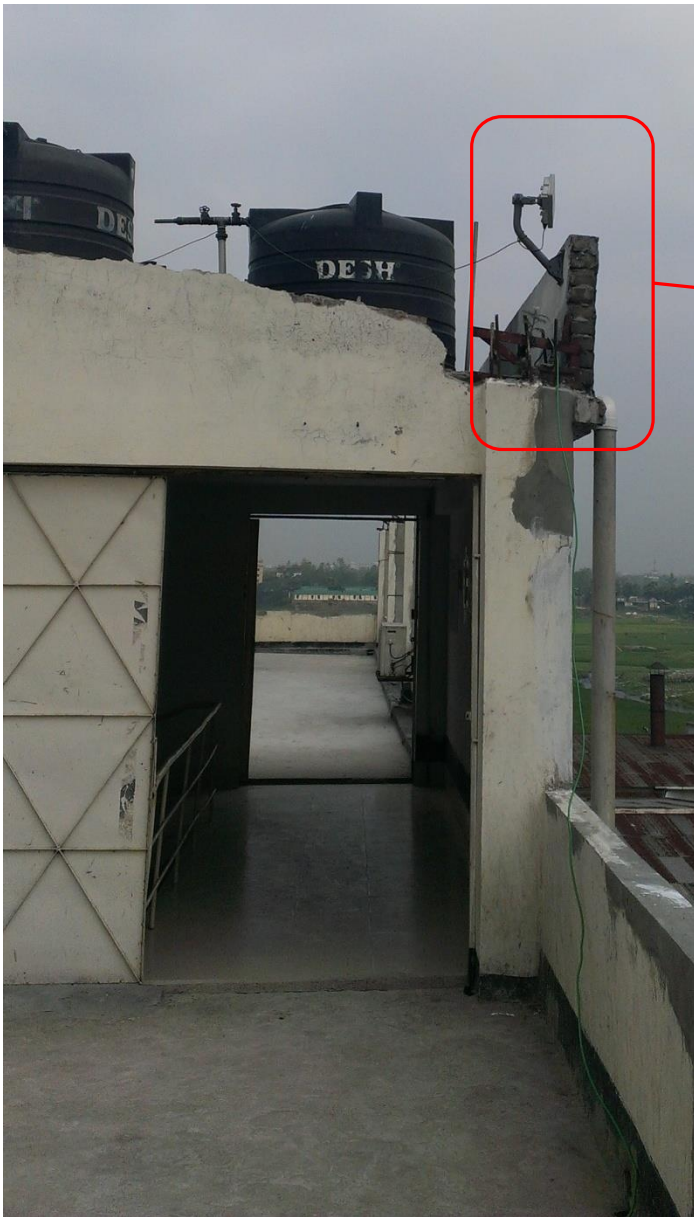
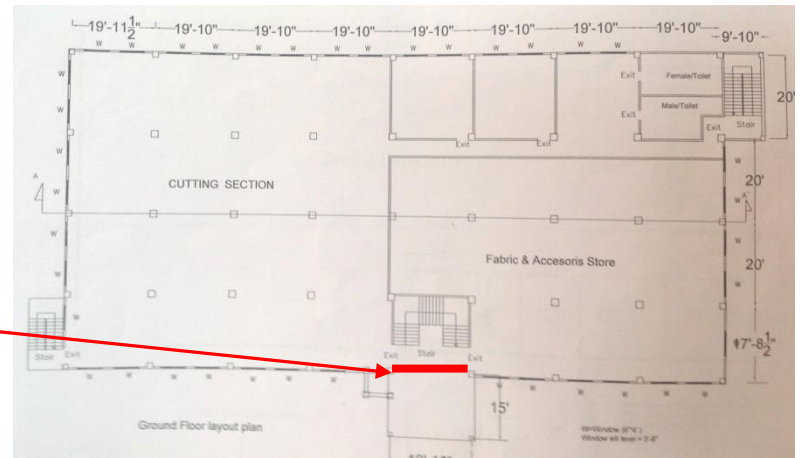
Unrestrained parapet at roof level

Location of parapet adjacent to water tank storage.

Roof parapet in the water tank storage area observed to be unrestrained and out of plumb.

Item No.	Observation	Recommended Action Plan	Recommended Timeline
13	Unrestrained parapet at roof level	Building engineer to assess stability of the roof partitions.	6-weeks
14	Unrestrained parapet at roof level	Repairs to be carried out as required by engineering assessment.	6-months
15	Undocumented single storey industrial and utility buildings	Building Engineer to verify that building has an appropriate lateral stability system and submit relevant design document	6-weeks
16	Undocumented single storey industrial and utility buildings	Carry out remedial work if required.	6-months
17	Undocumented single storey industrial and utility buildings	Building engineer to assess single storey utility building and confirm its ability to withstand all wind loading pressure, suctions and uplift forces	6-months

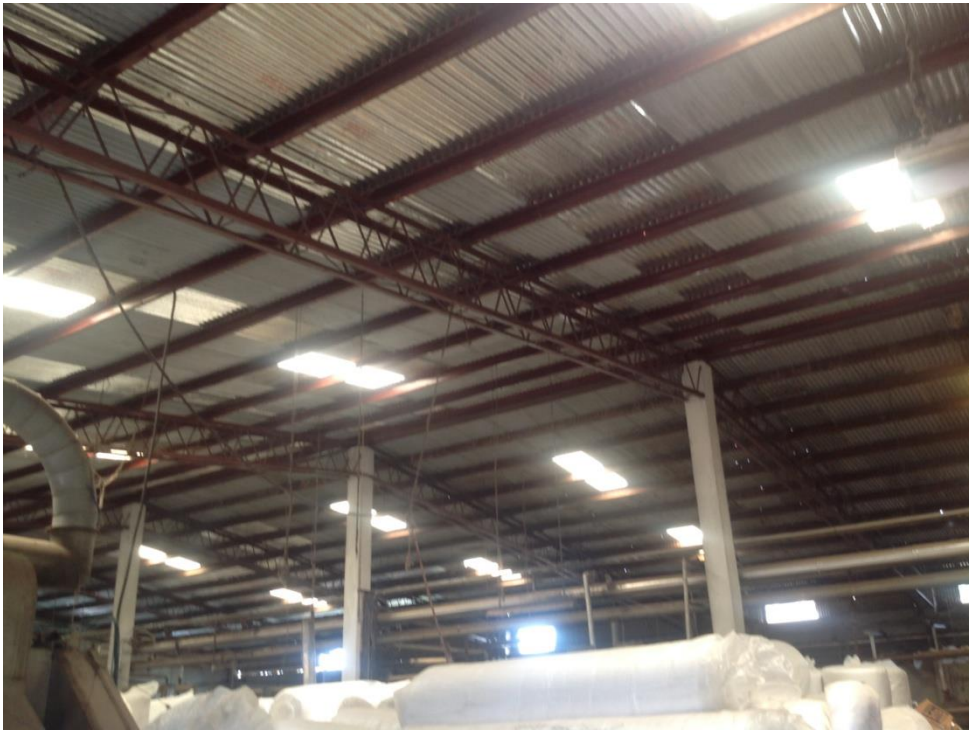
Undocumented single storey industrial and utility buildings

No roof bracing observed in single storey industrial building. Cantilevering perimeter walls are the only evident stability structure.
