# ELECTRICAL SAFETY INSPECTION REPORT

## TAQWA FABRICS LTD.

Kewa, Boherarchala, Gila Beraeed, Sreepur, Gazipur, Bangladesh.

Inspected on April 26, 2014

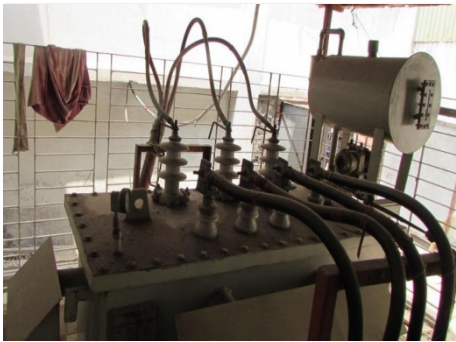
| <b>Finding #:</b> E- 1 | |

| <b>Finding:</b><br><br>Excessive lint and dust found o transformer top. | |
| <b>Remediation Timeframe:</b> Within 1 month | Power transformer. |

| <b>Recommendation:</b><br>Establish a routine cleaning program to keep neat and clean the transformer room. Shut down the power of the transformer and clean the exterior of the transformer at scheduled period. | |

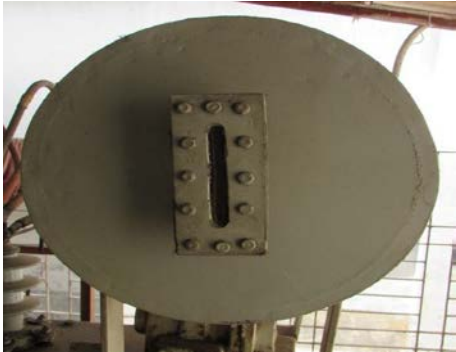
| <b>Finding #:</b> E- 2 | |

| <b>Finding:</b><br><br>Conservator tank oil level is low. | |
| <b>Remediation Timeframe:</b> Within 1 month | Conservator tank |

| <b>Recommendation:</b><br>Required oil level must be maintained as per the instruction of the manufacturer. | |

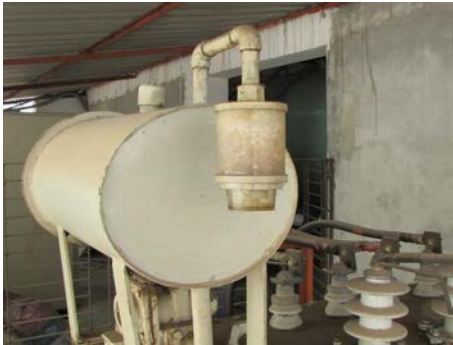
| <b>Finding:</b><br>Silica gel is discolored. | |
| <b>Remediation Timeframe:</b> Within 1 month | Breather silica gel |

| <b>Recommendation:</b><br>Shut down the transformer and replace the silica gel or perform maintenance to remove moisture from it. Consult with transformer servicing company before performing the task. Establish a routine maintenance & inspection program for transformer to ensure any future repetition of the occurrence. | |

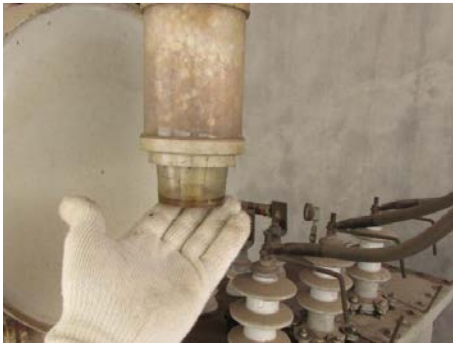
| <b>Finding #:</b> E- 4 | |

| <b>Finding:</b><br>Breather oil cup is empty. | |
| <b>Remediation Timeframe:</b> Within 1 month | Breather oil cup |

| <b>Recommendation:</b><br>Fill the Breather oil cup with transformer oil up to the required level as instructed by the manufacturer. | |

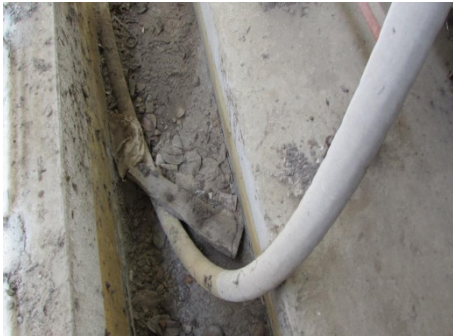
| <b>Finding #:</b> E- 5 | |

| <b>Finding:</b><br>HT cable trench is filled with debris. | |
| <b>Remediation Timeframe:</b> 3 months | HT cable trench |

| <b>Recommendation:</b><br>Provide trench cover(slab) and clean it in regular interval. | |

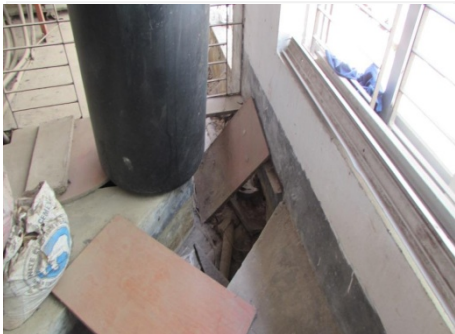
| <b>Finding #:</b> E- 6 | |

| <b>Finding:</b><br><br>Cable trench is partially covered by wood. | |
| <b>Remediation Timeframe:</b> 3 months | <p>Wooden cover on trench.</p> |

| <b>Recommendation:</b><br><br>Inflammable material must be removed and slab or checkered plate must be used to cover the trench. | |

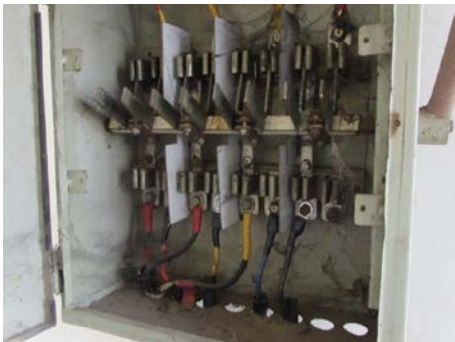
| <b>Finding:</b><br><br>Excessive lint and dust is found in the panel. | |
| <b>Remediation Timeframe:</b> Within 1 month | <p>Changeover switch.</p> |

| <b>Recommendation:</b><br><br>Disconnect the power source of the panel and clean dust and debris of all interior components. Establish a periodic cleaning program and maintain records of the activities. Provide cover made of noncombustible material on the opening for preventing ingress of dust and debris in future | |

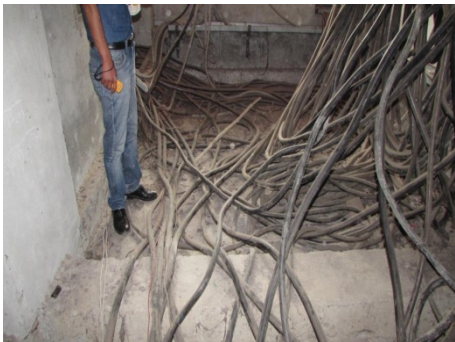
| <b>Finding #:</b> E- 8 | |

| <b>Finding:</b><br><br>Cables are laid directly on the floor. | |
| <b>Remediation Timeframe:</b> 3 months | <p>Power cables on the floor</p> |

| <b>Recommendation:</b><br><br>Provide cable tray or cable ladder with protective cover to support the noted cables from any damage due to stepping of operator or occupants. | |

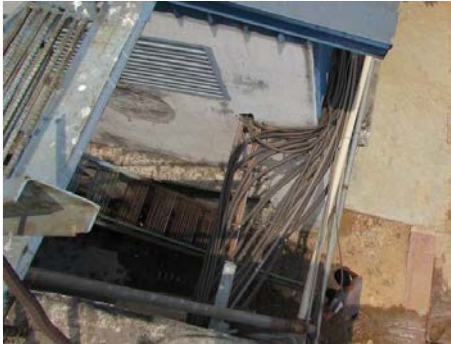
| <b>Finding #:</b> E- 9 | |

| <b>Finding:</b><br><br>Cable tray size is not sufficient. | |
| <b>Remediation Timeframe:</b> 3 months | Insufficient cable tray. |

| <b>Recommendation:</b><br><br>Existing cable tray may be extended or one additional cable tray may be installed to accommodate all the cable. The cable tray must be continuous throughout of the length of the cable. | |

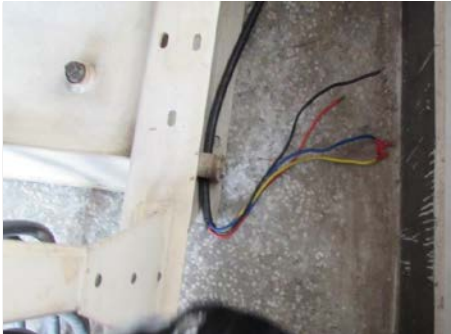
| <b>Finding #:</b> E- 10 | |

| <b>Finding:</b><br><br>Live cable is not terminated. | |
| <b>Remediation Timeframe:</b> Within 1 month | Live cable is not terminated |

| <b>Recommendation:</b><br><br>Cable must be terminated properly. Unused cable must be removed. | |

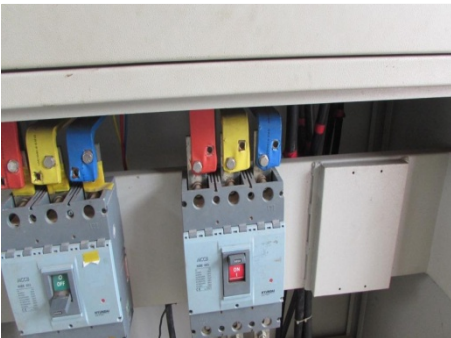
| <b>Finding #:</b> E- 11 | |

| <b>Finding:</b><br><br>No phase barrier is installed in MCCB. | |
| <b>Remediation Timeframe:</b> Within 1 month | MCCBs without phase barrier. |

| <b>Recommendation:</b><br><br>Install separators between different phases of MCCB. Standard separators provided by the MCCB manufacturer must be used. | |

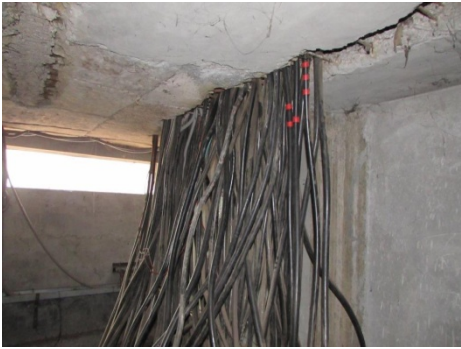
| <b>Finding #:</b> E- 12 | |

| <b>Finding:</b><br>Cables passing through the wall are not protected. | |
| <b>Remediation Timeframe:</b> 3 months | Cables are passing through the wall |

| <b>Recommendation:</b><br>Cables passing through permanent walls must be protected in steel cable duct and remaining holes around the pipe must be sealed with appropriate fire rated materials. The duct shall be installed throughout the length of the cable to prevent any physical damage. | |

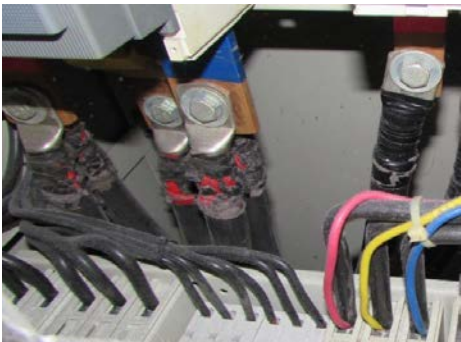
| <b>Finding #:</b> E- 13 | |

| <b>Finding:</b><br>Cables tape inside the panel deteriorated. | |
| <b>Remediation Timeframe:</b> Within 1 month | Cables inside the panel |

| <b>Recommendation:</b><br>Remove the damaged tape and heat shrinkable tube may be used after punching the socket. Arrange periodic inspection & thermal scan to identify the overloading, loose connection, unbalanced load which may cause the excessive heat-rise and take action accordingly. | |

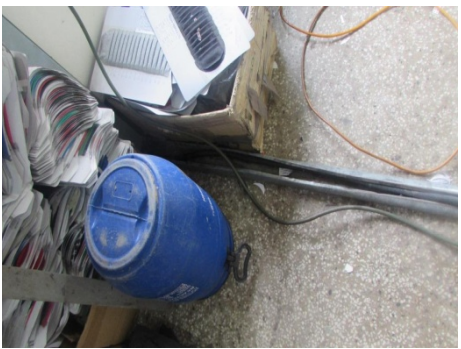
| <b>Finding #:</b> E- 14 | |

| <b>Finding:</b><br>Cables are passing through the combustible storage. | |
| <b>Remediation Timeframe:</b> Within 1 month | Combustible storage |

| <b>Recommendation:</b><br>Remove all combustible storage around electrical apparatus or wiring system may be installed through a safe route. | |

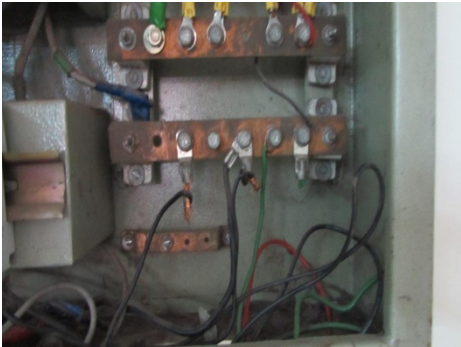
| <b>Finding #:</b> E- 15 | |

| <b>Finding:</b><br><br>Wires are joint twisted. | |
| <b>Remediation Timeframe:</b> Within 1 month | Wires are joint twisted |

| <b>Recommendation:</b><br>Use cable socket according to the respective cable size for termination of each cable. | |

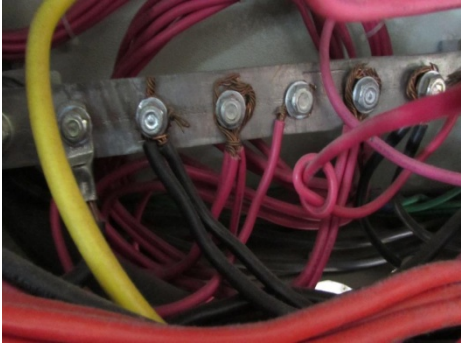
| <b>Finding #:</b> E- 16 | |

| <b>Finding:</b><br><br>Wires are connected with the busbar without lug. | |
| <b>Remediation Timeframe:</b> Within 1 month | Wire lug is missing. |

| <b>Recommendation:</b><br>Use cable socket according to the respective cable size for termination of each cable. Terminate each cable individually on the bus bar (providing individual lug according to the cable size). Multiple cables shall not be terminated on same point of bus bar. | |
